2008 Stormwater Needs Assessment Program

Salmon Creek (RM 03.83)/Cougar Creek
Subwatershed Needs Assessment Report

Clark County Public Works Clean Water Program

April 2009

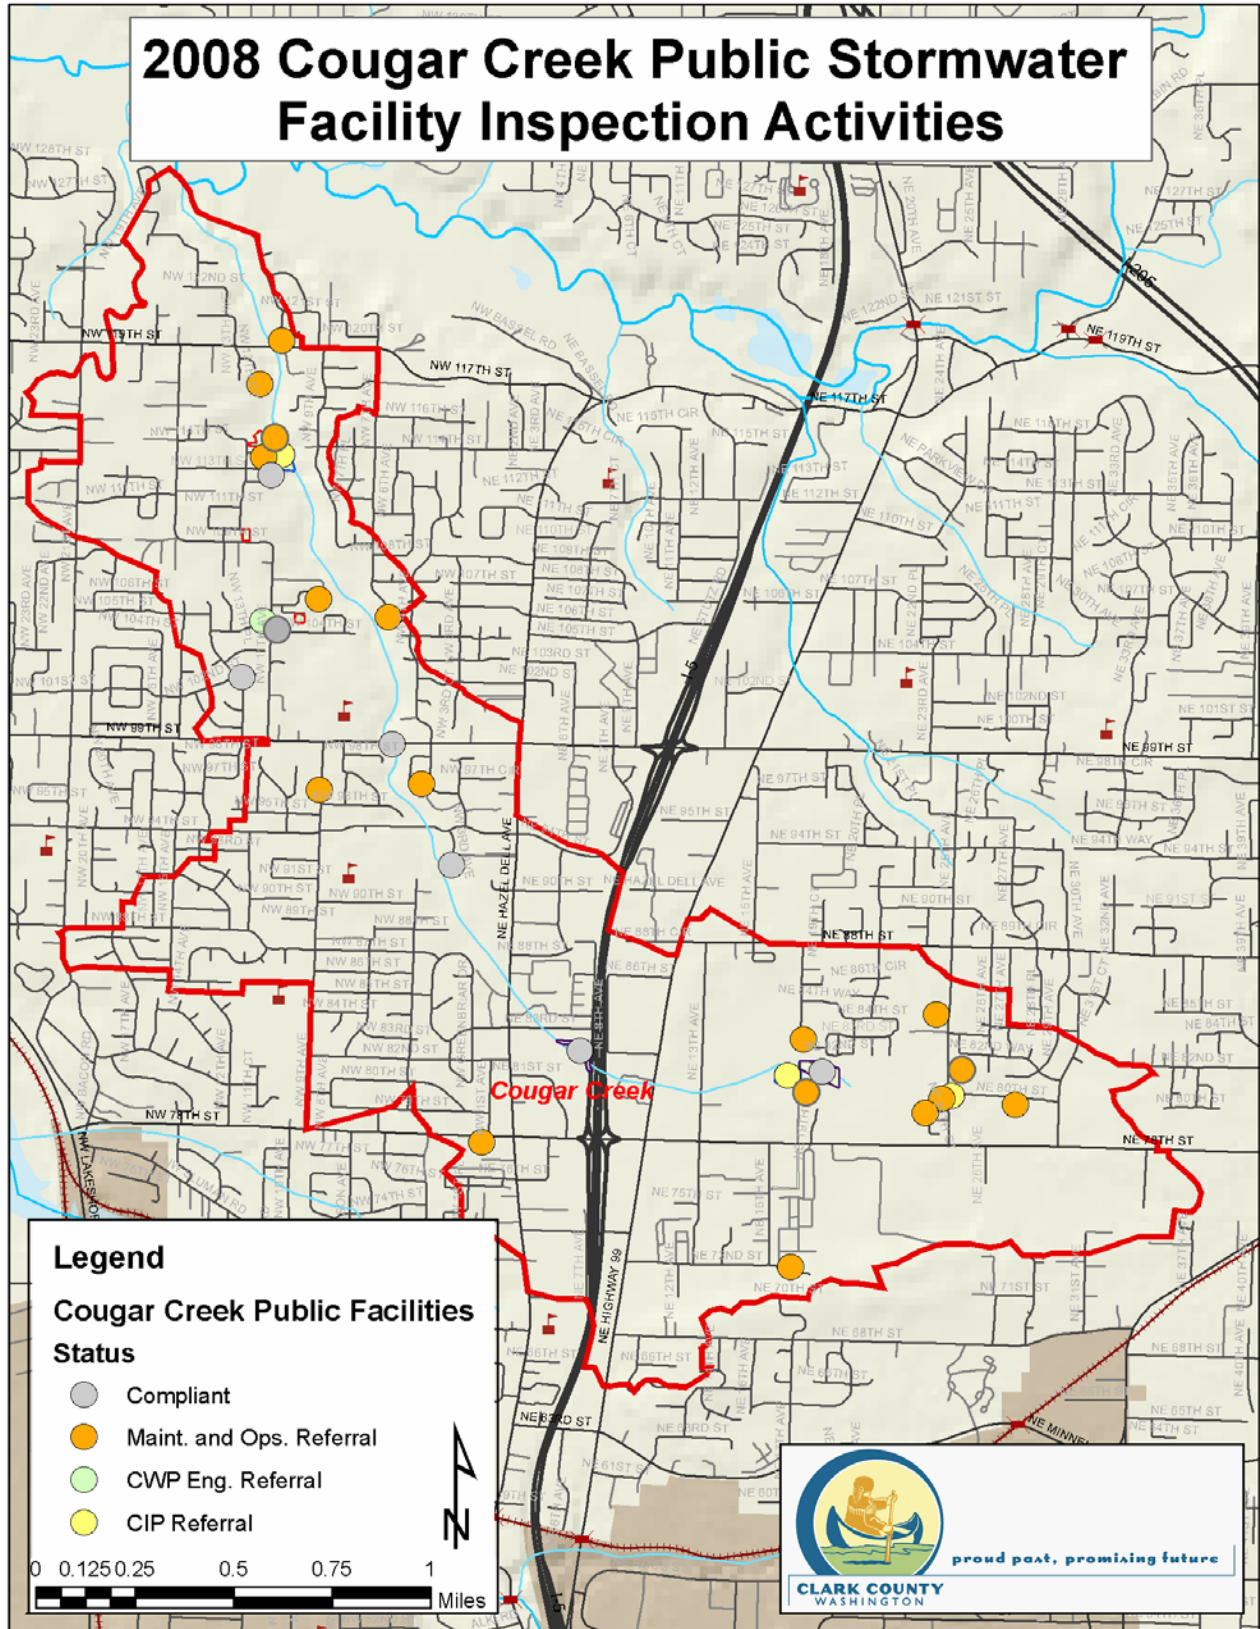
Figure 5: Summary of 2008 Public Stormwater Facility Inspection Activities in the Cougar Creek Subwatershed

The most common facility objects found out of compliance during the public stormwater facility inspection process were energy dissipaters, bioswales, and lack of stormwater facility signage. Excessive sedimentation was the most common noncompliant defect across facility objects. Vegetative management issues were the most common noncompliant defects regarding bioswales. These defects included overgrown bioswales where grasses exceeded 10 inches in height with nuisance weeds and other vegetation starting to take over.

Approximately 45 percent of public stormwater facilities were missing signage. Correcting facility sedimentation issues and maintenance of bioswales, and adding appropriate signage will bring most facilities into compliance.

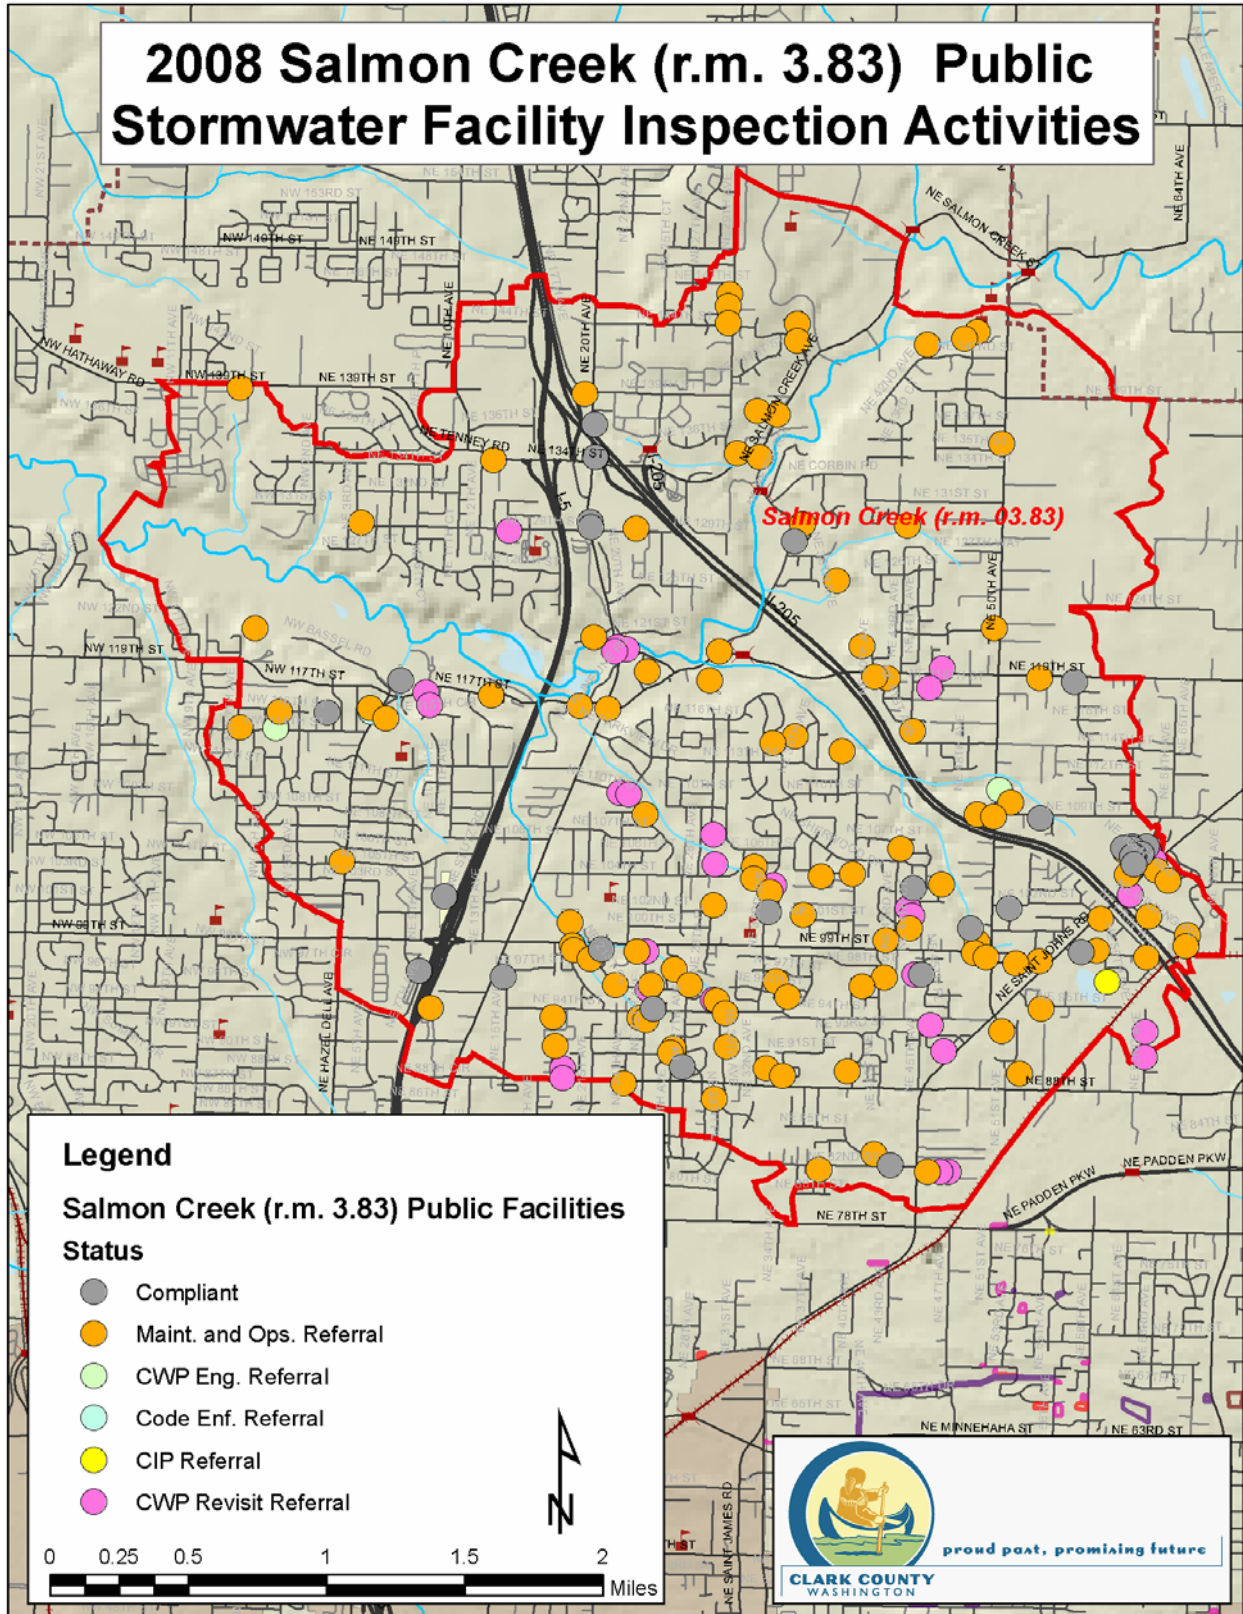
Figure 6: Summary of 2008 Public Stormwater Facility Inspection Activities in the Salmon Creek (RM 03.83) Subwatershed

The most common facility objects found out of compliance during the public stormwater facility inspection process were flow control structures, conveyance stormwater pipes, energy dissipaters, bioswales, and lack of stormwater facility signage. Excessive sedimentation was the most common noncompliant defect across facility objects. Sedimentation defects were the common noncompliant issue for flow control structures, conveyance stormwater pipes, sediment traps, and energy dissipaters. Vegetative management issues were the most common noncompliant defects regarding bioswales. These defects included overgrown bioswales where grasses exceeded 10 inches in height with nuisance weeds and other vegetation starting to take over. Approximately 33 percent of public stormwater facilities were missing signage. Correcting facility sedimentation issues and maintenance of bioswales, and adding appropriate signage will bring most facilities into compliance.

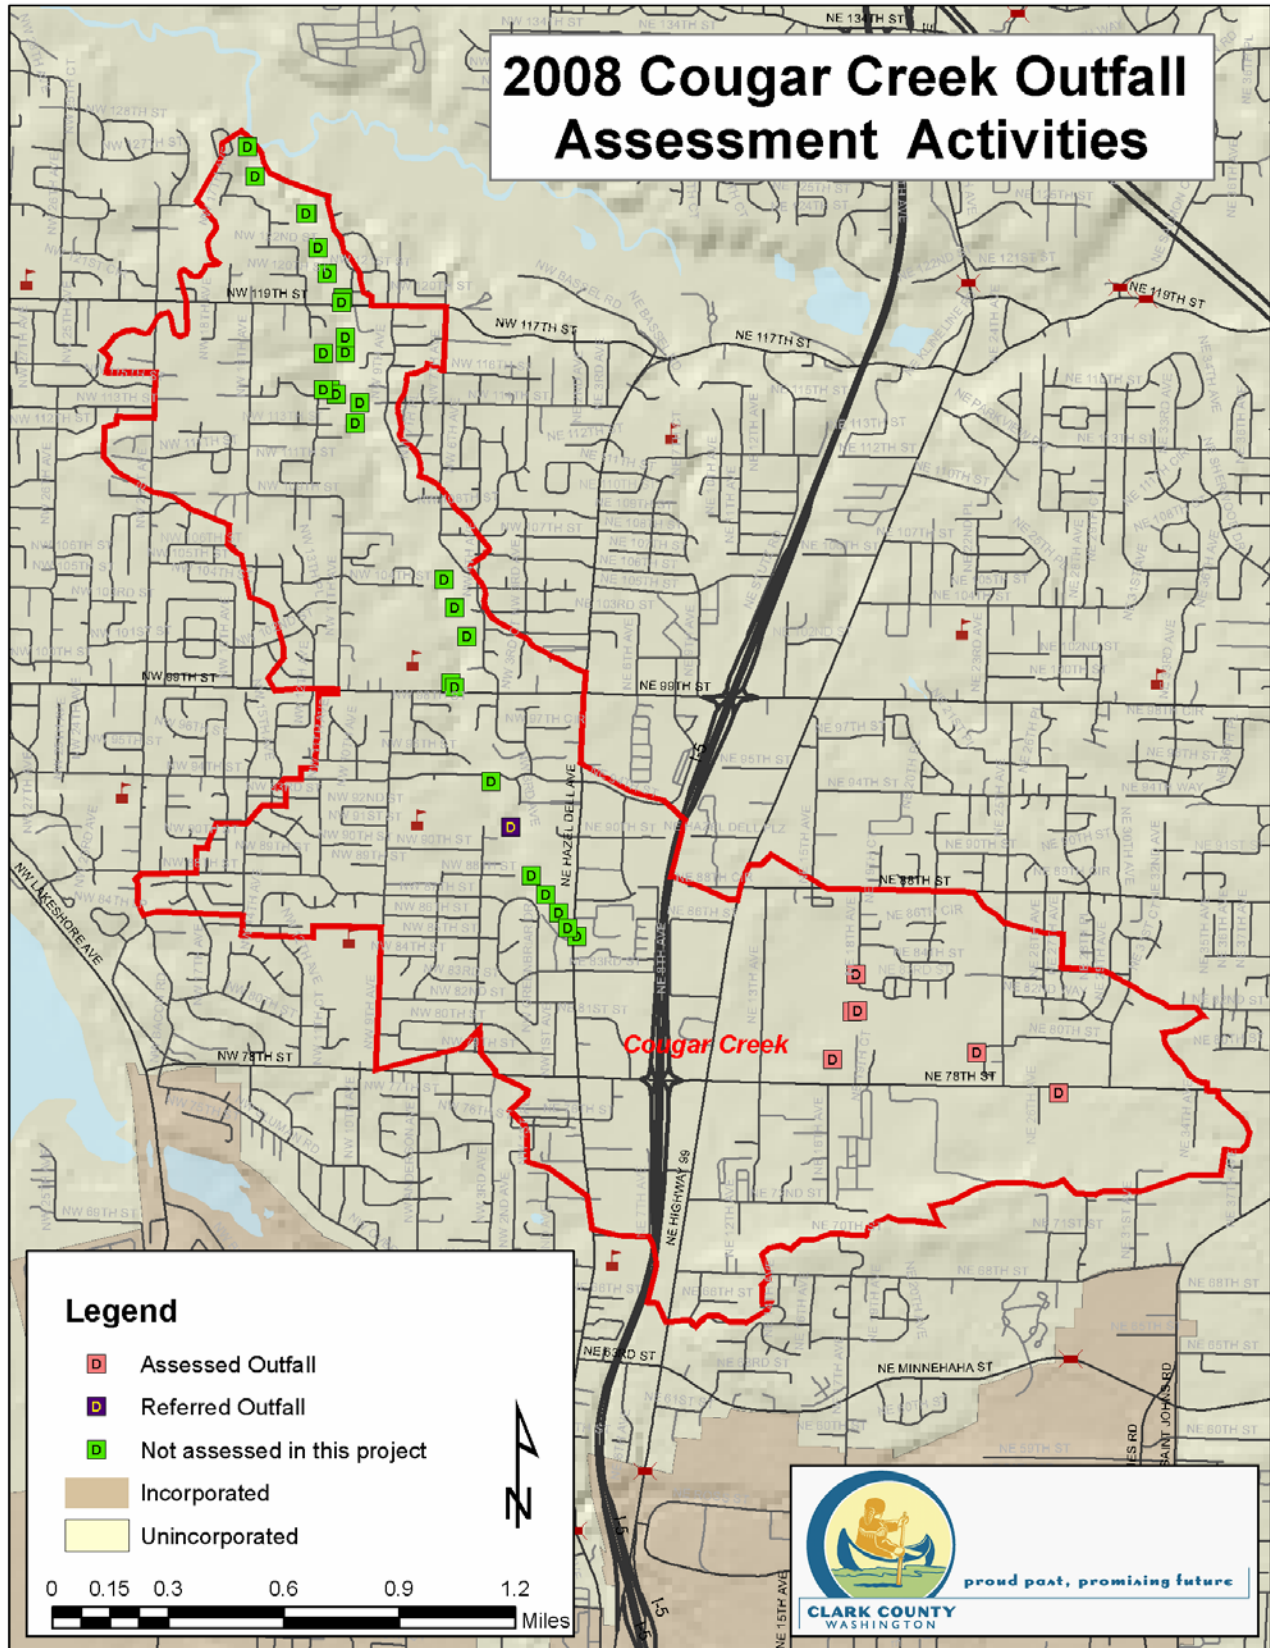
Figure 7: Summary of 2008 Outfall Assessment Activities in Cougar Creek Subwatershed.

Figures 7 and 8 summarize notable outfall assessment activities including general outfall locations in the Salmon Creek (RM 03.83) and Cougar Creek subwatersheds.

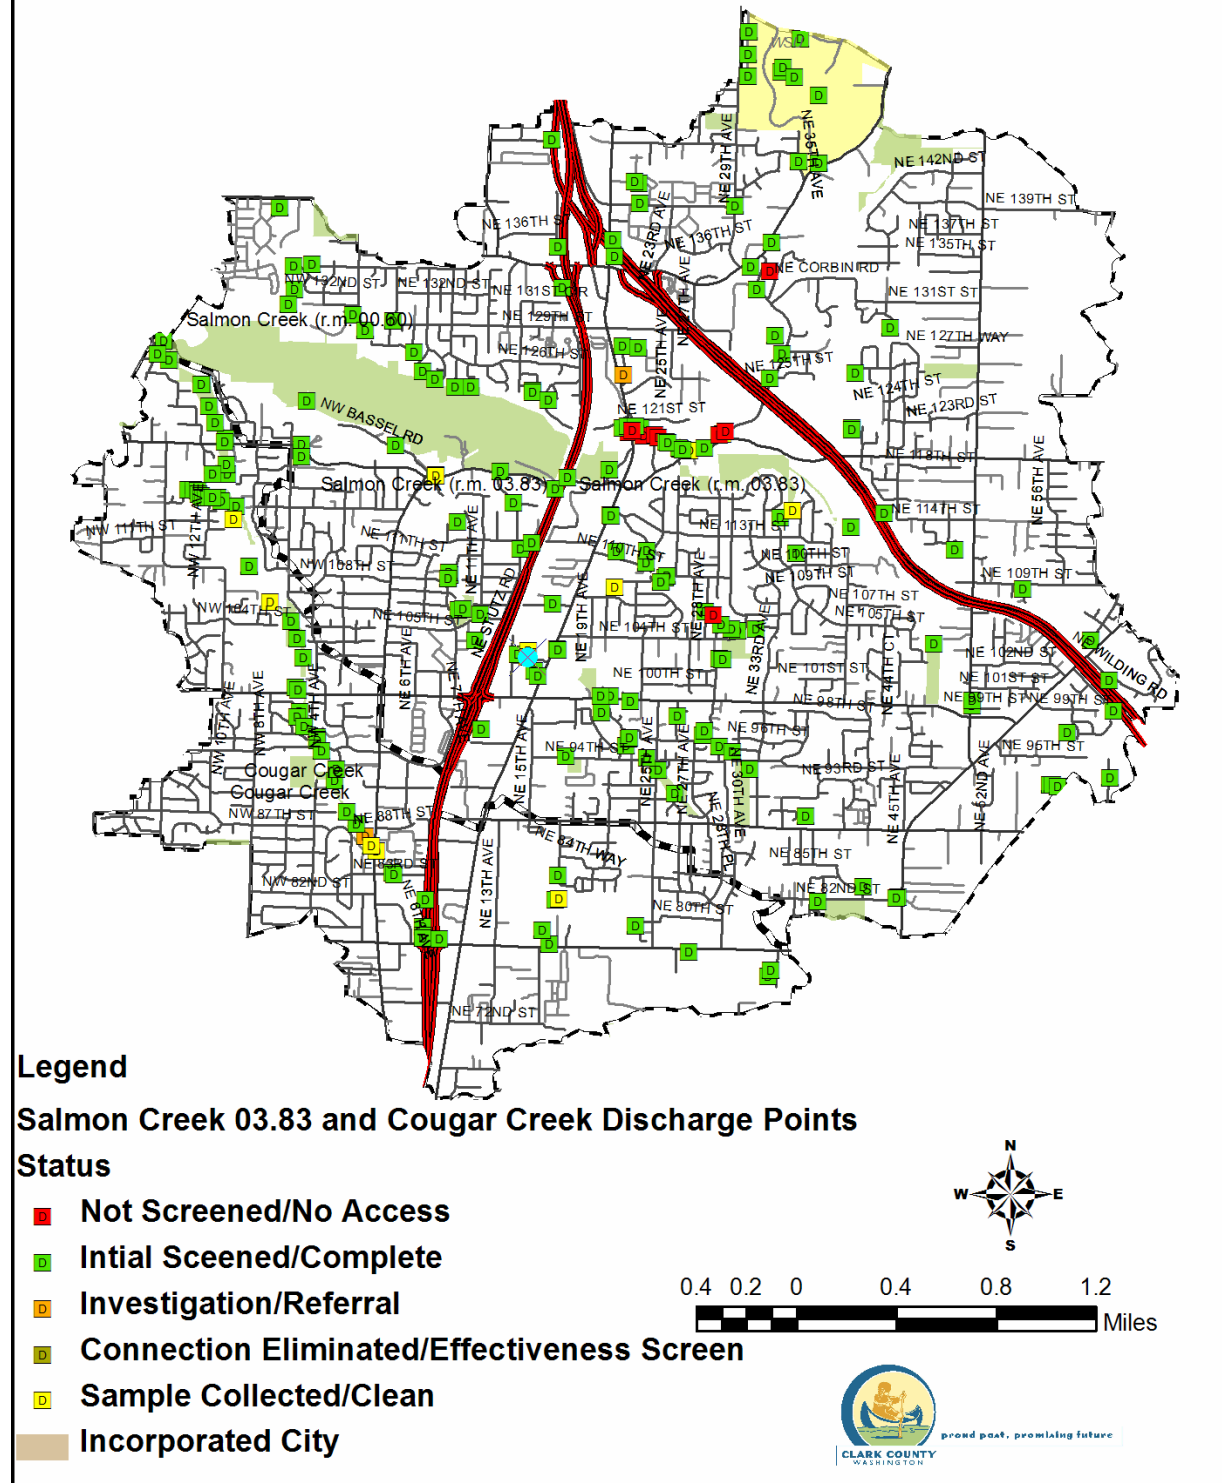
Figure 9: 2008 IDDE Screening Project in Salmon Creek (RM 03.83) and Cougar Creek Subwatersheds

Clark County IDDE staff noticed soapy water running from a motorcycle dealership across a parking lot and entering catch basin that drains to a county stormwater facility (Unique ID 1254) on September 4, 2008. Investigation GM15041 was initiated by visual confirmation, no samples were taken. The site was referred to code enforcement and an on-site investigation was coordinated with CWP section Waste Reduction Specialist. Soap run-off was determined to be motorcycle washing in the shop area. Removal activities included education outreach with both business managers and property owners on September 8, 2008. Business will attempt to reduce use of soap in wash water. Wash water enters a treatment facility where it is appears to get proper treatment.

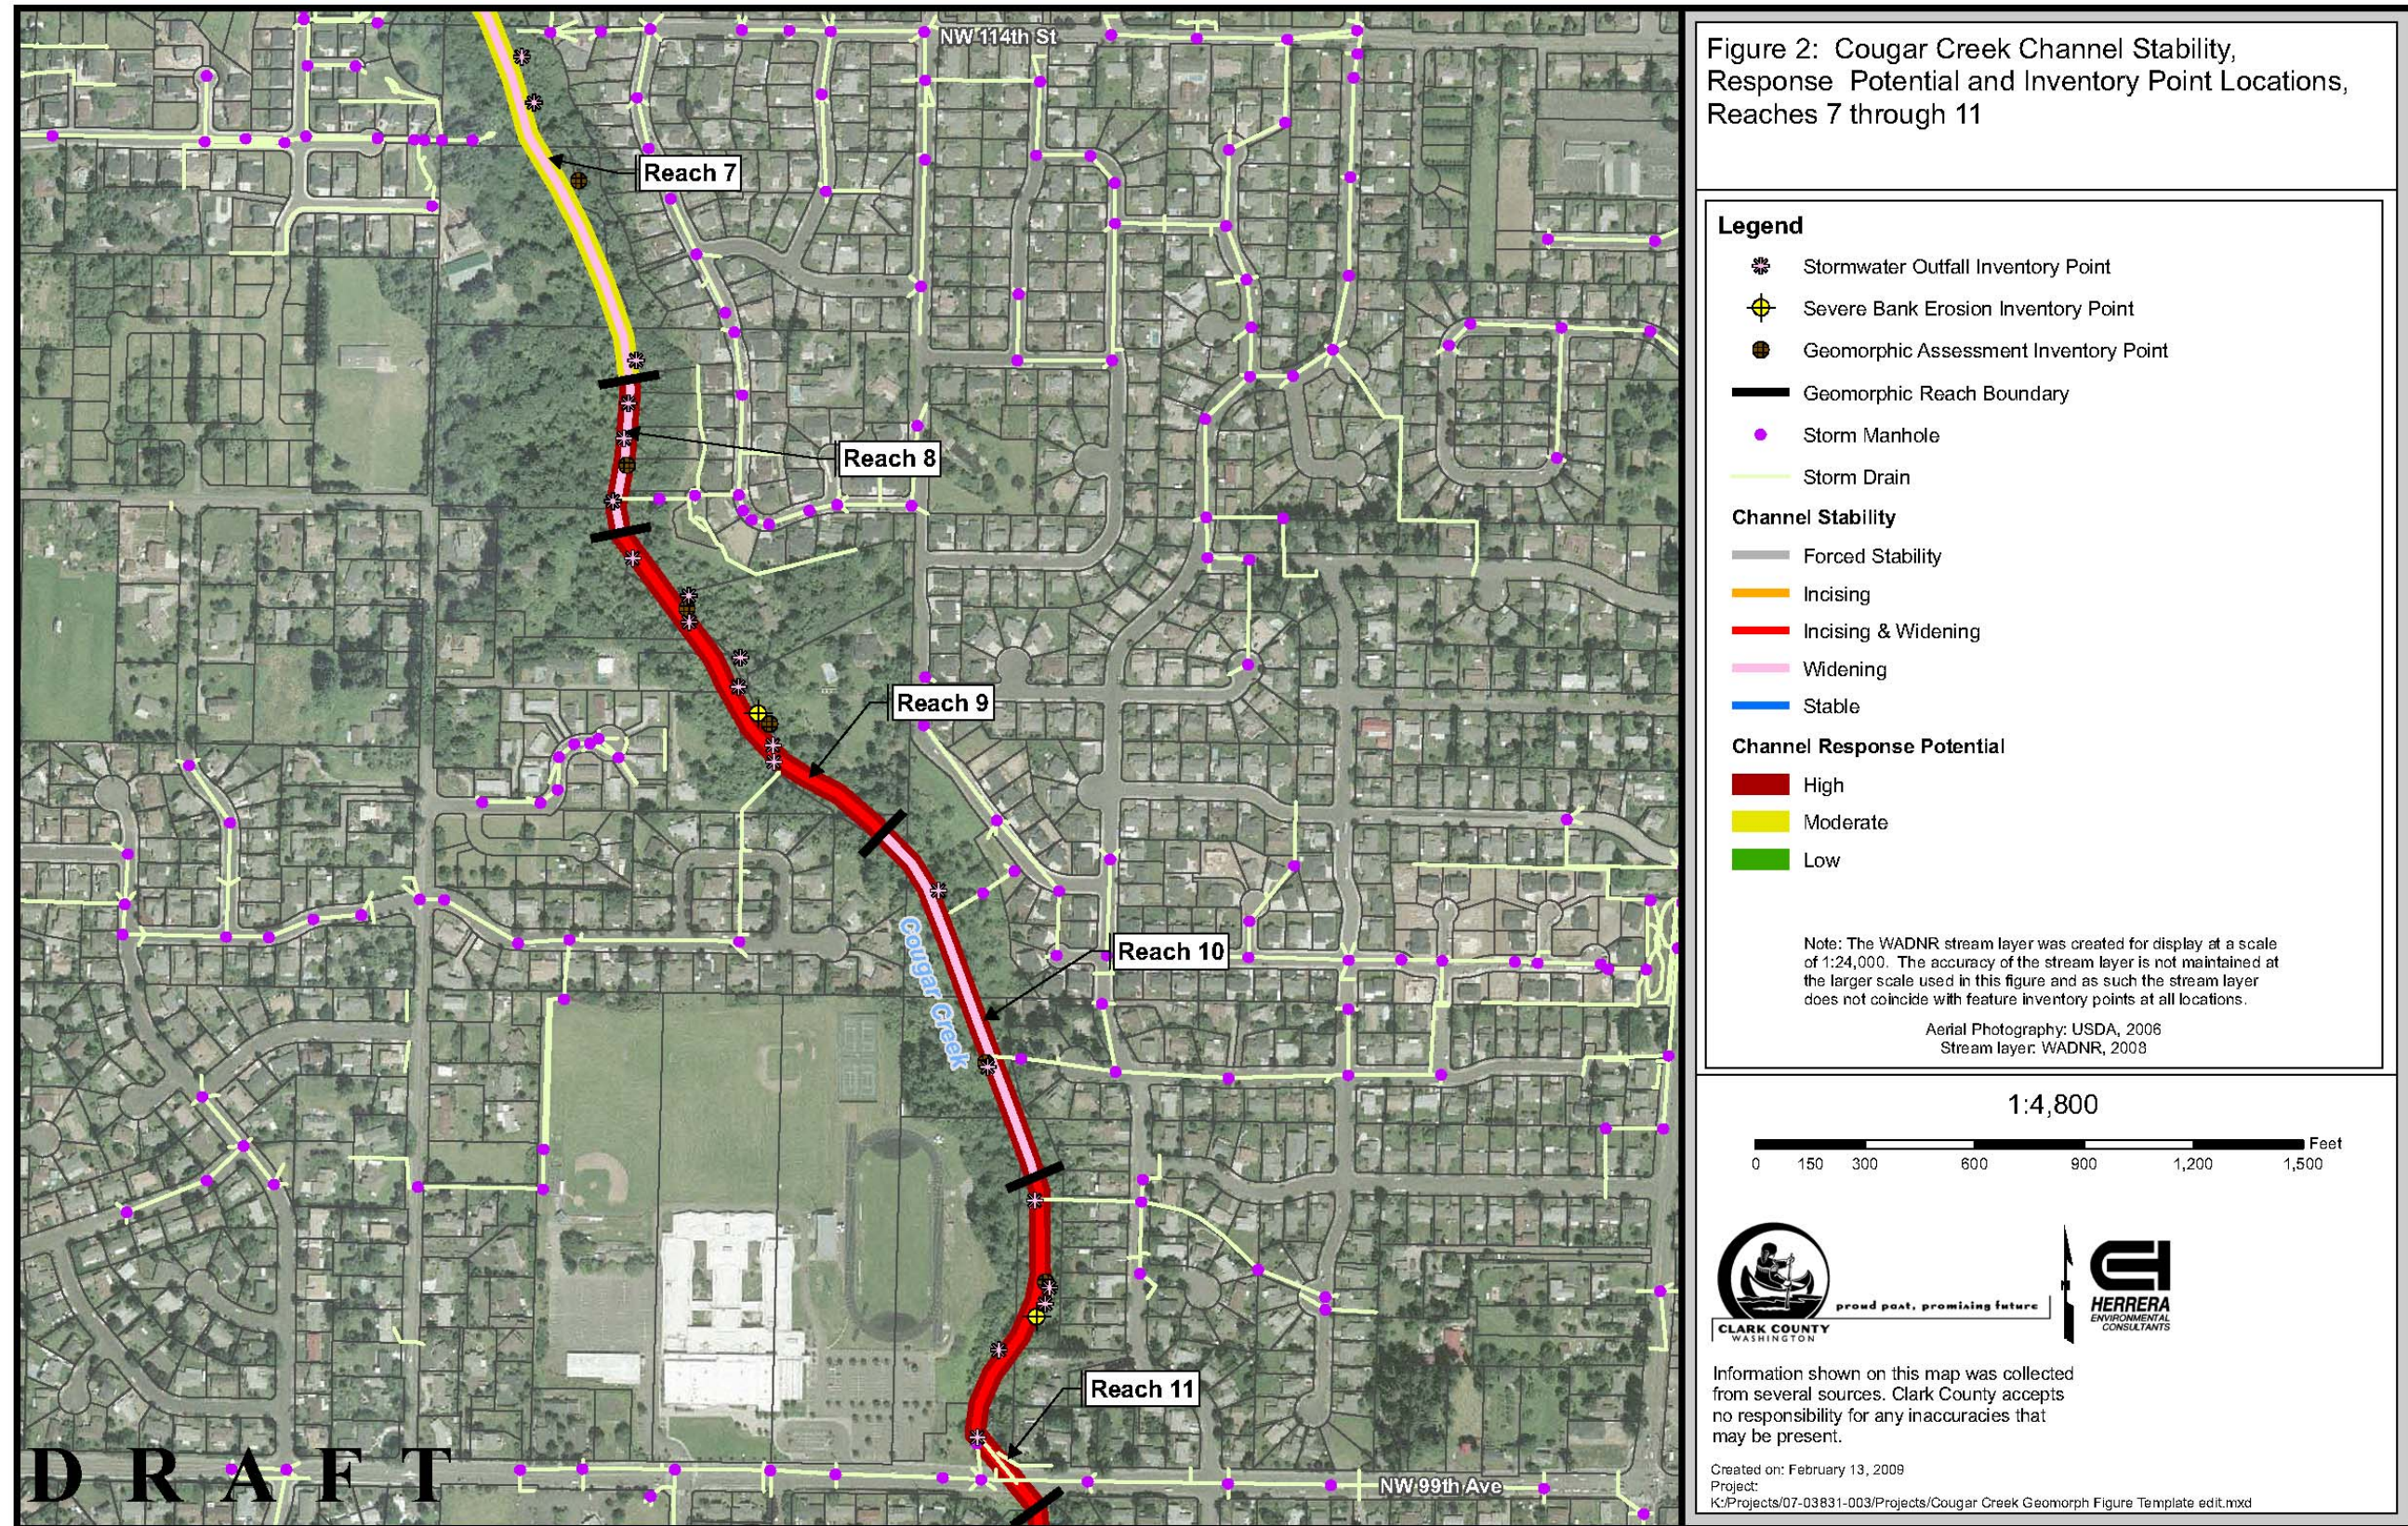
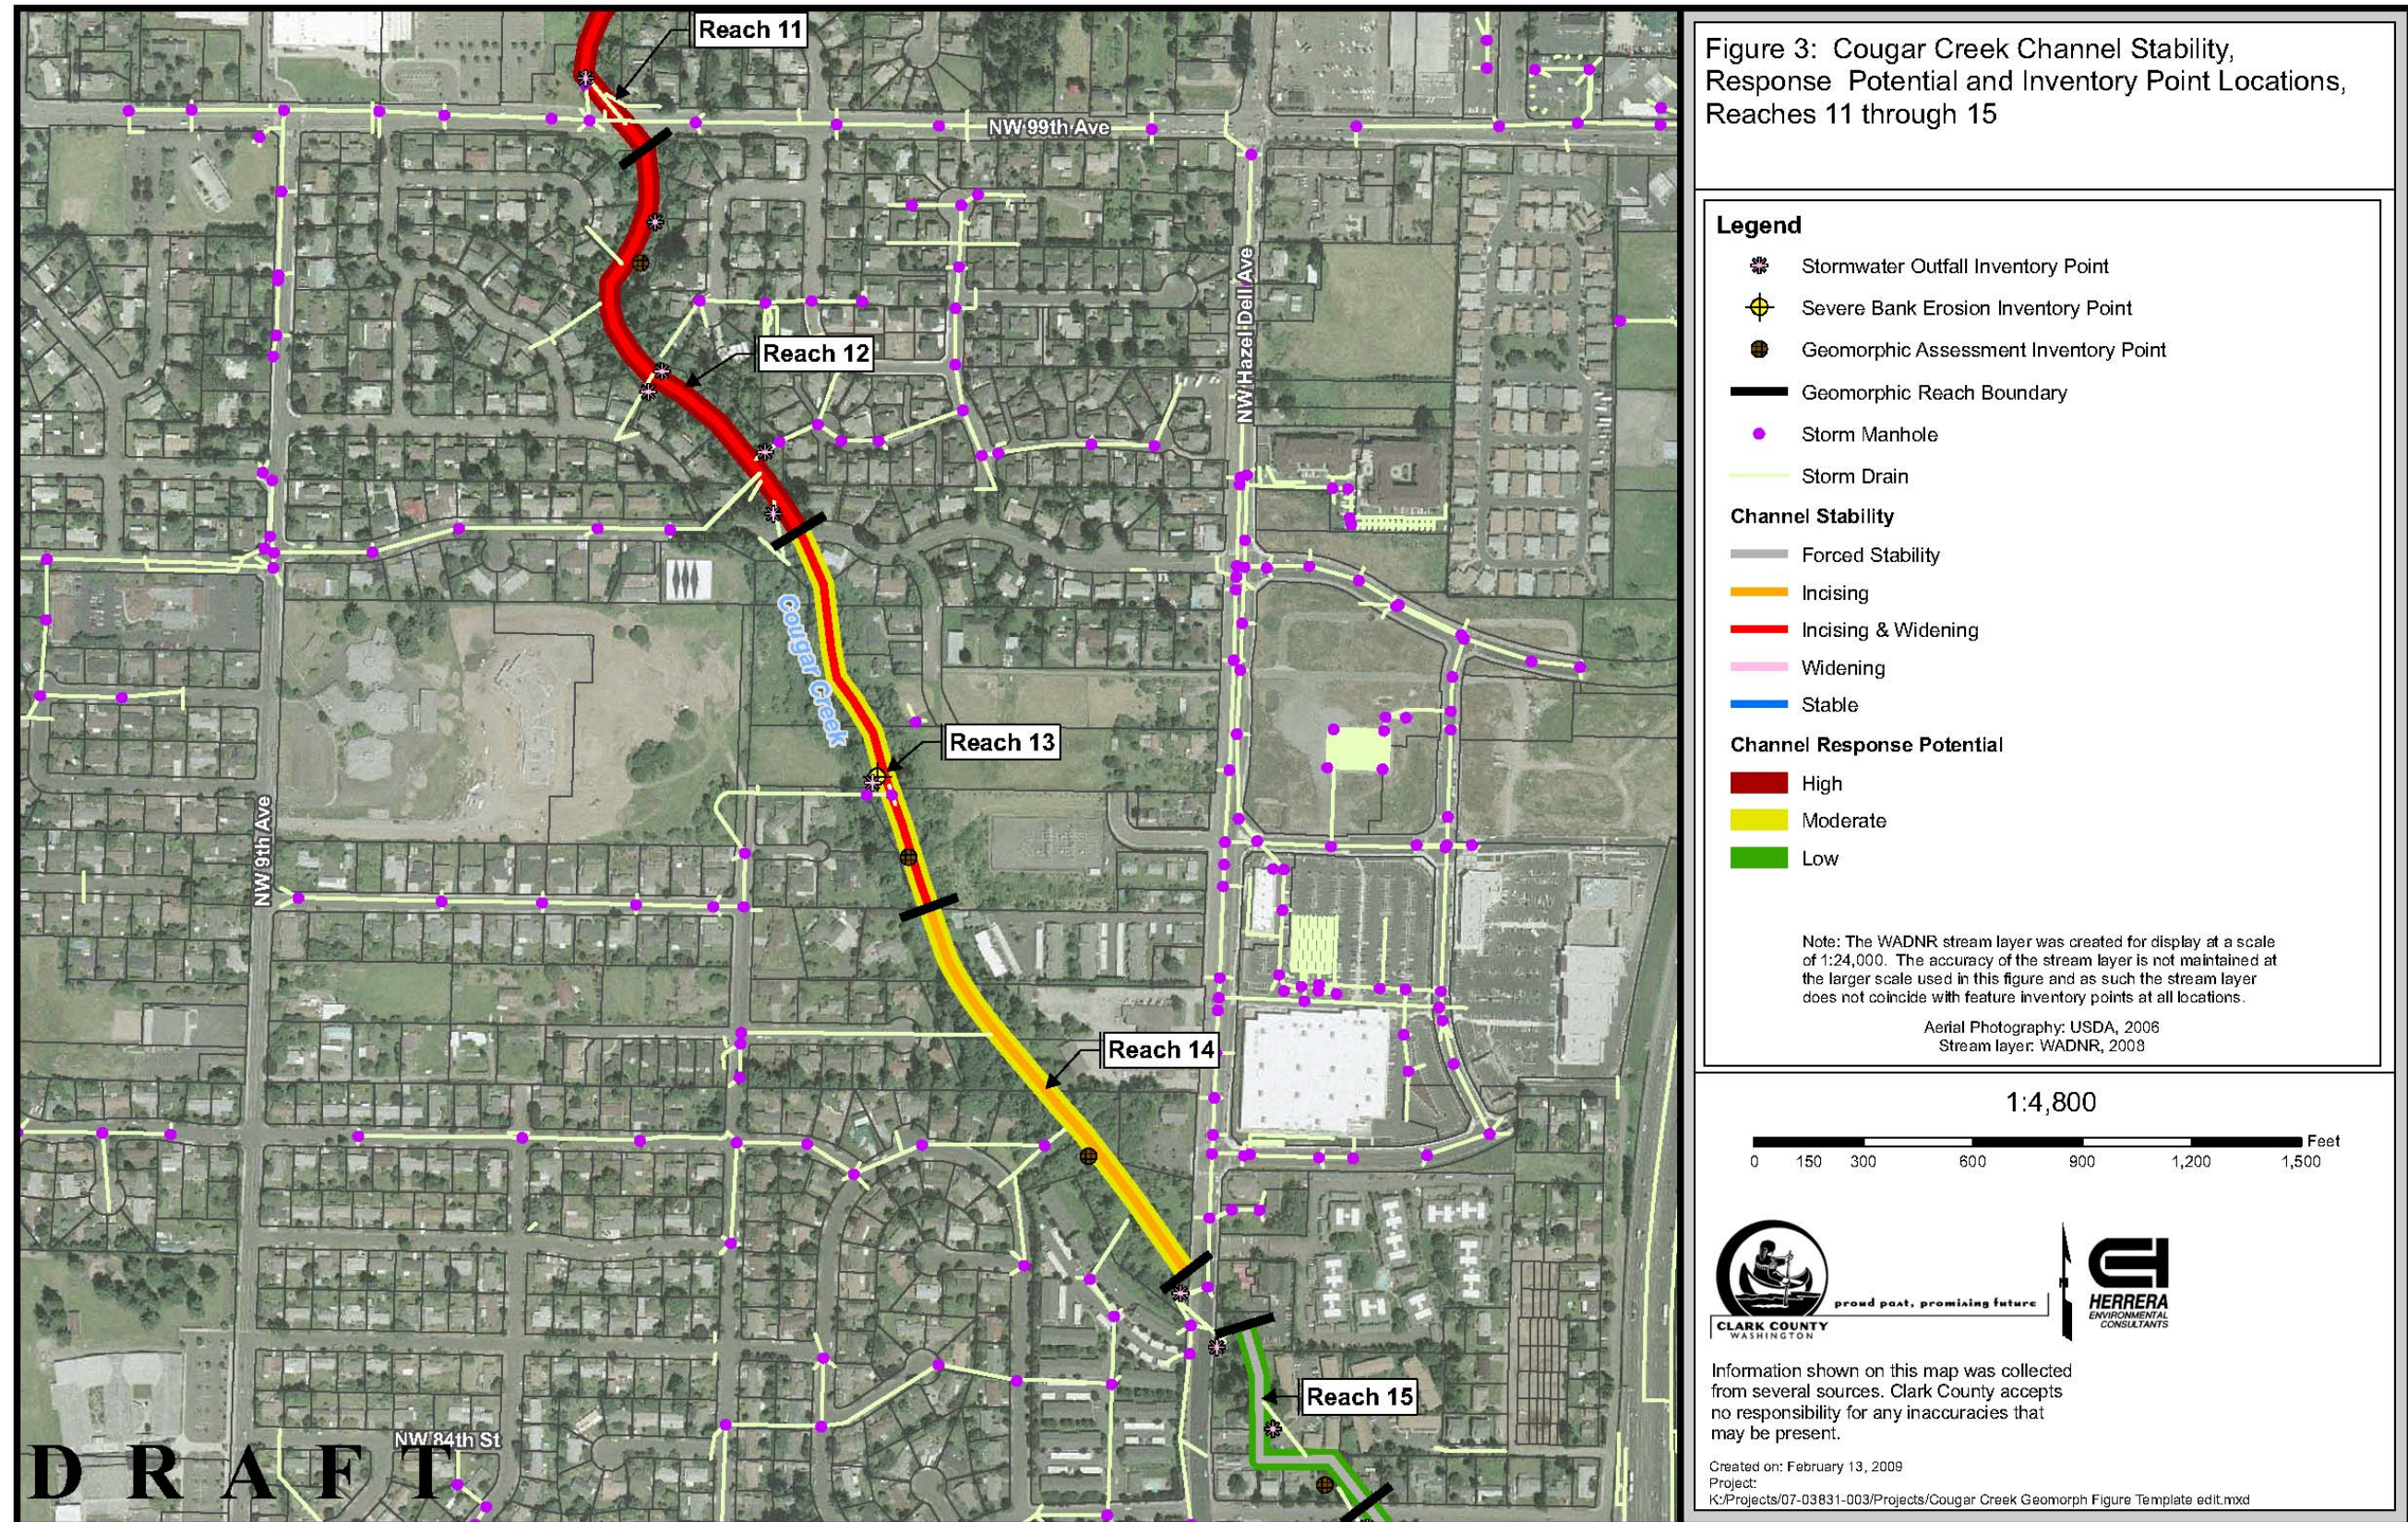
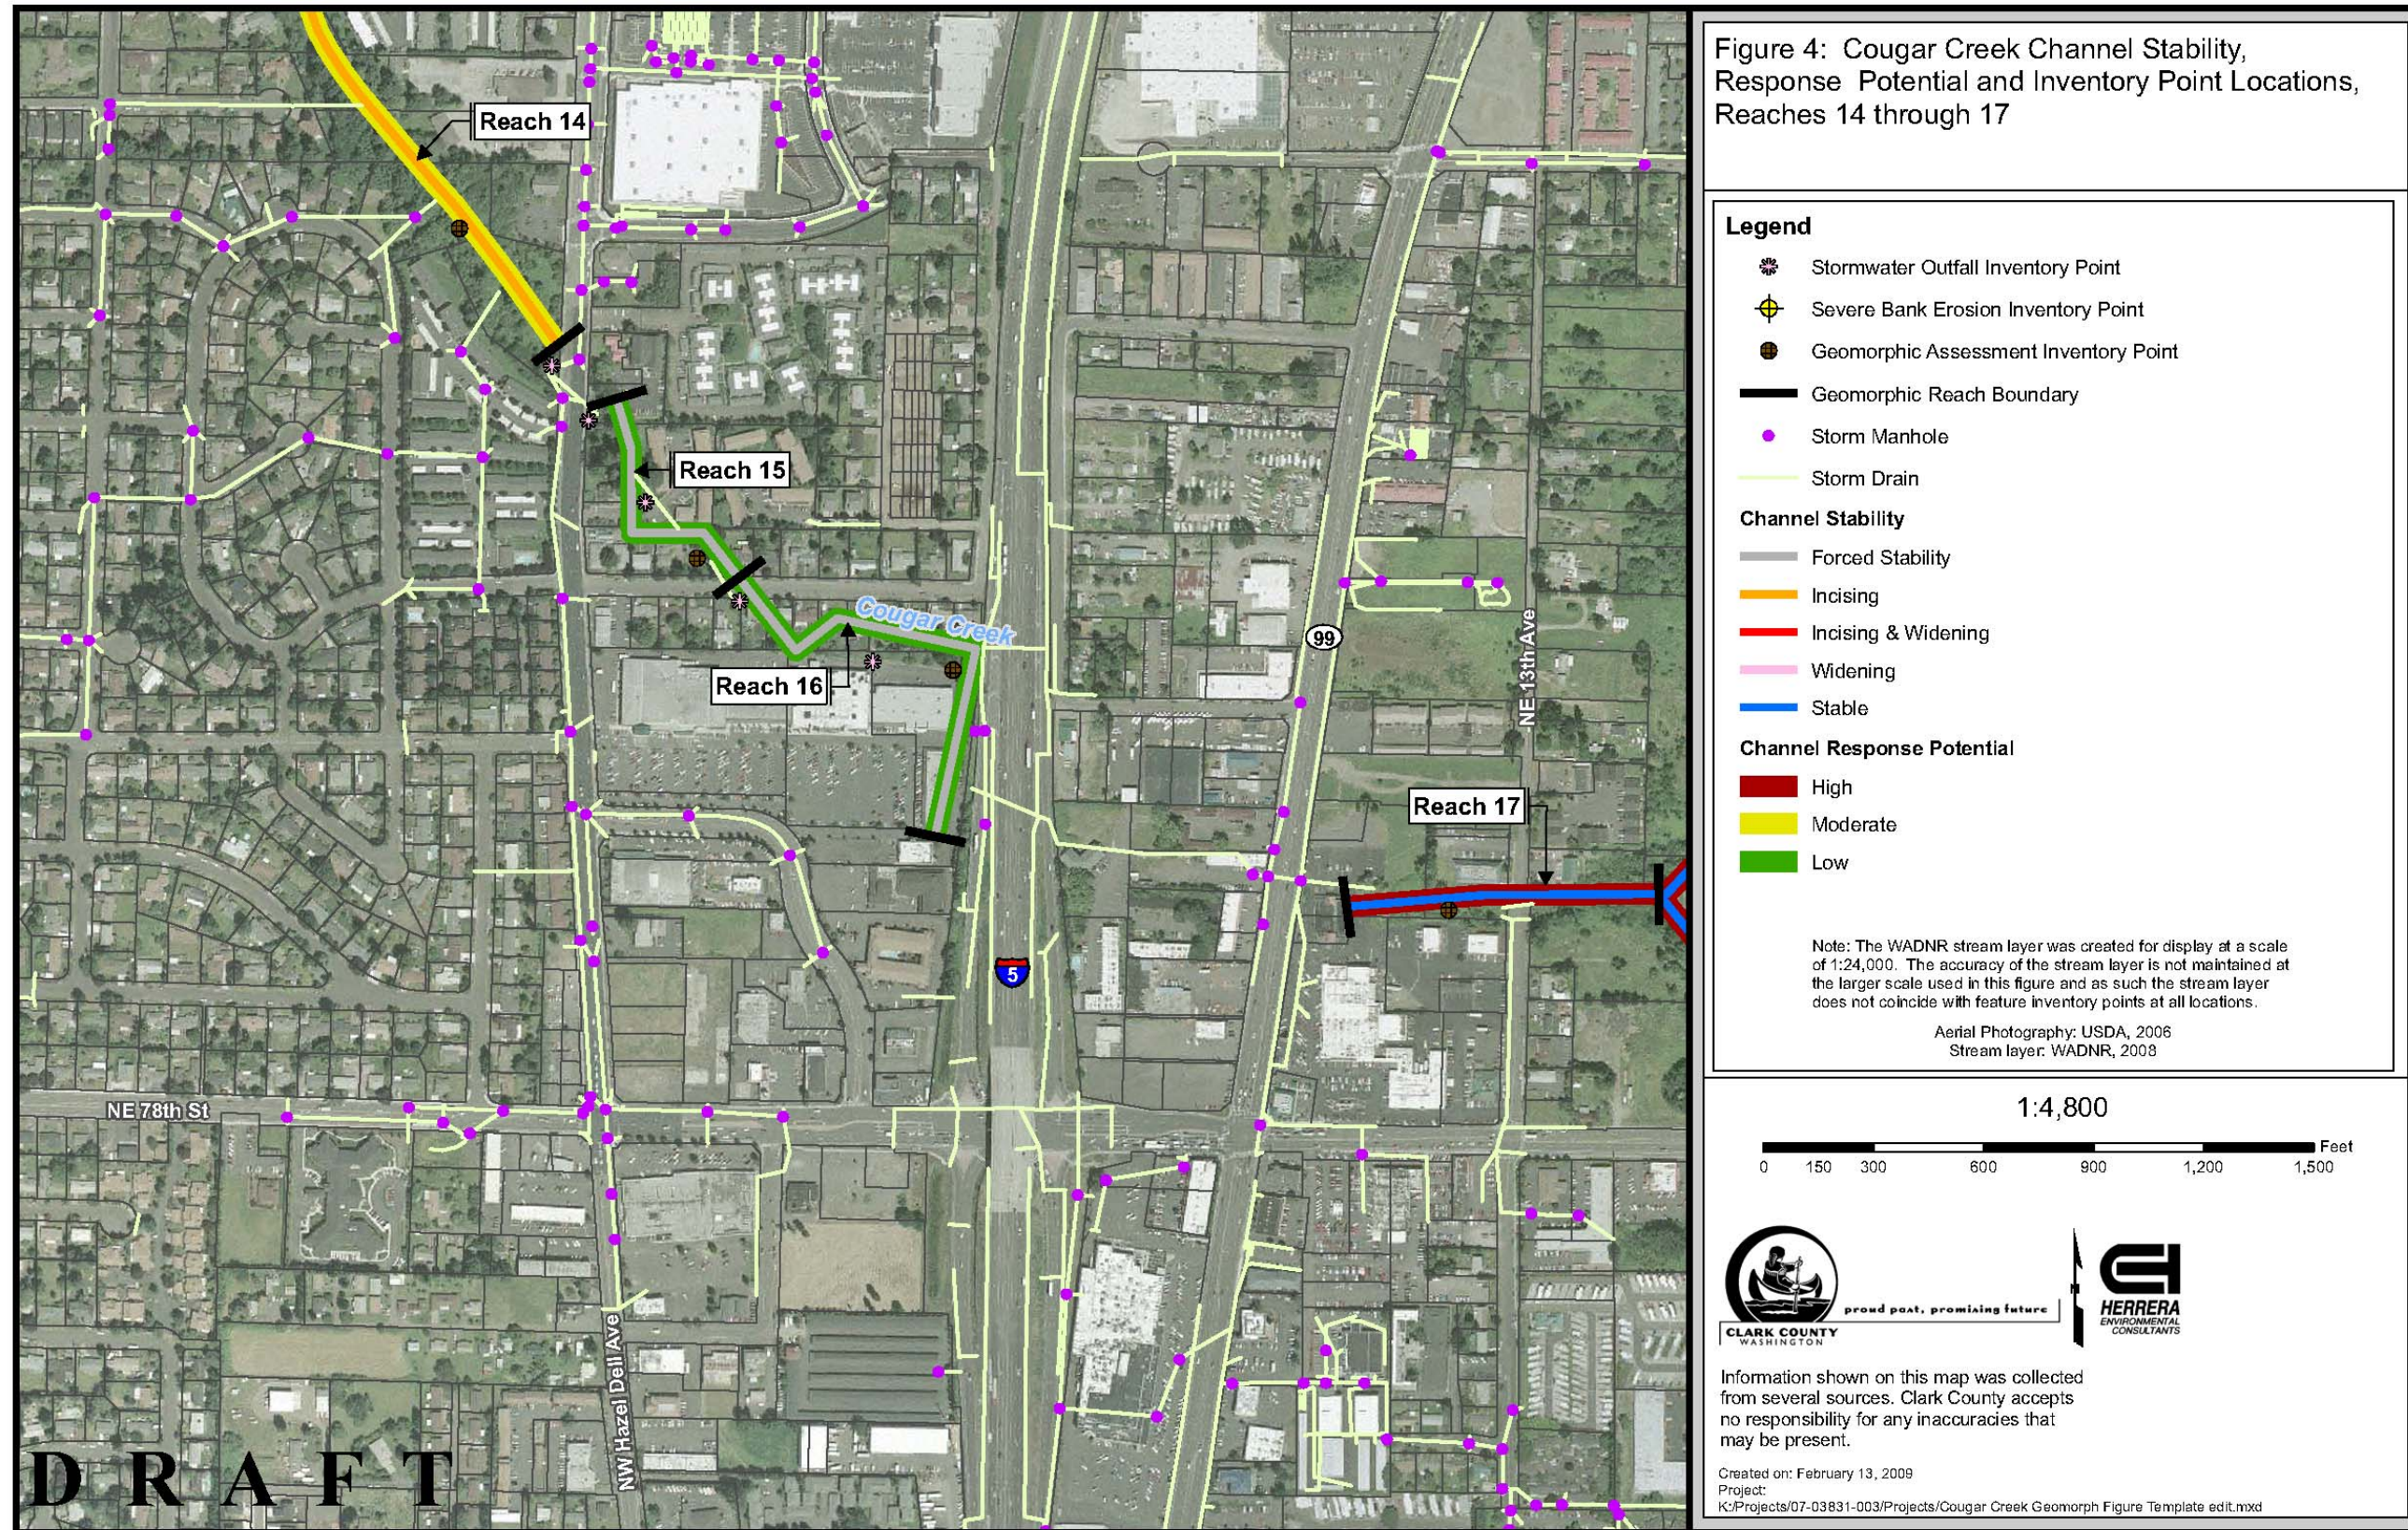
Middle Cougar Creek (Reaches 6 through 16) extends from NW 119th St upstream to the drainage system beneath Interstate 5 (I-5) (Figures 13 through 15). The reaches in middle Cougar Creek demonstrate the greatest impacts of past and ongoing changes in watershed land use and the hydrologic regime. In contrast to lower Cougar Creek, middle Cougar Creek generally has a moderate to high channel response potential. The only exceptions are Reaches 15 and 16 which are hardened by bank armoring and were therefore classified as having forced channel stability and a low response potential. Urban residential land use characterizes much of the middle portion of the watershed. A protected riparian buffer exists along most of the channel, with the exception of the reaches farthest upstream (Reaches 15 and 16), where Cougar Creek weaves through residential backyards and is channelized along lot boundaries.
