2008 Stormwater Needs Assessment Program

Salmon Creek (RM 03.83)/Cougar Creek
Subwatershed Needs Assessment Report

Clark County Public Works Clean Water Program

April 2009

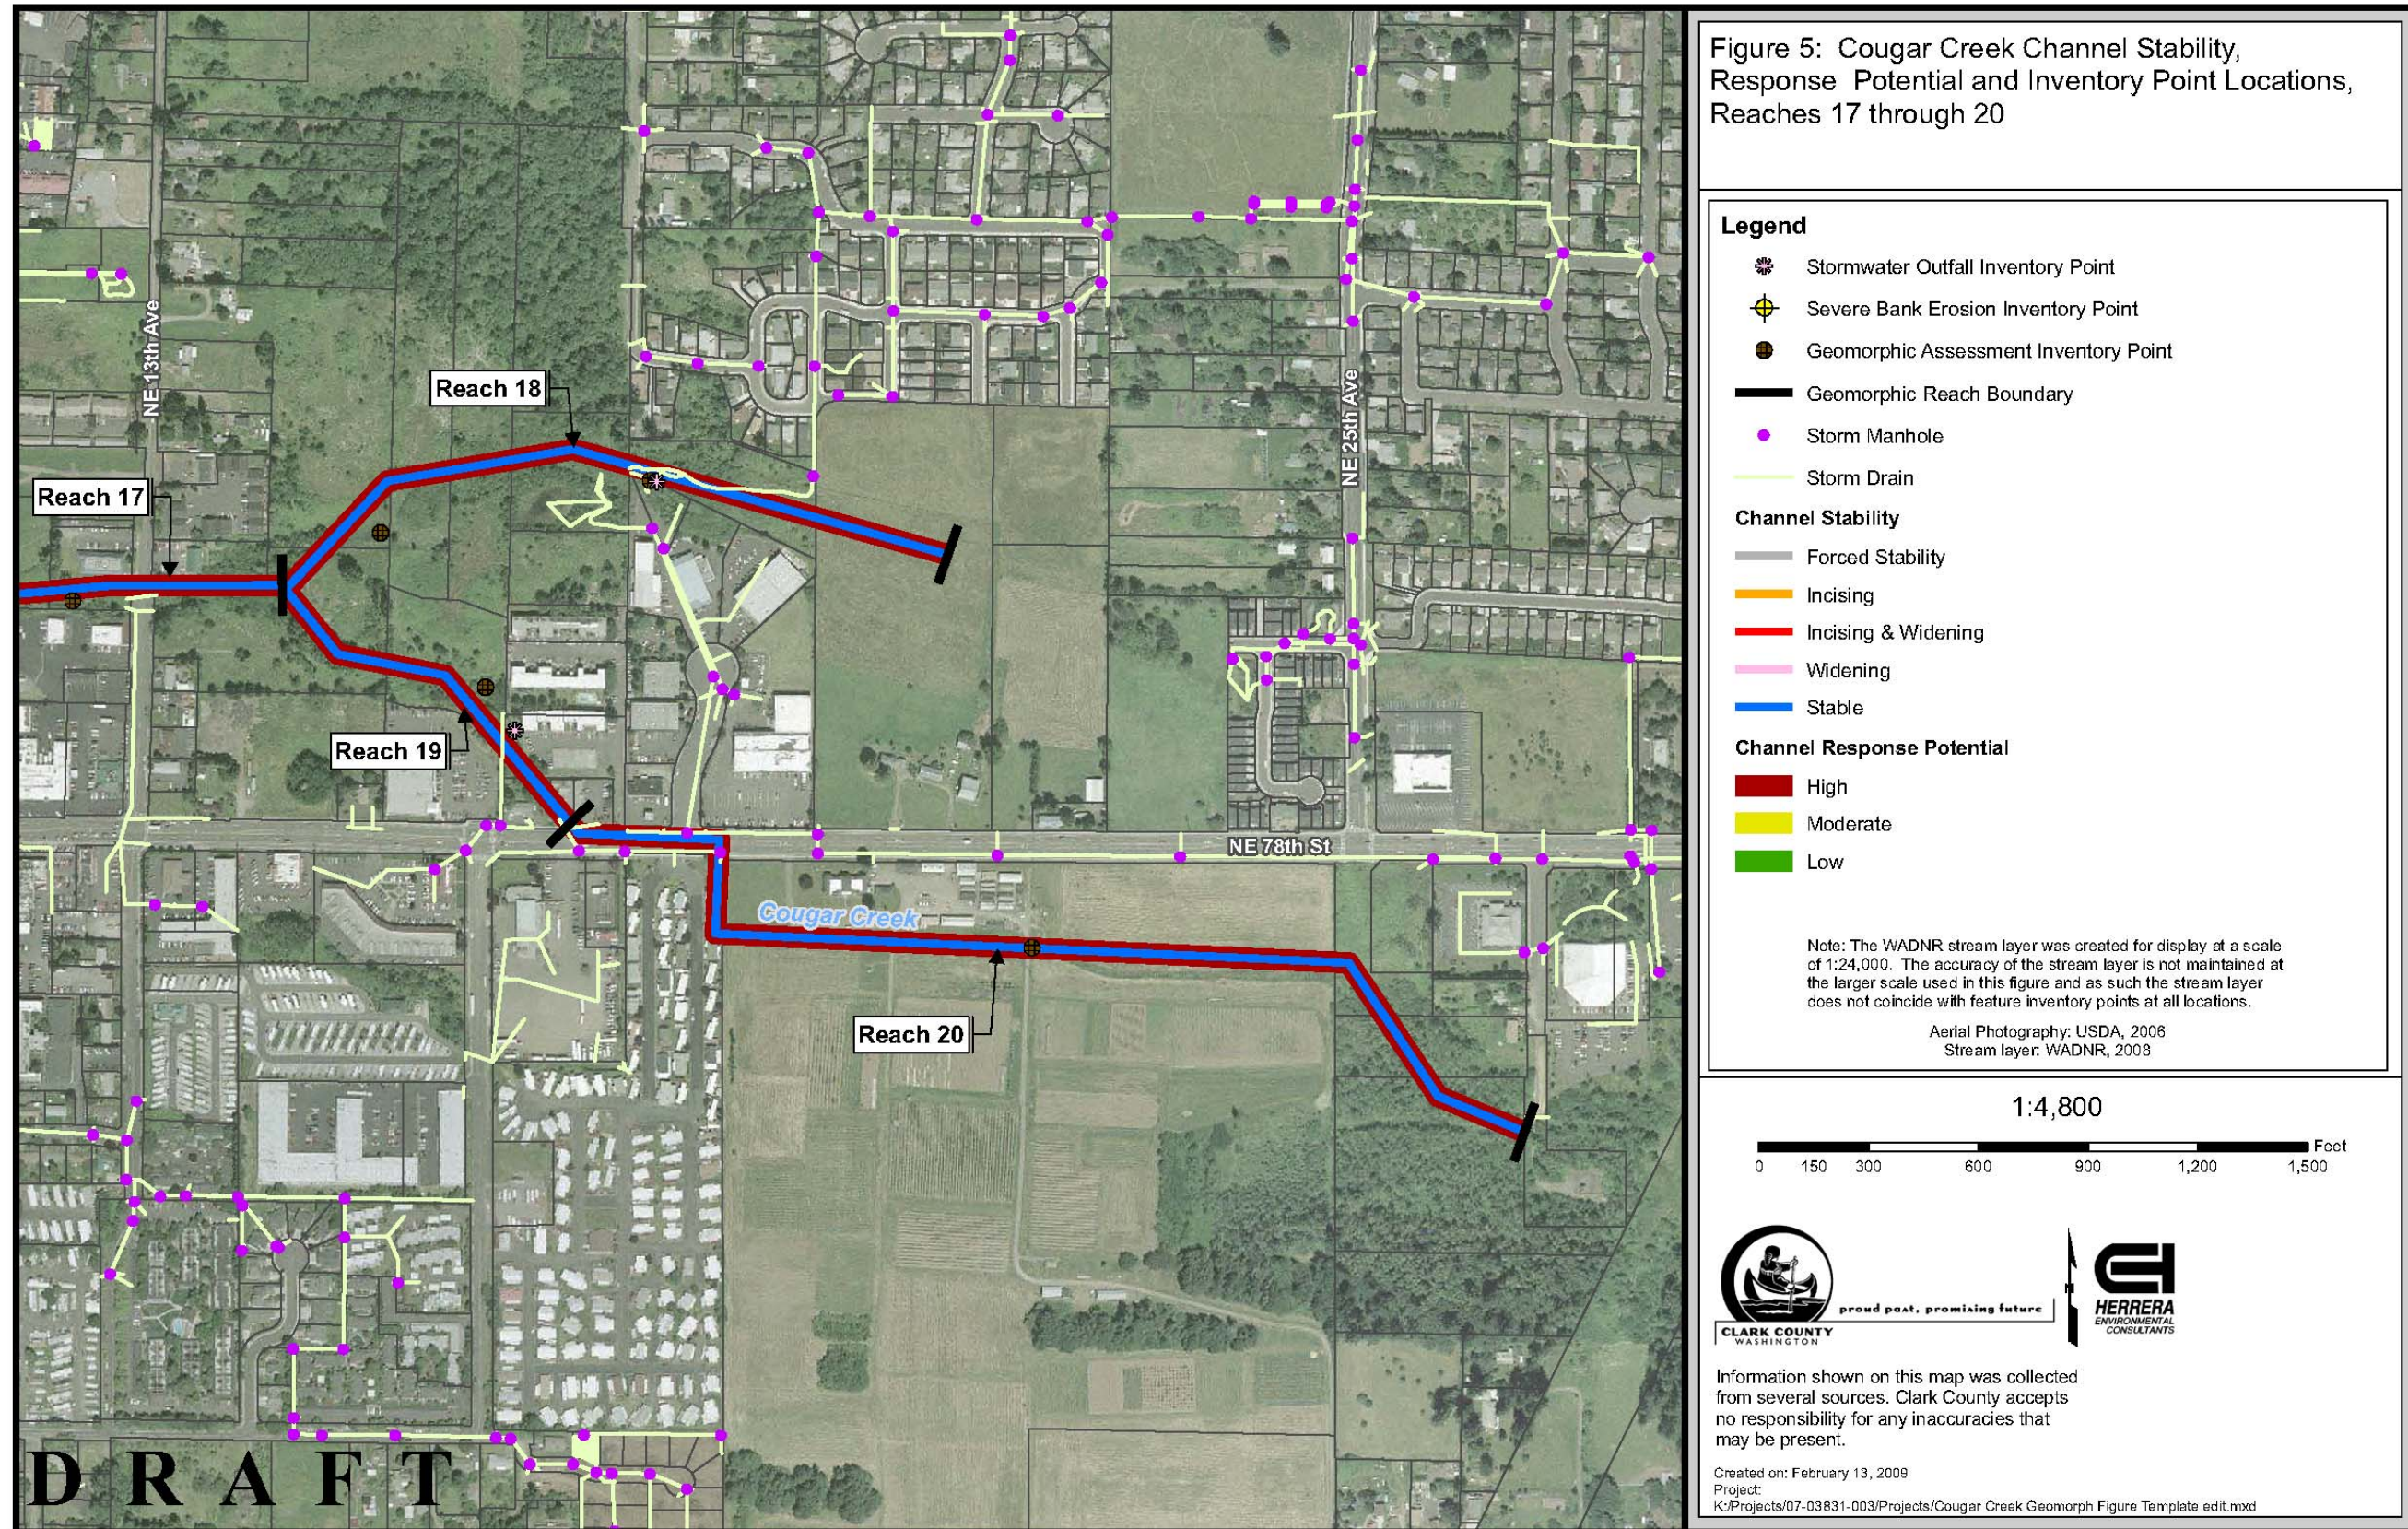
Figure 16: Cougar Creek: Channel Stability, Response Potential and Inventory Point Locations, Reaches 17 through 20.

Upper Cougar Creek (Reaches 17 through 20) extends from the storm drainage network under I-5 to the backwaters located in pastures and open wetland fields east of Highway 99 (Figures 4 and 5). Upper Cougar Creek is naturally broad and flat and was historically characterized by wetlands formed on depressions in cataclysmic flood deposits. The channel bed and banks predominantly composed of fine material. The upper Cougar Creek watershed includes a variety of land uses that have altered the hydrologic regime, including agricultural, industrial, residential, commercial, and transportation uses. There are stormwater contributions from NW 78th Street, as well as from the urban residential developments and the commercial and industrial land uses that lie adjacent to headwater wetlands and channel. However, there is still significant open space in this portion of the subwatershed, providing unique opportunities to preserve and restore natural hydrologic function and geomorphic processes. At the same time, upper Cougar Creek has a high potential to respond unfavorably to future development of these open spaces.

The downstream limit of Reach 17 is the storm drain network that conveys the flow below parking lots, Highway 99, and I-5. The open channel of Reach 17 continues upstream to the confluence of two tributaries (here termed the south and north tributaries), located just east of NE 13th Avenue (Figure 16). The riparian vegetation downstream of NE 13th Avenue is dominated by invasive vegetation, including reed canary grass, Himalayan blackberry, and cattails. There is no overstory and no distinctive channel form. Instead the water filters through a 50- to 80-foot-wide floodplain composed of fine sediment and full of dense, invasive vegetation. The dense vegetation and fine wetland sediments cause a backwater condition through the culvert beneath NE 13th Avenue. On the day of the geomorphic survey, backwater filled two-thirds of the culvert. It is possible that some of the backwater observed was compounded by high groundwater levels at the time of the observations. There is some deciduous canopy upstream of NE 13th Avenue, but invasive vegetation such as Himalayan blackberry, reed canary grass, and nightshade, surround the creek. Throughout the reach, the channel type was characterized as wetland; however, portions of the reach exhibit modified or excavated characteristics and it is likely that the channel was at one time excavated or realigned and has subsequently become infested with invasive vegetation.
