Geomorphology and Hydrology Assessment
for
Upper Gee Creek

Department of Public Works
Clean Water Program
1300 Franklin Street
Vancouver, WA 98666

June 3, 2008

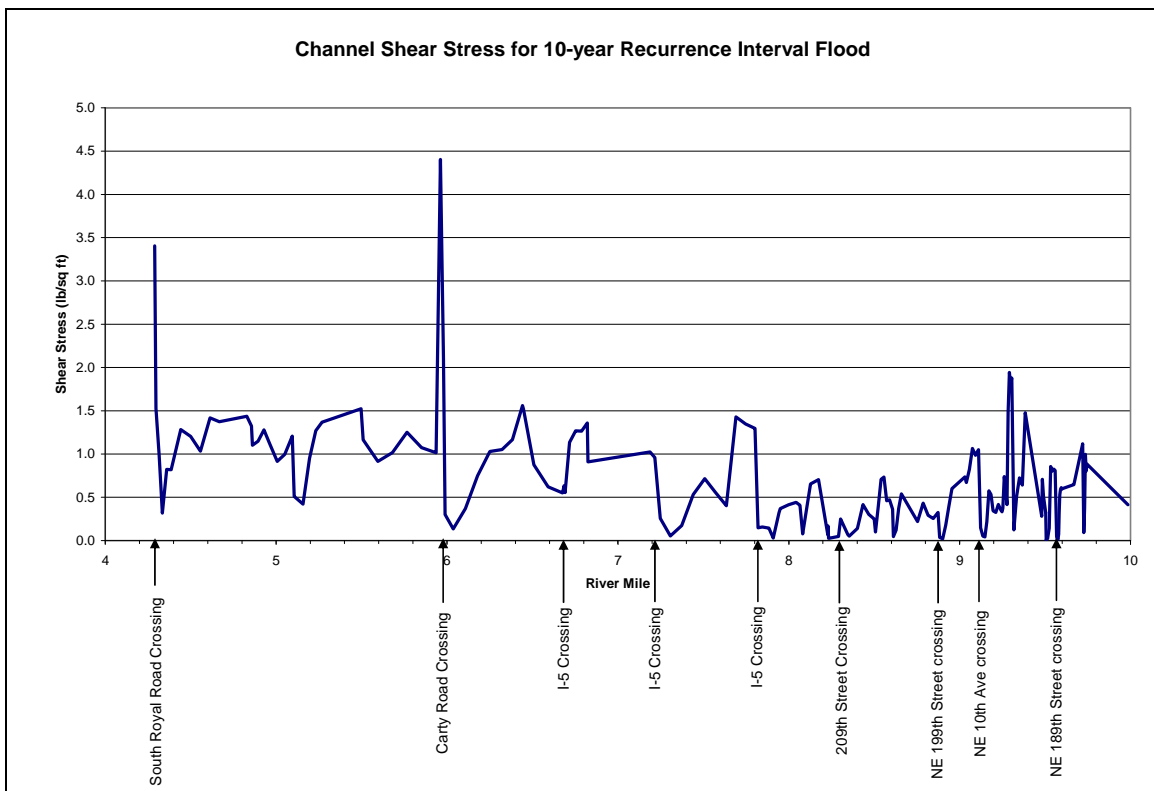
Figure 8. Channel shear stress profile for 10-year flood along Upper Gee Creek (WEST, 2005).

Figure 8 shows a channel shear stress profile of Upper Gee Creek developed from the existing HEC-RAS hydraulic model (WEST, 2005). As seen in the figure, the channel shear stress for the 10-year recurrence interval flood is significantly reduced upstream of and significantly increased downstream of several road crossings, most notably South Royle Road and Carty Road. Significant scour of the channel downstream of the Carty Road culvert was observed to be occurring. South Royle Road was not observed as it is just outside of the Upper Gee Creek basin boundary and therefore not included in this analysis.

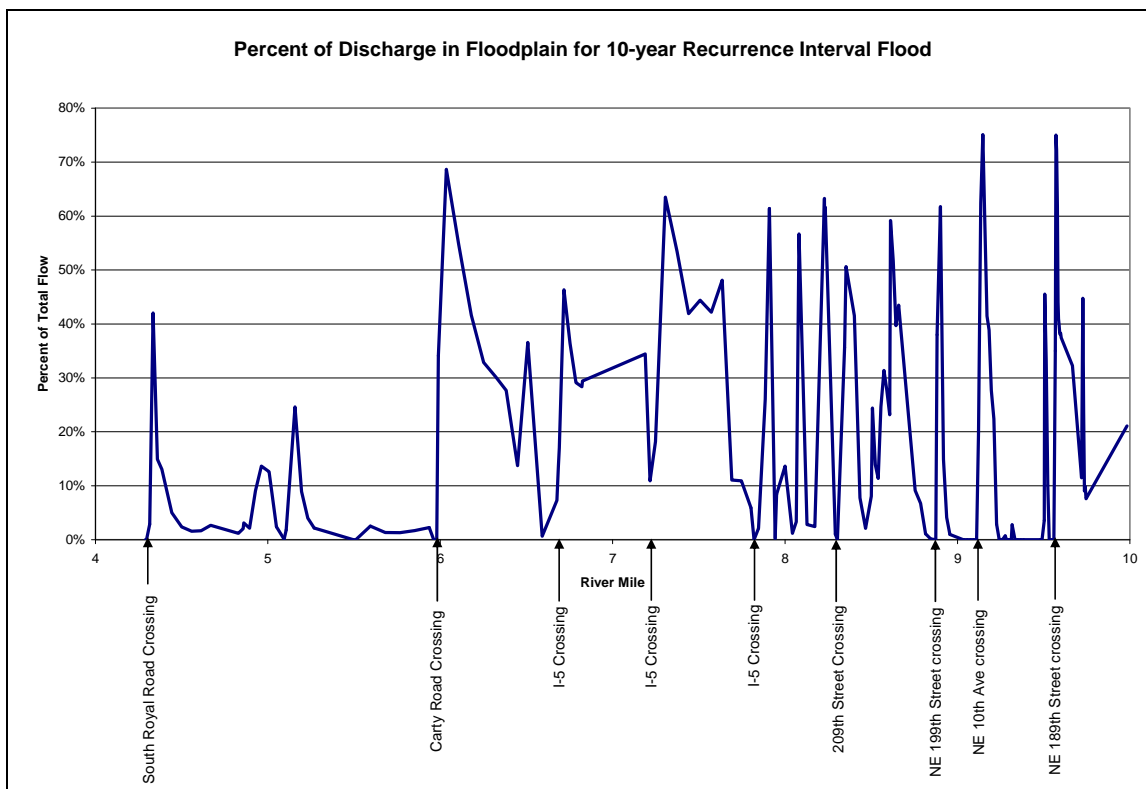
Figure 9. Percentage of total 10-year peak discharge conveyed in the Upper Gee Creek floodplain (WEST, 2005)

As seen in Figure 9, the relative percentage of the total 10-year peak flood discharge conveyed in the floodplain is significantly influenced by the existing road crossings. Backwater conditions upstream from the existing road culverts result in a greater portion of the total discharge being conveyed within the floodplain. Downstream of the culverts the discharge is mostly confined to the channel.

Existing culverts provide local grade control; however, the culverts that are located in the lower stream reaches inhibit natural channel migration. As seen in Figure 9, culverts have significant impacts on channel hydraulics and floodplain connectivity. The culverts are providing a benefit by increasing floodplain connectivity within the system of naturally incised channels. However, floodplain connectivity would have historically been provided by backwater caused by large woody debris jams. Further, several culverts are creating additional impacts such as excessive upstream sedimentation, excessive downstream channel scour, limiting channel migration and potentially creating barriers to fish passage. These negative impacts may outweigh the floodplain connectivity benefit. Replacement structures that include proper mitigation could minimize the negative impacts and continue to provide floodplain connectivity.

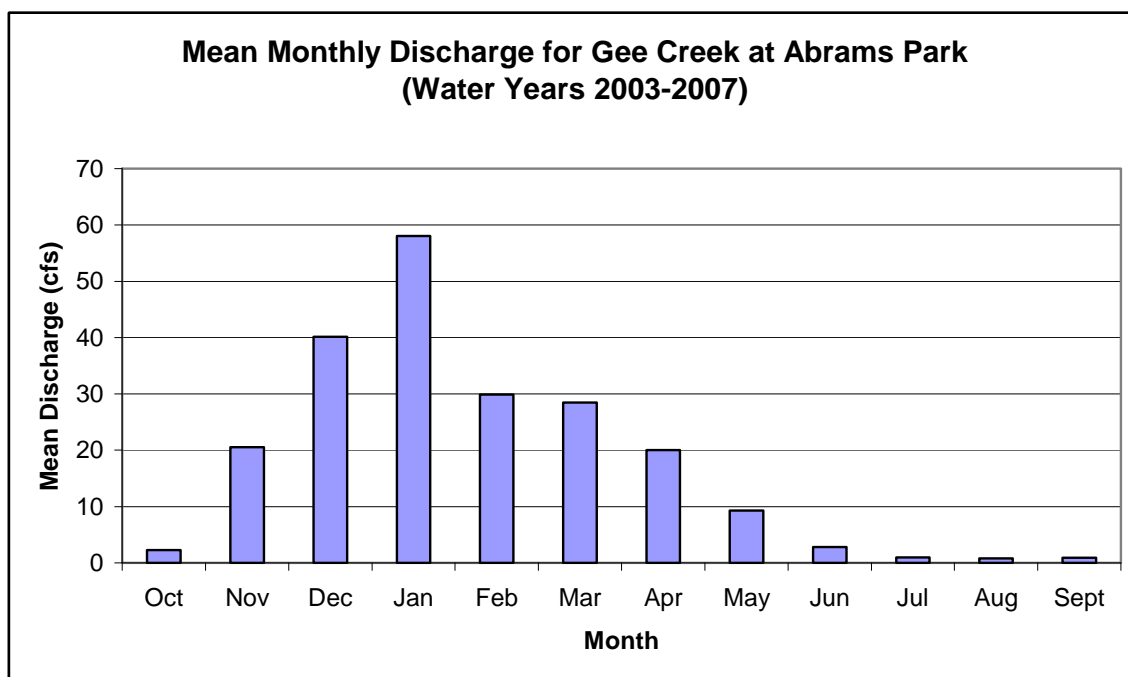
Figure 10. Mean Monthly Discharge for Gee Creek at Abrams Park

precipitation events. Mean monthly discharges for water years 2003 through 2007 are shown in Figure 10. As seen in the figure, the highest flows occur during the winter and spring months with lows flows occurring during the summer and early fall months.

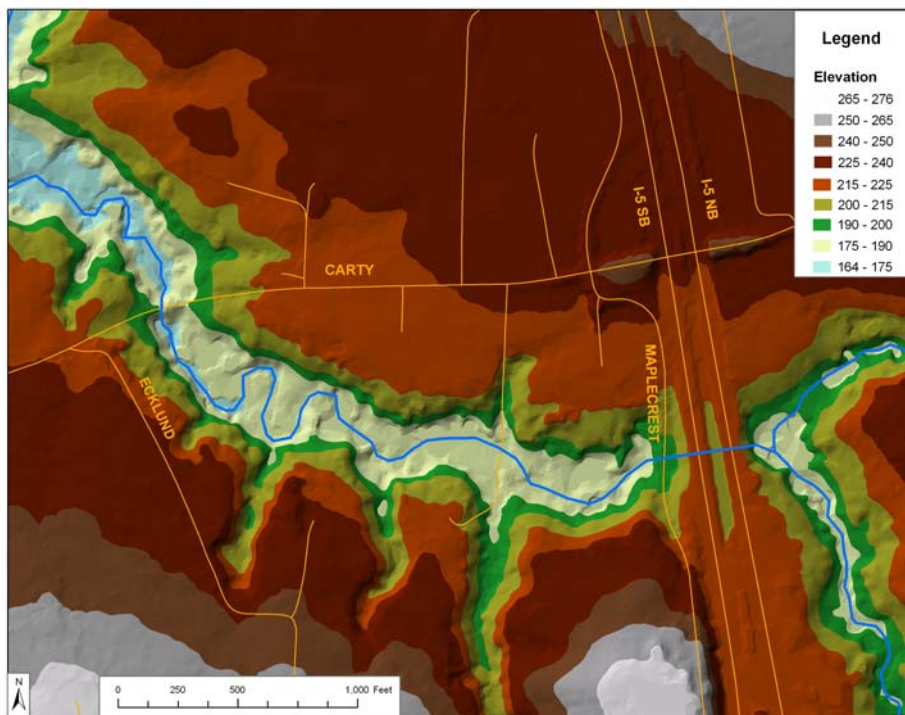
Figure 11. Plan view of Gee Creek between I-5 and Carty Road.

The channel reach with the greatest sinuosity is located between I-5 and Carty Road (see Figure 11). This is a transport limited reach, in that sediment supply generally exceeds sediment transport capacity. As seen in Figure 1, the underlying bedrock exposed by Gee Creek transitions from the finer grained Cataclysmic Flood Deposits to the coarse grained Plio-Pleistocene conglomerate downstream of Carty Road. The coarser sediment is less transportable and provides greater resistance to channel incision. The culvert at Carty Road is also restricting the flows of Gee Creek causing backwater conditions that reduce stream velocities and induce sediment deposition. The combination of the underlying geology and the hydraulic conditions associated with Carty Road culvert crossing are influencing sediment transport conditions resulting in greater channel migration within this reach. Available historic aerial photography were not of sufficient resolution to determine historic channel locations or channel migration rates; however, the current channel planform and unconfined valley form imply that the channel has migrated within the confines of the valley in the past.

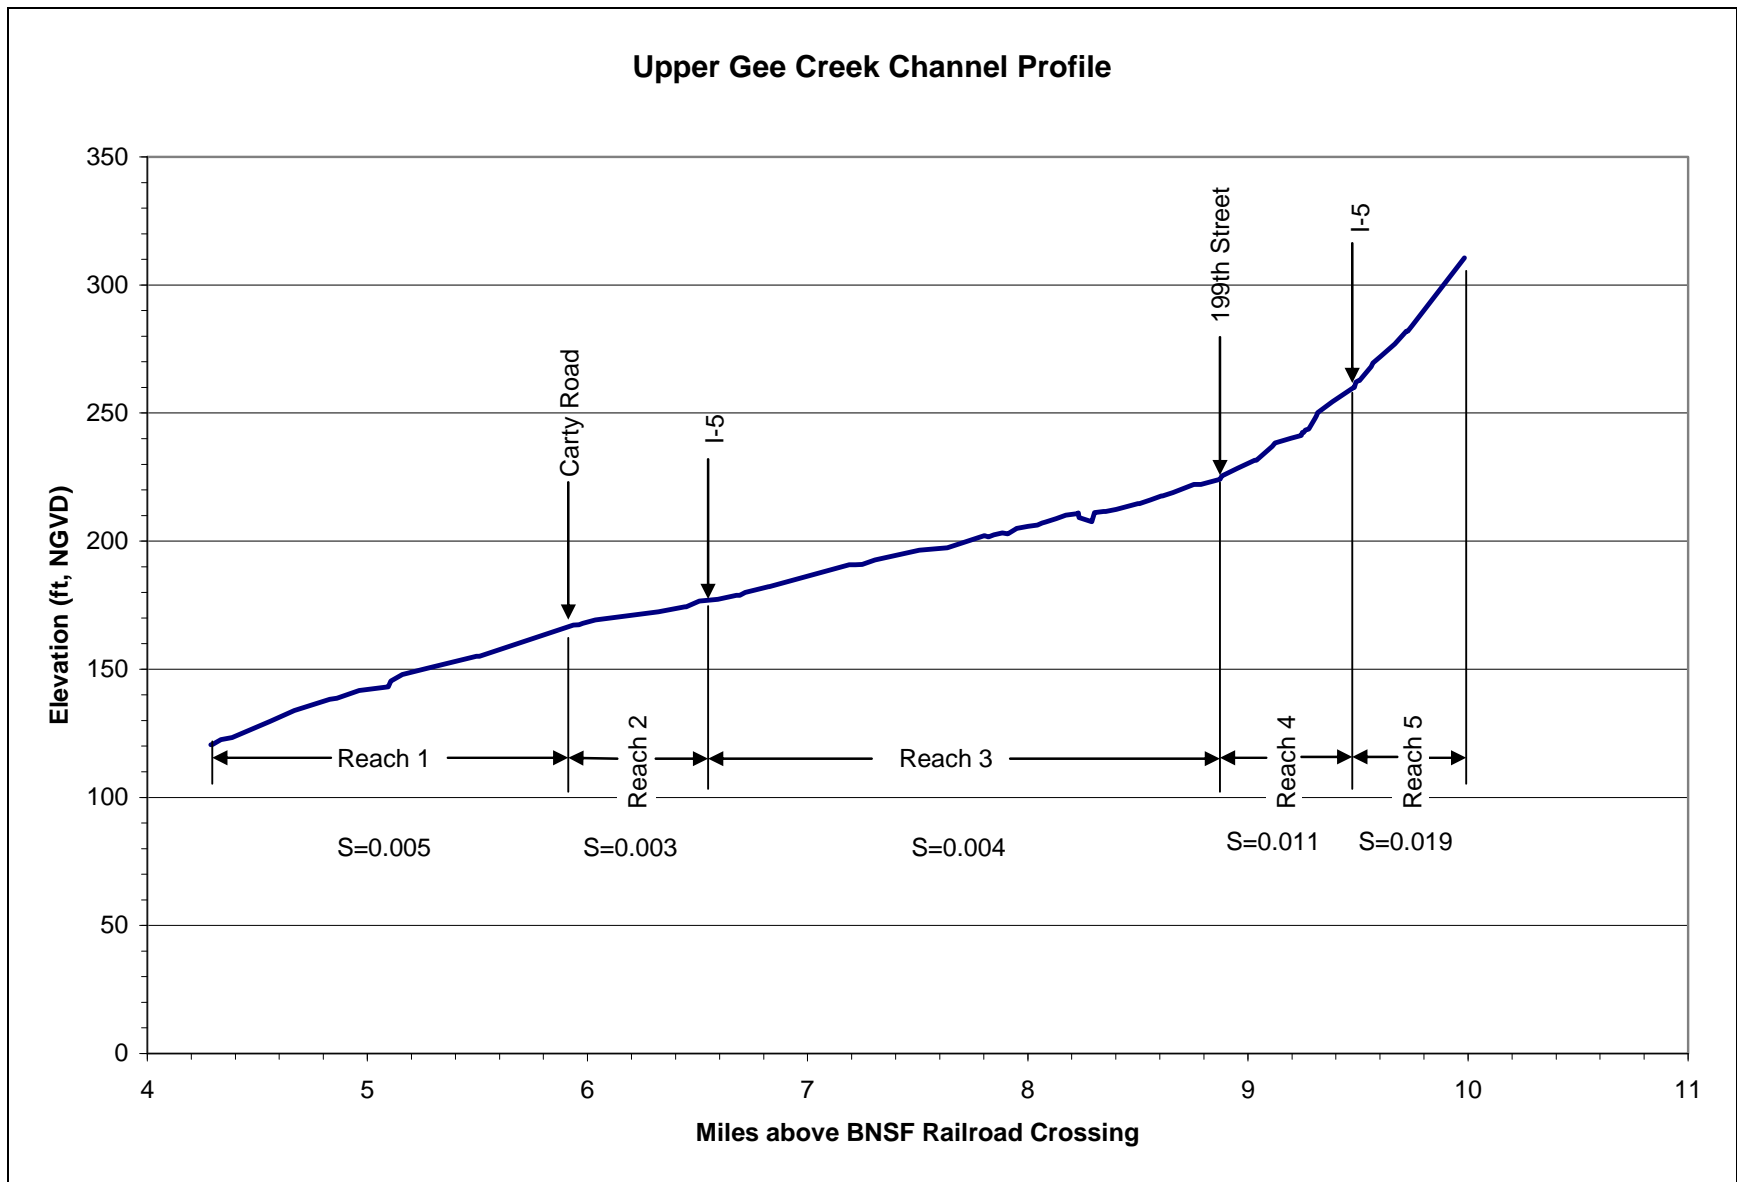
Figure 12. Stream channel profile of Upper Gee Creek (data from WEST, 2005).

The reach of Upper Gee Creek between I-5 and Carty Road (Reach 2 in Figure 12) is a transport limited “response” reach in that, over the long-term, sediment supply generally exceeds sediment transport capacity. The channel slope is controlled at the downstream end by hydraulic conditions associated with the Carty Road culvert crossing and the intersection of the stream bed with the underlying coarse grained Plio-Pleistocene conglomerate bedrock. The combination of these two features reduces the sediment transport capacity of the channel below the sediment supplied from upstream reaches resulting in long-term sediment deposition.

The reach of Upper Gee Creek downstream of Carty Road (Reach 1 in Figure 12) is considered to be a supply limited “source” reach in that, over the long-term, sediment transport capacity generally exceeds sediment supply. The underlying coarse grained Plio-Pleistocene conglomerate is more resistant to transport except during larger flows and is therefore limiting the supply of sediment to the stream. Any input of fine sediment from upstream will be transported through this reach except where local hydraulic conditions reduce the velocities and shear stresses sufficiently to encourage deposition. This condition would be typical of floodplain areas with sufficient hydraulic roughness or in backwater areas upstream of hydraulic constrictions. Temporary storage of fine sediment occurs within overbank areas of this reach resulting in greater sinuosity compared to the supply reaches further upstream.

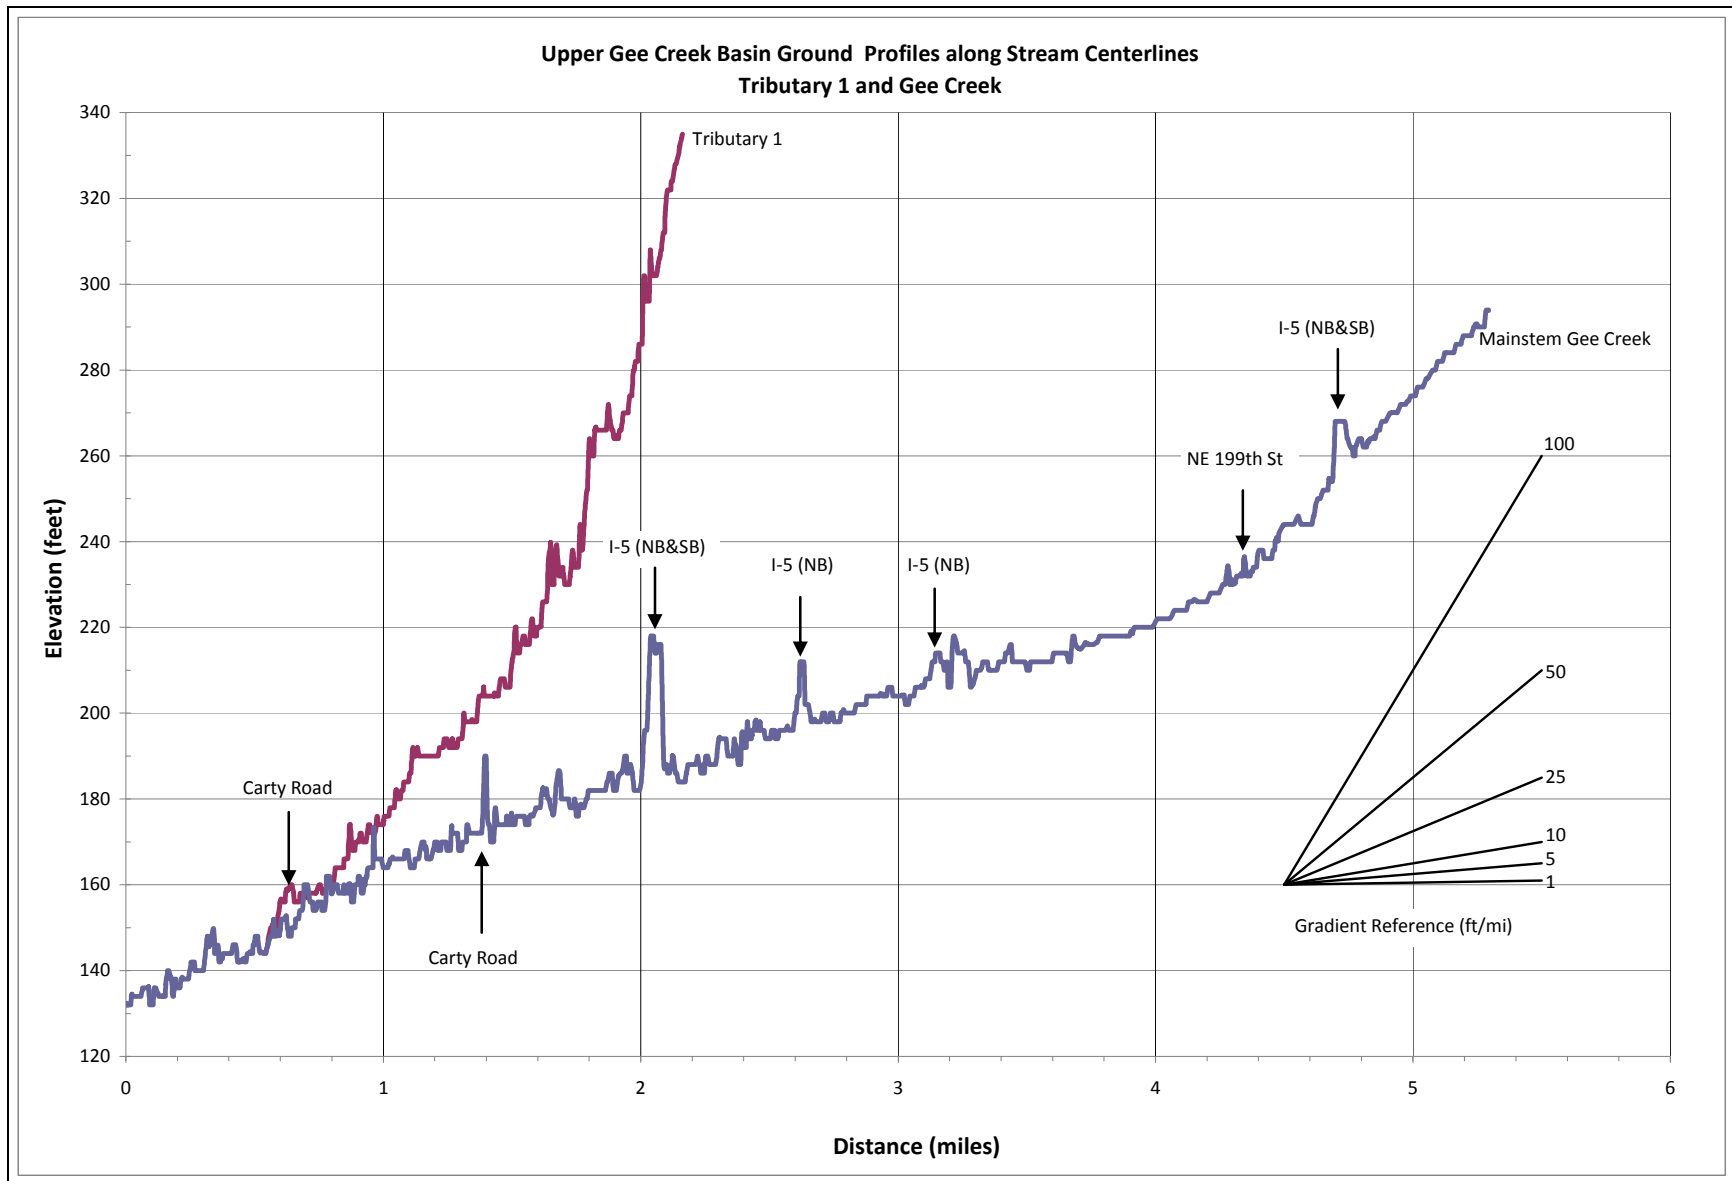
Figure 15. Ground profiles along stream channel centerlines for Tributary 1 and Gee Creek.

As seen in Figure 15, Tributary 1 has a significantly steeper slope compared to the rest of the basin streams. This is likely the result of the underlying geology which is the coarse grained Plio-Pleistocene conglomerate. The stream does not have the ability to transport significant quantities of gravel and cobble that are found within this geologic formation. Therefore, the channel is maintained at a much steeper slope than the remainder of the basin streams which have sand and silt sized bed material reflecting the nature of the underlying fine grained Cataclysmic Flood Deposits.
