2007 Stormwater Needs Assessment Program

Curtin Creek Subwatershed Needs Assessment Report

Clark County Public Works Water Resources

June 2008

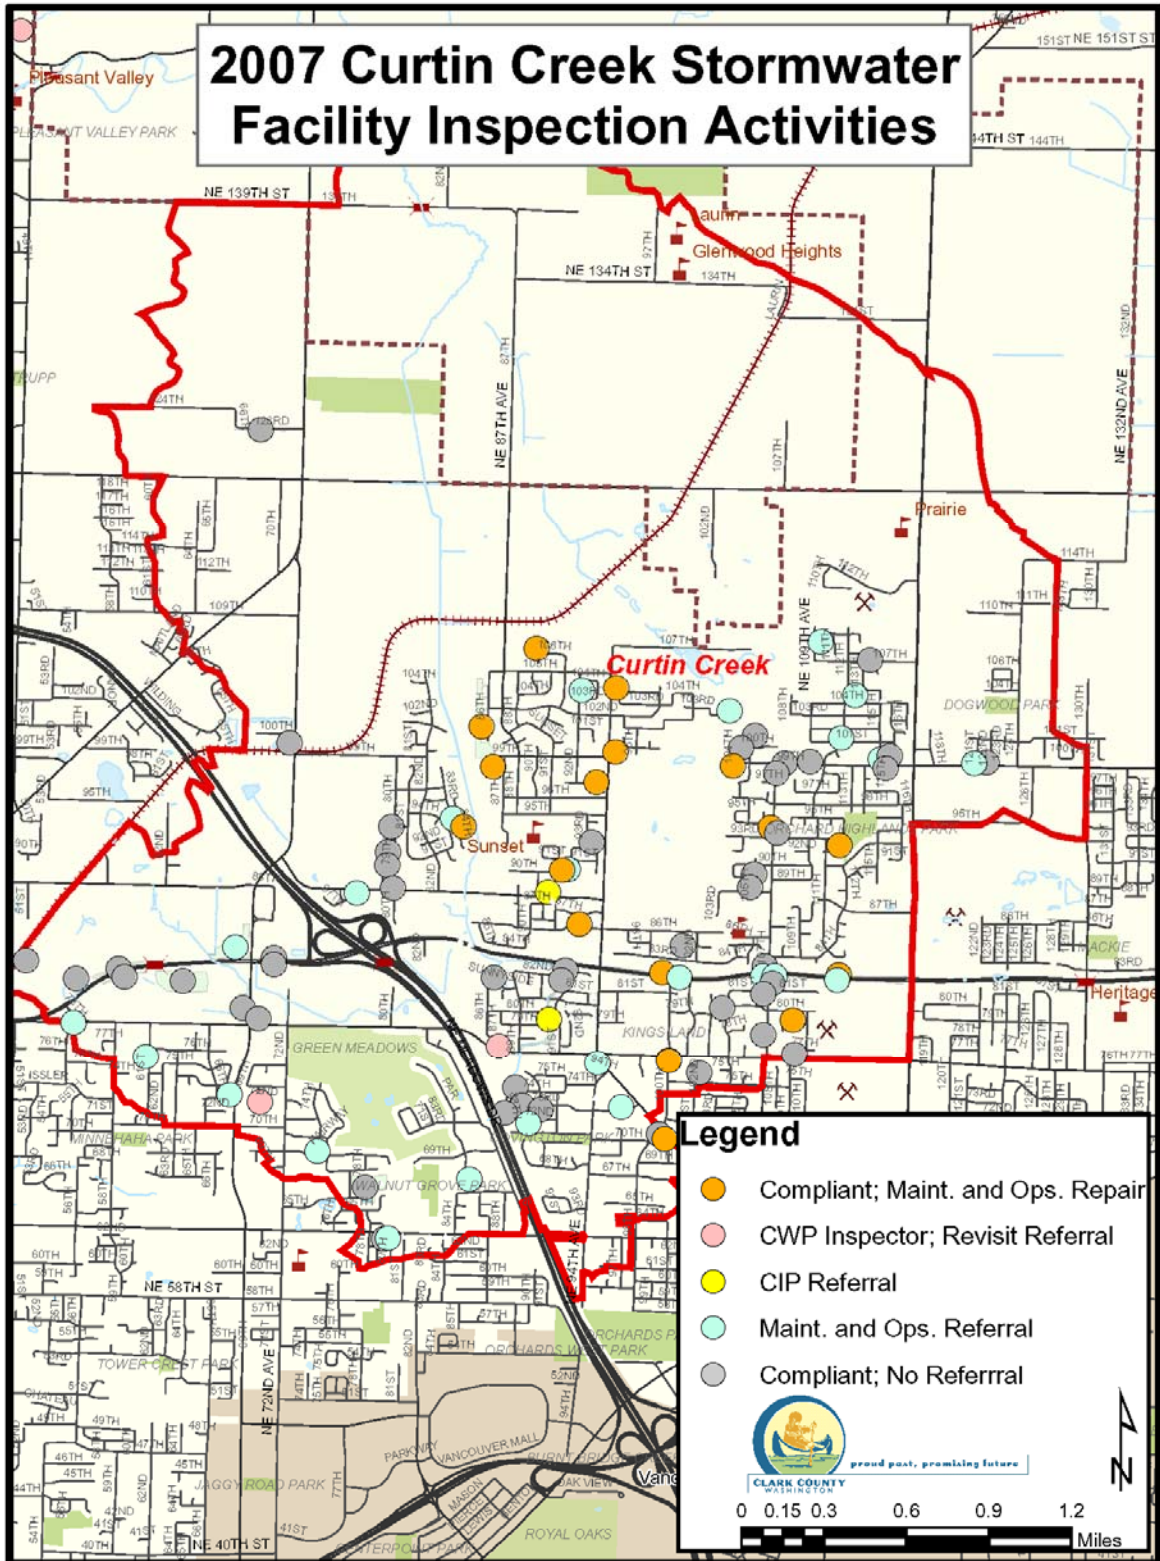
Figure 6: Summary of 2007 Public Stormwater Facility Inspection Activities in the Curtin Creek Watershed

No major defects or hazardous conditions were discovered; non-compliant issues included excess sediment depth, trash or debris, and lack of signage.

The most common facility objects found out of compliance during the public stormwater facility inspection process were catch basins, StormFilter® treatment vaults, and facility fencing.

Catch basin defects included sediment exceeding 60 percent of sump depth, and storm pipe damaged preventing normal function. StormFilter® defects included sediment accumulation on media and sediment accumulation in vault. Facility fencing defects consisted of missing or unreadable water quality signs. These defects were consistent with inspection results for public stormwater facilities from other subwatersheds.

Maintaining catch basins, StormFilter® vaults, and providing appropriate water quality signs for stormwater facilities will bring most facilities into compliance.

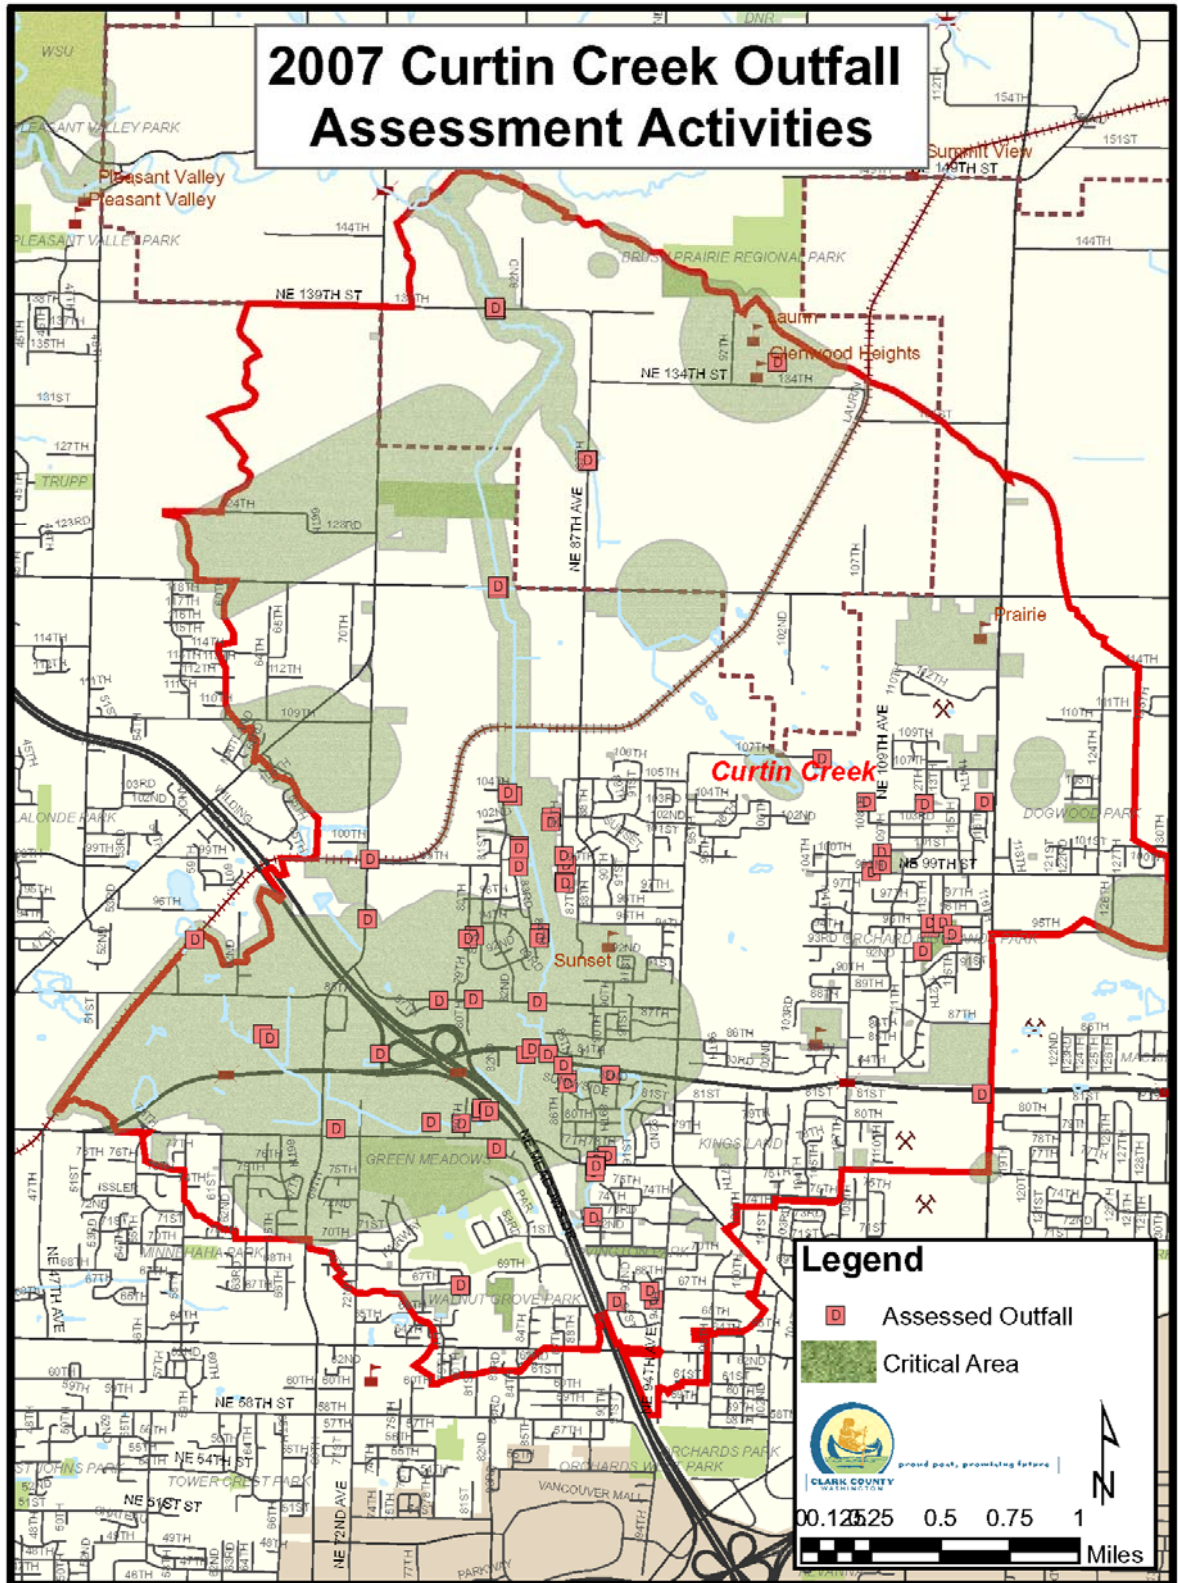
Figure 7: Summary of 2007 Outfall Assessment Activities in Curtin Creek Watershed

All outfalls that discharged into critical areas were assessed and found to be in compliance.

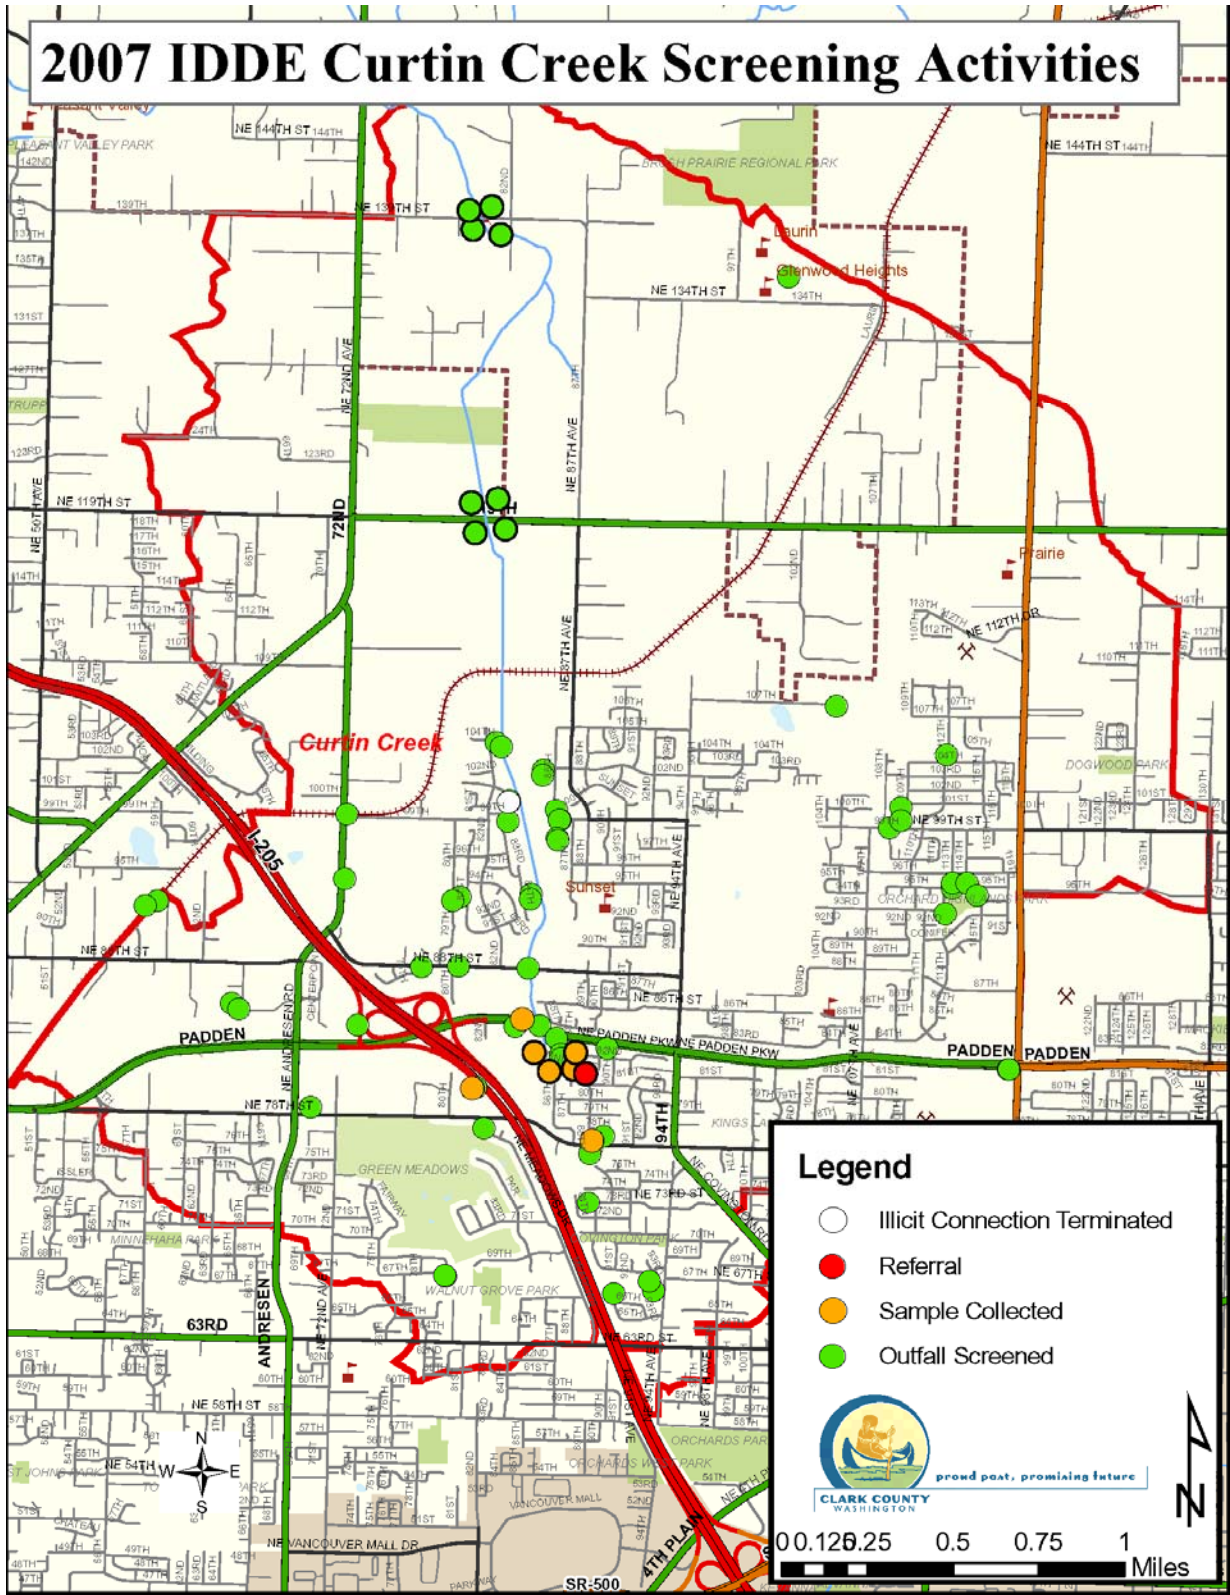
Figure 8: Summary of 2007 IDDE Screening Project Activities in Curtin Creek Subwatershed

The investigation revealed that based on flowchart analysis of fecal coliform concentration, drainage area investigation, and mapped stormwater conveyance system, a strong possibility that a failing septic tank(s) may be a possible source for the illicit discharge. Removal activities are ongoing for this discharge as of December 2007 (see Case Summary 14248).

Removal activities include education outreach, disconnection of washwater pipe, and removing sediment from the downstream conveyance storm pipe system.

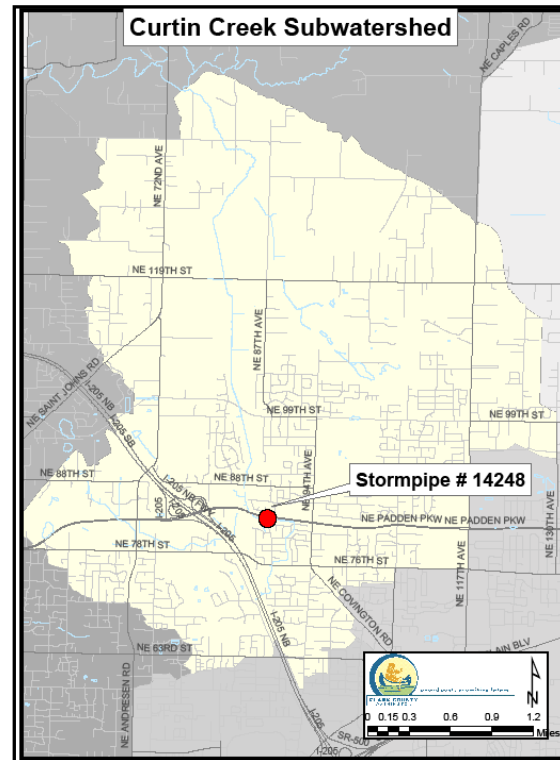
Figure 9: General Location of Storm Pipe #14248

During the investigation, CWP attempted to locate the origin of stormwater pipe with the assistance of private property owners. Private residences indicated failing septic tanks as potential fecal coliform sources.

Laboratory results received on December 28, 2007 revealed that fecal coliform values were high for Sample 1 and low for Samples 2, 3, and 4 (Table 12). The investigation indicated, based on flowchart analysis of fecal coliform concentration, drainage area investigation, and mapped stormwater conveyance system, a strong possibility of a sanitary wastewater source.

The Clean Water Program may have fecal source tracking tools in 2008. Fecal source tracking involves using a molecular-based method that utilizes host specific biomarkers to determine if fecal coliform sources are human or non-human. Outfall from storm pipe #14248 will be a candidate for fecal source tracking.

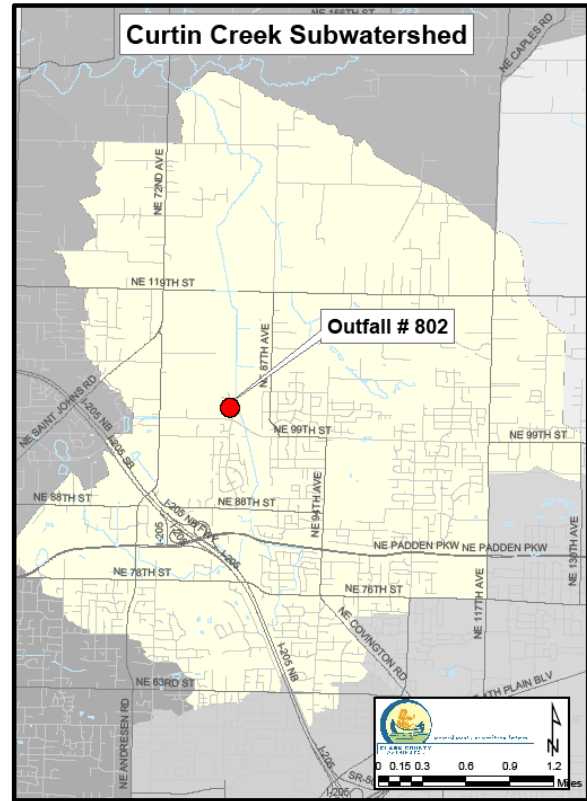
Figure 11: General location of Outfall #802

Laboratory results received on August 12th revealed that surfactants concentrations were high at outfall #802 and upstream site "B"

on July 23rd (Table 14), suggesting that a continuous illicit discharge was entering the storm sewer along 99th Street.

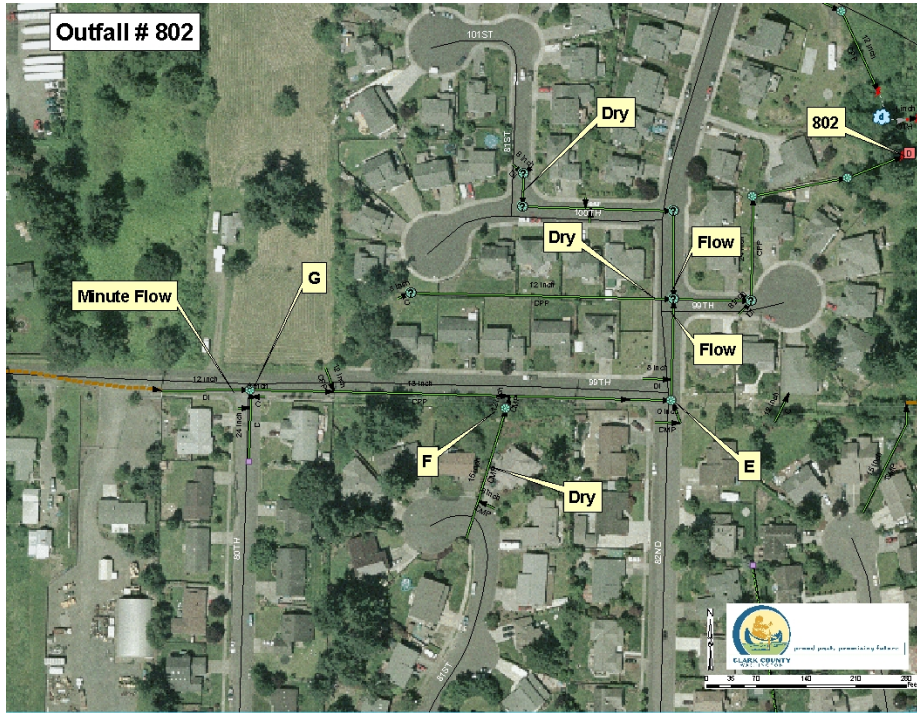
Figure 12: Investigation Map of Outfall #802 Conducted on July 23, 2007

Outfall #802 was re-sampled on July 23rd for surfactants to confirm the presence of elevated levels. Four additional samples were collected from the storm system upstream from outfall #802 (see Figure 12) as part of a network investigation.
