# **Kalama, Washougal and Lewis River Habitat Assessments**

## **Chapter 2: The Kalama River Basin**

**R2 Resource Consultants, Inc.**

December 2004

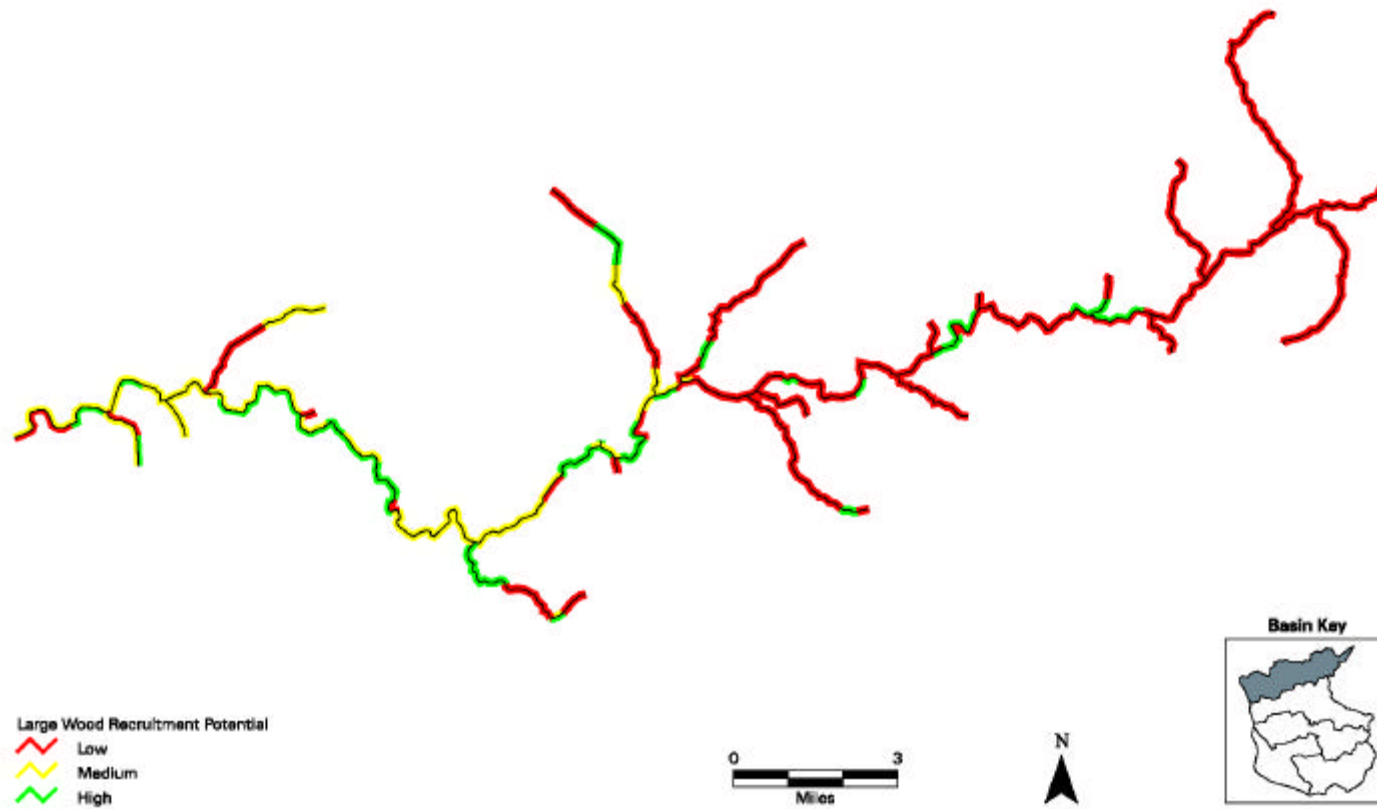
Map 2-2. Large wood condition ratings for EDT reaches in the Kalama Basin.

*Large Wood (LW) Assessment:* The location and current LW recruitment condition of 43 EDT reaches are shown in Map 2-2. The condition rating for each of the reaches is included in Appendix A.

Aerial photo assessment, along both shorelines of nearly 77 miles of anadromous fish streams, indicates the overall LW recruitment potential of riparian stands in the Kalama basin is relatively poor.

Portions of Kalama 5, 7, 9, 15, and 21, the little Kalama River, Arnold, Bush, Gobar, Summers and Wildhorse creeks offered good current LW recruitment conditions [low recruitment hazard] on both sides of the stream. Riparian vegetation in these situations consisted of dense stands of either large or medium-sized conifer or mixed species.

However, most of the reaches in the basin represented poor [high hazard] LW recruitment conditions. The existing poor stand conditions were not reflected in species composition of riparian stands. Based on photographic interpretation, only 3 percent of the stands appeared to be dominated by deciduous species. Conversely, conifer and mixed conifer/hardwood stands were prevalent at 96 percent of total. The poor existing stand situation appeared to be related to the size of riparian trees rather than the species composition or the density of the stands.

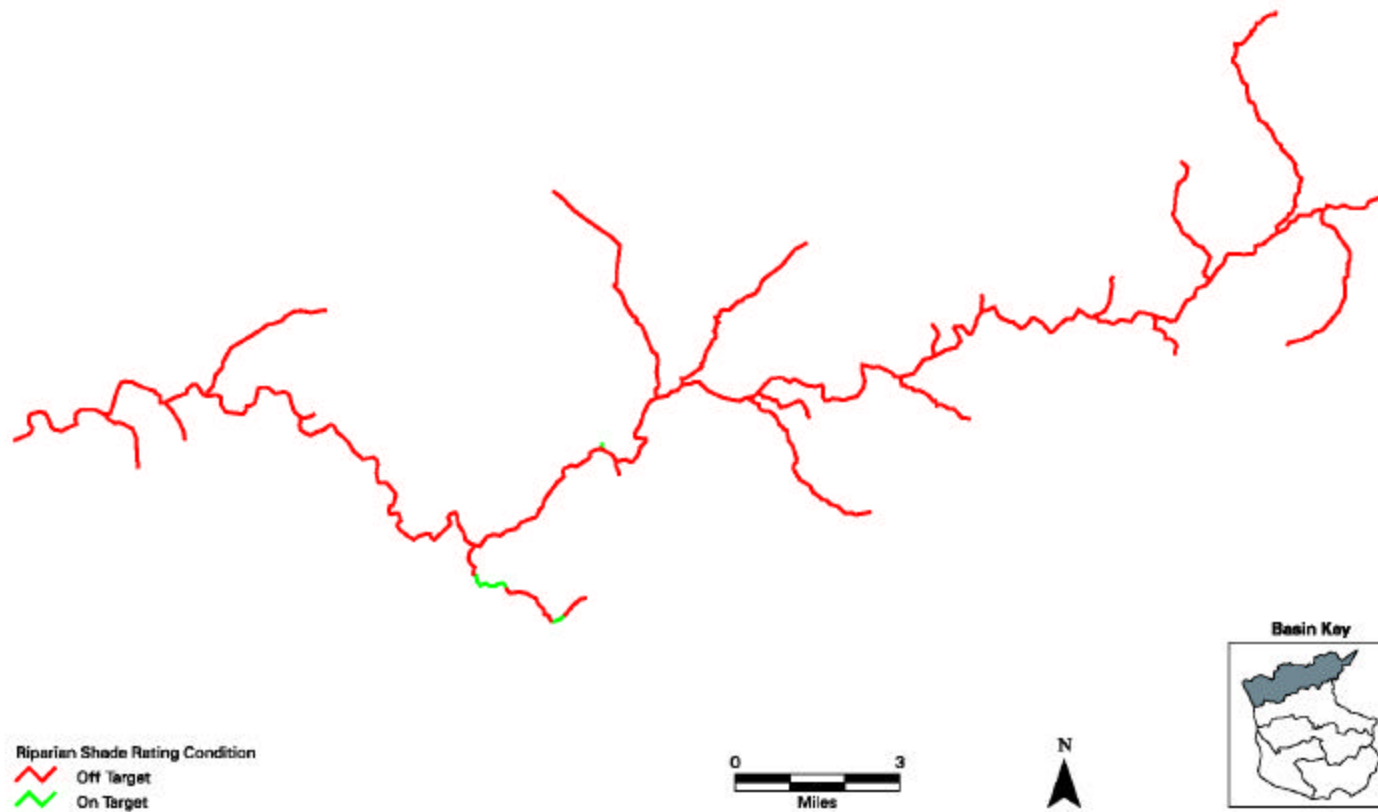
Map 2-3. Shade condition ratings for EDT reaches in the Kalama Basin

The location and current shade condition of the 43 EDT reaches is shown in Map 2-3. The condition rating for each of the reaches is included in Appendix A.

Aerial photo assessment suggested, on average, that the riparian stands provide little in the way of effective shade. Existing shade levels ranged between 0 and 80 percent shade while the mean level is approximately 28 percent shade. According to the State shade/elevation screen, this amount of shade is anticipated to maintain water temperature standards in streams located upstream of approximately the 760m (2,500 ft) msl elevation in the basin.

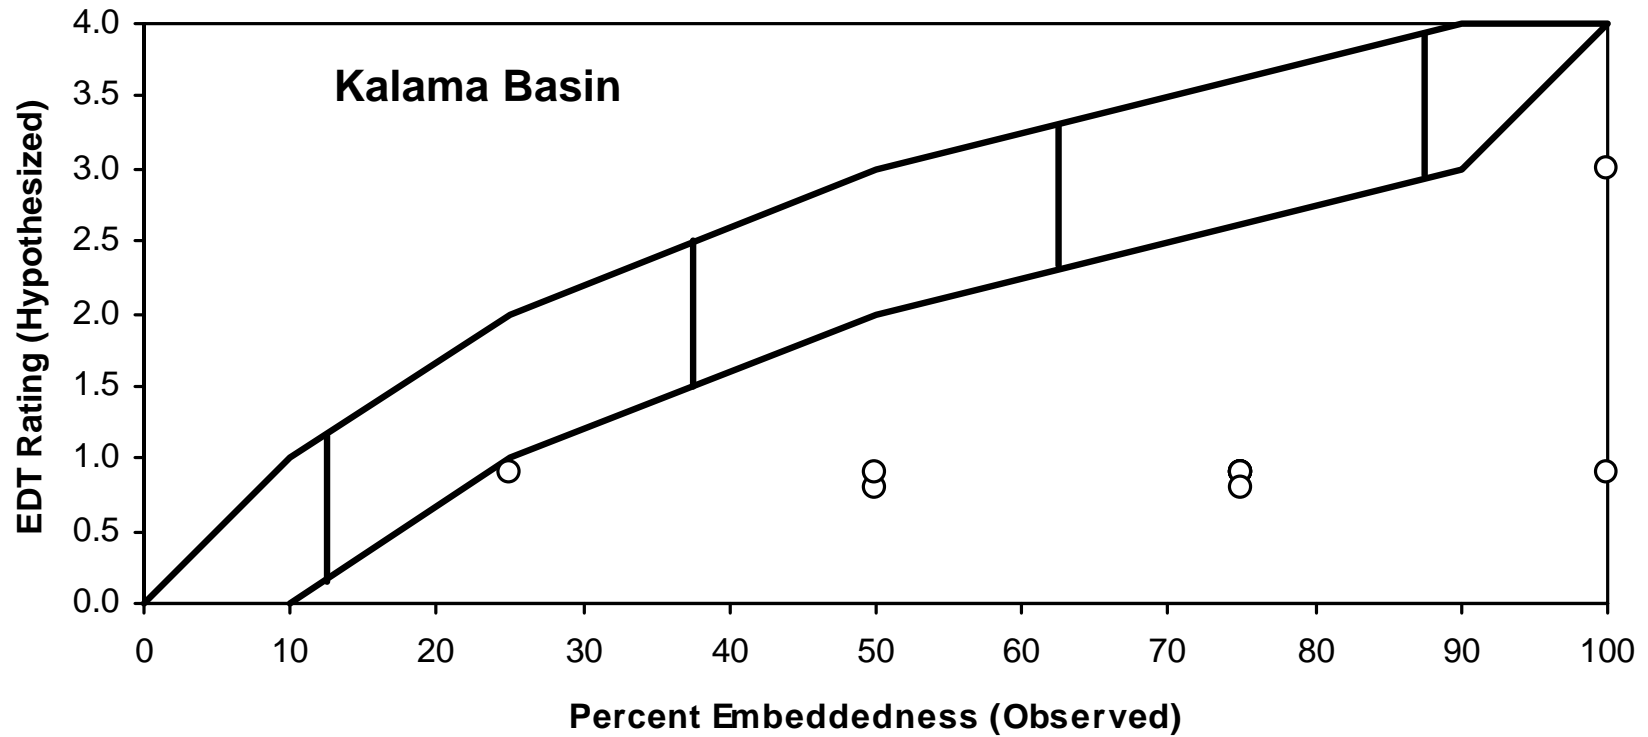
Comparison of the data collected in this study with the assigned EDT ratings indicated that modeled embeddedness levels were underestimated throughout the basin. If the EDT categorical ratings were accurate, the points depicted in Figure 2-5 would have been expected to fall within the diagonal range defining the EDT ratings. The EDT model should be revised to more accurately reflect current conditions.

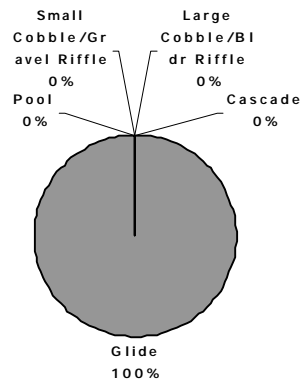
**Figure B-1. Unit composition by percent surface area of the surveyed section of Kalama 1-tidal.**

Kalama 1-tidal is a large palustrine to estuarine channel with a dune-ripple bedform. It is comprised entirely of glide habitat type (Figure B-1). Depending upon river discharge and the tidal stage, reverse stream flows are possible.

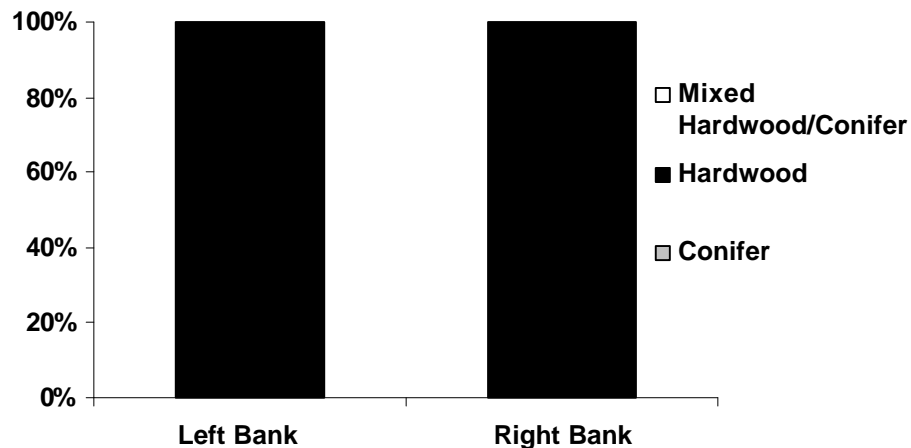
**Figure B-2. Vegetation type by percent of units observed. Data presented as proceeding downstream.**

Kalama 1-tidal is a wide floodplain bottom channel that is open to the sky. Riparian vegetation on both banks is provided in the inner zone by grasses, forbs, small shrubs and saplings. The vegetation stands along the outer riparian zone primarily consist of sparse, young, deciduous communities (Figure B-2). Estimates of the distance of trees beyond the bank full stage of the channel range between 13.5 and 63 m (45-207 ft) and average 32 m (104 ft) of open bank. This zone represents an area of Kalama River floodplain disturbance where tree growth is difficult to establish. As such the open channel width to the sky averages 64 m (210 ft) of channel width plus an additional 32 m (104 ft) of open bank or a total of 96 m wide zone without vegetative cover. The mean view to sky angle is 145 degrees or nearly 81 percent (Table B-5). Nearly 60 percent of the riparian zone is also currently disturbed by both urbanization and forest harvest.

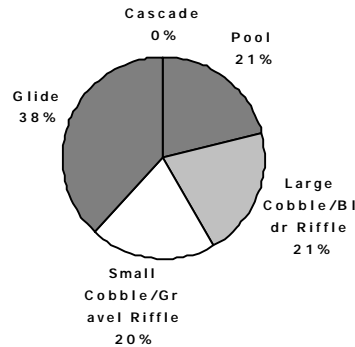
**Figure B-3. Unit composition by percent surface area of the surveyed section of Kalama 2.**

Kalama 2 remains dominated by glide habitat types, but it includes a relatively equal contribution of pool, small riffle and large riffle habitat features (Figure B-3).

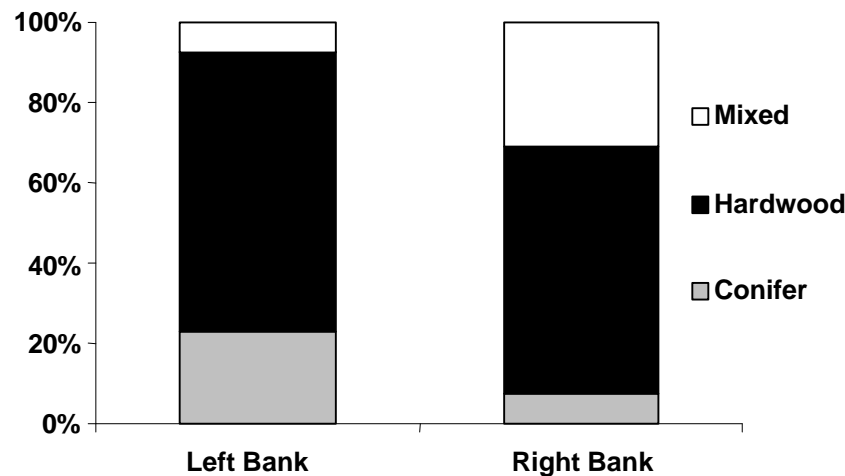
**Figure B-4. Vegetation type by percent of units observed. Data presented as proceeding downstream.**

Kalama 2 is a wide floodplain channel that is open to the sky, even in the canyon. Riparian vegetation on both banks is provided in the inner zone by grasses, forbs, small shrubs and saplings. The vegetation stands along the outer riparian zone primarily consist of sparse, young, deciduous communities but mixed conifer and hardwood stands and conifer dominated stands exist (Figure B-4). Estimates of the distance of trees beyond the bank full stage of the channel range between 23 and 155 m (75-510 ft) and average 55 m (180 ft) of open bank. This zone represents an area of Kalama River floodplain disturbance where tree growth is difficult to establish. As such the open channel width to the sky averages 39 m (128 ft) of channel width plus an additional 55 m (180 ft) of open bank or a total of 94 m wide zone without vegetative cover. The mean view to sky angle is 114 degrees or 63 percent open (Table B-14).

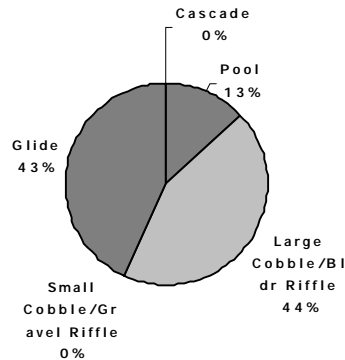
**Figure B-5. Unit composition by percent surface area of the surveyed section of Kalama 3.**

Kalama 3 is expected to be only moderately responsive to LW, as the large size and high stream energy mean that accumulations of wood or large logs will be mobilized relatively frequently compared with smaller channels. Sediment is stored in association with channel obstructions (boulders, bedrock outcrops or stable LW accumulations). This reach is generally semi-alluvial except during periods of extremely high sediment supply (e.g., volcanic episodes). However, good deposits of spawning gravel exist in locally low gradient areas.

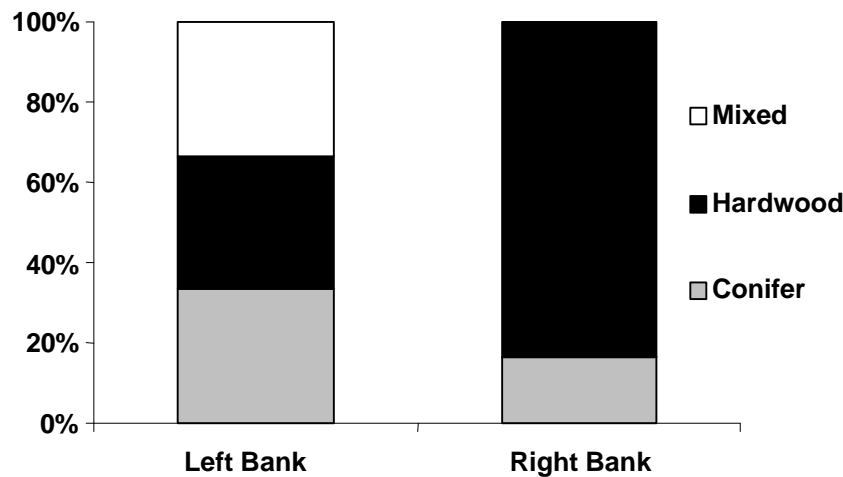
**Figure B-6. Vegetation type by percent of units observed. Data presented as proceeding downstream.**

Kalama 3 is a wide, moderately confined channel that is open to the sky, even in the canyon. Riparian vegetation on both banks is provided in the inner zone by grasses, forbs, small shrubs and saplings. The vegetation stands along the outer riparian zone primarily consist of hardwood or mixed hardwood conifer communities, although there are some mature conifer stands in undeveloped areas along the left bank (Figure B-6). The open channel width to the sky averages 44 m (144 ft) of channel width plus an additional 51 m (167 ft) of open bank or a total of 95 m wide zone without vegetative cover. The mean view to sky angle is 64 percent (Table B-23). From 30 to 50 percent of the riparian zone on both banks is currently disturbed by urbanization and stream adjacent roads.

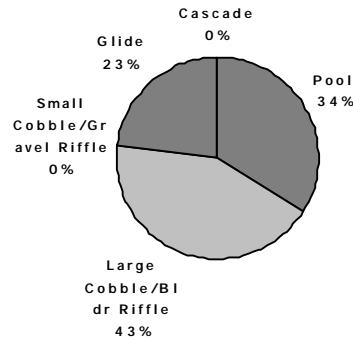
**Figure B-7. Unit composition by percent surface area of the surveyed section of Kalama 4.**

Kalama 4 is not expected to be responsive to LW, as the large size and high stream energy mean that accumulations of wood or large logs will be mobilized relatively frequently compared with smaller channels. Sediment is stored in areas of divergent flow or velocity breaks downstream of channel obstructions (primarily boulders or bedrock outcrops). This reach is generally supply limited and semi-alluvial. However, good deposits of spawning gravel exist in locally low gradient areas.

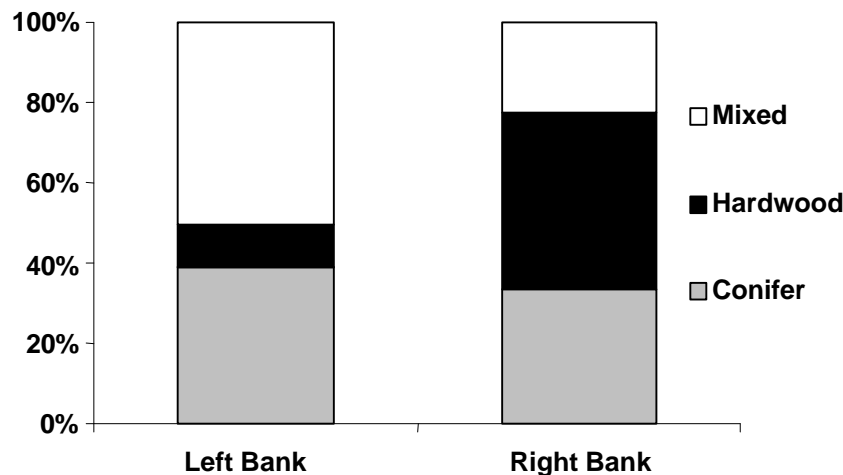
**Figure B-8. Vegetation type by percent of units observed. Data presented as proceeding downstream.**

Kalama 4 is a wide, confined channel that is open to the sky, even in the canyon. Riparian vegetation on both banks is provided in the inner zone by grasses, forbs, small shrubs and saplings. The vegetation stands along the outer riparian zone primarily consist of hardwood or mixed hardwood conifer communities, although there are some mature conifer stands in undeveloped areas along the left bank (Figure B-8). The open channel width to the sky averages 42 m (138 ft) of channel width plus an additional 20 m (66 ft) of open bank or a total of 62 m wide zone without vegetative cover. The mean view to sky angle is 47 percent (Table B-32).

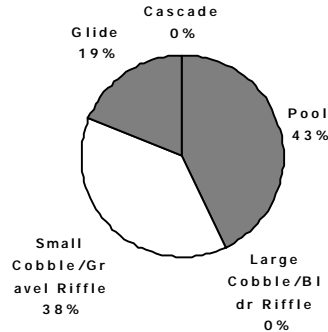
**Figure B-9. Unit composition by percent surface area of the surveyed section of Kalama 6.**

Kalama 6 is not expected to be responsive to LW, as the large size and high stream energy mean that accumulations of wood or large logs will be mobilized relatively frequently compared with smaller channels. Sediment is stored in areas of divergent flow or velocity breaks downstream of channel obstructions (primarily boulders or bedrock outcrops). This reach is generally supply limited and semi-alluvial. However, good deposits of spawning gravel exist in locally low gradient areas.

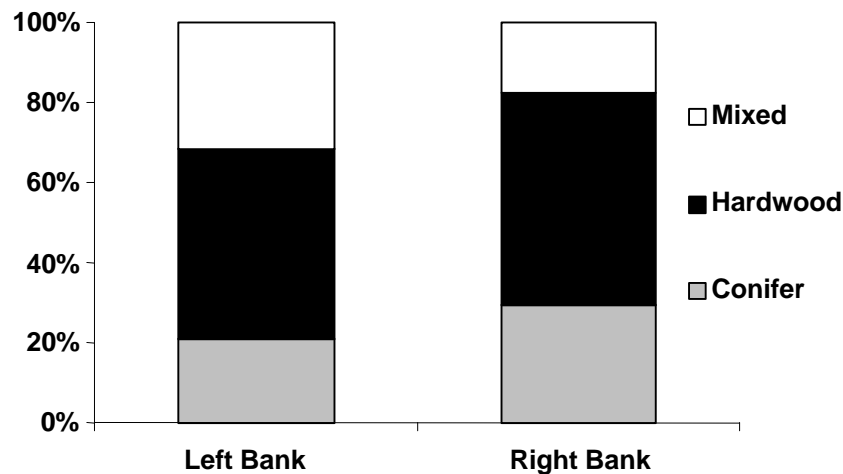
**Figure B-10. Vegetation type by percent of units observed. Data presented as proceeding downstream.**

Kalama 6 is a wide channel that is open to the sky, even in the canyon. Riparian vegetation on both banks is provided in the inner zone by grasses, forbs, small shrubs and saplings. The vegetation stands along the outer riparian zone primarily consist of hardwood or mixed hardwood conifer communities, although there are some mature conifer stands in undeveloped areas along the left bank (Figure B-10). The open channel width to the sky averages 33 m (108 ft) of channel width plus an additional 24 m (79 ft) of open bank or a total of 57 m wide zone without vegetative cover. The mean view to sky angle is 43 percent (Table B-41).

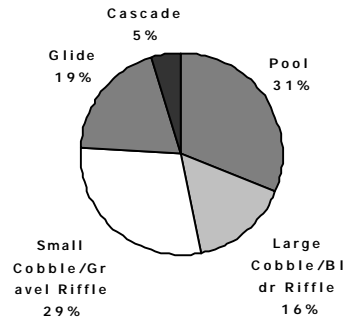
**Figure B-11. Unit composition by percent surface area of the surveyed section of Kalama 7.**

Kalama 7 is not expected to be responsive to LW, as the large size and high stream energy mean that accumulations of wood or large logs will be mobilized relatively frequently compared with smaller channels. Sediment is stored in areas of divergent flow or velocity breaks downstream of channel obstructions (primarily boulders or bedrock outcrops). This reach is generally supply limited and semi-alluvial. However, good deposits of spawning gravel exist in locally low gradient areas.

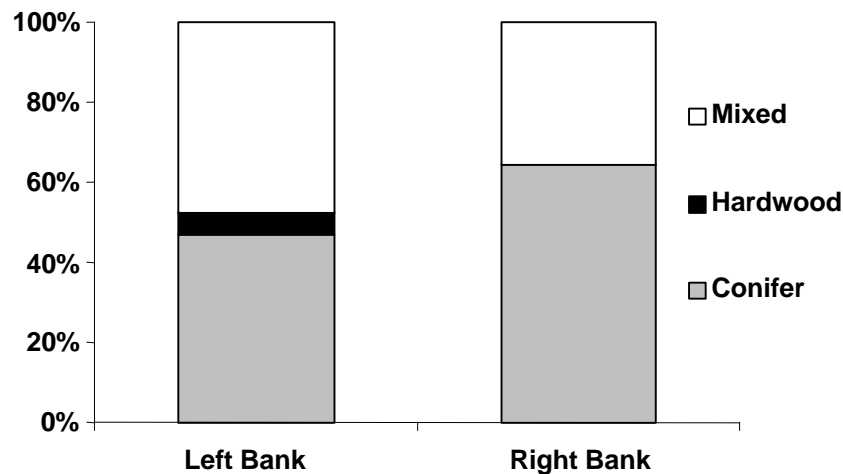
**Figure B-12. Vegetation type by percent of units observed. Data presented as proceeding downstream.**

Kalama 7 is a wide channel that is open to the sky, even in the canyon. Riparian vegetation on both banks is provided in the inner zone by grasses, forbs, small shrubs and saplings. The vegetation stands along the outer riparian zone primarily consist of conifer or mixed hardwood conifer communities (Figure B-12). The open channel width to the sky averages 30 m (98 ft) of channel width plus an additional 16 m (52 ft) of open bank or a total of 46 m wide zone without vegetative cover. The mean view to sky angle is 39 percent (Table B-50).

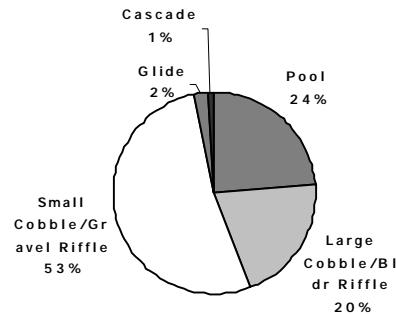
**Figure B-13. Unit composition by percent surface area of the surveyed section of Hatchery Creek.**

Given the overall valley morphology (narrow valley, moderate gradient), Hatchery Creek functions mainly as a transport reach. Sediment storage is expected to be strongly correlated with LW loading. Sediment accumulates where LW blocks the channel or forms velocity breaks.

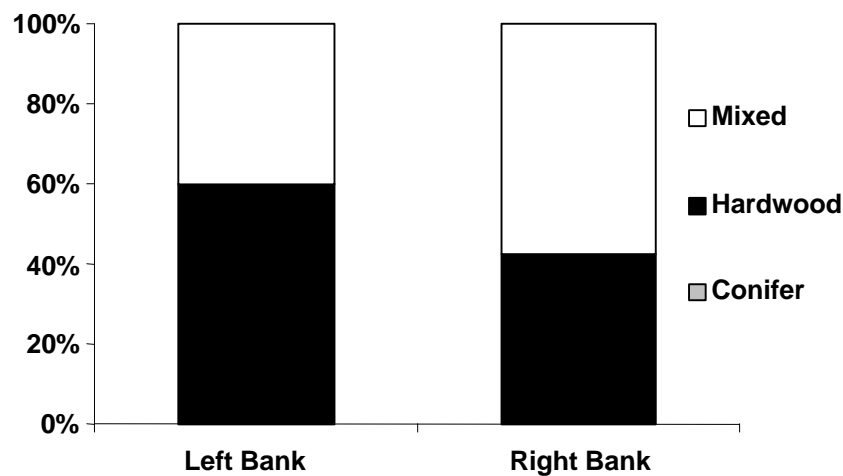
**Figure B-15. Vegetation type by percent of units observed. Data presented as proceeding downstream.**

Wildhorse Creek is a small channel that well shaded by both vegetation and topography. Riparian vegetation stands consist of hardwood and mixed hardwood/conifer communities (Figure B-16). The open channel width to the sky averages 4.9 m (16 ft) of channel width plus an additional 22 m (72 ft) of open bank or a total of 27 m wide zone without vegetative cover. The mean view to sky angle is 15 percent (Table B-68).
