Geomorphology and Hydrology Assessment for Mill Creek

Department of Public Works
Clean Water Program
1300 Franklin Street
Vancouver, WA 98666

October 9, 2008

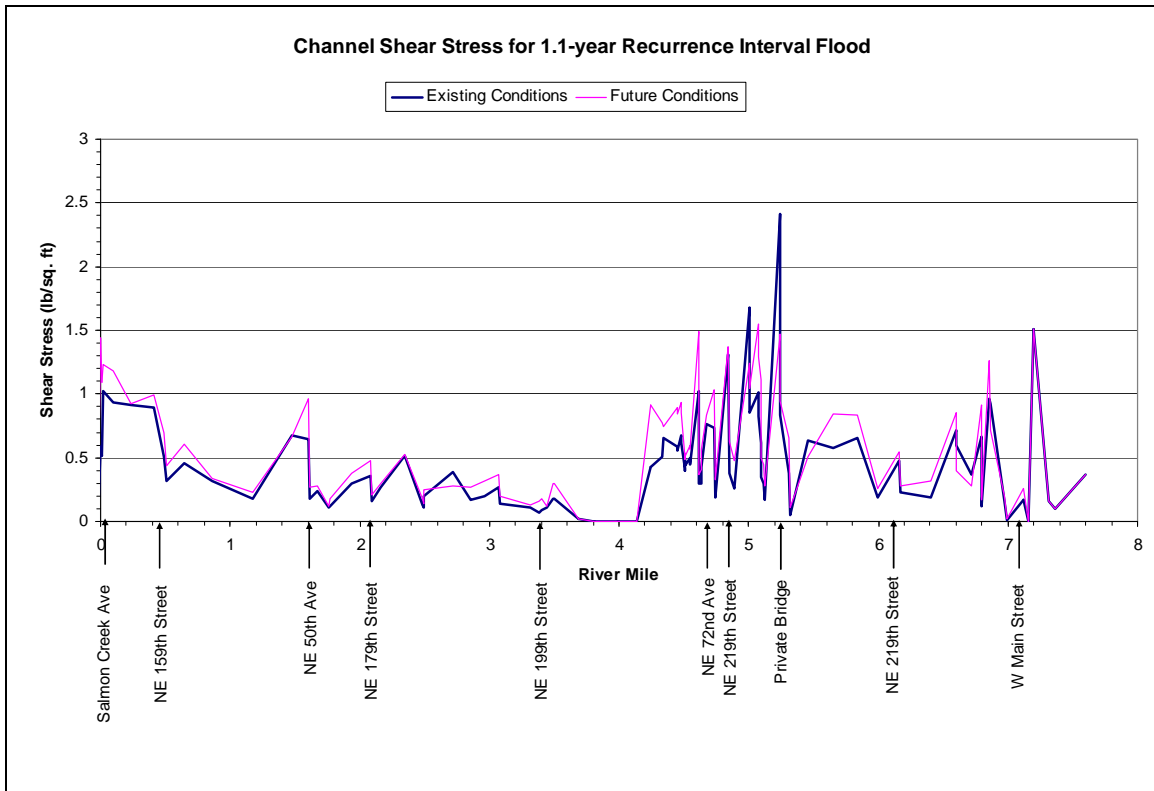
Figure 9. Channel shear stress profile for 1.1-year flood along Mill Creek (WEST, 2008).

Figure 9 shows a channel shear stress profile of Mill Creek developed from the updated HEC-RAS hydraulic model (WEST, 2008). The RAS model includes future conditions flows for Mill Creek based on the updated HSPF hydrologic model (WEST, 2008). For the evaluation, the threshold for channel instability, which is assumed to be one-half of the 2-year event based on work by Booth (1989) which for Mill Creek is equivalent to the 1.1-year flood event (WEST, 2008), was used. As seen in the figure, the channel shear stress for the 1.1-year recurrence interval flood is significantly reduced upstream of and significantly increased downstream of various road crossings, most notably a private bridge near RM 1.2 as well as multiple public and private road crossings between RM 4.5 and 5.2. Local scour, channel incision, and bank failures were observed in this reach.

Channel shear stress is also seen to increase downstream of NE 159th Street to the confluence with Salmon Creek. Along this reach, Mill Creek is seen to have a steeper gradient than the reach immediately upstream. As seen in Figure 9, the future conditions 1.1-year flow is not expected to significantly alter the magnitude of channel shear stress. At RM 3.2 and RM 5.2, channel shear stress is significantly reduced for future conditions flows. Although the magnitude of the 1.1-year flow for future conditions is greater than for existing conditions, the higher discharge results in greater backwater from the culverts located downstream of these two locations. The increased backwater elevation reduces channel velocities and shear stresses.

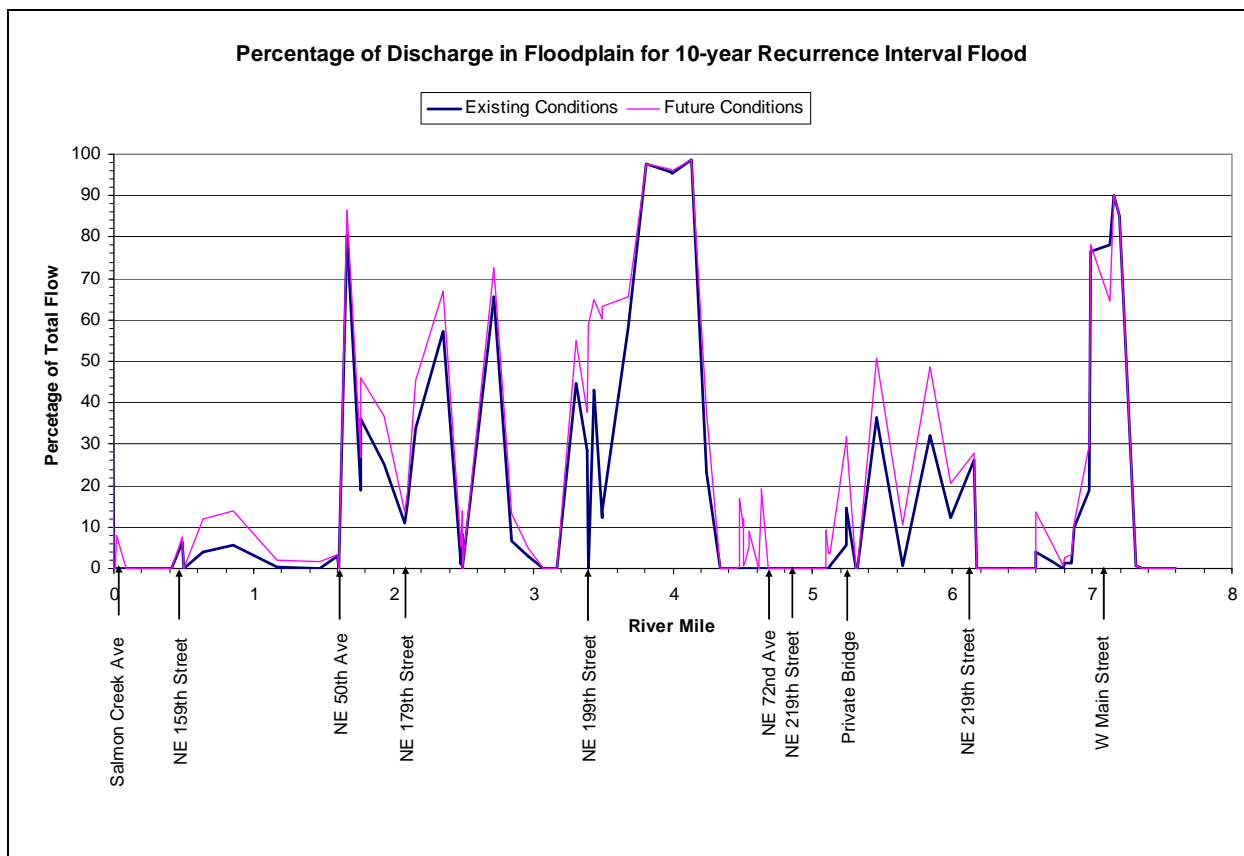
Figure 10. Percentage of total existing and future conditions 10-year peak discharge conveyed in the Mill Creek floodplain (WEST, 2008)

As seen in Figure 10, the relative percentage of the total 10-year peak flood discharge conveyed in the floodplain is influenced by several existing road crossings. Backwater conditions upstream from the road culverts and bridges result in a greater portion of the total discharge being conveyed within the floodplain. Downstream of the culverts and bridges, the discharge is often confined to the channel. It should also be noted that the stream reaches with the greatest percentage of flow in the floodplain shown in Figure 10 are seen in Figure 9 to have the lowest values of shear stress while the more confined reaches which have little or no flow in the floodplain have larger values of shear stress.

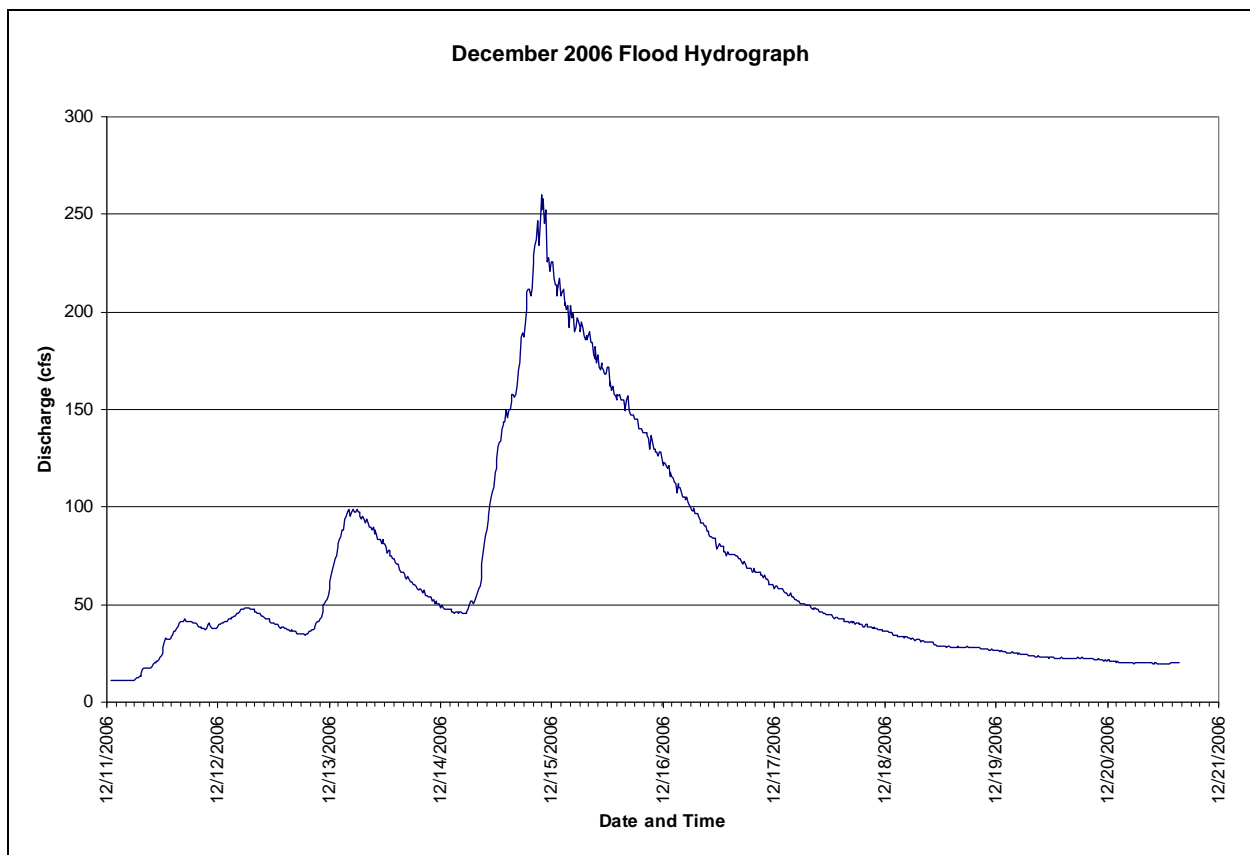
Figure 12. December 2006 flood hydrograph for Mill Creek at WSU.

respectively. Values of $T_{Q_{mean}}$ for Mill Creek generated from the gage data are relatively low and are typical for an urbanized watershed while the values generated from the HSPF model are somewhat high and are more representative of suburban watersheds. The discrepancy between the gage data and the existing conditions HSPF model is likely the result of the relatively short period of record for the gage compared to the much longer period of record used to develop the HSPF model results. Therefore, the values of $T_{Q_{mean}}$ developed from the HSPF model are likely more representative of the Mill Creek basin. The value of $T_{Q_{mean}}$ generated from the future conditions HSPF model suggest that, if not mitigated, Mill Creek will become flashier in the future resulting in increased peak flows and reduced summer low flows. It is noted that the majority of existing urban development in the Mill Creek basin is located in the upper basin in and around the City of Battleground. Values of $T_{Q_{mean}}$ generated from the existing and future conditions HSPF model for this area are 0.31 and 0.28, respectively. This suggests that impacts to flows resulting from urbanization are more significant in the upper basin than in the lower basin.

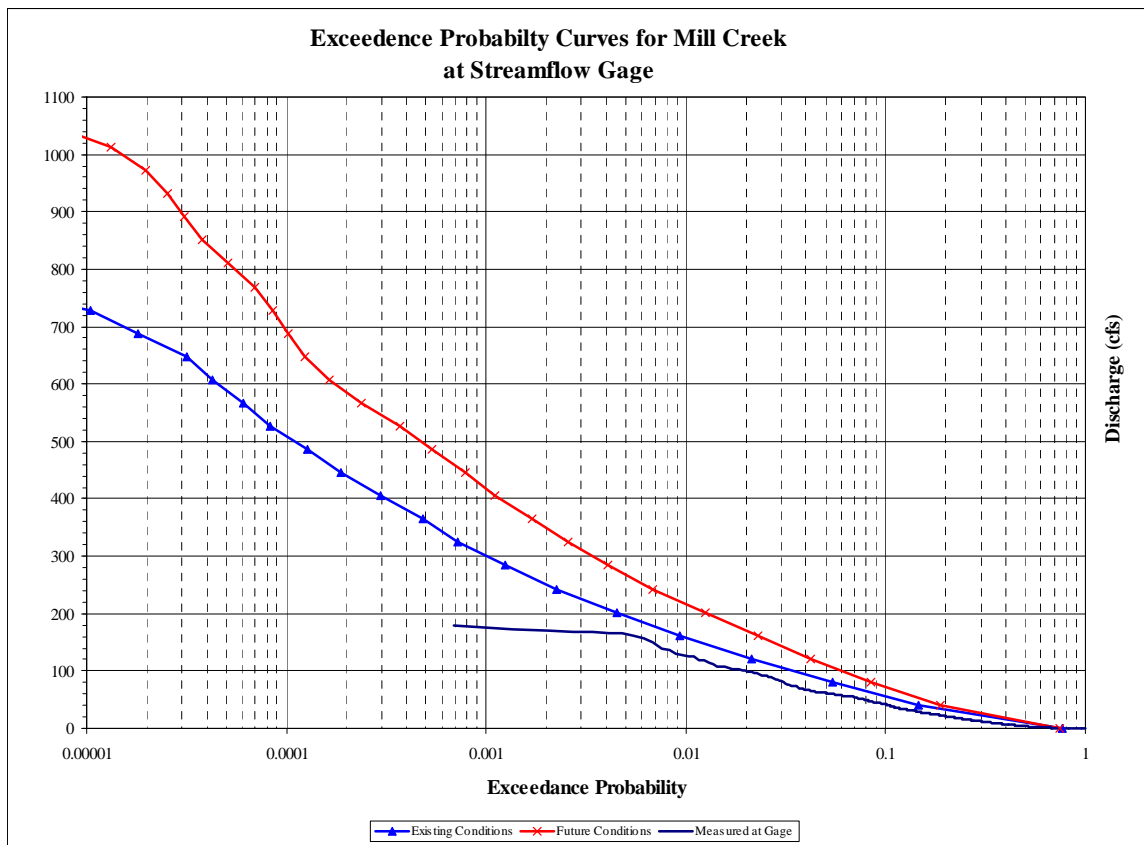
Figure 13. Flow-duration curves for Mill Creek at WSU gage.

Existing and future conditions flow-duration curves for Mill Creek are provided in Figure 13. As seen in the figure, the existing and future conditions flow-duration curves diverge from one another at approximately 20 cfs. For future conditions, the duration of flows greater than 20 cfs is expected to increase while flows less than 20 cfs are expected to have roughly the same duration. Flows are expected to equal or exceed 20 cfs approximately 35 percent of the time. Therefore, approximately 65 percent of the time, future flow conditions will be about the same as for existing conditions.

As seen in Figure 13, the flow-duration curve developed for the gage (located near WSU) is much lower than both the existing and proposed conditions curves developed from the HSPF model. As was previously noted, the period of record for the gage is rather short compared to the existing and future conditions HSPF model (WEST, 2008) Therefore, the gage data may not fully represent the flow-duration conditions of the basin.

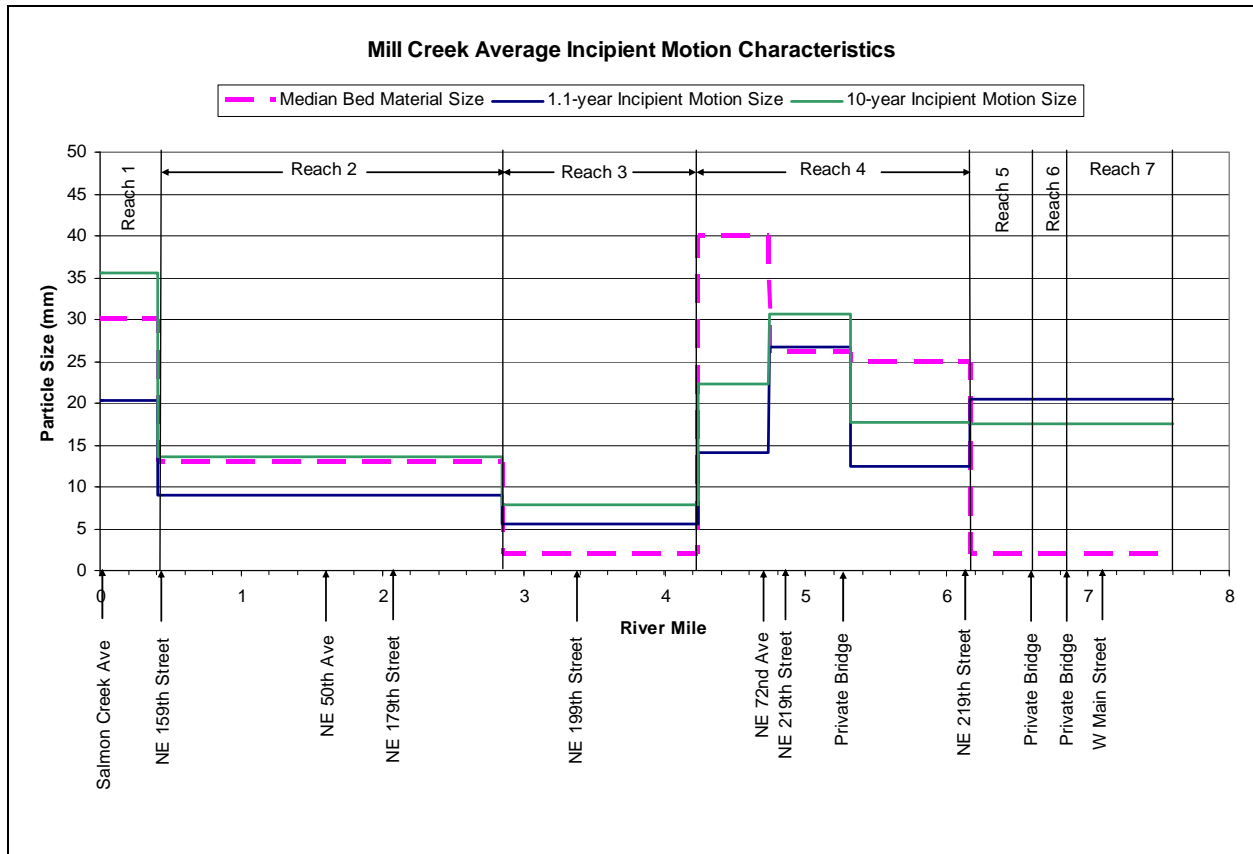
Figure 26. Incipient motion particle size characteristics for Mill Creek.

The 1.1-year discharge which is approximately equal to 50% of the 2-year discharge for Mill Creek (WEST, 2008), and the 10-year discharge were used to calculate the average incipient motion sediment sizes along Mill Creek using the Meyer-Peter and Muller equation (1948) for the reaches with gravel and cobble sized bed material and Shield's diagram (Vanoni, 1975) for the reaches with sand and silt sized bed material. As seen in Figure 26, Reaches 1, 2, and 4 generally have incipient motion particle sizes that are less than or approximately equal to the median bed material size for the 1.1-year discharge. The bed material would not be expected to be transportable in these reaches for the 1.1-year or smaller discharge. However, Reaches 3, 5, 6, and 7 have incipient motion particle sizes that are greater than the median bed material size. Therefore, the bed material would be expected to be transported for the 1.1-year discharge. However, in these reaches resistance to sediment movement is provided by grassy vegetation that lines much of the channel bed and banks. It should be noted that the incipient motion particle sizes shown in Figure 26, are based on reach averaged hydraulic conditions and that not all locations within a particular reach will be represented by the figure. This is particularly the case at road crossings where the incipient motion particle size decreases upstream of road crossings and increases downstream of road crossing due to local hydraulic conditions associated with the bridge or culvert crossing. It should also be noted that the above discussion of sediment transport potential is based on the bed material size characteristics and does not reflect the potential for erosion of the bank material. Where local hydraulic conditions exceed the sediment transport threshold for the bank material and vegetation or other protection is not provided, bank erosion would be expected to occur.
