Woodward Creek Habitat Restoration Project Siting and Design Project

Final Report

November 2007

*Tetra Tech, Inc.
Portland, Oregon*

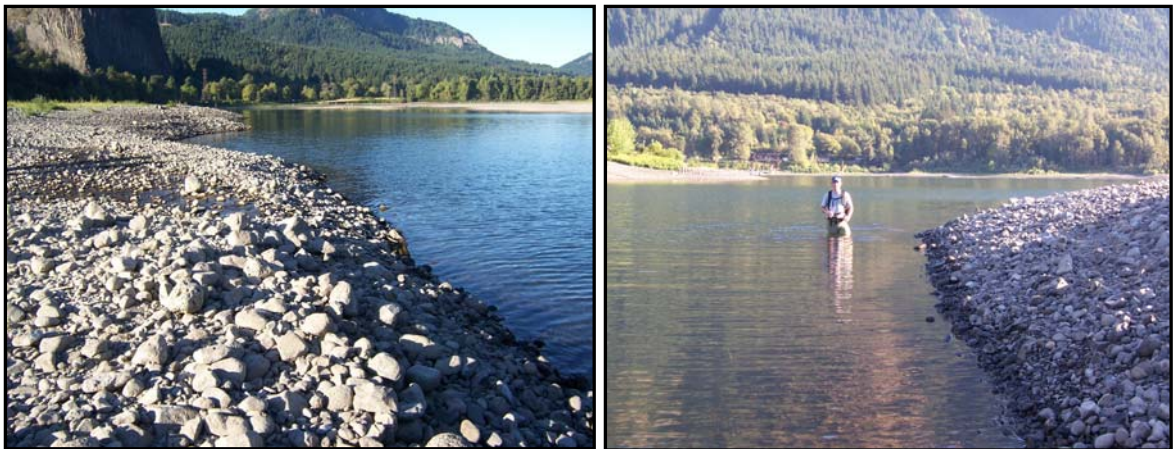
Figure 3. Mouth of Woodard Creek when Columbia River elevation at Bonneville = 7.0 (September 2006). *Note the 3 to 4 foot steep drop which Woodard Creek cannot scour due to backwater.*

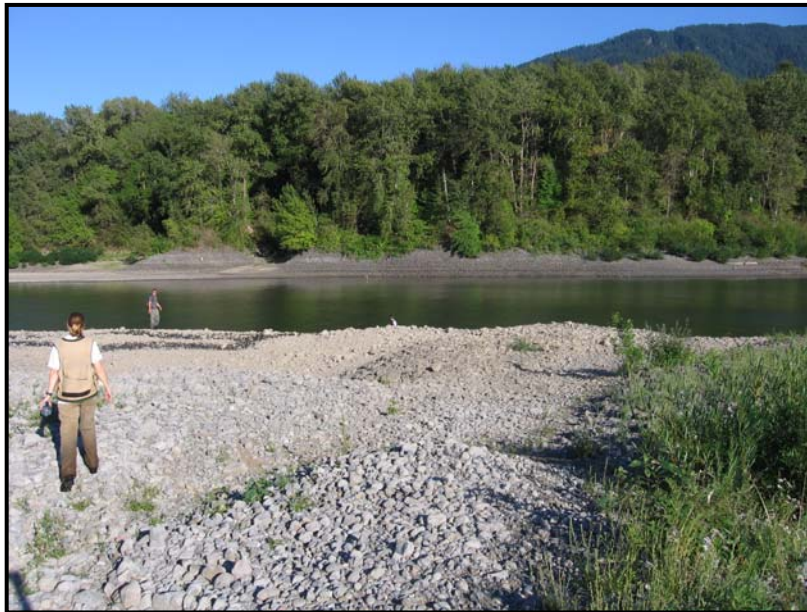
Restoration opportunities in this reach include improving fish passage at the mouth, reconnecting a side channel in the floodplain to provide rearing habitat for juveniles and possible Chinook, coho and chum spawning habitat, roughening the floodplain to collect more sediment out of the main channel to help maintain the channel opening at the mouth, and riparian restoration. Until the sediment load is addressed in the reaches upstream of the railroad culvert, measures to improve the mouth for fish passage may only be successful in the short-term.

Figure 7. Mouth of Woodward Creek during Low Flows in Columbia River (September 2006).

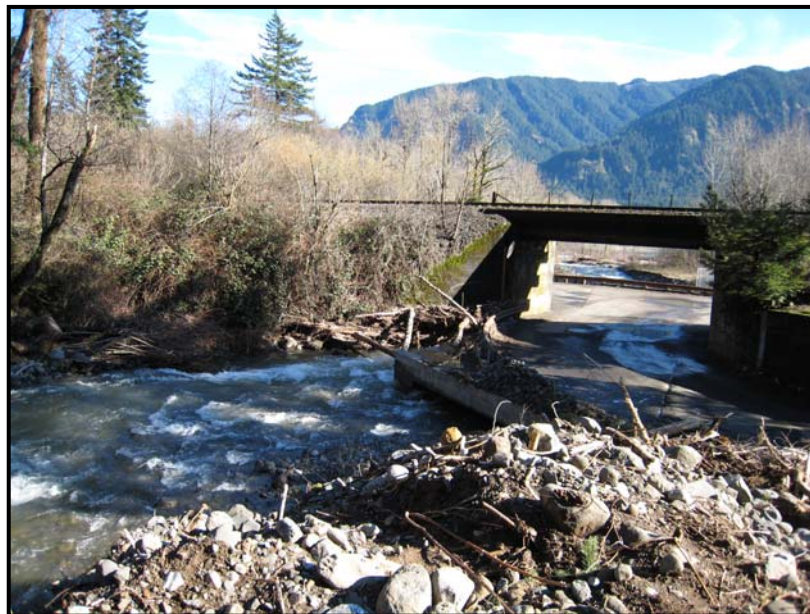
The channelization of this reach limits restoration opportunities in the short-term. The immediate problems are the constriction of the culvert and the deposition of sediment and debris at its upstream end. One or more wood or rock vanes could be placed upstream of the culvert to direct the channel in a more direct alignment into the culvert; although this would only provide temporary benefits. Control of sediment upstream of SR-14 and reconnection of the floodplain in Reach 2 will be the most effective and long-term opportunities to reduce sediment and debris deposition and allow the creek to migrate in a more natural alignment. One or more LWD jams could be placed immediately upstream of the SR-14 bridge to capture wood from Reach 3 before it reaches the bridge. In the long-term, removal or setback of the dike and Beacon Rock Moorage Road and reconnecting the creek to its floodplain would allow the channel to migrate without damaging infrastructure, thus creating off-channel and other habitats and providing a floodplain for sediment and debris deposition. These modifications would also increase the channel length and decrease the slope which, along with log jams create improved spawning habitat. If another road is eventually planned to connect potential future camping or other uses to the new road to the boat ramp, the road under the railroad could be abandoned and the culvert could be removed to allow the creek to flow through the railroad opening without a blockage. The railroad grade would still limit the channel width to 38 feet, the length would be very short and channel design features upstream would improve sediment transport through the crossing.

Figure 9. Railroad Culvert and Roadway after 2006 High Flows (January 2007).

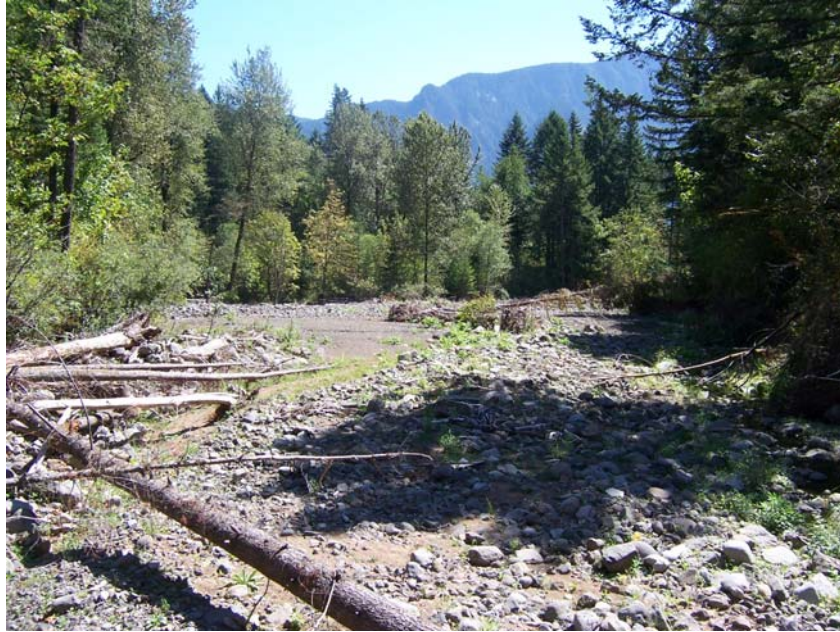
Figure 11. Reach 3, After November 2006 Flood.

This reach would be an excellent location to place additional wood and LWD jams. The wood could be used to protect the existing high quality side-channel from sediment deposition and could also be used to trap sediment in the floodplain, and to create further spawning areas as well as providing scouring of pools and providing cover. Many juvenile fish (trout and coho) have been observed in the upper end of this reach. This reach also could benefit from the removal of non-native vegetation and plantings of native species. Removal of the dike along the right bank and reconnection of the floodplain would further trap sediments and provide the opportunity for the natural creation of off-channel habitats. This reach is easily accessible from SR-14 and an old road in the right bank floodplain. Because the dike currently protects the highway and bridge from erosion, a longer-term solution would be to widen the SR 14 bridge to 150 feet and reduce the need for the channel diversion dike and then provide protection for the road with rock set back closer to the roadway.

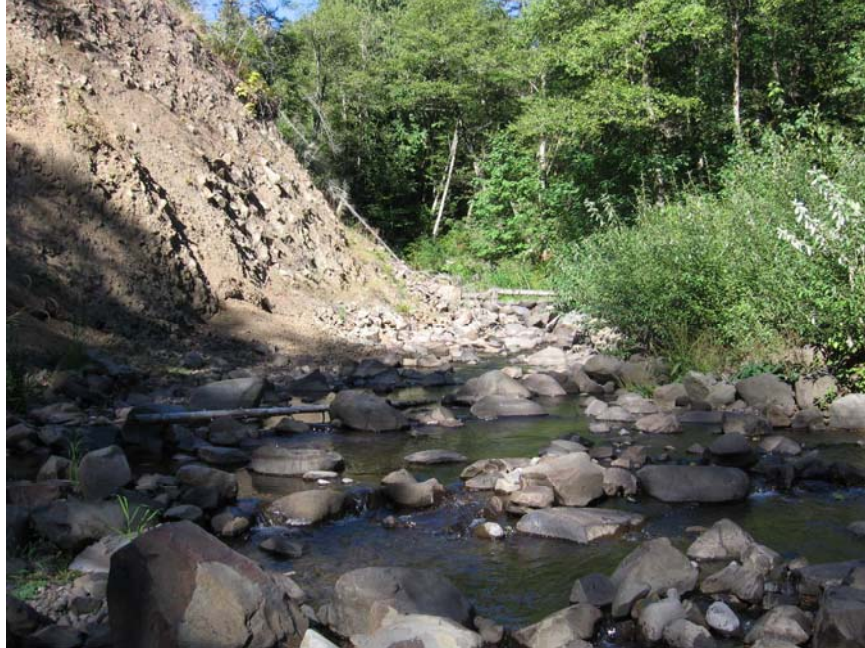
Figure 12 Eroding Bank Near Downstream End of Reach 4

Potential access by construction equipment is feasible at the powerline crossing, but is limited above the bedrock falls in this reach. It may be possible to trap some of the sediment eroding off the steep banks by placing wood structures at the toe of the banks to accumulate the material. It is likely not feasible to prevent the slides because they are occurring all along the face of the slope in highly weathered volcanic material, and are not due to timber harvest or other human caused activities. There are also revegetation opportunities with willows and other native shrubs in the powerline area as long as trees are not planted under the powerlines.

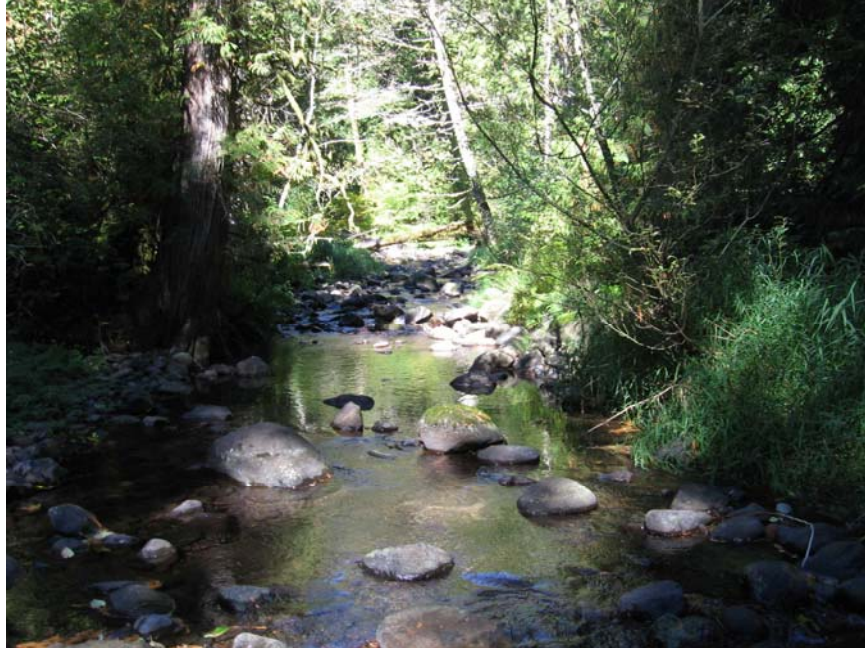
Photo 3 – Typical portion of Woodward Creek upstream of bridge, this area has experienced deposition with large cedar growing at current bed level (photo is upstream view)

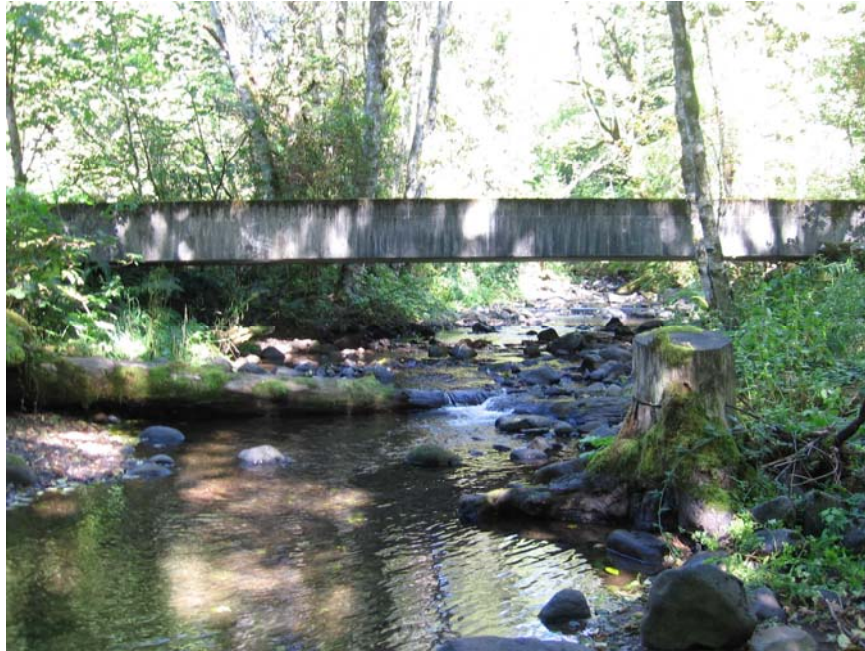
Photo 5 – Deflector log structure right bank and cabled rootwad on left bank immediately below Woodward Creek Road bridge

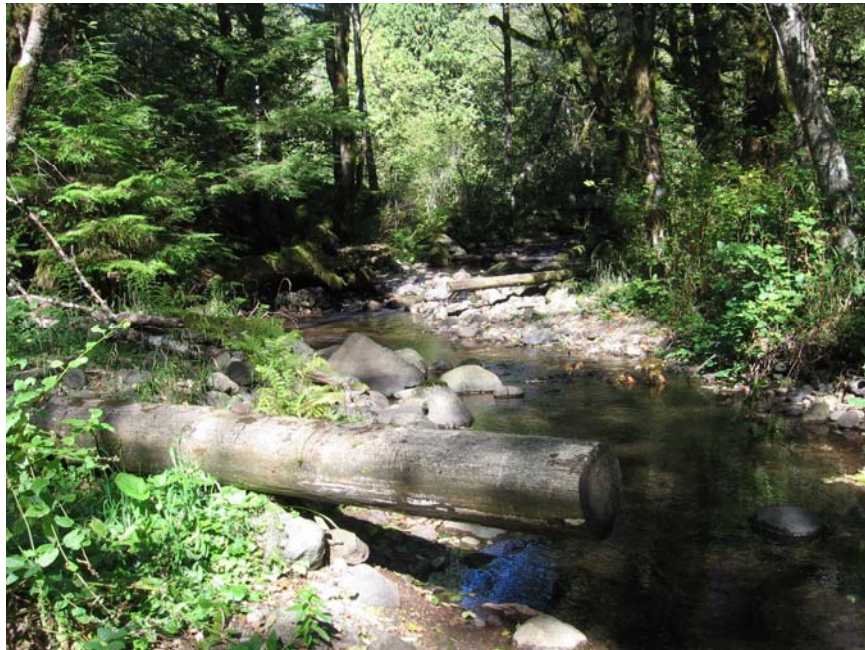
Photo 6 – Looking upstream at a series of alternating (left bank then right bank) log deflectors about 1,000 feet downstream of bridge, bed may have degraded and left structures perched.

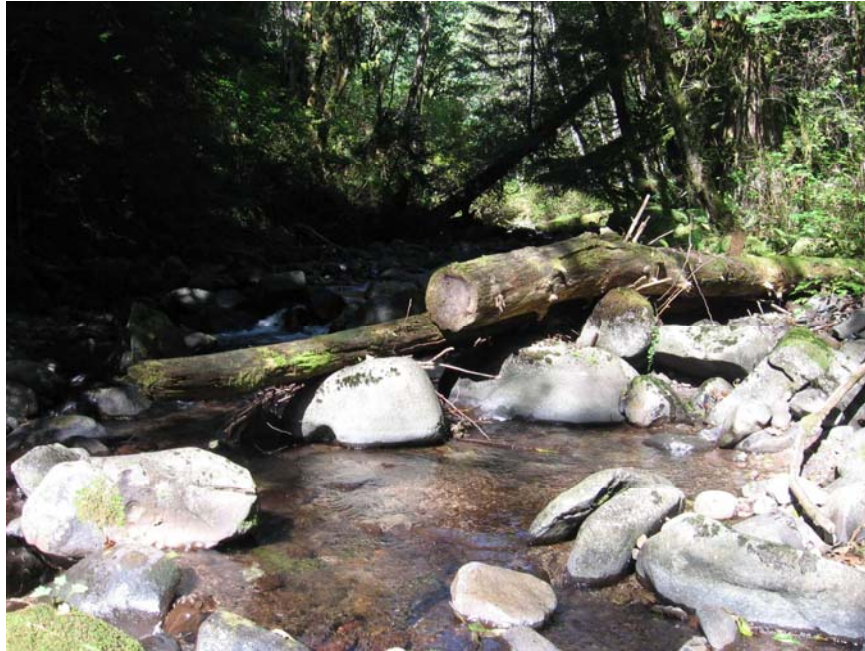
7. Within the third reach two additional log structures were observed. There were tags identifying these structures as # 22 and #23. Structure 23 is shown in Photo 9.

Photo 9 - Looking upstream at structure #23 (ID based on metal tag on adjacent tree), this was the downstream most structure identified, some small gravel present between boulders

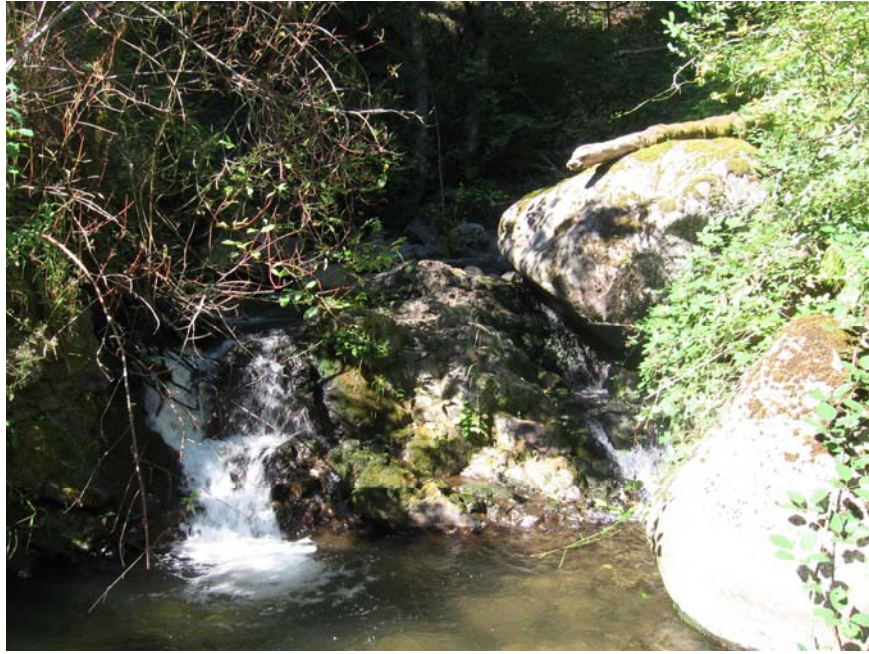
12. Wetted width generally varies from 10 to 20 feet, where boulders constrain the flow, the bankfull width would be equal to the wetted width.
13. At the confluence of the East Fork tributary, the right bank is bedrock of highly fractured basalt entablature (Photo 15), likely corresponding to the Steever-Rock outcrop soil association that also becomes much more prevalent further downstream of the East Fork confluence (Photo 16). Just upstream of the East Fork confluence, the basalt outcrops in the bed and creates a falls with about 6 feet of drop (Photo 17)

Photo 17 – Bedrock falls just above East Fork confluence, fourth reach

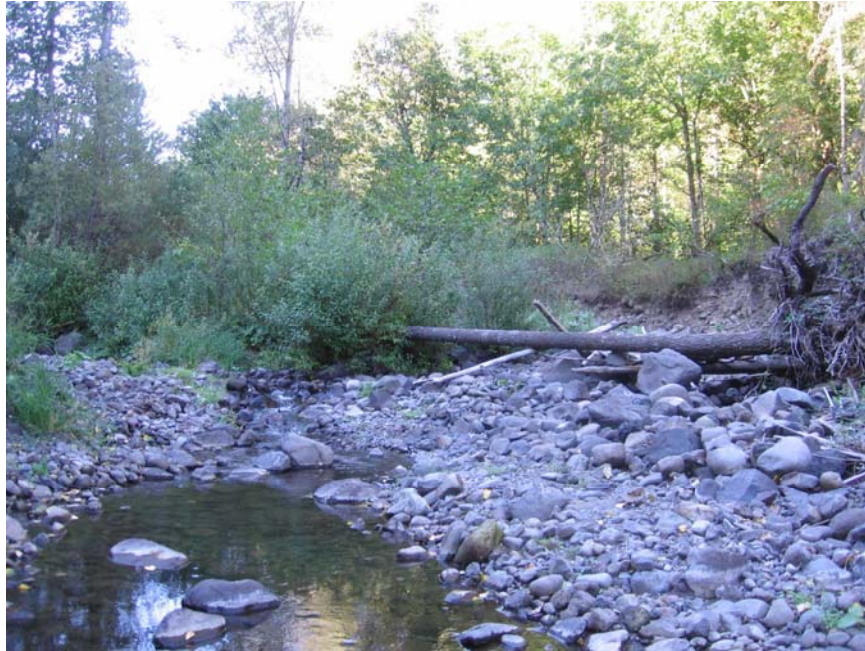
Photo 19 – Looking upstream into split flow reach as water reappears from loose gravel and cobble bed. Flow goes subsurface for several 100 feet upstream of this location in both sides of the split flow. Note eroding left bank, floodplain in this reach has significant gravel deposits.

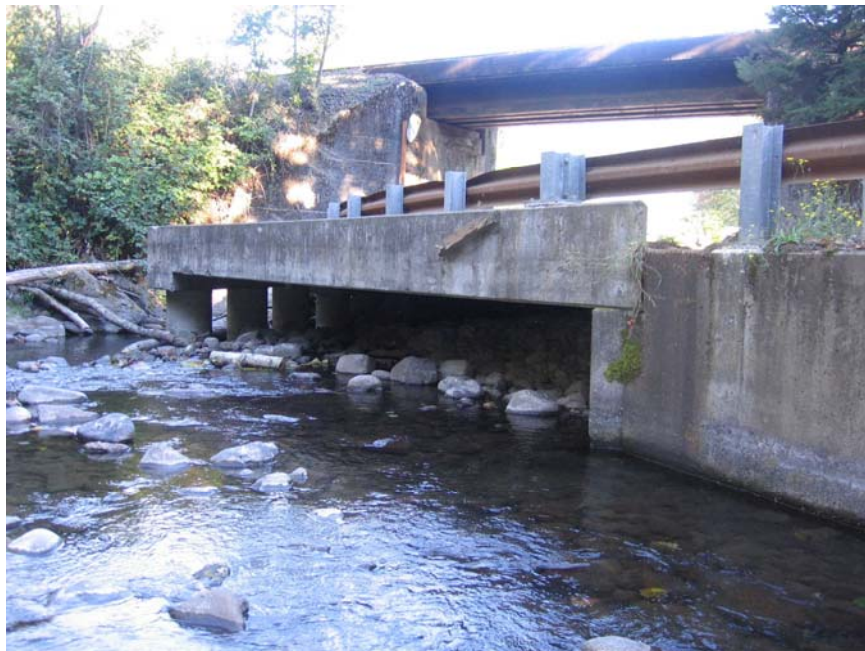
Photo 22 – Upstream side of Beacon Rock Moorage Road culvert crossing. Some bed load is depositing at the upstream end and possibly within the culvert.

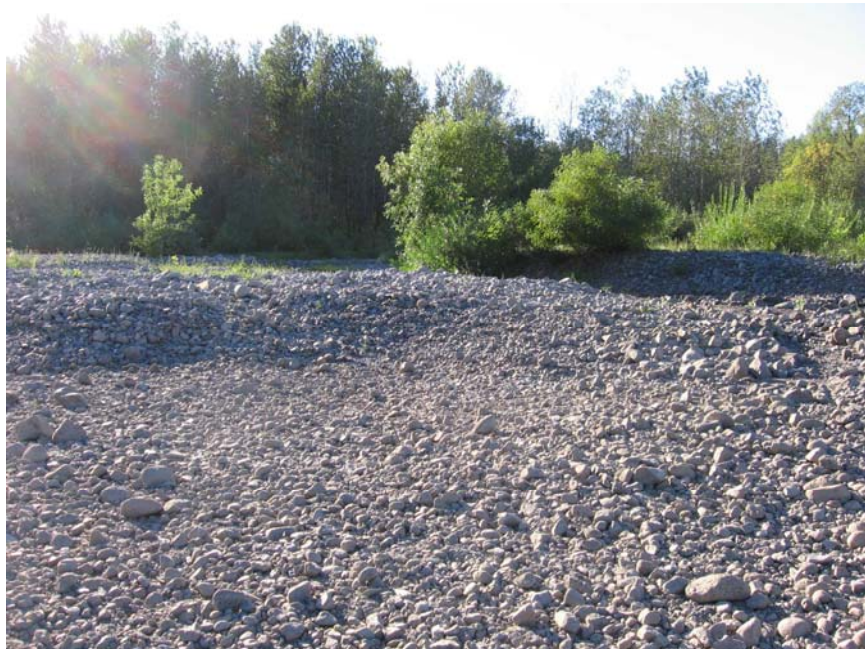
Photo 26 – Large area of gravel and cobble deposition near the Columbia River confluence. This area is currently abandoned by the channel at low flow, but experienced flow last winter.

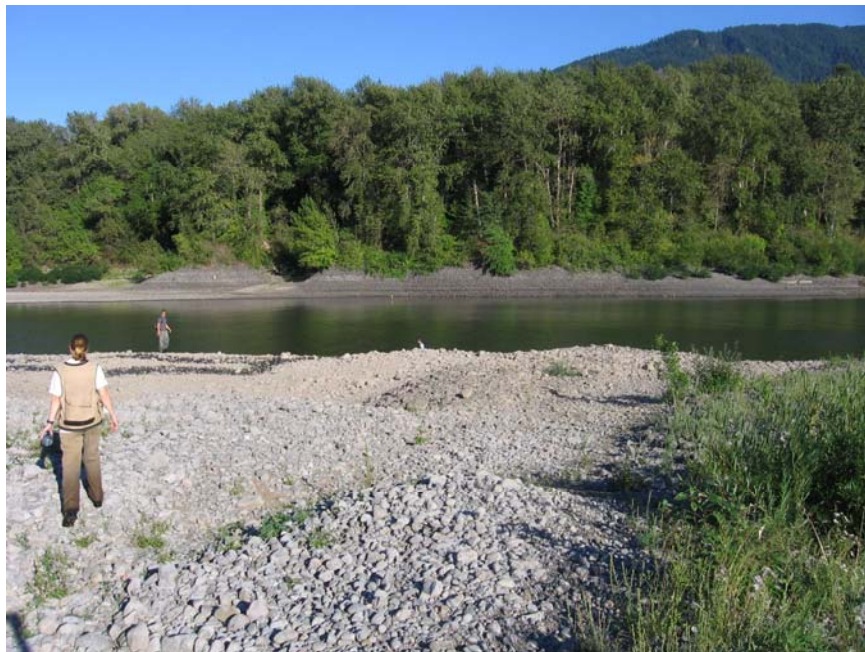
Photo 28 – Depositional area at the confluence with the Columbia River. Channel becomes steeper as it is influenced by removal of material by the Columbia River as well as interaction of varying deposition zones dependent on the stage of the Columbia River. Flow also disappears in the loosely deposited gravels and cobbles. This condition creates problems for fish passage.
