Appendix D: Landscape Unit Conditions

Appendix D includes detailed results from the assessment of the Upper Cowlitz Cispus watershed. Landscape units (LUs) are first summarized here describing Hillslope and Valley Bottom characteristics in the Upper Cowlitz and Cispus Basin. Following that, individual LUs are described in detail.

Upper Cowlitz-Cispus
Community-based Habitat
Strategy Development

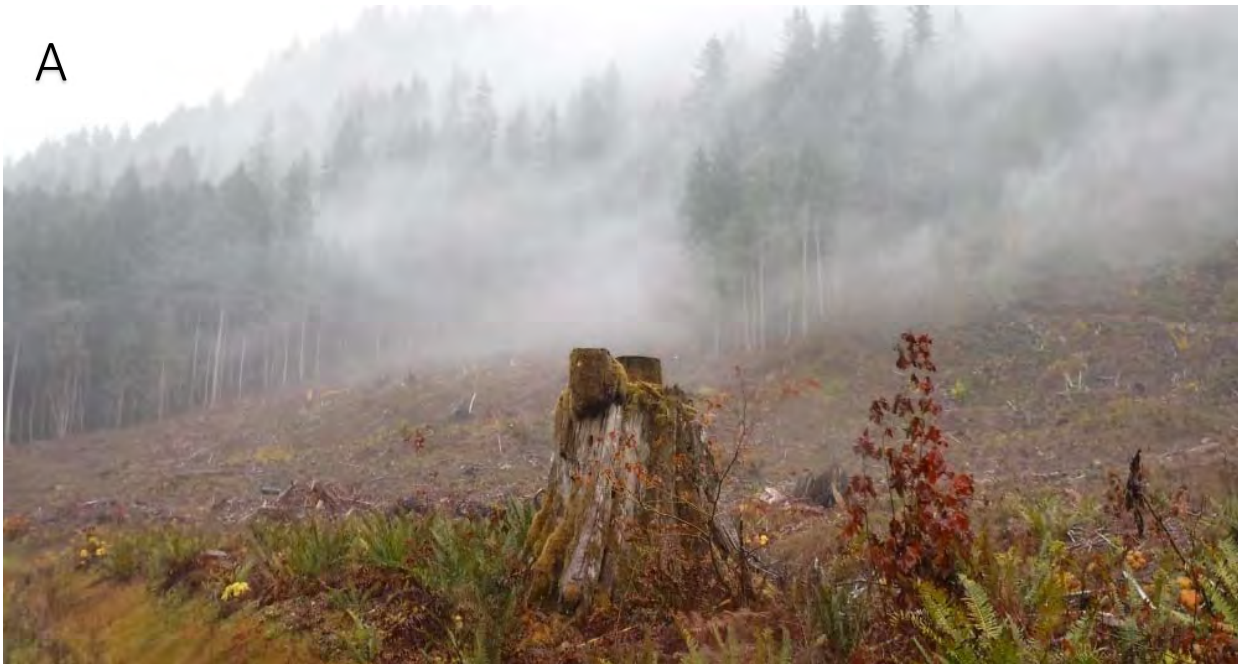
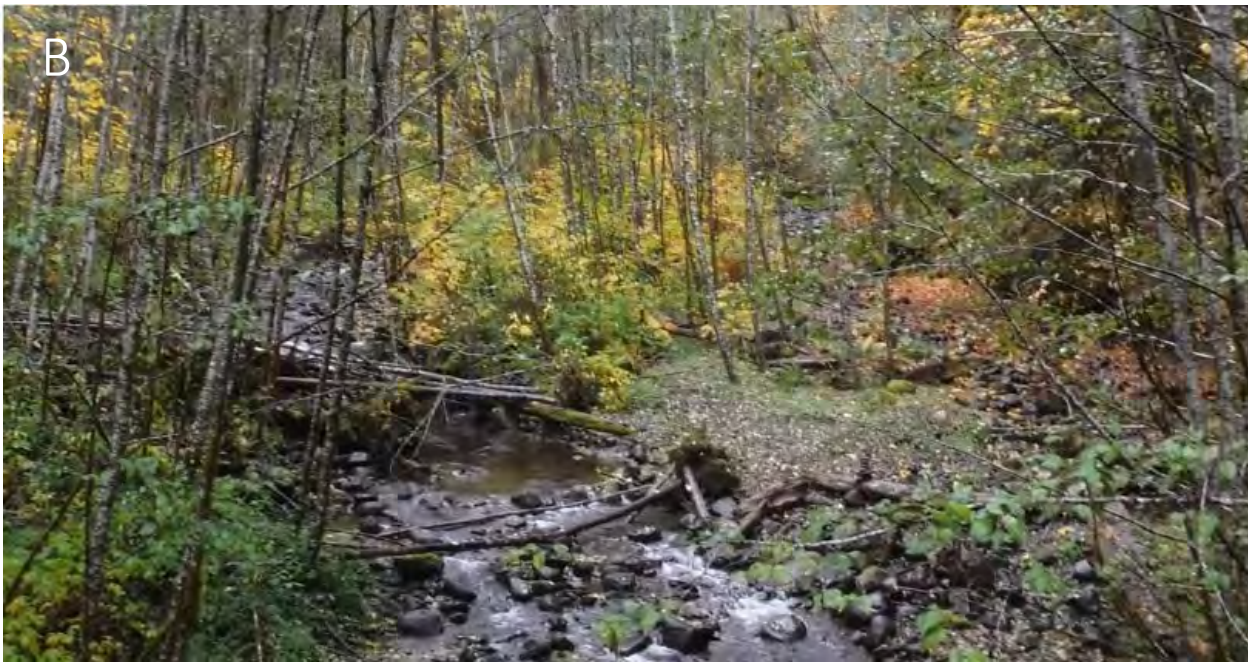
Figure 1. Representative images from the Lower Hillslopes LU. A: Private forest land adjacent to the Cowlitz River, B: Greenhorn Creek, a tributary to the Cispus River.

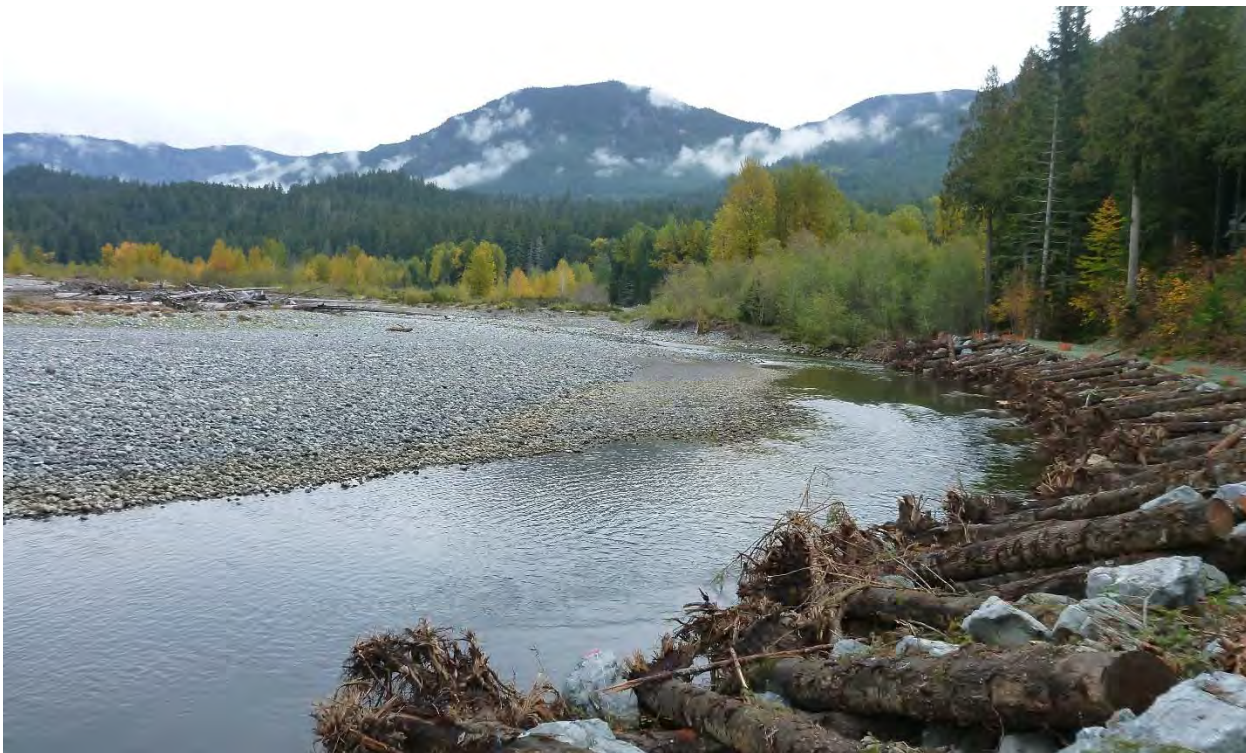
Figure 2. Recent bank stabilization project with large wood and riprap at RM 131.5 (Timberline community).

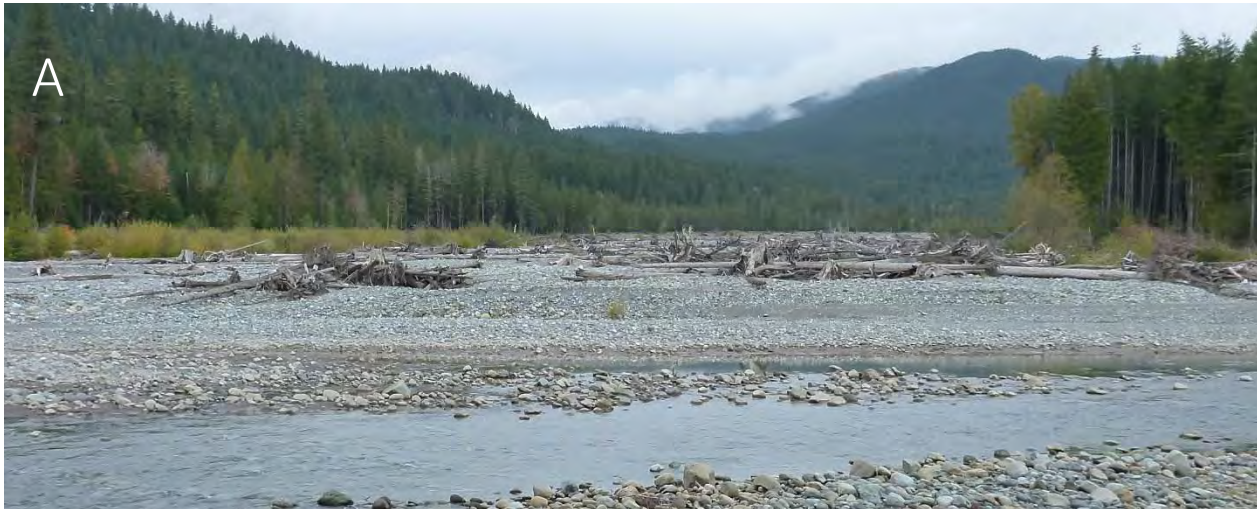
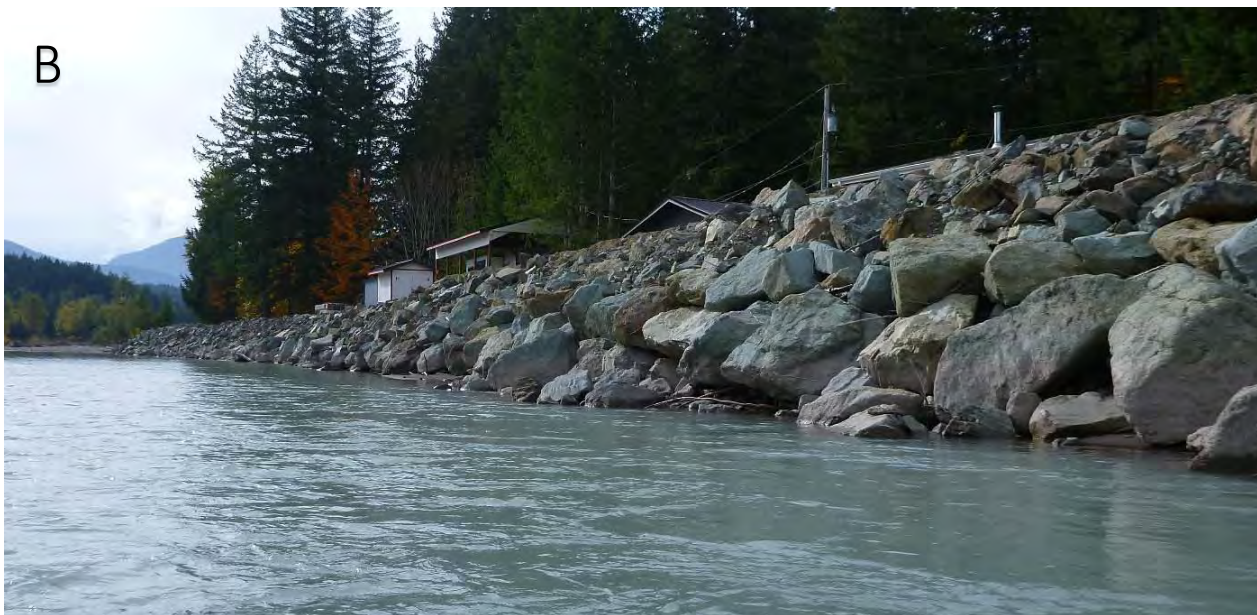
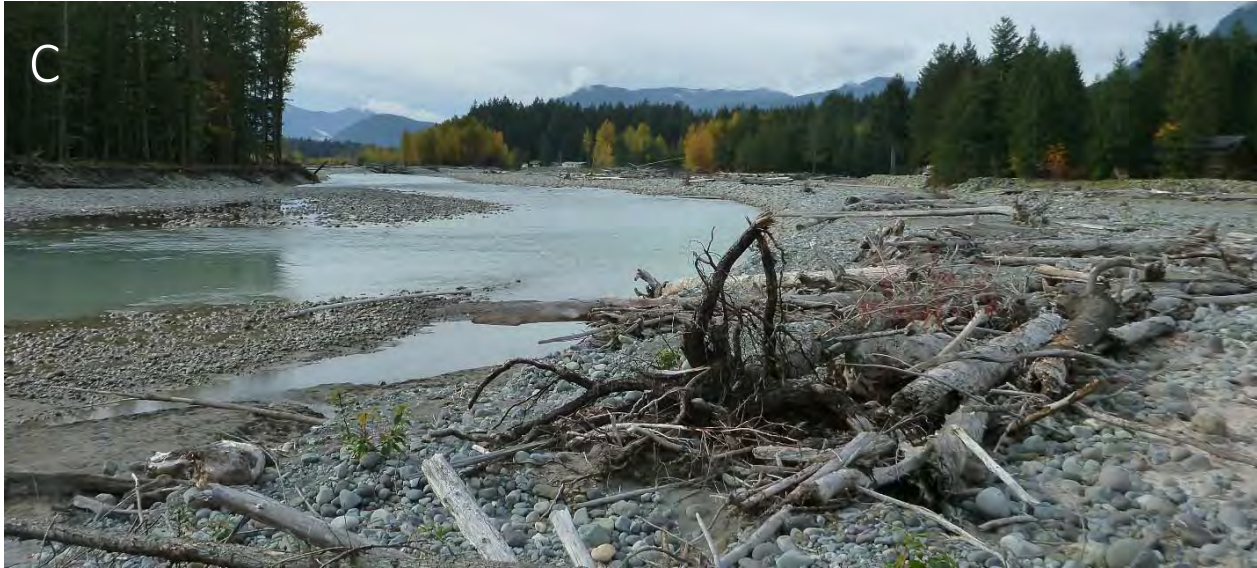
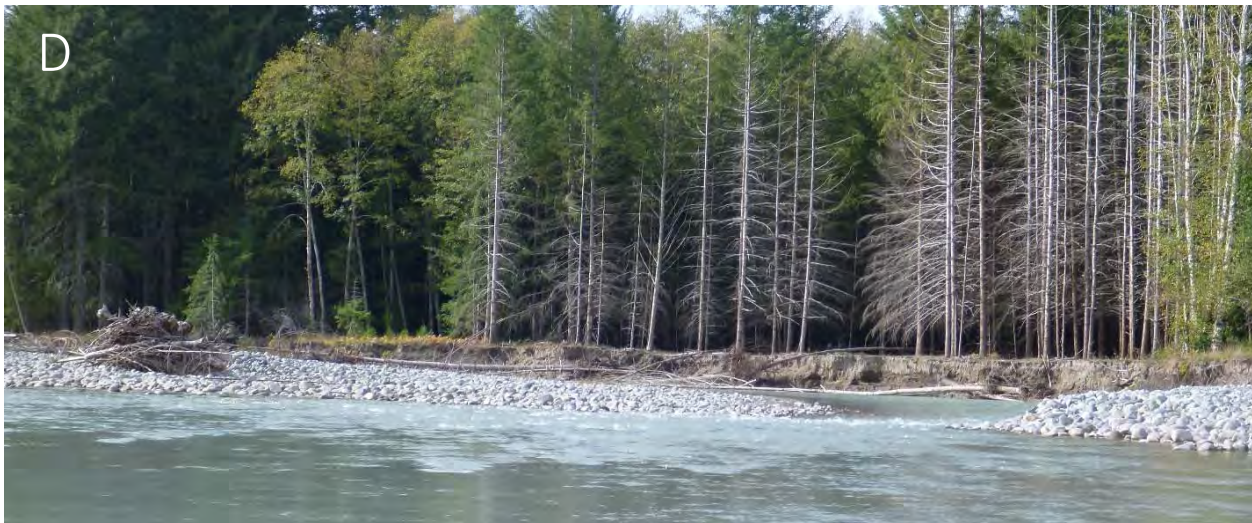
Figure 3. Representative images from the Cowlitz - Muddy Fork Avulsion-Affected LU. A = Upstream view of broad braid-plain from Muddy Fork avulsion. B = Long riprap along High Valley community. C = Example of abundant large cobble bars with large wood deposits. D = Example of well-connected floodplain forest with active recruitment of riparian trees.

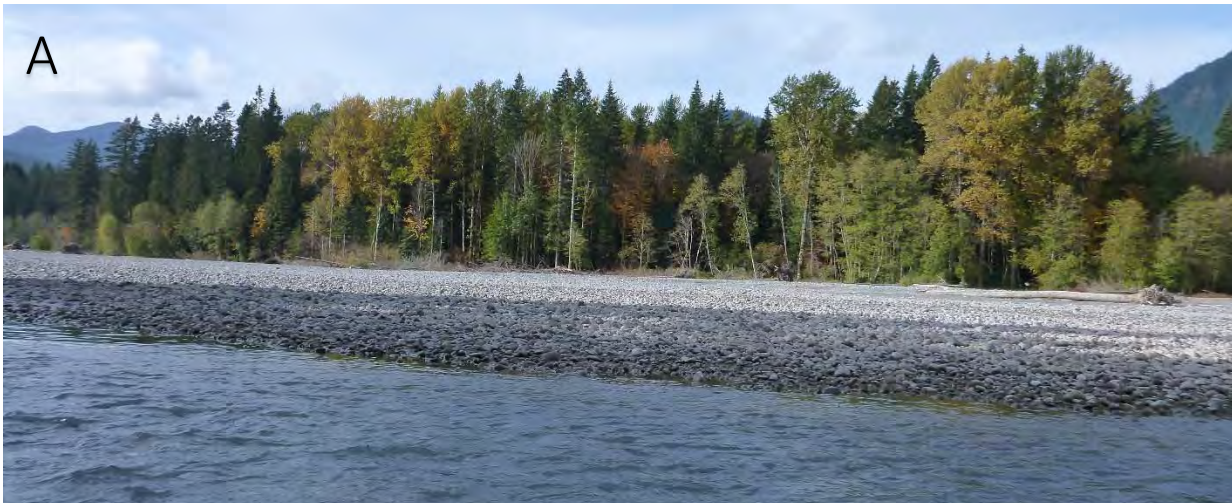
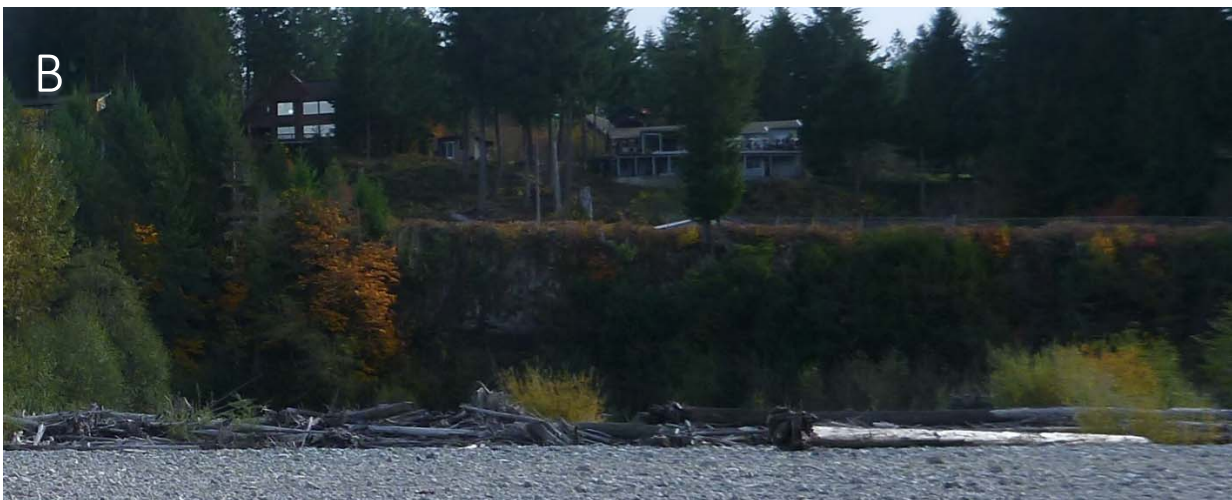
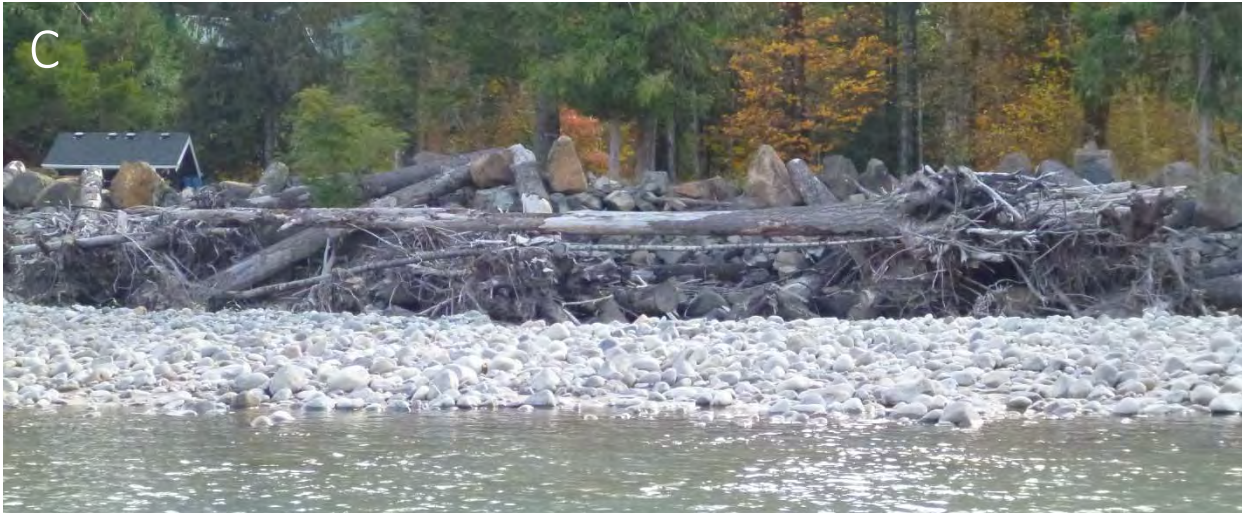
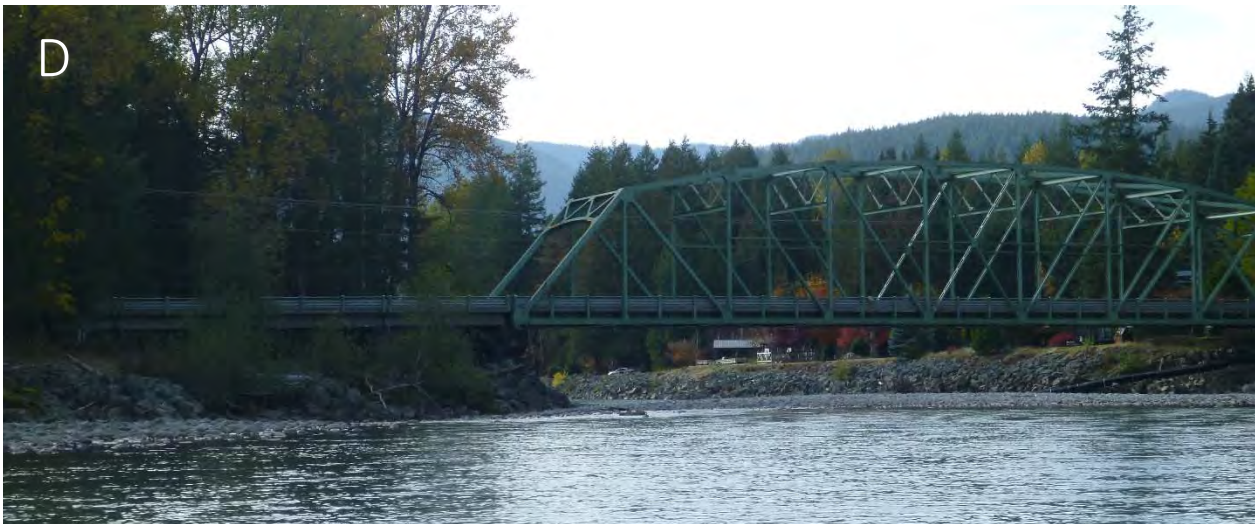
Figure 4. Representative images from the Cowlitz-Packwood LU. A = typical broad flat gravel and cobble bar. B = houses high on south bluff in Packwood area. C = Riprap and large wood bank protection structure on south bank upstream of Skate Creek Bridge. D = Skate Creek Bridge and riprap extending up- and downstream.

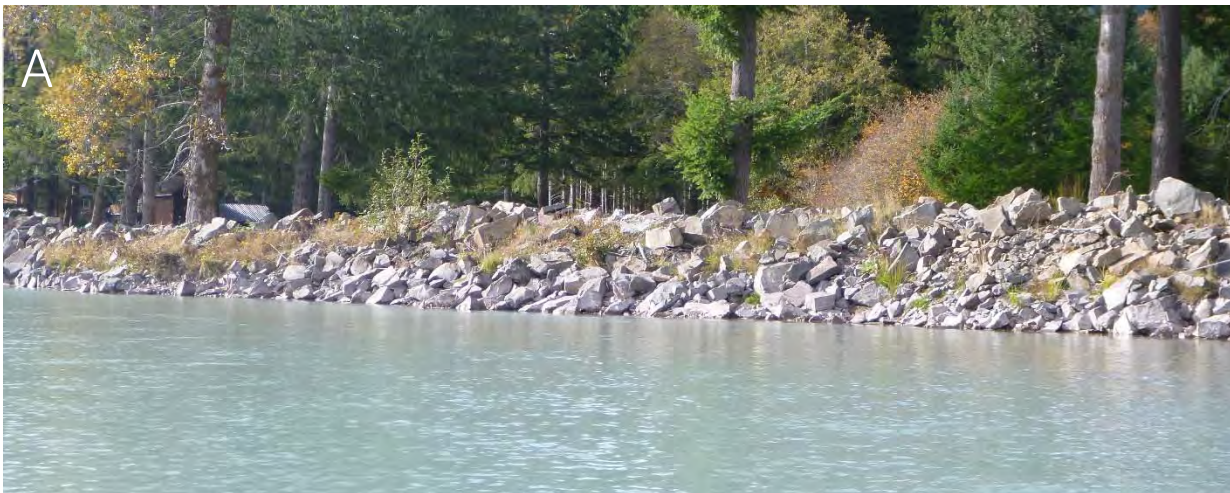
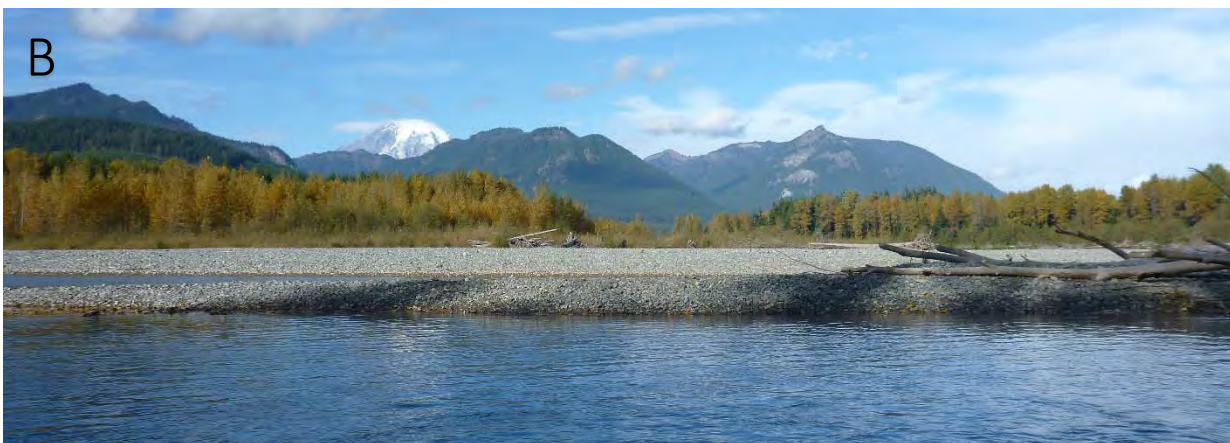
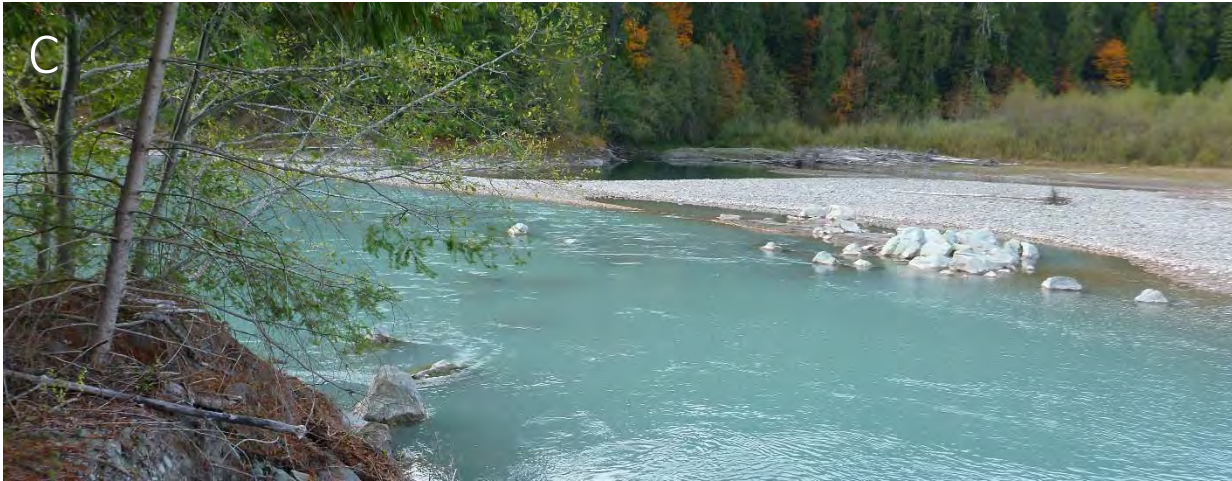
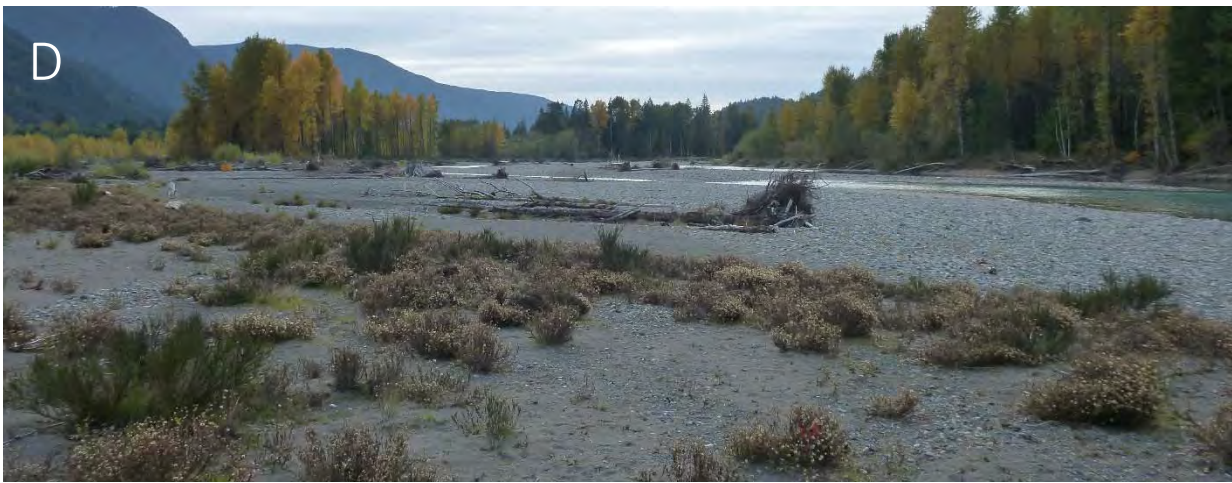
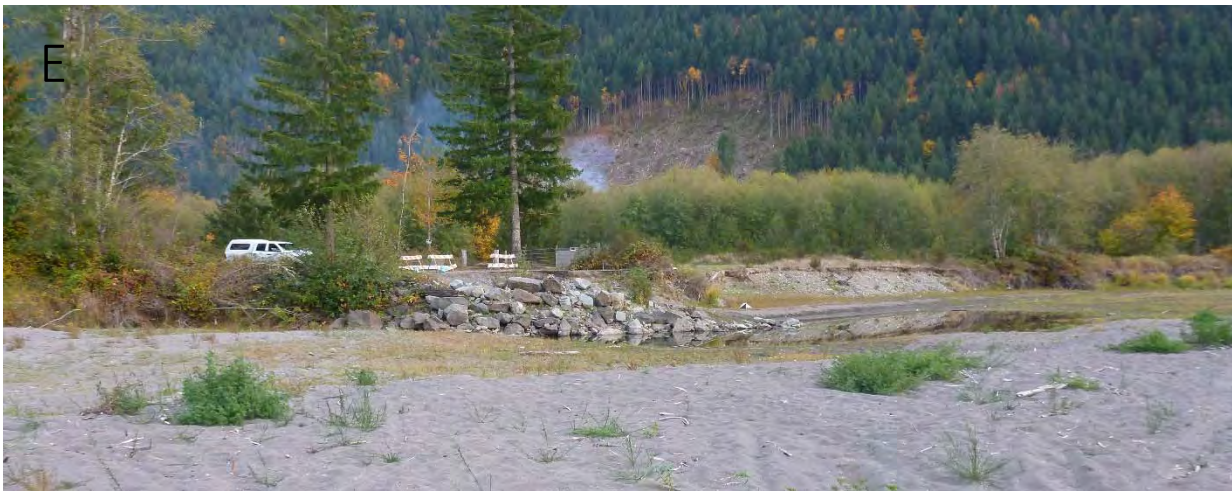
Figure 5. Representative images from the Cowlitz-Mid-Valley LU. A = riprap bank protecting houses river-right near RM. B = broad braid-plain typical of this reach (near RM 123). C = riprap failing into channel near RM 120. D = Elements of island-braided system downstream of RM 120. E = road washout (and now rock barb protection) river-left near RM 118.5.

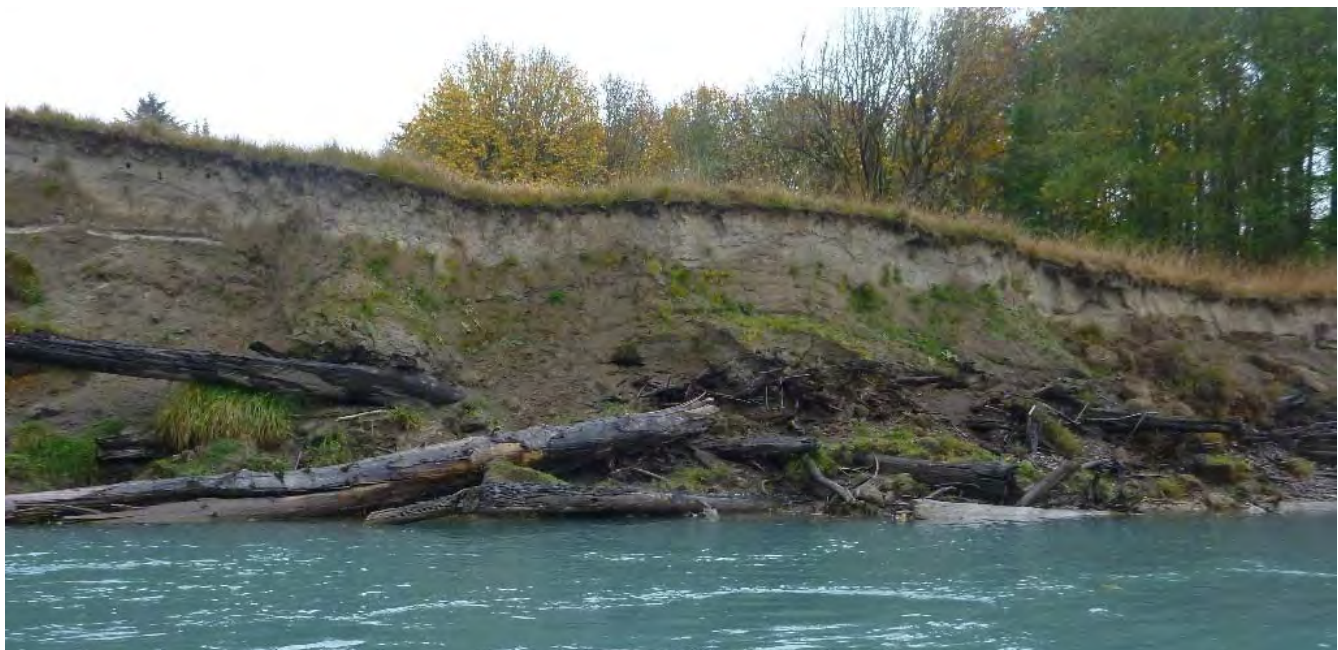
Figure 6. Deeply buried wood being exhumed from river bank due to bank erosion near RM 110.

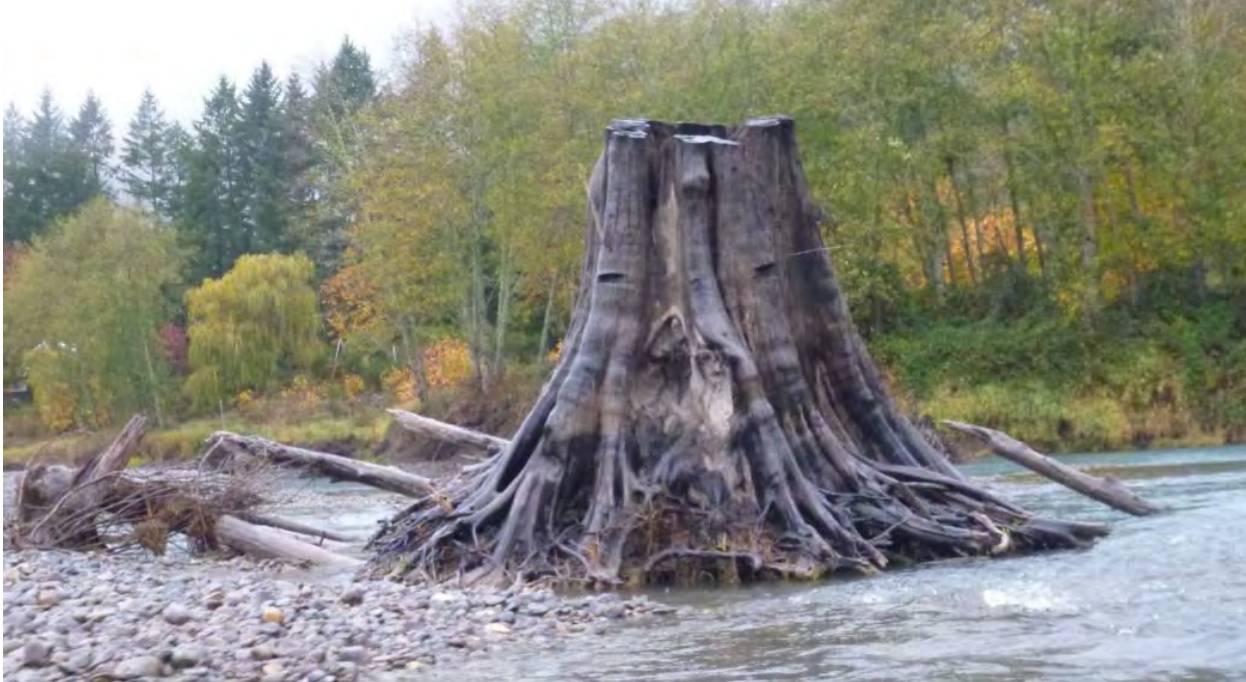
Figure 7. Large stump in channel near RM 113.

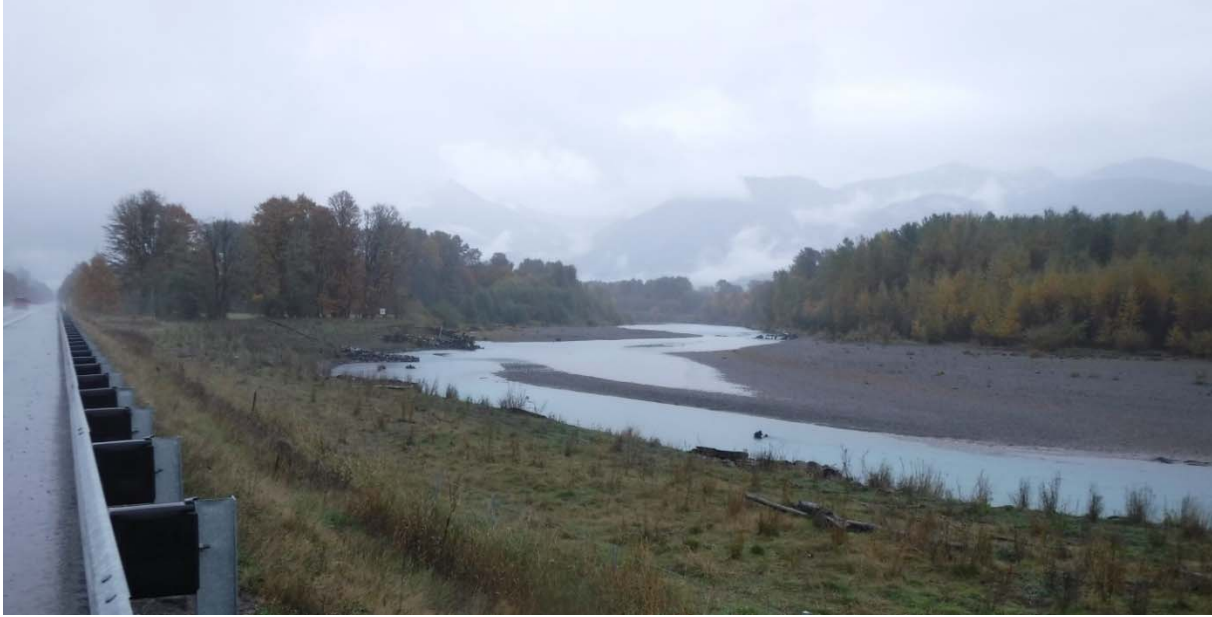
The Lewis County channel migration study (GeoEngineers, 2003 and 2009) describes this as the “meander bend section”. The most dramatic channel evolution in this reach has been at the River Ranch area just downstream of the Cora Bridge (at the upstream portion of this LU). In several places the CMZ includes portions of Highway 12. The proposed protection reaches Cowlitz 4, Cowlitz 3, Cowlitz 2 and Cowlitz 1 are included in this LU (Cardno, 2014). Bank stabilization projects have occurred in this reach, including the work along Highway 12 (Figure 8).

Figure 8. Bank stabilization adjacent to Highway 12 with barbs.

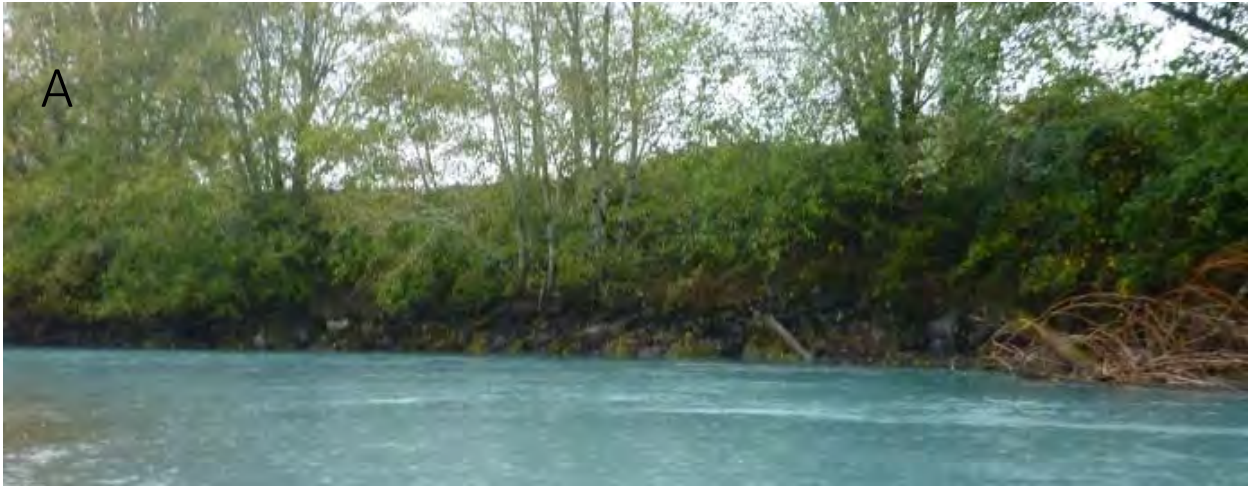
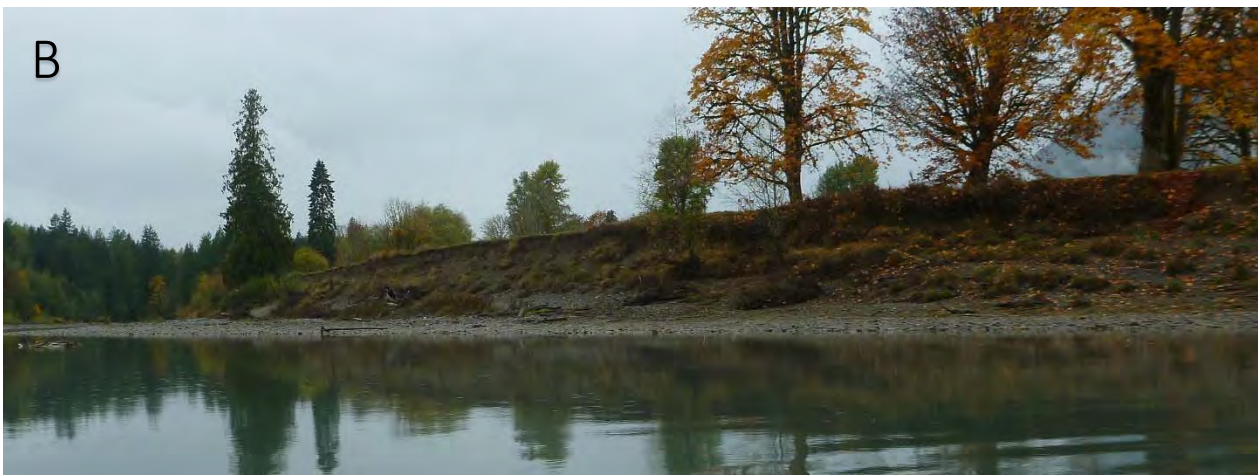
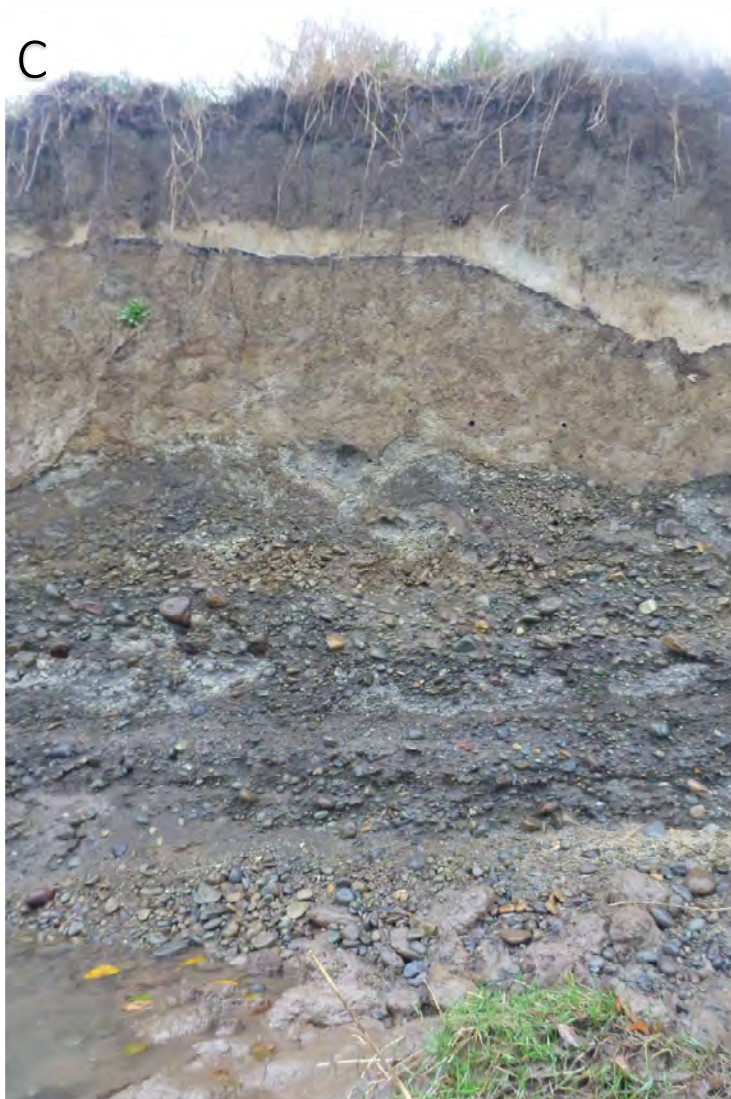
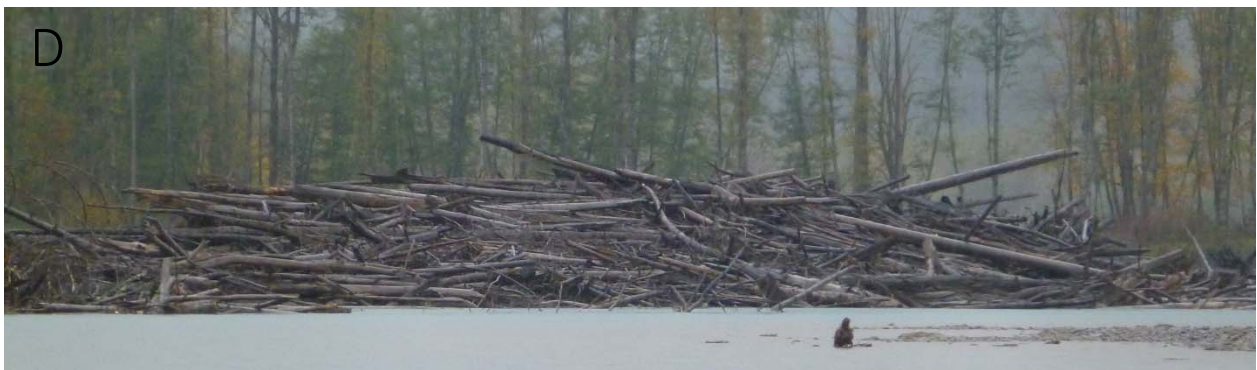
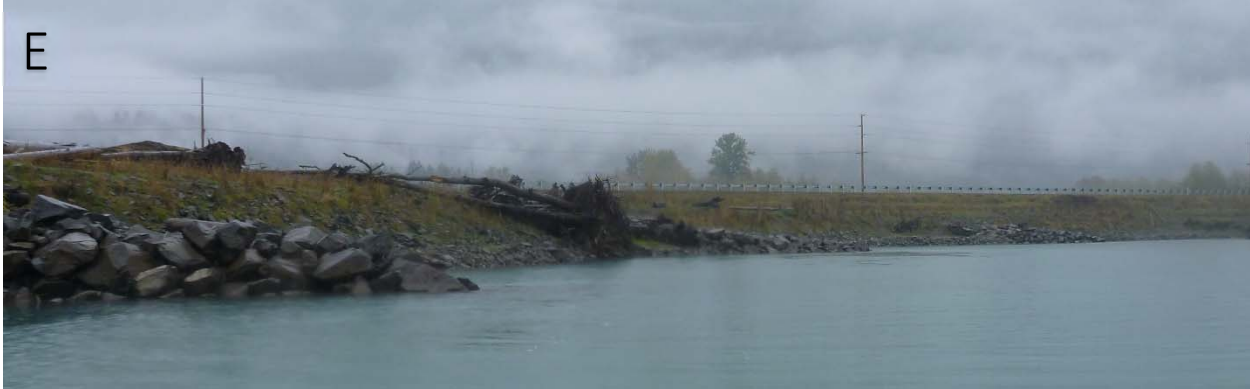
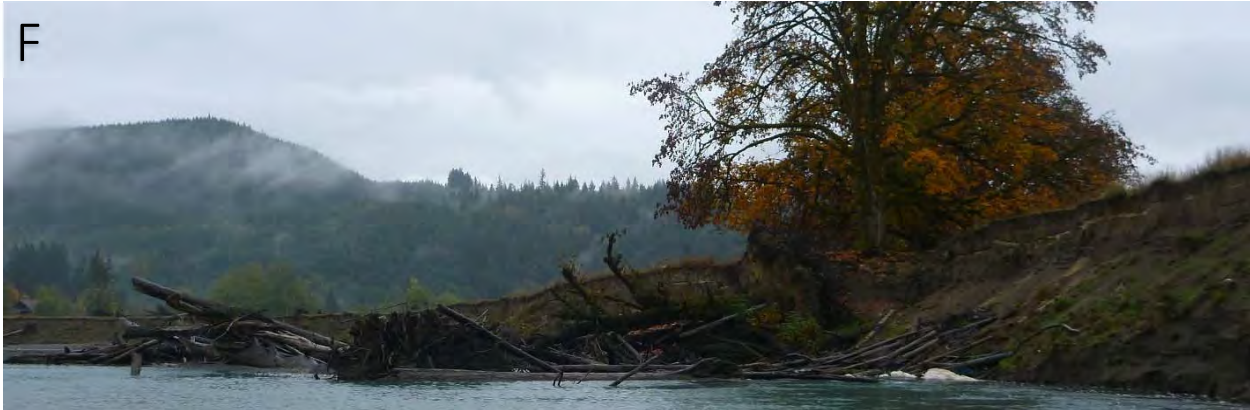
Figure 9. Representative images from the Cowlitz-Randle LU. A = old levee river-left downstream of Cora Bridge. B = typical of the high banks in the LU (near RM 115). C1 = Example of bank stratigraphy. C2 = close up of ash and charcoal layer. C3 = close up of tephra layer that is persistent throughout LU and believed to be from the St. Helens eruption in 1479. C4 = close up of charcoal layer that underlies the tephra layer in upstream portion of LU. D = giant log jam near RM 112. E = bank barbs for bank protection along highway near RM 108.5. F = recruited maple creating large jam near RM 107. G = riprap river-right upstream of mill. H = Siler Creek. I = across from Kiona Creek mouth.

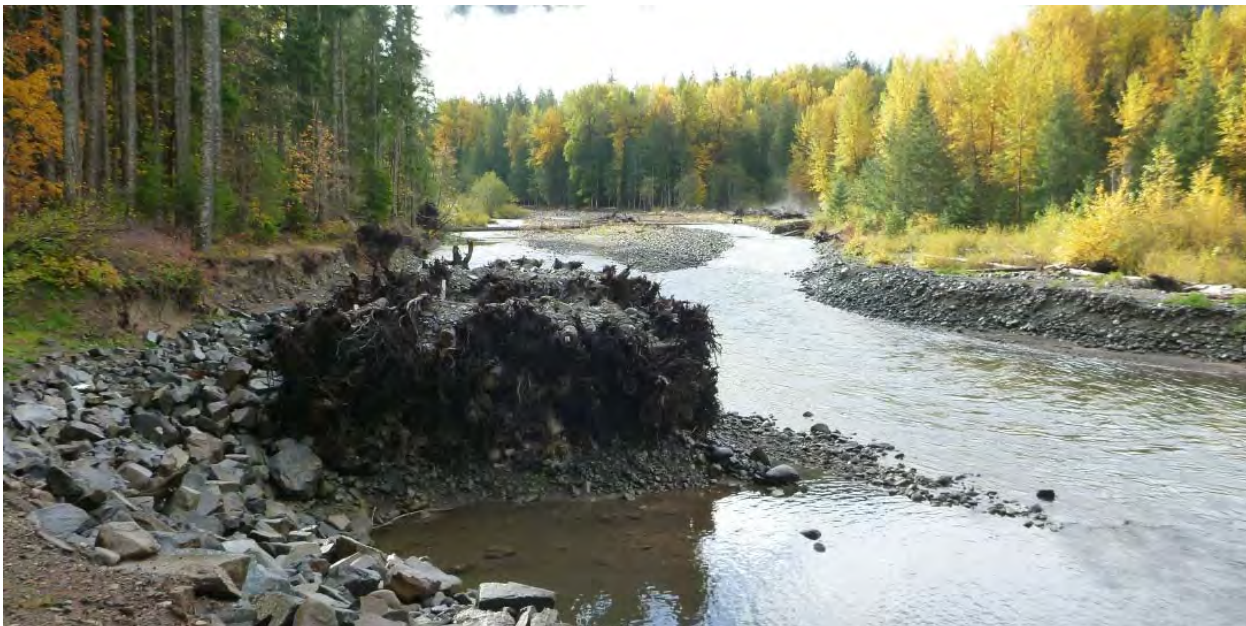
Figure 10. Large engineered log jam at upstream of FS Road 23 repair near RM 21.

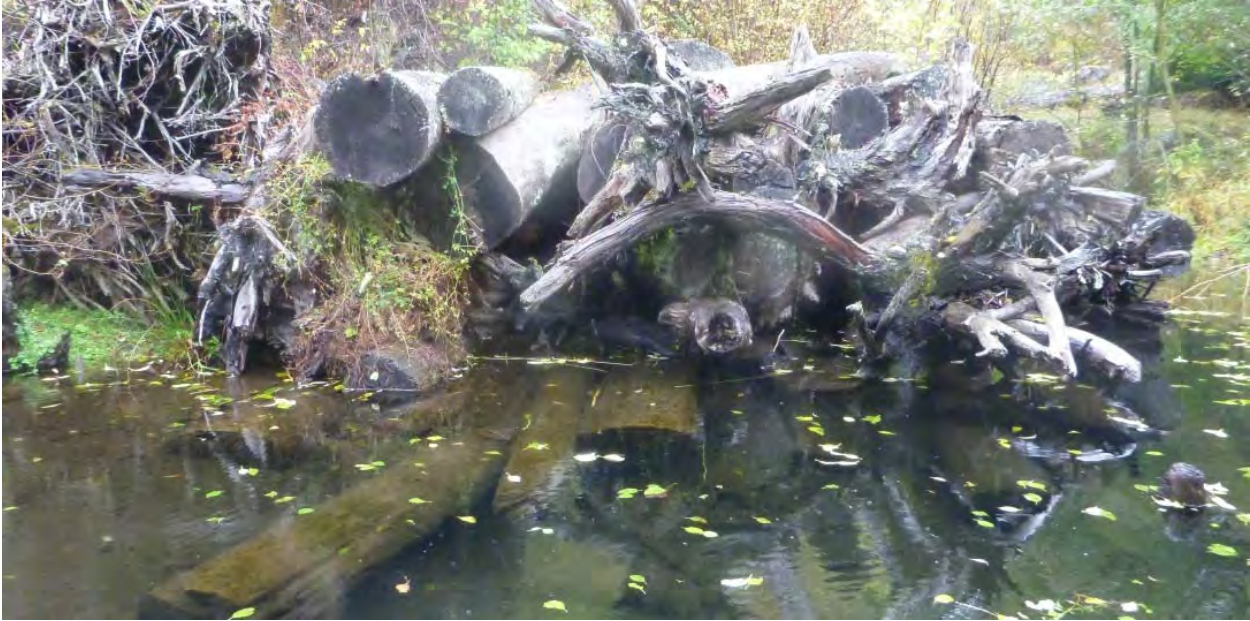
Figure 11. Older engineered log jam placed along FS Road 23 near RM 19 (now in abandoned oxbow).
