Appendix D: Landscape Unit Conditions

Appendix D includes detailed results from the assessment of the Upper Cowlitz Cispus watershed. Landscape units (LUs) are first summarized here describing Hillslope and Valley Bottom characteristics in the Upper Cowlitz and Cispus Basin. Following that, individual LUs are described in detail.

Upper Cowlitz-Cispus
Community-based Habitat
Strategy Development

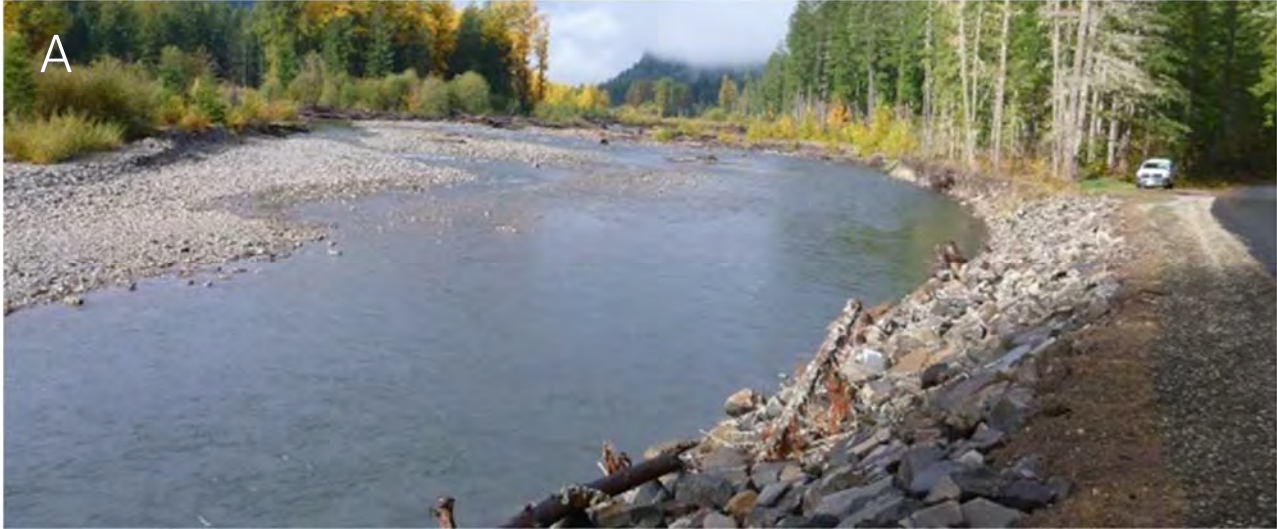
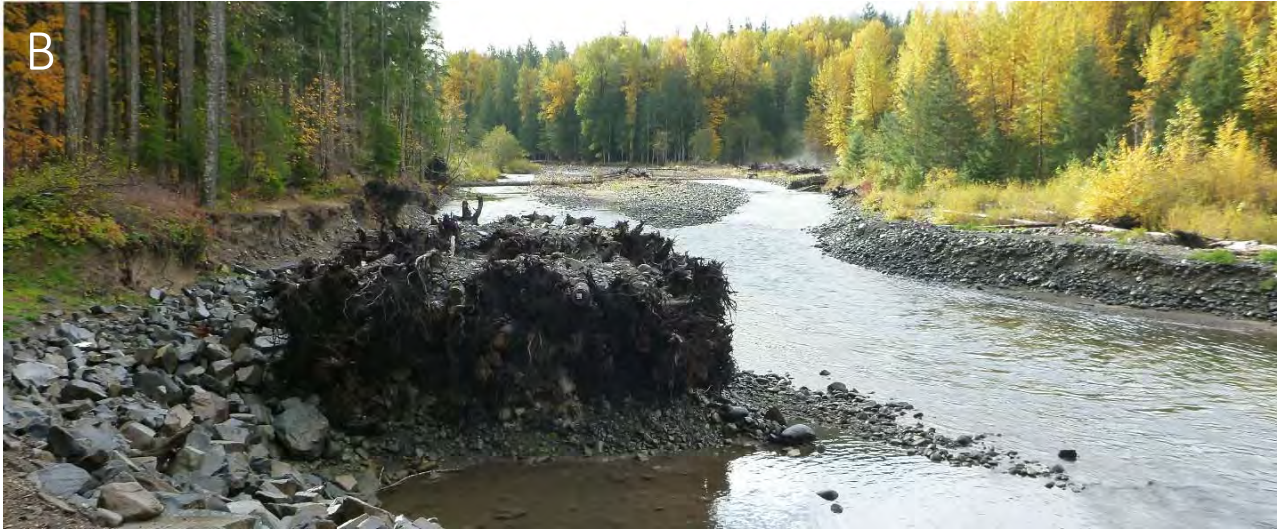
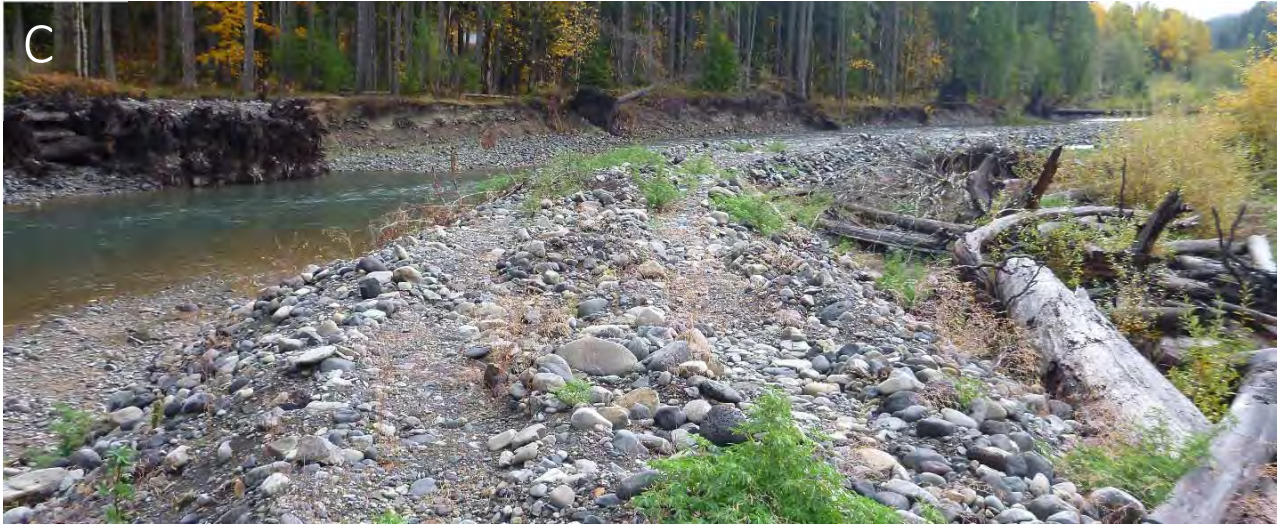
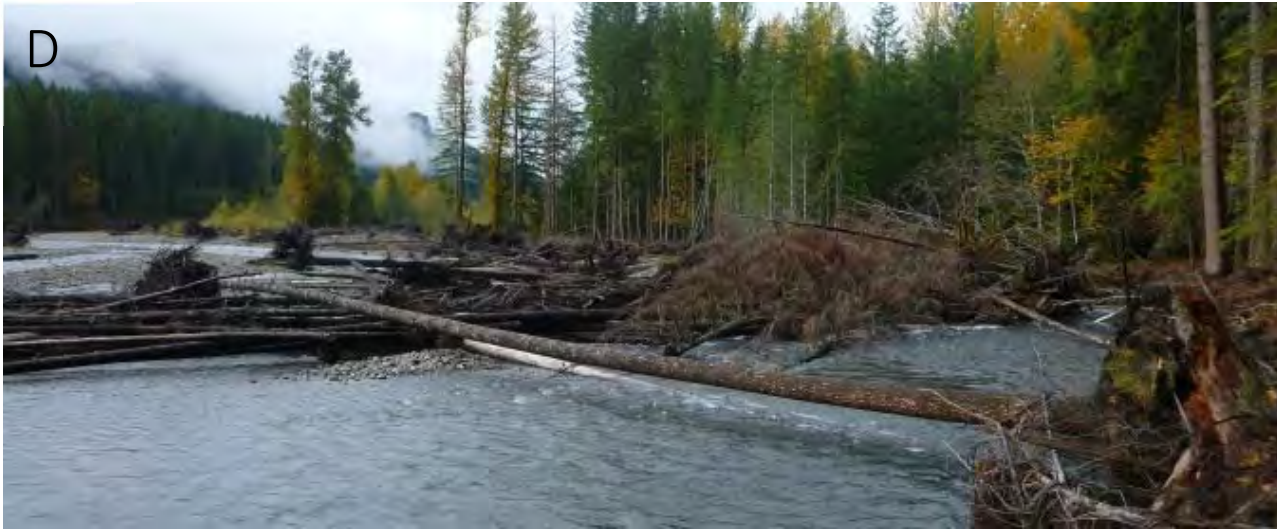
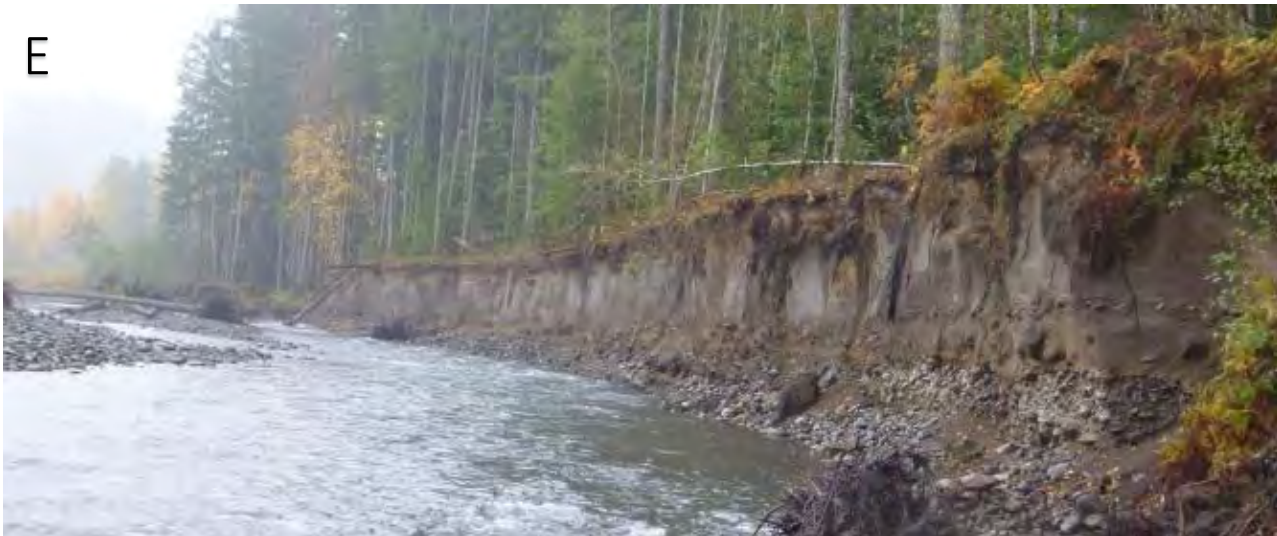
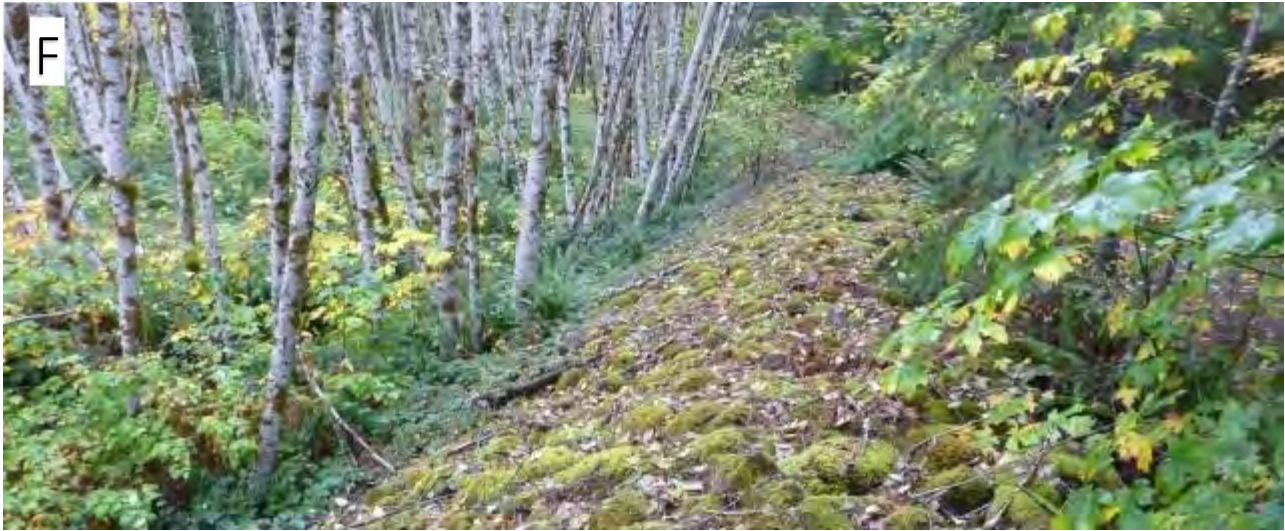
Figure 12. Representative images from the Cispus-Mid-Valley LU. A = USFS Road 23 repair near RM 21. B = large ELJ at upstream end of USFS Road 23 repair. C = push-up levee created across from USFS Road 23 repair. D = large wood complexity typical of this reach. E = high terrace being eroded into near RM 20. F = riprap bank along spur road along oxbow near RM 19.5. G = failing riprap bank near RM 19.5. H = large wood complexity typical of this LU. I = Channel incision through aggraded bed material upstream of Cispus Road Bridge.

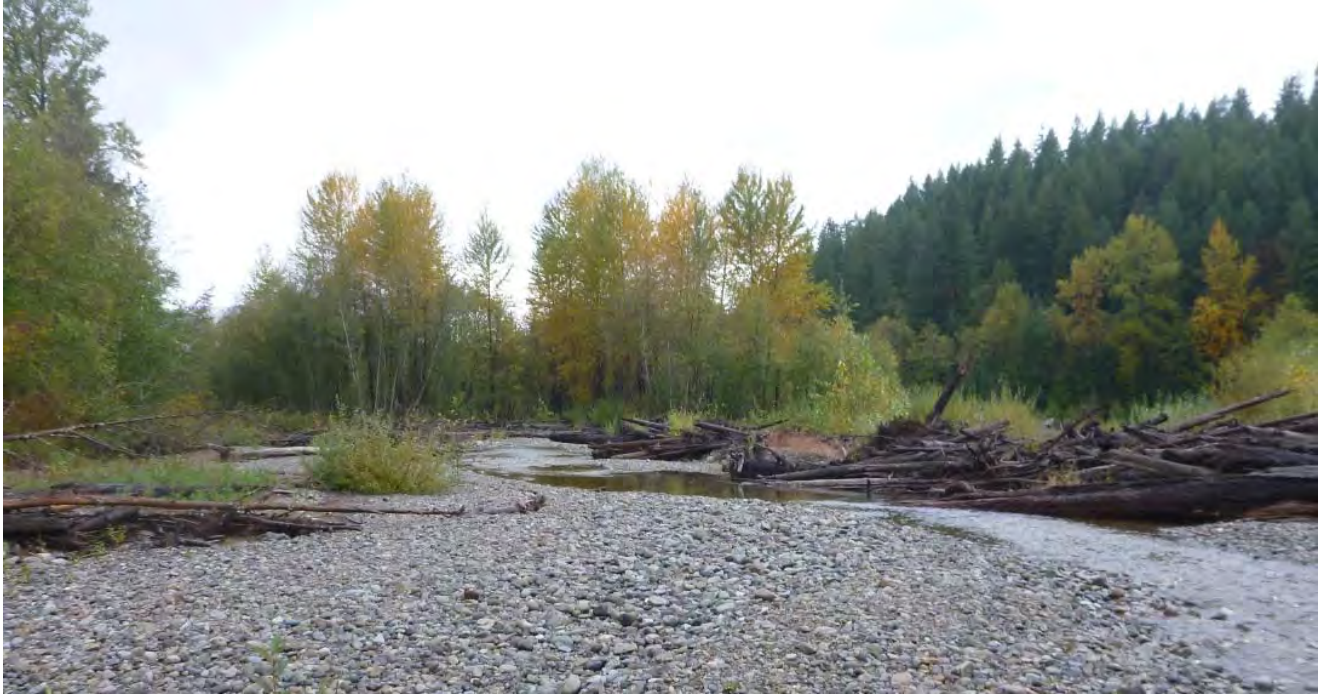
Figure 13. Yellowjacket Creek projects with large wood

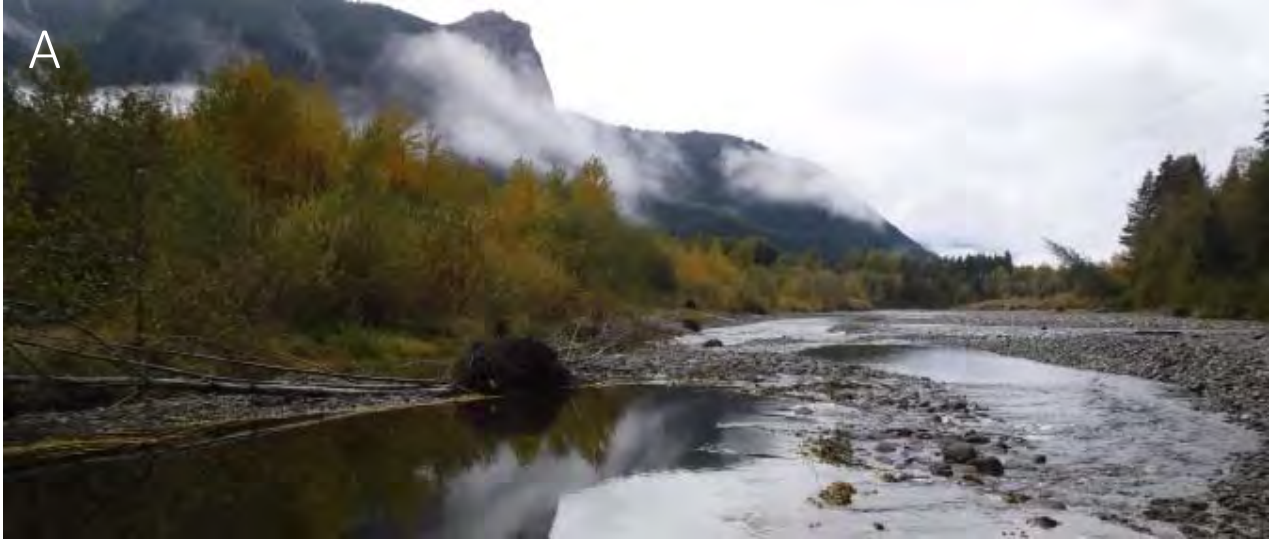
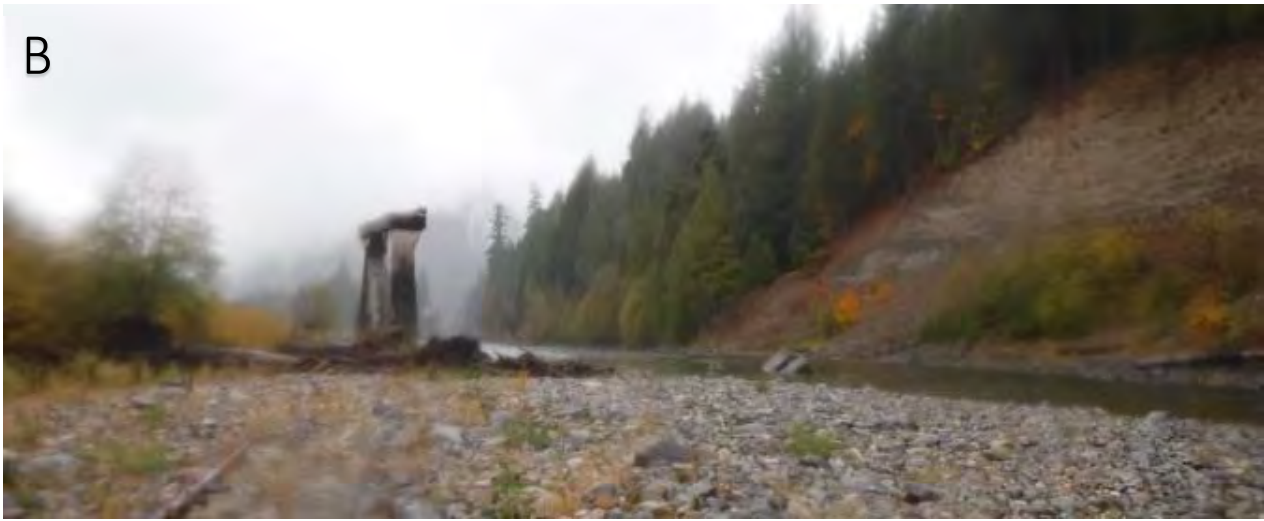
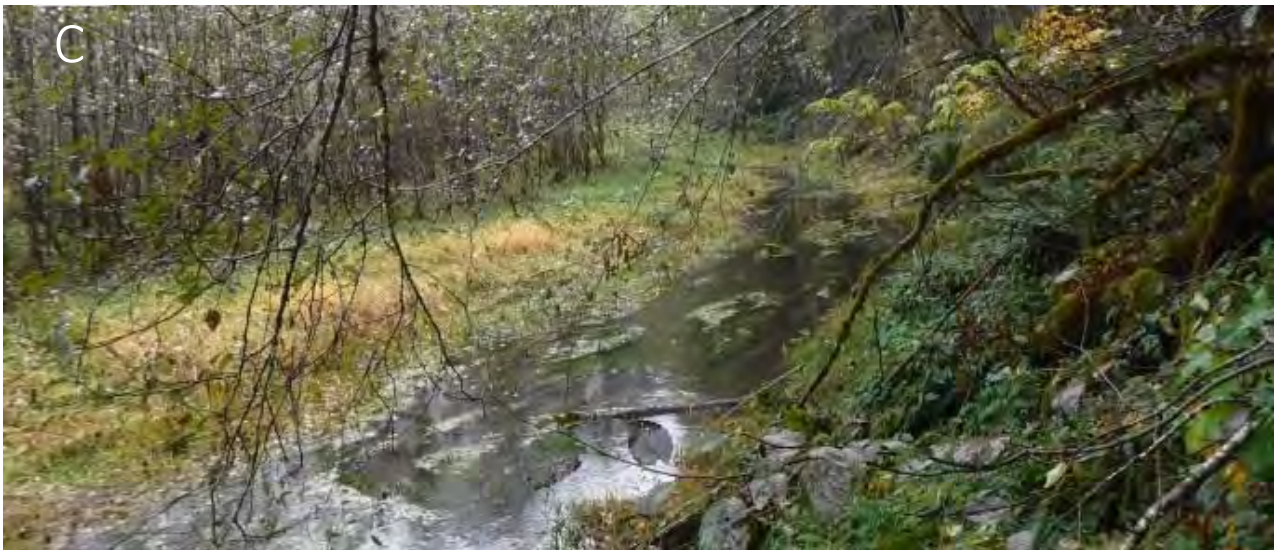
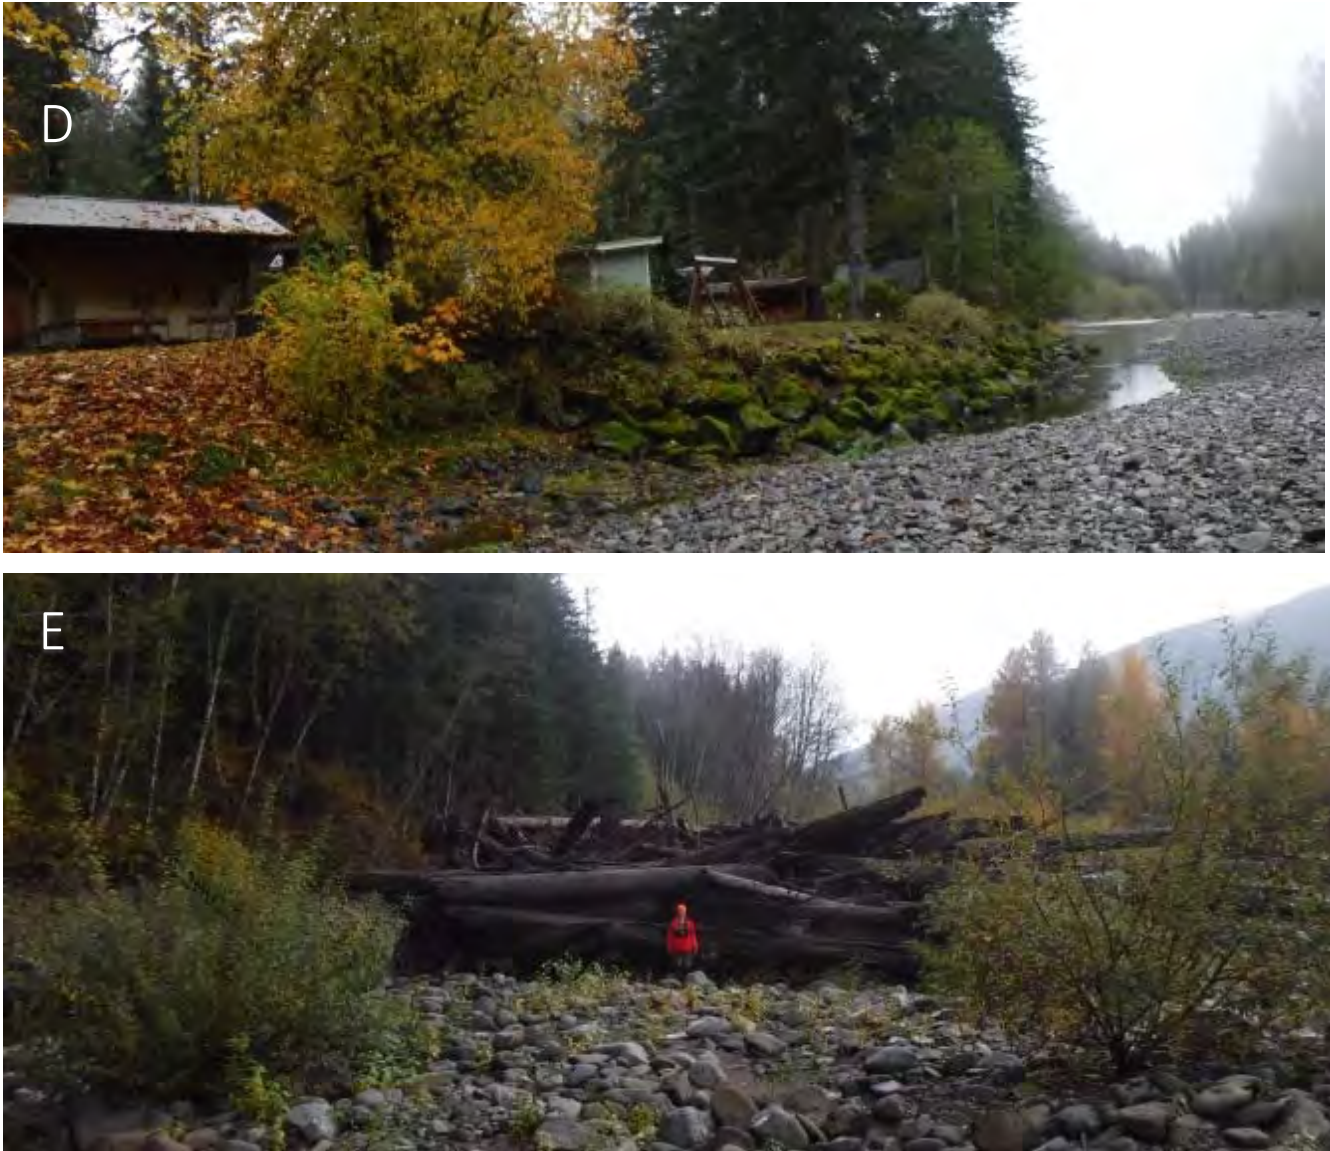
Figure 14. Representative images from the Cispus-Tower Rock LU. A=Looking downstream near confluence with Yellowjacket Creek. B=Washed out bridge. C=within historical alignment. D=riprap protecting Tower Rock community (RM14). E=wood accumulation on Yellowjacket Creek.

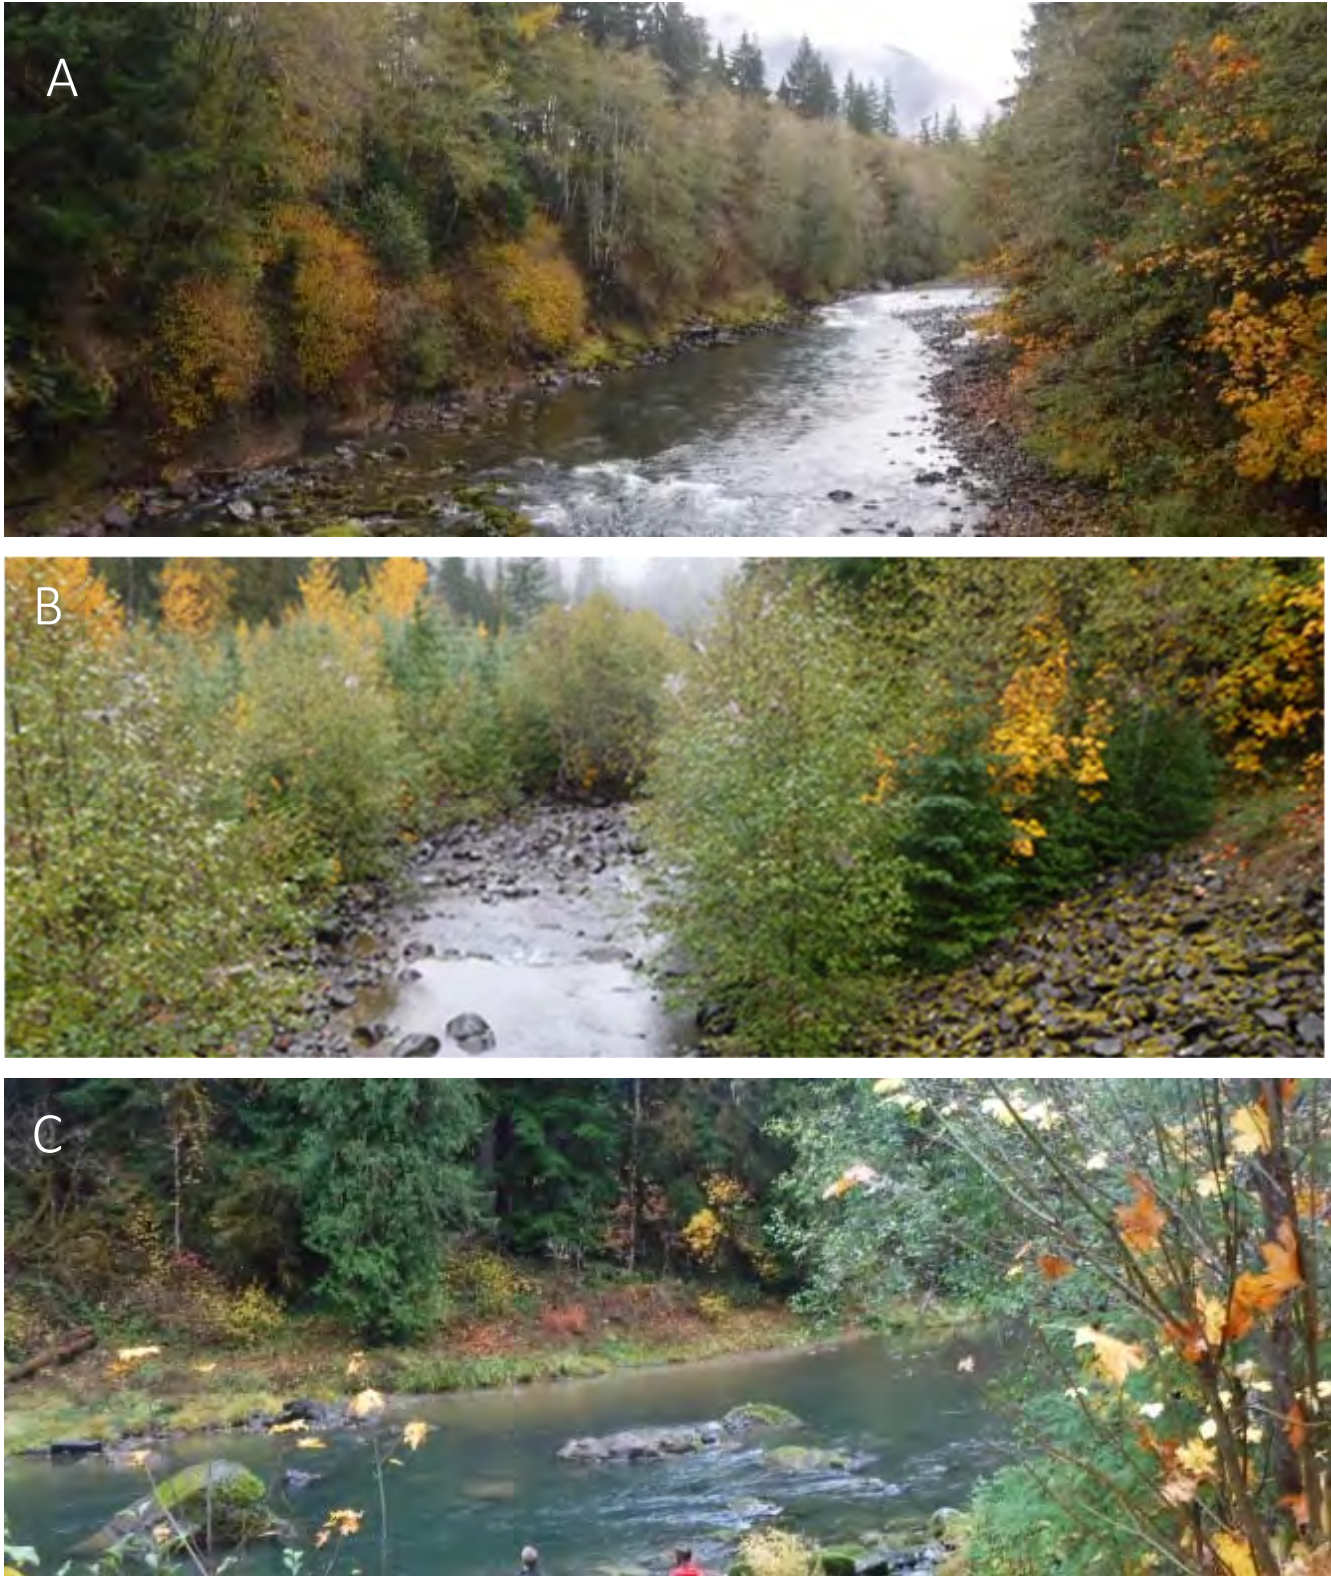
Figure 15. Representative images from the Cispus-Lower LU. A= looking downstream at RM7 at bridge. B=Iron Creek. C: RM 9, boulders and minimal in-channel wood.
