## APPENDIX D. GROUNDWATER PUMP TESTS

Groundwater pump tests were conducted at four test pits in 2008 to evaluate the presence of groundwater at potential project sites. At each site, soil and water samples were collected and analyzed. In this appendix, the four sites are described, and the results and analytical reports are presented.

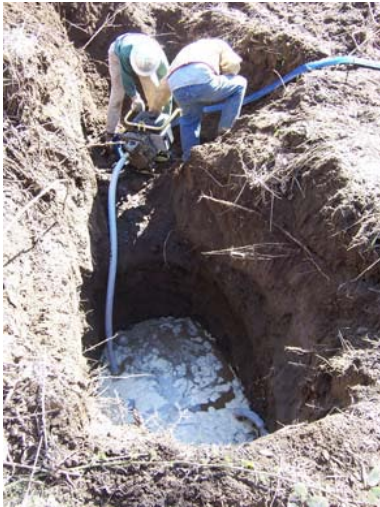
Test Pit 1 was located on the left bank of the Kalama River at RM 2.5 (Ledgett Property). The ground elevation was 23.7 feet. The excavation proceeded to a depth of 10 feet (Figures D1 and D2). The upper 4 feet consisted of fine grained silts and sand, from 4 to 6 feet there was a transition to gravel and below 6 feet river alluvium. The digging below 6 feet was very hard, as the material was compacted. Water was encountered at elevation 15.2 feet (7 feet below the ground surface). A groundwater pump test was conducted. Test results for the pump test, soil samples and water quality measurements are shown in Table D1 and Figure D7.

Figure D1. Test Pit 1 Excavation

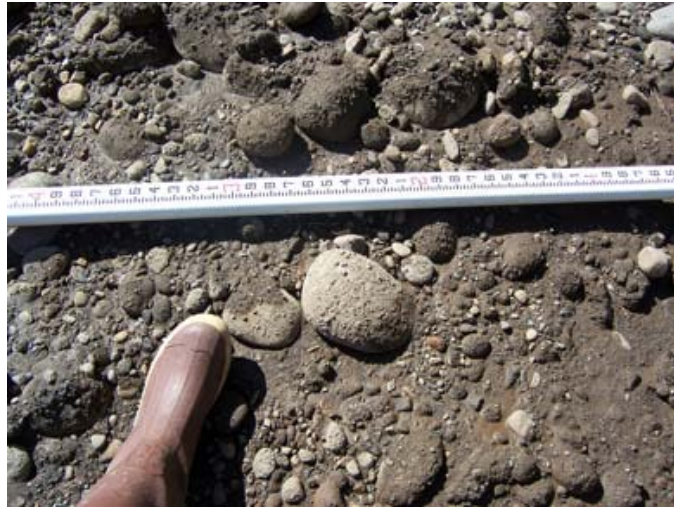
Figure D2. Test Pit 1 Soils

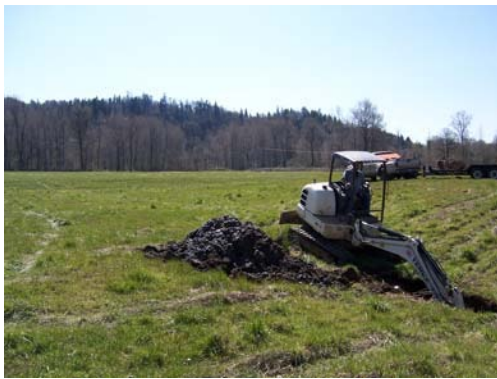
Test Pit 2 was dug out in a low point of the open pasture owned by the Port of Kalama (Figure D3). The ground elevation was 19.6. The water level was 15.8. Excavation proceeded down to an approximate elevation of 13.6 feet (6 feet deep). Below elevation 15 feet, the excavated soil walls were collapsing, and it would have been very difficult to stabilize the slopes without a major excavation. Soil tests within this area indicate a much lower percentage of gravel compared to Test Pit 1.

**Figure D3. Test Pit 2 Excavation**

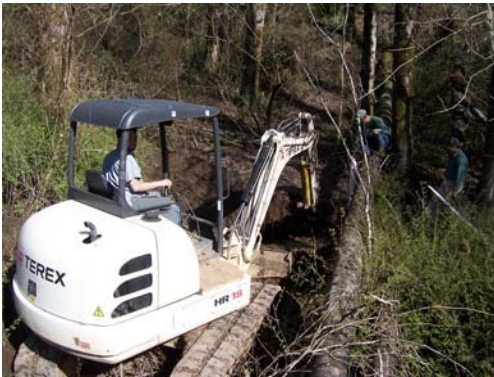
Test Pit 3 was dug within an existing swale on the right bank of the Kalama River downstream from Test Pit 1. The ground elevation was 15.0 feet and static water surface was at 12.6 feet.

The first three feet of excavation were very wet sandy loam. When the excavator bucket removed water from the pit, the groundwater recharge appeared to have a high iron content; the cobble removed were covered with iron rich sediment. This condition was confirmed by the water quality tests with a 35 part per million (ppm) iron reading. Similar to Test Pit 2, the soil walls were collapsing and it would have been very difficult to stabilize the slopes without a major excavation so a pump test was not completed.

**Figure D4. Test Pit 3 Excavation Area**

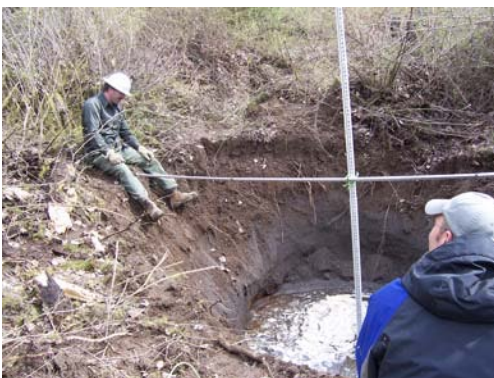
Test Pit 4 was dug within land owned by WDFW on the right bank floodplain at RM 0.4. The ground elevation was 12.5 feet, and the groundwater elevation was 7.5 feet. The excavation proceeded to a depth of 6.5 feet. There was no gravel, but a very consistent sand material after 2

to 3 feet of sandy loam was removed. A pump test was conducted at this site. Pumping started at a static water surface of 7.5 feet. The water level was pumped down 1.1 feet at a rate of 97 gallons per minute (gpm) over a time of 4 minutes. The drawdown rate, or the rate at which the water elevation dropped, exceeded the pumping rate and the hole was pumped dry. The adjacent water elevation in the Kalama River during pumping was 7.0 feet. This reach of the river is tidal with water elevations varying from 6 to 10 feet of elevation. Drawdown curve and results are shown in

**Figure D5. Test Pit 4 Excavation**

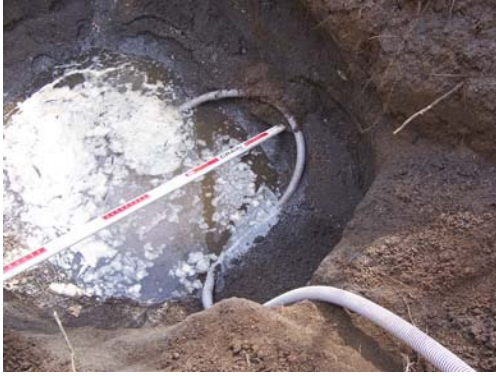
**Figure D6. Test Pit 4 Bottom of Hole**

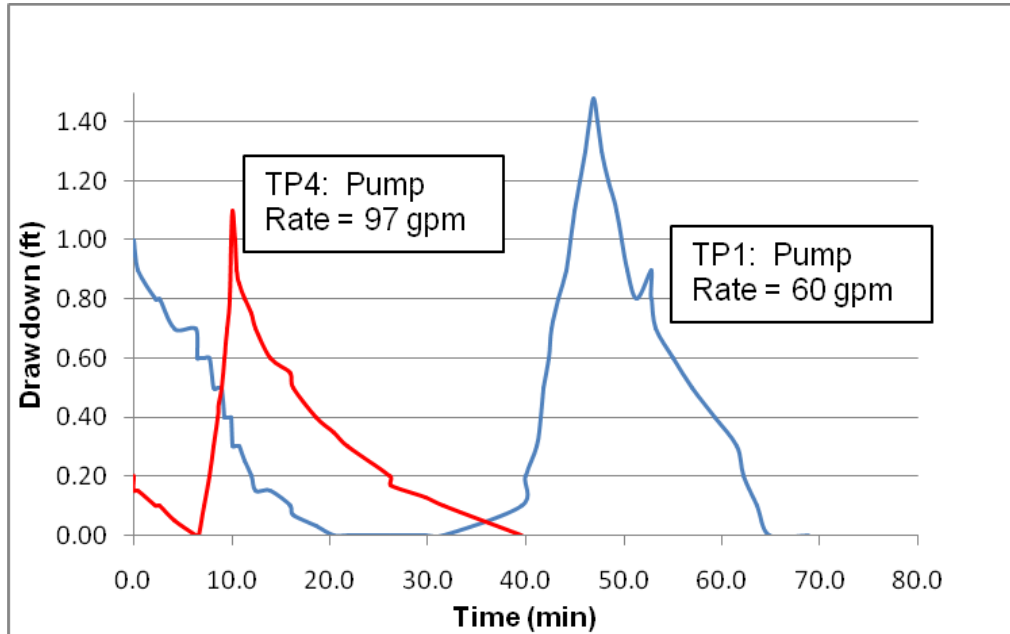
For the Lower Kalama River sites the low drawdown index, and the very slow recharge rates tends to indicate a low potential for the development of adult salmon spawning channels. The exception may be the area around Test Pit 4, as this is tidal and adult access could be provided at higher tides. Spawning gravel would have to be imported. The high quality groundwater and substrate does provide excellent opportunities for creation of year round off channel rearing for juvenile salmonids.

The drawdown and recharge curves of Figure D7 show that the test holes were drawn down very fast and took much longer to recharge. The soil was very compacted at Test Pit 1. Conditions for summer and fall (low flow periods) need to be monitored to check for water elevations. These low flow elevations need to be correlated to the surveyed project datum. Figure D8, shows the water levels for all the monitoring areas within the Lower Kalama and Columbia River.

**Figure D7.** Lower Kalama River Test Pit 1 (TP1) and Test Pit 4 (TP4) drawdown and recharge curves superimposed to a common start time.

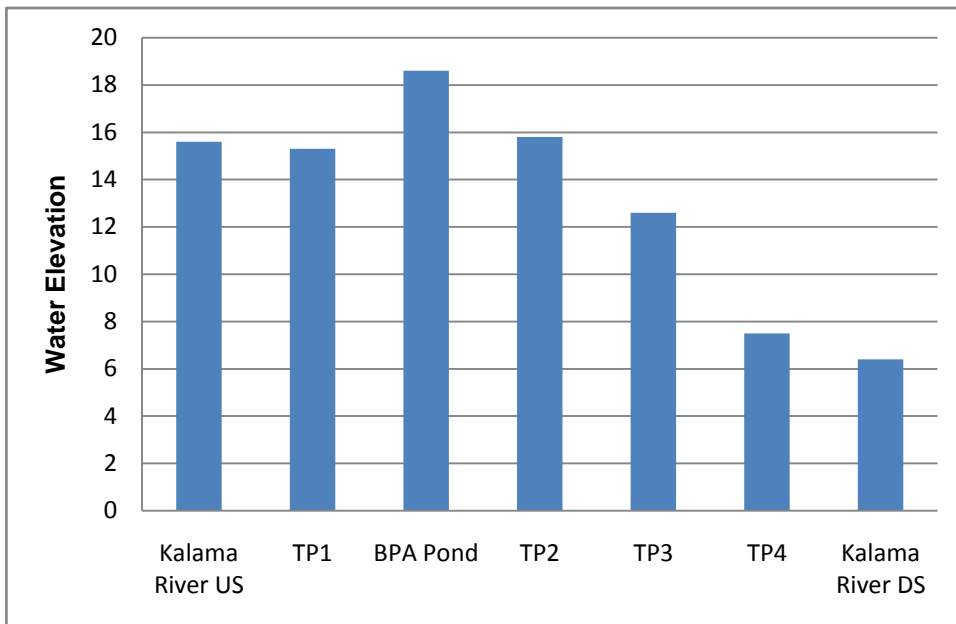
**Figure D8.** April 3 and 4, 2008 water surface elevations during the test pit period. Datum is Port Survey datum.
