Appendix F – Project Descriptions and Concept Maps

Wind River Restoration Strategy

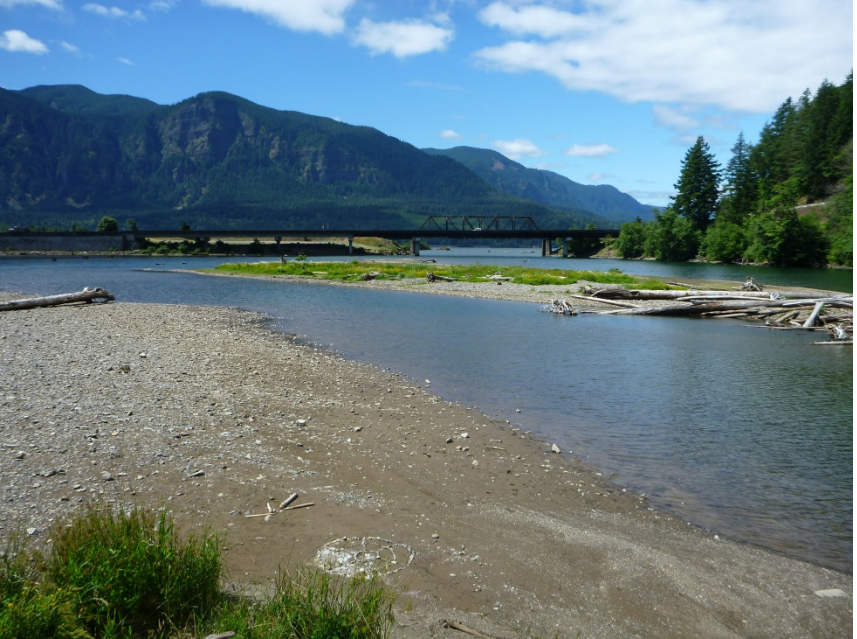
Reach	Project Name	Project Code	Project Description	Considerations	Photo
Wind 1 and 2	Wind River Confluence	W1	Confluence area contains open water, boat ramp, parking area, riprap shorelines, old bridge abutments, and sand bars. Future plans include moving boat ramp and parking area to southeast corner of mouth area. Once this occurs, convert former parking area\boat ramp and existing sand bars to multi-thread side-channel complex with vegetated islands. This would re-create delta features, increase margin habitat, and increase habitat complexity. Also look for opportunities to improve shoreline complexity at riprap banks throughout mouth area. Utilize old log raft logs that will be moved for new boat ramp work for habitat logs. Remove old concrete bridge abutments.	Mouth area is used by multiple user groups. Need to coordinate work with County/Port.

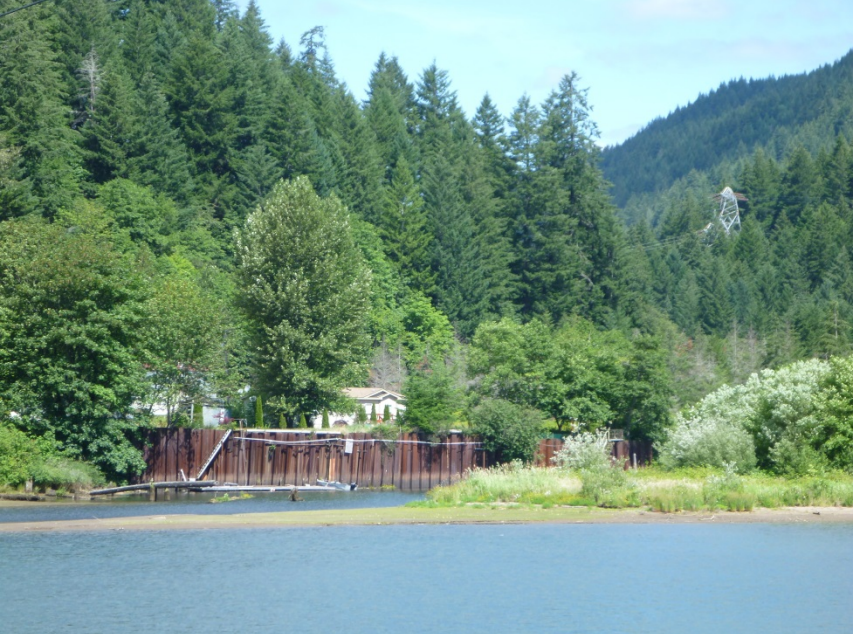
Wind 2	Log Dump Bend	W2	Fill, levees, bank armoring, and docks affect river processes and habitat at the old log dump. At the outside of the bend on river-left, there is erosion of the high bank. Enhance the log dump area to re-create, to the extent possible, river delta dynamics and habitat conditions. This could include removal of the levee at the top end of the log dump, creating a multi-thread side-channel complex through the log dump pond (with vegetated islands), re-grading the right-bank floodplain to increase inundation, and removing or setting back bank armoring, including a section of sheetpile. Actions would also include re-establishment of native riparian and floodplain vegetation. These actions would take pressure off of the eroding left-bank; look for other opportunities to address left-bank erosion, but access is challenging.	Private lands. Work here would likely require land acquisition. Work on the left bank would be challenging given access conditions.

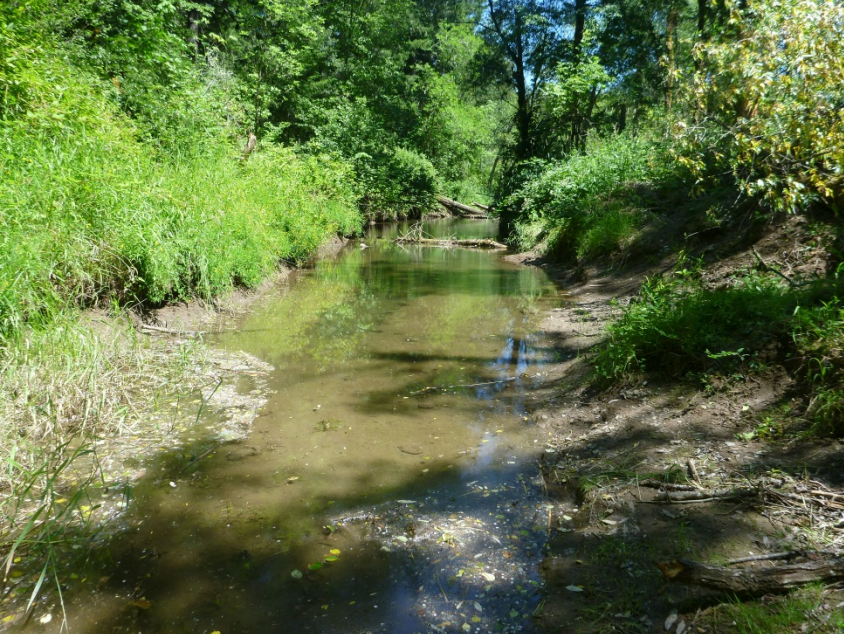
Reach	Project Name	Project Code	Project Description	Considerations	Photo
Wind 2	In-Lieu Bend	W3	The inside of the bend contains side-channel scars and a backwater area at the downstream end. There is a large jam at the upstream end of the side-channel scar complex. Could reposition the wood in the jam, and use select excavation, to increase activation of the side-channel. Could also redistribute wood into mainstem jams or into the existing backwater area downstream. Could add wood to mainstem channel margins and to the apex of the mid-channel island downstream. Work with tribes to enhance riparian conditions and margin habitat at the In-lieu fishing area.	Important to avoid any main channel work that would increase erosion of the high and erodible right bank. In-lieu fishing uses will need to be considered.

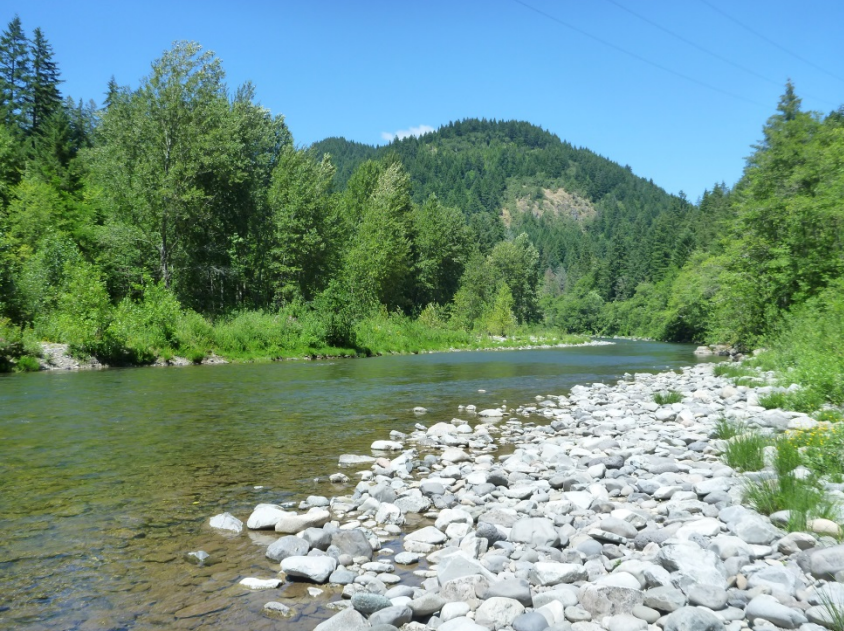
Wind 2	Indian Cabin Road Reach	W4	Uniform reach with riprap along left bank (along access road). Add large jams to right-bank bar to increase planform diversity and multi-thread conditions, and to potentially increase activation of right-bank floodplain/off-channel habitat. Add wood to left-bank riprap to enhance margin habitat. Remove old metal bridge supports.	High energy reach for mainstem jams. Effects on road would need to be assessed. Private Properties.

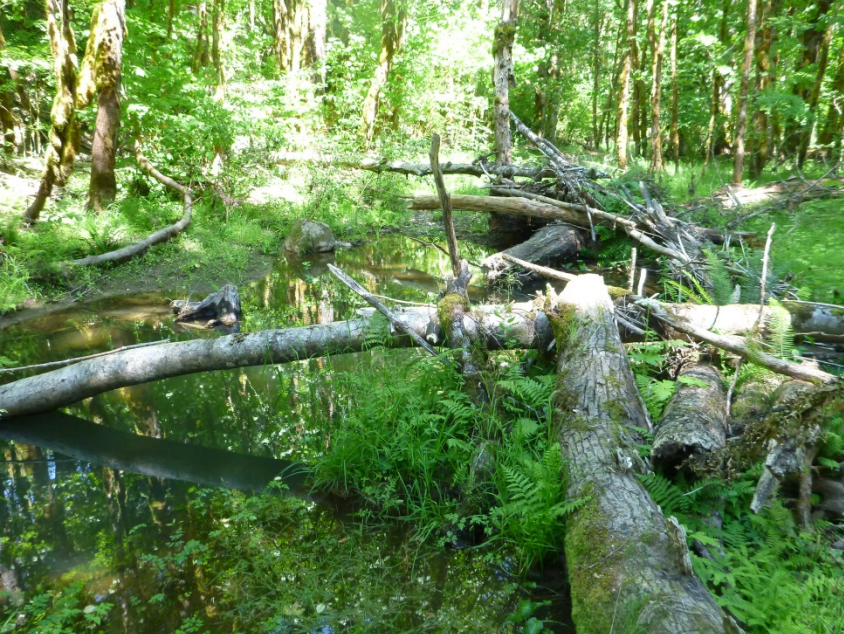
Reach	Project Name	Project Code	Project Description	Considerations	Photo
Wind 5a	Stabler Bend	W5	<p>Activate the complex of channel scars (none are active at low flows). Could put ~20% of flow through here to take pressure off of Stabler Bend. Put in far left bank channel against the hillslope toe. Keep channel against hillslope at downstream end (in the trees). Revegetate open area at downstream end and control for invasives (mainly scotchbroom). Old Stabler log jams at upstream end beginning to deteriorate. At downstream end, some signs of additional erosion and undermining of jams. Possibly place more jams here and/or design a controlled neck cut-off to relieve pressure on this bend.</p>	<p>Depending on gradient and elevation, might be able to activate complex with large wood and select excavation only at the upstream end. Wetlands could be an issue if there is a need for excavation throughout length of side-channel complex. Any work in this area needs to keep in mind imminent avulsion risk across neck at downstream end. Site is private property. There is some interest in controlling Scotch broom but difficult access for owners.</p>

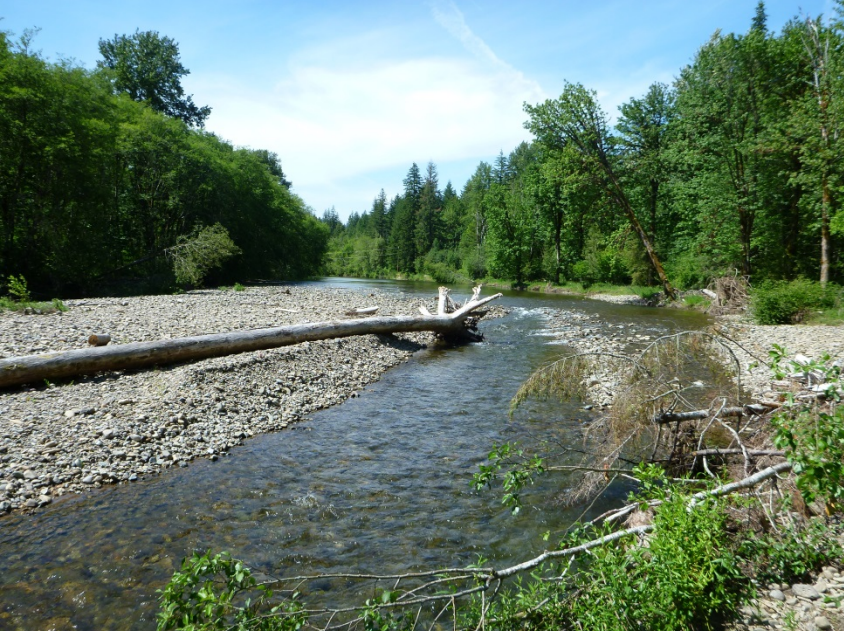
Wind 5a	Stabler North	W6	<p>This is a long and straight uniform reach with glide habitat and very little cover. There is also high width-to-depth especially given recent bank erosion. Good opportunity for bank and bar apex jams to enhance split flows and channel complexity. Possible off-channel habitat enhancement by increasing activation of right bank floodplain. Good alcove potential at downstream end on right bank above private residence.</p>	<p>Possibly tough access across private property.</p>

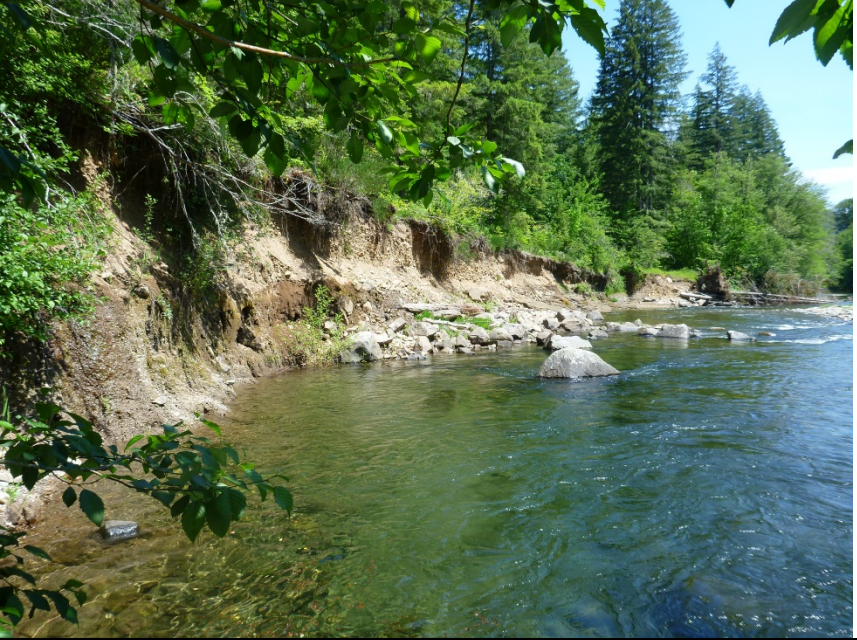
Reach	Project Name	Project Code	Project Description	Considerations	Photo
Wind 5a	Whisky	W7	Uniform reach with Jurzik cut bank at downstream end left-bank and semi-active right bank side-channel. Cut-bank is conglomerate plus mudstone with boulders on the lower bank and alluvium on the upper bank. There is some large wood at the downstream end already. Could mimic this further upstream along bank. Add large wood for complexity and anchor to boulders. Activate the right bank side channel more (currently not flowing). Add right bank margin jams and apex jams. Investigate activating the far right-bank floodplain/side-channel for possibly improving off-channel habitat and taking pressure off of Jurzik cut bank. Replant cleared riparian area on the left bank upstream of the Jurzik cut bank.	Possibly tough access across private property. Anchoring large wood along the cut-bank may be challenging. Activating far right-bank side-channel may be challenging given landowner permissions.

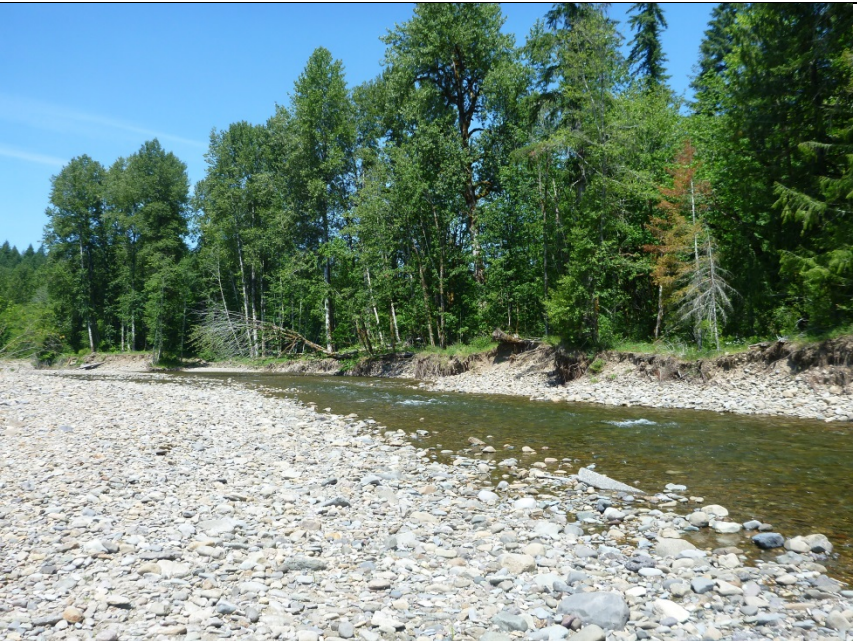
Wind 5a	Cannavina	W8	Multiple private parcels with cleared riparian areas and uniform channel. Look for opportunities to replant riparian zones and add instream complexity using large wood.	Work will take cooperation from landowners.	
Wind 5c	Stump House	W9	This is a newly avulsed section of stream that is currently too dynamic to allow vegetation to establish. Large wood structure using large apex jams would help create and maintain islands and allow vegetation to establish. Could also add large key piece analogs or up-angled rootwads to capture wood. Most of the off-channel areas are fairly well connected but there are some opportunities to enhance connectivity at low flows.	Adjacent landowners that have not given permissions for surveys limits how much of the floodplain was investigated and will likely limit the larger scale opportunities here. UCD has previously placed some wood in a left bank side-channel in this reach.

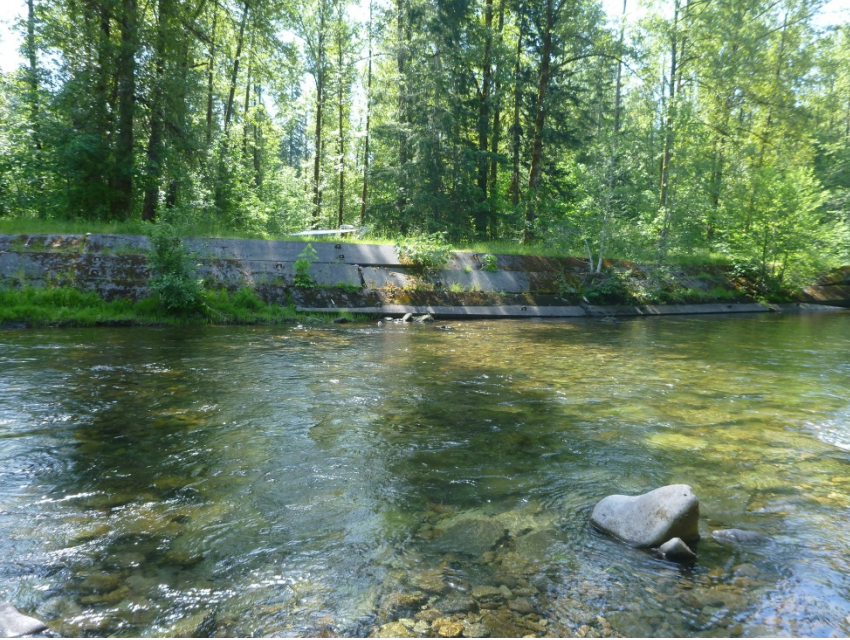
Reach	Project Name	Project Code	Project Description	Considerations	Photo
Wind 5c	Beaver Campground	W10	<p>Levees, fill, and armoring associated with Beaver Campground have significantly impacted floodplain connectivity, off-channel habitat, and instream habitat. There are multiple opportunities for restoration, including: 1) Removal of concrete bulkhead armoring and removal/set-back of associated levee on river-left upstream of CG - creation of low floodplain surface and riparian buffer; 2) Removal/set-back of left bank levee extending downstream along CG, or activation of adjacent side channel; 3) Activate right bank side-channel; 4) Activate left bank floodplain and off-channel complex at downstream end; 5) Add complexity to the main channel throughout, including apex and bank jams,</p>	<p>Campground is the primary constraint. Could it be reconfigured to allow for levee set-back? Past UCD work is located on left bank at lower end, including buried jams, near and at inlet to left bank side channel complex. Goal was to keep the main channel from occupying the side channel but to keep the side channel active. Would be good to increase the level of activation of this left bank side channel complex. There is groundwater flow at lower end of right bank side-channel scar. Could be good to preserve or enhance GW conditions rather than fully activate side channel.</p>

<p>Concrete bulkhead at upstream end of Beaver CG, river-left.</p>

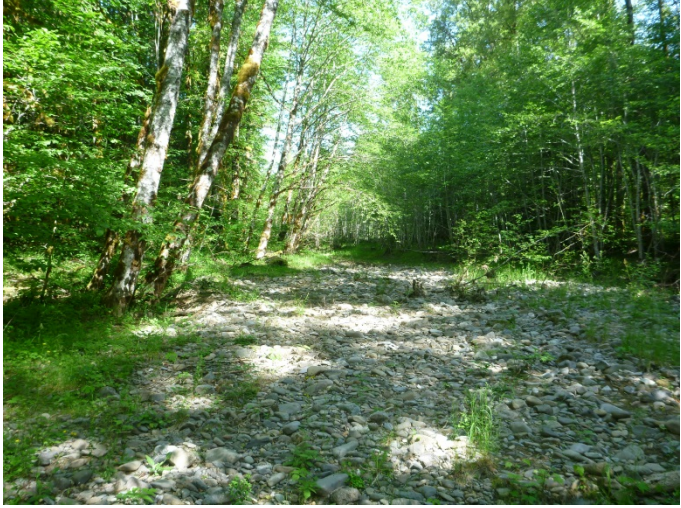
Reach	Project Name	Project Code	Project Description	Considerations	Photo
<p>Wind 5c</p>	<p>Beaver North</p>	<p>W11</p>	<p>Uniform reach with disconnected side channel and riprap bank armoring. Opportunities include: 1) Construct alcove at existing left-bank side-channel outlet at upstream end (groundwater inputs); 2) remove riprap on river left (from Wind River Road) at upstream end of armoring and set back, closer to the road. Create a lower floodplain and revegetate; 3) Activate large side channel scar on the right bank using a large apex jam on bar near the inlet and a left bank margin jam. Load the side channel with large wood. There is a good bar apex/riffle crest from which side channel can be activated. Currently there are large old-growth pieces at jam at head of side channel which can be repositioned and used. Consider shifting main channel into this alignment to remove channel from riprap and bulkhead at Campground. Another option is to enhance the lower end as a groundwater channel; 4) Add wood/complexity in the form of bank and bar apex jams throughout.</p>	<p>Modifying road riprap where road is close would be challenging. May have to enhance in place. There is bedrock located in this reach and needs to be considered when planning earthwork.</p>

<p>Left-bank riprap</p>

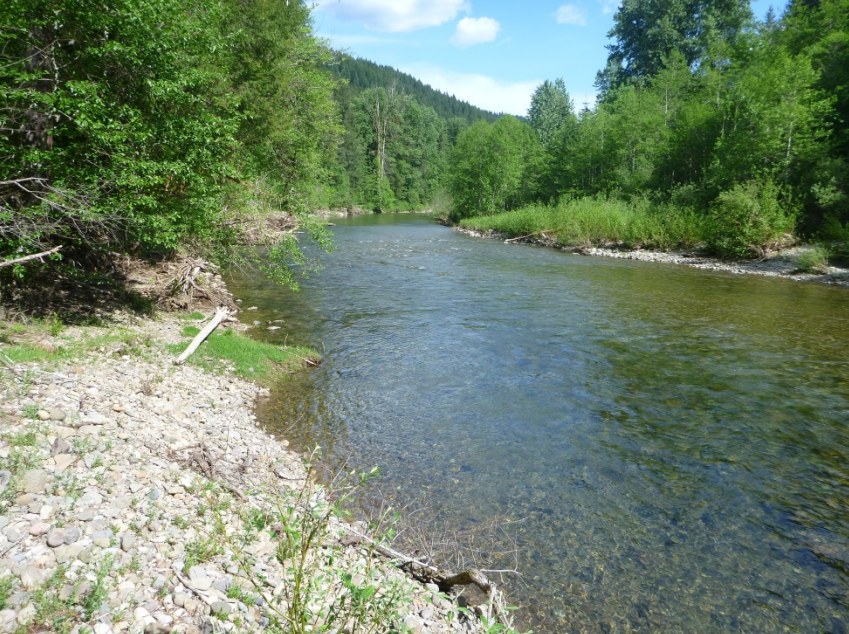
Reach	Project Name	Project Code	Project Description	Considerations	Photo
Wind 5c	Big Butte	W12	Very little mainstem or off-channel complexity. Opportunities include: 1) Increase mainstem complexity throughout reach by adding bank and bar apex jams. At upstream end, add wood to right bank at large pool. At downstream end, there are some buried bank jams - add more and larger bank as well as apex jams; 2) Might be opportunities to activate side-channels including on the left bank at upstream end and on right bank at downstream end. Or create alcoves at side-channel scar outlets.	Access might be difficult at upstream end.

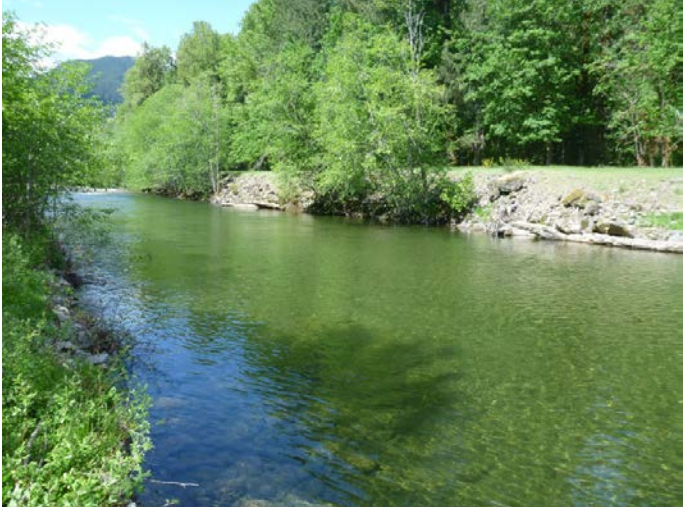
Reach	Project Name	Project Code	Project Description	Considerations	Photo
<p>Wind 5d and 5c</p>	<p>Hatchery Reach</p>	<p>W13</p>	<p>There is abundant potential for restoration of channel and floodplain processes here. Several sub-projects are possible: 1) Remove or set back the levee on left bank near the hatchery to reconnect the left-bank floodplain; 2) Add large wood (apex and big bank jams) to main channel and active side-channels throughout; 3) Remove fill at head of disconnected right-bank side-channel at upstream end of project reach; 4) Reconnect off-channels, side channels, and floodplain wetlands in the right-bank floodplain across from hatchery (possibly connecting up with side-channel described in #3) where large wood appears to have been placed to prevent channel movement to the west and away from the hatchery entrance; 5) Remove, modify, or enhance left-bank riprap downstream from hatchery entrance; 6) Enhance connectivity of right-bank side-channel complex across from hatchery entrance (re-enters downstream at project terminus) using select excavation and a bar apex jam at inlet; 7) Add complexity (apex and bank jams) at pool downstream of riprap; 8) Create cold water alcove on left bank where Tye Springs reenters channel.</p>	<p>The hatchery and associated infrastructure presents significant constraints. The contemporary need and function of levees, riprap, and other hydromods needs evaluation to understand realistic opportunities. Past work appears to have been conducted to maintain the main channel in its current alignment, presumably to maintain fish access into hatchery entrance channel. Investigate options for restoring floodplain and channel migration zone processes while maintaining fish access.</p>

<p>Left-bank levee upstream of hatchery</p>

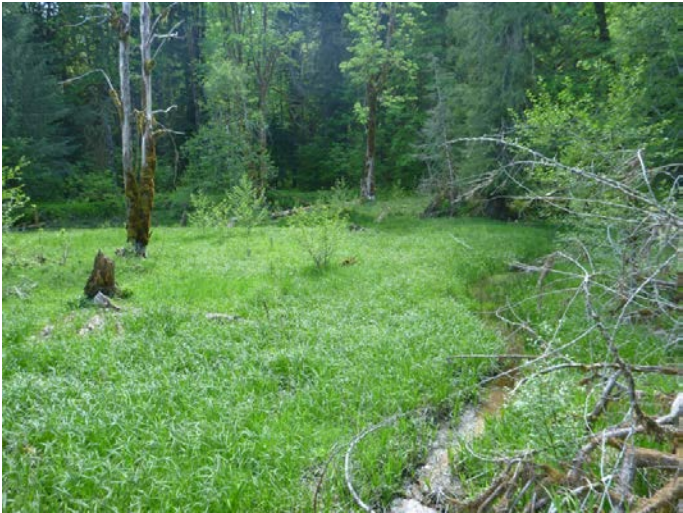
<p>Floodplain wetland complex west bank across from hatchery</p>

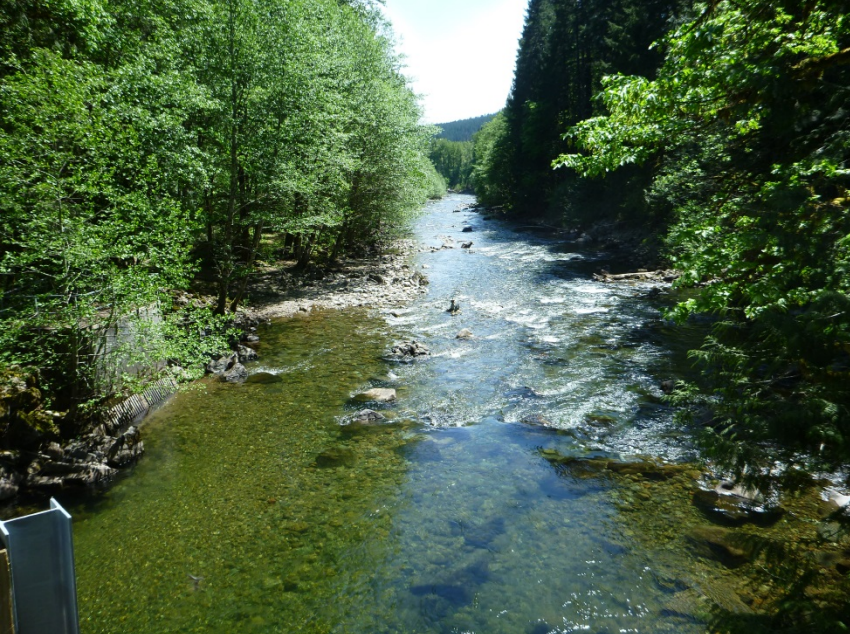
Reach	Project Name	Project Code	Project Description	Considerations	Photo
Wind 5d	Mineral Springs Bridge Reach	W14	This reach is incised and disconnected from floodplain due to upstream bridge/fill and levee/canal on river-left. Reach is straight, cobbles and boulders, steep riffles and glides, high energy flow, and very little complexity. No off-channel habitat. Boulders probably provide some decent steelhead cover. There are some existing logs placed along margins (cabled and/or buried). At a minimum, add more large wood (as has been done) but bigger and more aggressive to create deposition areas and habitat. Also look for opportunities for off-channel enhancement and floodplain reconnection, potentially using jams to activate floodplain and modifying left bank levee/canal system or activating the left-bank side channel scar as a low flow side-channel.	High energy reach. Log jams will need significant ballast to maintain integrity. Work to the east of the channel could affect diversion canal and berm. Need to evaluate current use and need for canal.

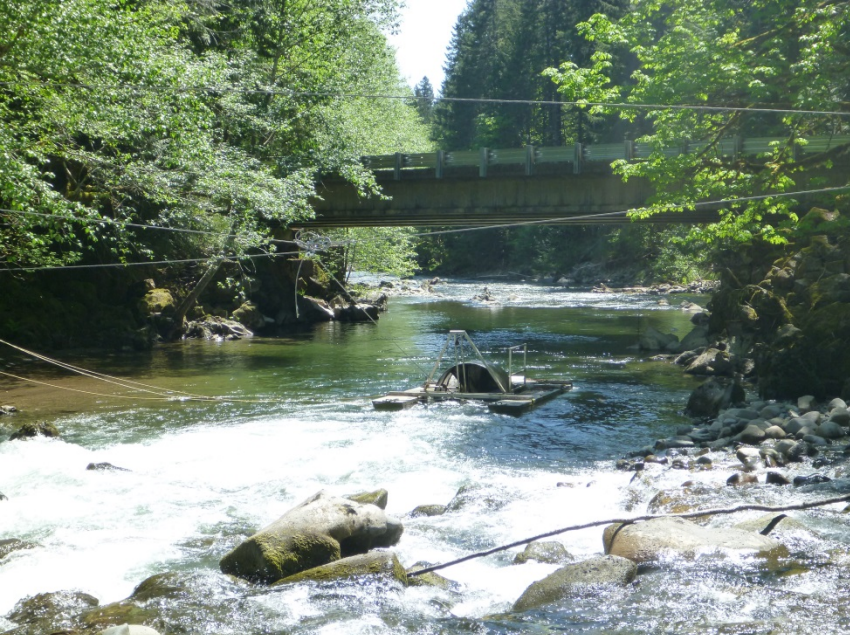
Wind 5d	Mineral Springs Road Bridge	W15	The bridge and associated approach fill on the west side severely disconnected the floodplain and has locked the channel into its current alignment, causing incision, simplification, and lack of off-channel habitat here and downstream. Look for opportunities to increase connectivity through modifying the road fill/crossing or mitigating for these impacts by creating new off-channel habitat features.	Modifications to road fill or bridge would be expensive.

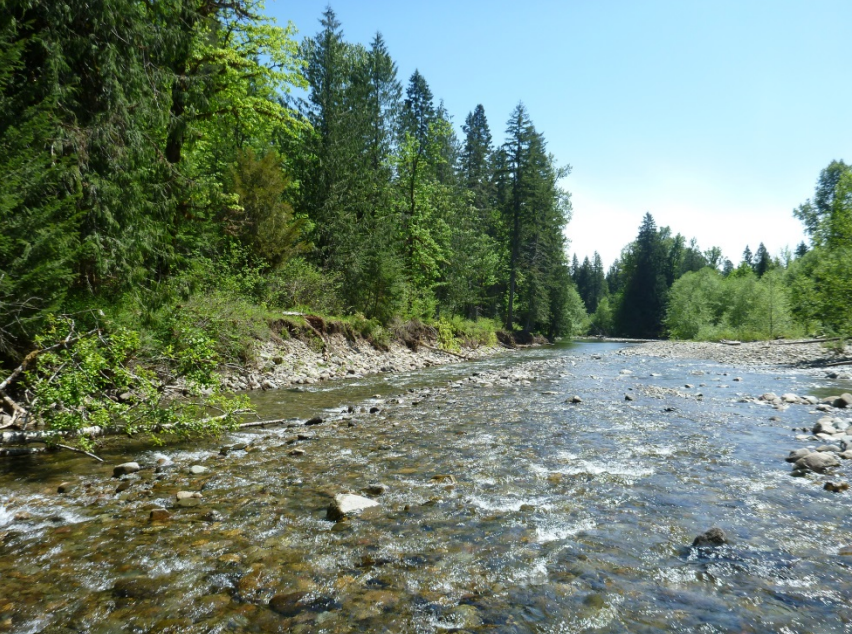
Reach	Project Name	Project Code	Project Description	Considerations	Photo
Wind 5d	Wind River below Trapper Creek Confluence	W16	There is past log jam work through here but more could be completed. Add large apex jams - piling or backfill burial ballasted. Add jams to left bank (be strategic and leave gaps where good recruitment would still occur). Place apex jam on bar towards downstream end.	There are cabled logs just downstream of Trapper Creek on the right bank and an existing apex log jam. There is a newly activated side channel on right bank, with some old restoration logs washed down near here. There is other evidence of placed logs moving - the ones in place are cabled or well-buried. There is a dispersed recreation area on the left-bank throughout.

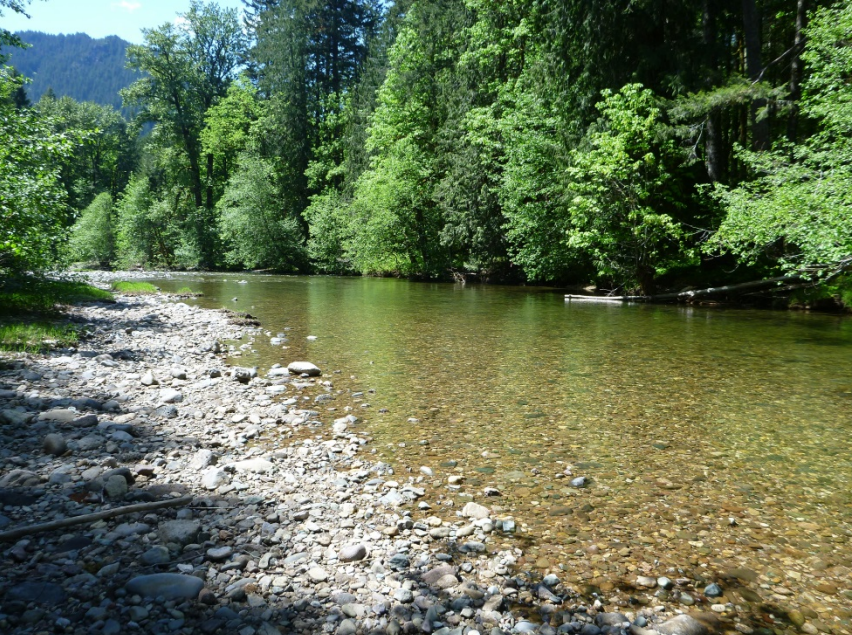
Wind 6a	Wind River below Dry Creek Confluence	W17	This is a very uniform glide with very little in-channel or margin habitat complexity. Add large wood to right bank to create pool scour and cover. Add apex jam just above Trapper Creek confluence.	There is an existing dirt access road along the river-left bank.

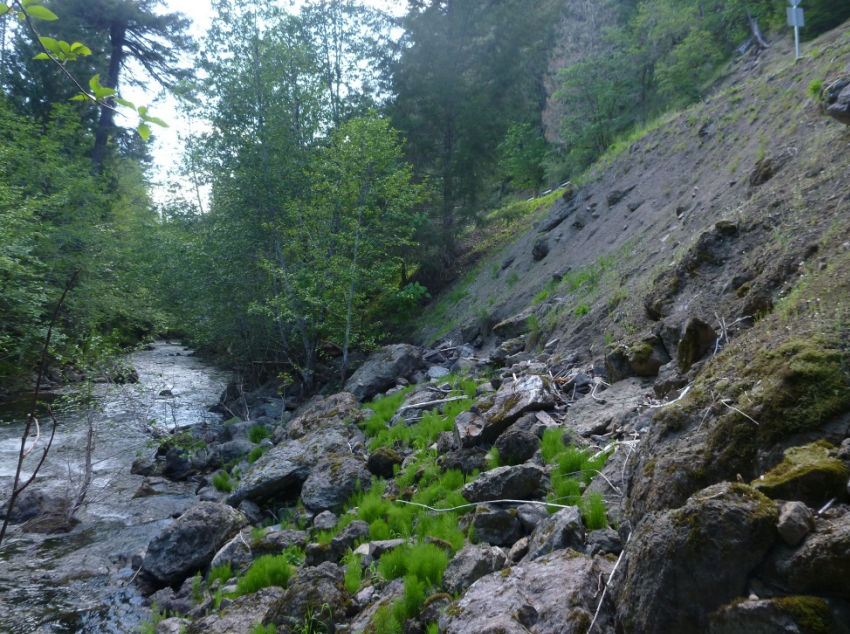
Reach	Project Name	Project Code	Project Description	Considerations	Photo
Wind 6c	Falls Confluence Highway Slope	W18	Over approximately a half-mile, the high road prism abuts the channel, with intermittent (sometimes heavy) riprap and impacted riparian vegetation. Look for opportunities to establish woody vegetation on the highway slope and to increase margin complexity in the channel using large wood. There are a few pieces of placed large wood at the base of the riprap from old projects.	Riparian work on highway slope could be challenging and large wood margin complexity along the riprap may not be worth it.

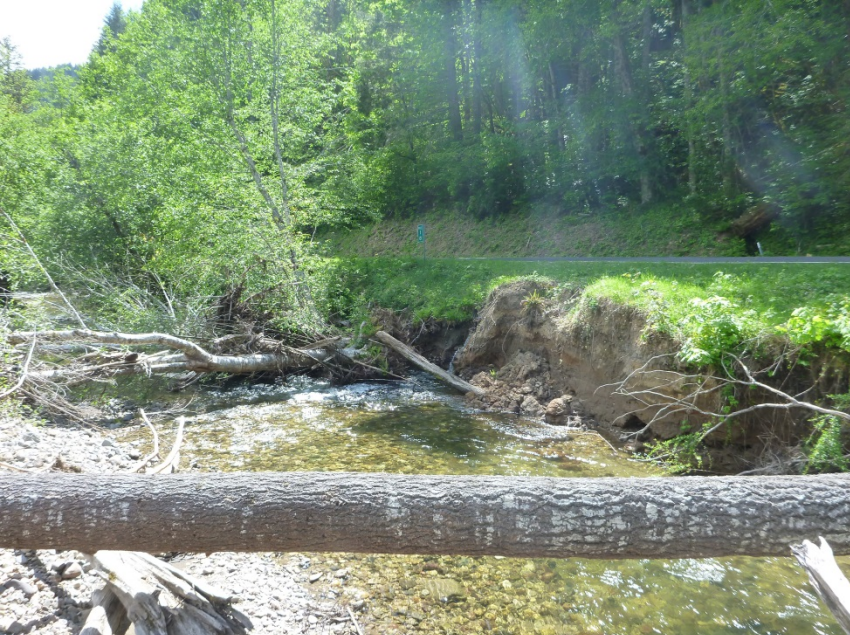
Wind 6d	Mining Downstream Road Contact	W19	A 50' riprap section appears to have been an emergency placement after big firs were recruited. Riprap is intermittent, with areas of failure. This is a multi-thread channel with some flow farther east - very complex. Shift the channel away from highway toward valley-left using log jams. Use jams along highway to prevent re-occupation of channel adjacent to highway. Establish a riparian buffer between river and road. Add large wood key pieces throughout the channel to capture numerous smaller deciduous large wood in the channel. There is a second riprap section along road at downstream end where margin complexity could be increased, but road bank is high and canyon is starting here so there is less impact or opportunity for improvement.	There are road integrity and safety issues at these sites, which could boost importance and help with funding.

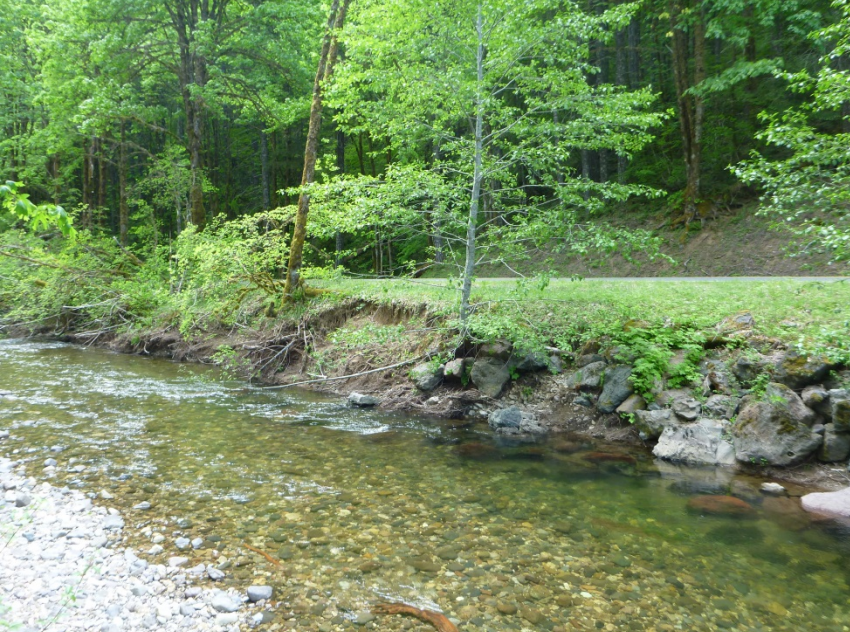
Reach	Project Name	Project Code	Project Description	Considerations	Photo
Wind 6d	Mining Middle Road Contact	W20	Two locations of highway riprap along right bank. At the downstream location, the riprap has failed or might soon fail. Near RM 22.9 the riprap is failing and a jam is putting the highway at risk. There is an old dry channel in the left bank floodplain that would be an easy place to shift the channel. Shift the channel away from highway toward valley-left using log jams. Use jams along highway to prevent re-occupation of channel adjacent to highway. Add large wood key pieces throughout the channel to capture numerous smaller deciduous large wood in the channel.	There are road integrity and safety issues at these sites, which could boost importance and help with funding.

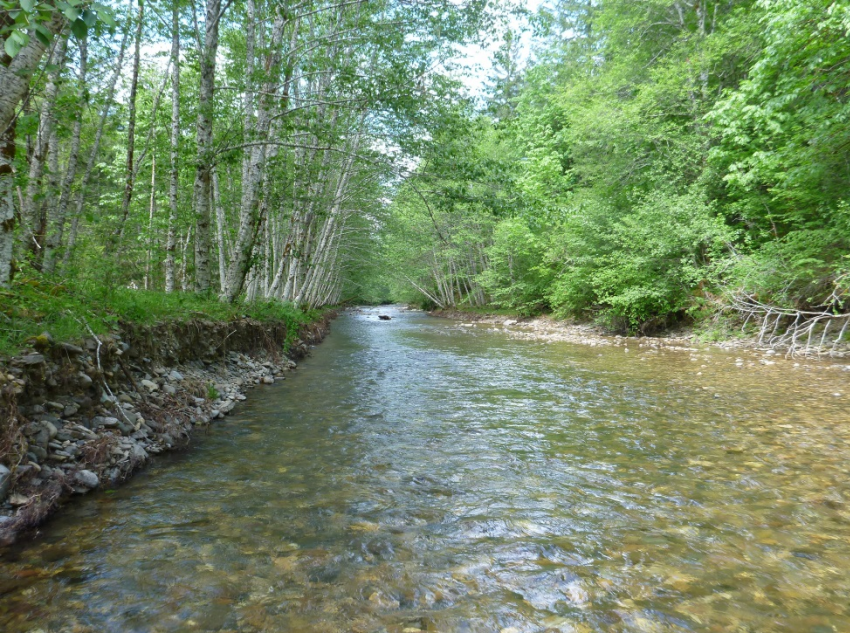
Wind 6d	Middle Butte Fan Large Wood	W21	Channel is currently very uniform and single thread. It has a higher gradient and is more confined from left bank fan. It's likely a constriction/valley grade control for depositional reach upstream. Young alder and maple are present on the right bank floodplain (less than 10" diameter). The left bank is a higher disconnected surface (fan). Add large wood "key" pieces (~0.2 miles) for complexity and to create pocket pools and to retain gravels. Large wood placements would recruit small/young large wood.	Access from Wind River Highway or helicopter drop key pieces.

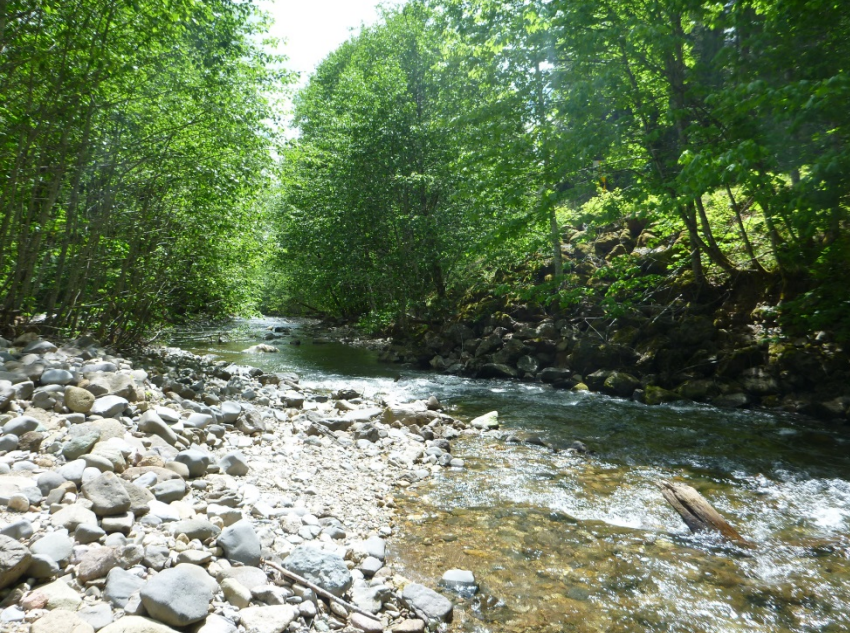
Reach	Project Name	Project Code	Project Description	Considerations	Photo
Wind 6d	Mining Upstream Road Contact	W22	Add large wood jam to right bank at the upstream end of the riprap. Possibly force river channel to shift into left bank floodplain (depending on elevation).	Potential to shift channel into left bank at the upstream end might be more feasible than at other locations.

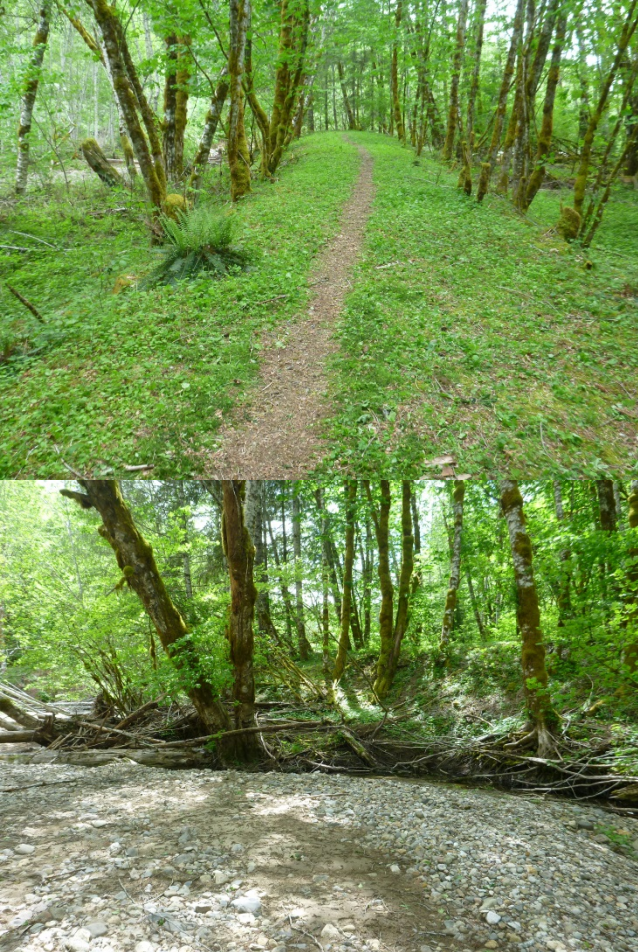
Wind 6d	650 Road Fill	W23	There is an old bridge approach fill/levee causing severe floodplain disconnection on right bank. A concrete abutment is located at the end of the fill approximately 10' from the active channel. Riprap is also located along the edge and at the end. A concrete abutment and road fill is also located on the left bank, with a couple of pilings still present. The left bank has a higher surface (above the floodplain elevation) so the encroachment on the floodplain is not as severe. Also present nearby at the end of the 650 spur road is a dispersed camp site with a 40' long berm and riprap. Remove right bank bridge approach fill/levee. Also remove left bank approach (at least the fill closest to river). Add instream habitat complexity - key pieces to capture alders and maples that have been recruited and will be coming down.	This is the old highway alignment. There is good access from spur road off of Wind River Highway.

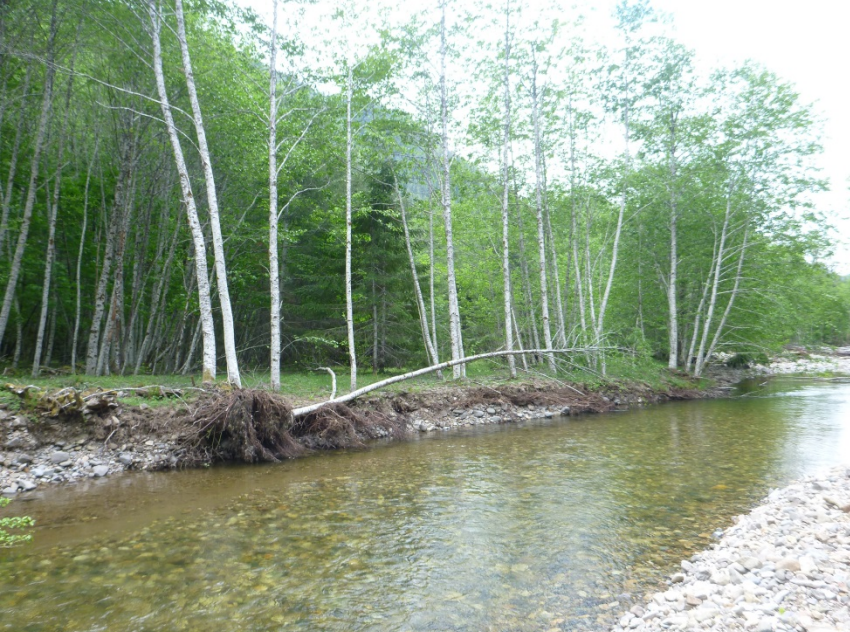
Reach	Project Name	Project Code	Project Description	Considerations	Photo
Wind 6d	Middle Mining LW	W24	Add large wood key pieces to help capture the numerous alders and maples that have been recruited and will be coming down over time.	Access via old hwy alignment (now abandoned - 650 spur road) or via helicopter placement.

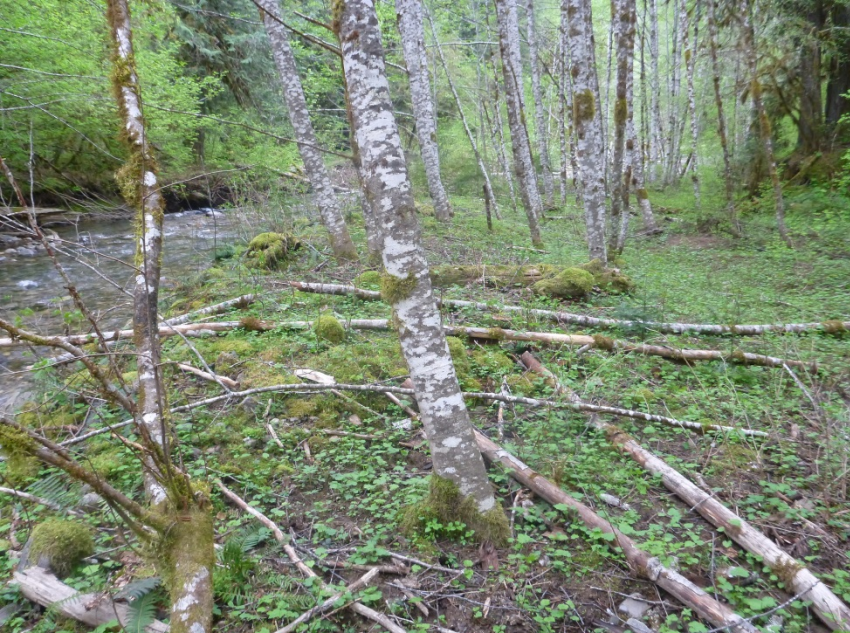
Paradise Creek	Paradise Campground Off-Channel Enhancement	P1	Right bank off-channel habitat potential. Excavate a low-flow side channel. Remove old push-up levee extending approximately 200 feet along right bank. Add apex jam (use existing LW) to encourage erosion on the left bank and recruitment of large trees and floodplain activation upstream at the top of the existing right bank bar.	Potential effects to eroding left bank along campground will need to be evaluated.

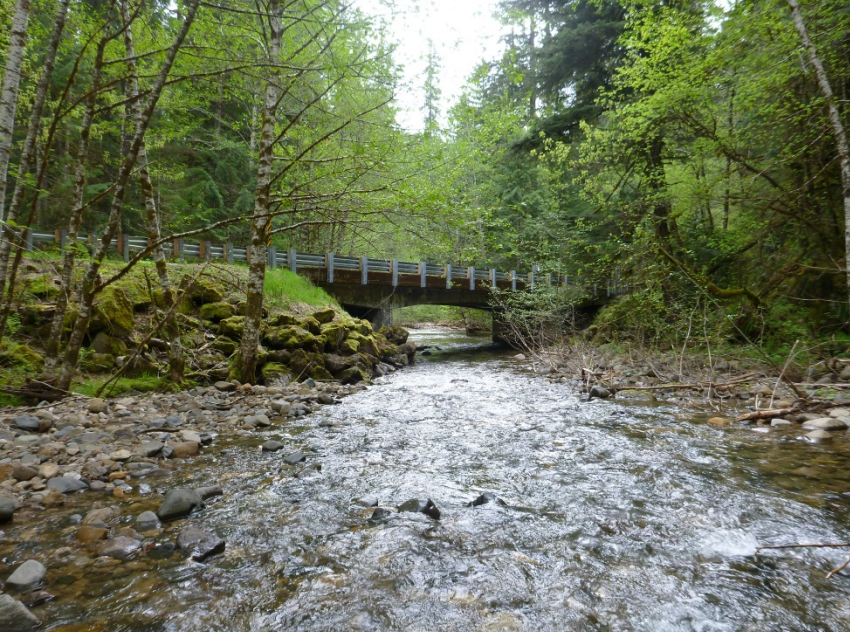
Reach	Project Name	Project Code	Project Description	Considerations	Photo
Paradise Creek	Paradise Bridge	P2	Increase the bridge span length to reduce floodplain constriction and increase the channel migration zone. Removing associated armoring would enhance margin complexity.	Costs may be prohibitive.

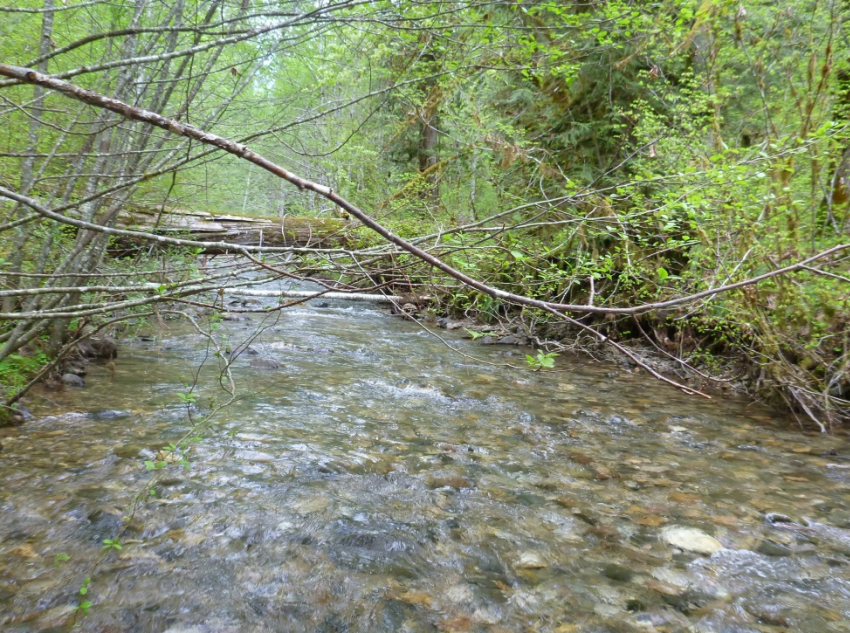
Paradise Creek	Paradise Creek Large Wood	P3	Use LW jam(s) to aggrade channel and activate floodplain. Use existing large key pieces currently spanning the channel (not much wood but a few large (3'-4' diameter) pieces). There is an opportunity to maneuver these logs together, add additional wood (including, potentially, newly dead snag trees on site), to create a log jam behind existing key pieces. The goal would be to aggrade a slightly incised channel and activate the adjacent floodplain.	<p>Relatively large buffer (100'?) between stream and Wind River Highway, but floodplain would need to be evaluated for hazards to infrastructure. There is a bridge downstream.</p> <p>Past incision indicated by inset floodplain with lower current bankfull width. Alders on lower surfaces potentially from 1996 flood. New signs of aggradation on lower surface might signify channel is on an aggrading trend.</p>

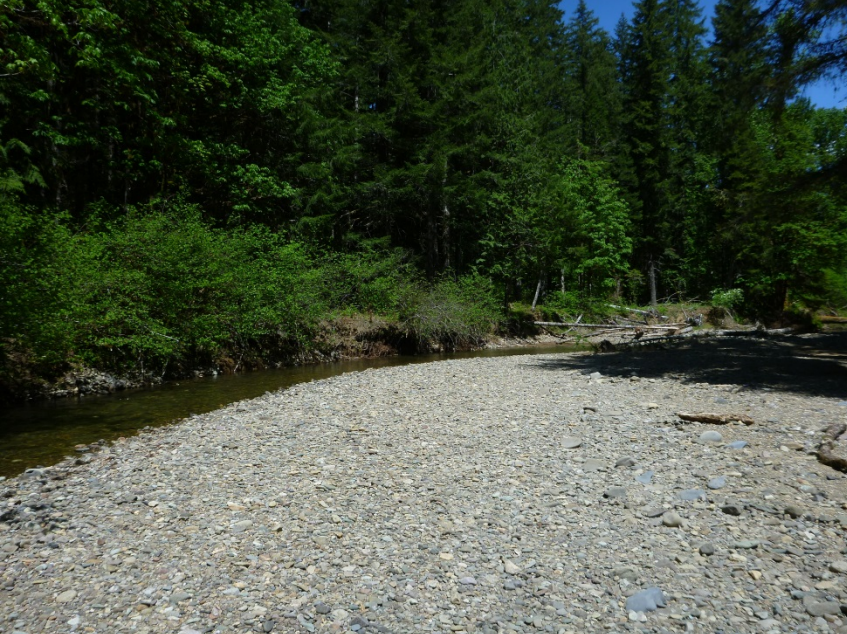
Reach	Project Name	Project Code	Project Description	Considerations	Photo
<p>Dry 1</p>	<p>Lower Dry Creek</p>	<p>D1</p>	<p>This project site is between the mouth and the beginning of the bedrock canyon. It is low gradient and alluvial with large active gravel bars and active scrolling. Needs large wood structure. There has been past work through here, including margin log placements at the upstream end and an engineered jam near the downstream end. Opportunities include: 1) Add wood, either construct margin and apex jams or add large key pieces that can collect smaller wood over time. Place jams to strategically erode banks where good tree recruitment would occur; 2) Use jams and select excavation to activate floodplains, side-channels, and alcove habitat. Lots of opportunity through here.</p>	<p>The effects of seasonal subsurface flow on fish needs to be evaluated before performing work here.</p>

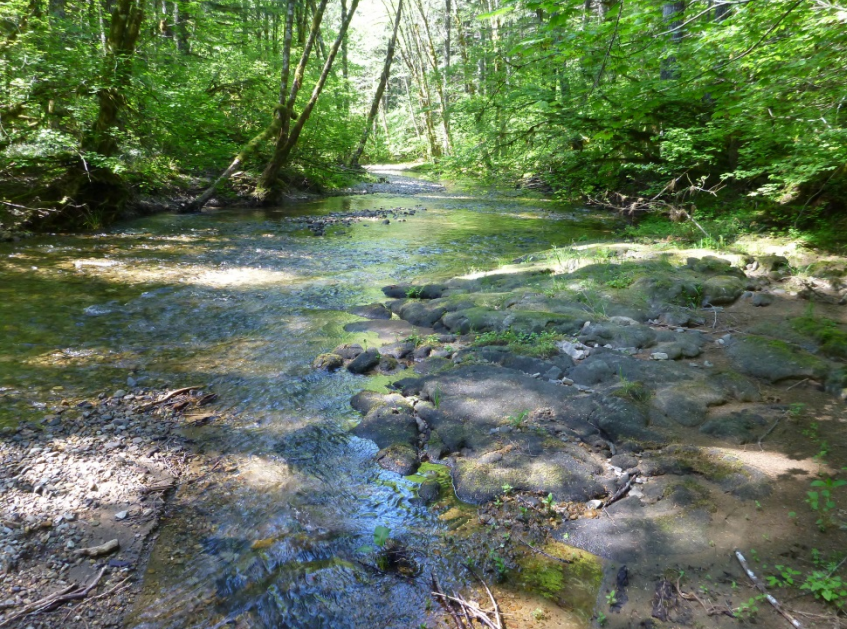
<p>Dry 1</p>	<p>Dry Creek Upper Bedrock Channel</p>	<p>D2</p>	<p>Low complexity and low large wood numbers. More confined and less natural floodplain, but low gradient and has potential to have good rearing and spawning habitat. Add key pieces of large wood to collect smaller debris and form jams. Jams would provide rearing cover as well as retain spawning gravels.</p>	<p>Bedrock contacts through here and likely high energy in floods due to natural confinement. Redd scour is a potential issue. The effects of seasonal subsurface flow, and passage at falls downstream, needs to be evaluated before performing work here.</p>

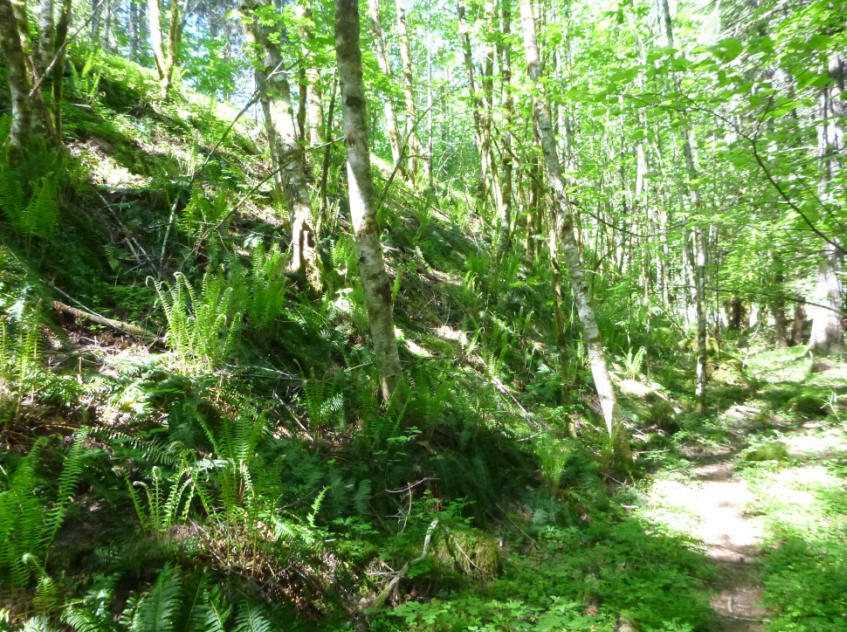
Reach	Project Name	Project Code	Project Description	Considerations	Photo
Dry 1	Spoil Bank	D3	<p>"Spoil Bank" forms cross-floodplain levee on river-left, which disconnects floodplain connectivity and limits off-channel habitat. There is past project work upstream in left-bank floodplain to enhance side-channel habitat. Remove spoil bank to reconnect floodplain. Create new side-channels and enhance connectivity to existing floodplain habitat in both the left- and right-bank floodplains. Enhance mainstem complexity (there is very little large wood throughout here). Plant riparian conifers (cedars) throughout.</p>	<p>Spoil bank material could be moved closer to road to avoid impacts to floodplain connectivity. Past project in left-bank floodplain could be enhanced by increasing level of activation of side-channel.</p>
