Appendix F – Project Descriptions and Concept Maps

Wind River Restoration Strategy

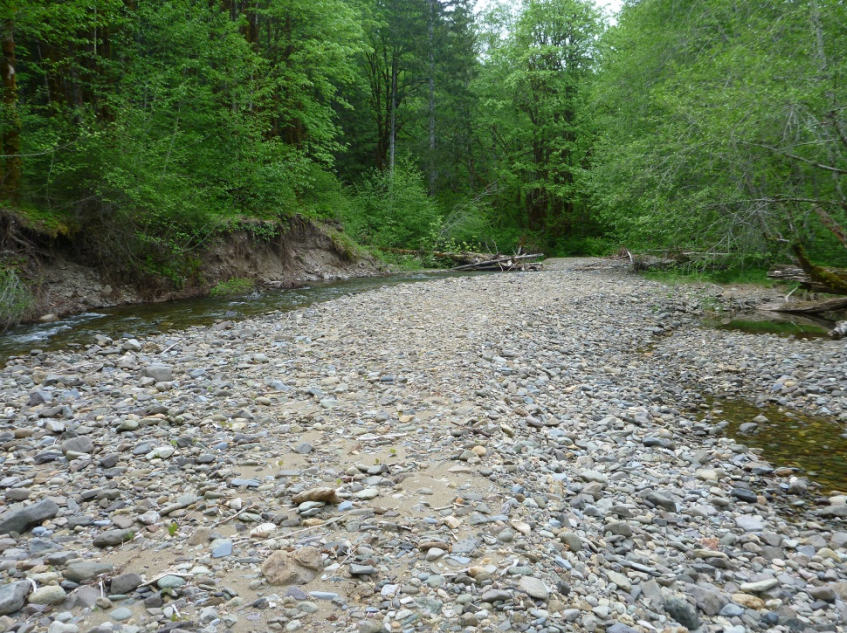
Dry 1	Upper Dry Creek Key Piece Supplementation	D4	<p>Reach has woody debris but most is small and riparian areas have young trees, mostly deciduous. Add large key pieces, possibly by helicopter to limit impacts. This would create stable key pieces to form and maintain jams. Good locations for placements are intermittent and do not encompass the entire project reach. Some areas through here have high complexity, with numerous smaller debris jams. Could also fall select large cottonwoods and maples (there are large ones >2' dbh).</p>	<p>Access from Dry Creek Road, may be challenging in places and will impact riparian zones.</p>

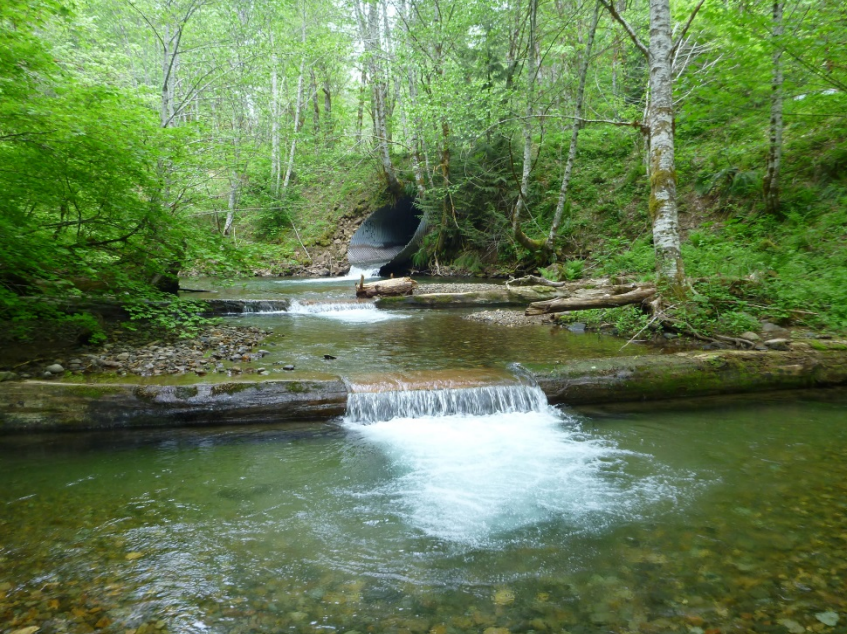
Reach	Project Name	Project Code	Project Description	Considerations	Photo
Dry 2	Forest Road 64 Crossing	D5	<p>The FR64 fill bisects and disconnects the Dry Creek floodplain significantly (original floodplain is wide, ~300 ft here). Culvert at FR64 is an 11' diameter CMP with side baffles but no streambed material. The downstream 15' of culvert is fast shallow flow then 1.5 ft drop to a deep pool, which probably limits passage at some flows (high and low). There are also two log sills downstream of the outlet pool, presumably to address passage issues. Upstream of FR64 crossing there is nothing to do: old growth, well-connected floodplain, good riparian cover and structure, and lots of wood, off-channel habitat, and deep complex pools. Downstream of the 64 road is more downcut and the floodplain is not well connected. There is a more open canopy and less old growth, less off-channel habitat, less active gravel bars, and sediment starved from the road crossing. Replace culvert with long bridge or multiple large culverts to enhance passage and floodplain connectivity. Add channel-spanning jams to downstream channel to aggrade stream, activate floodplain, and provide habitat complexity.</p>	<p>Floodplain and habitat enhancements downstream from the road crossing will have limited value if the road fill remains in place and continues to create a sediment deficit. The effects of seasonal subsurface flow in lower Dry Creek on fish needs to be evaluated before performing work in upper portions of Dry Creek.</p>

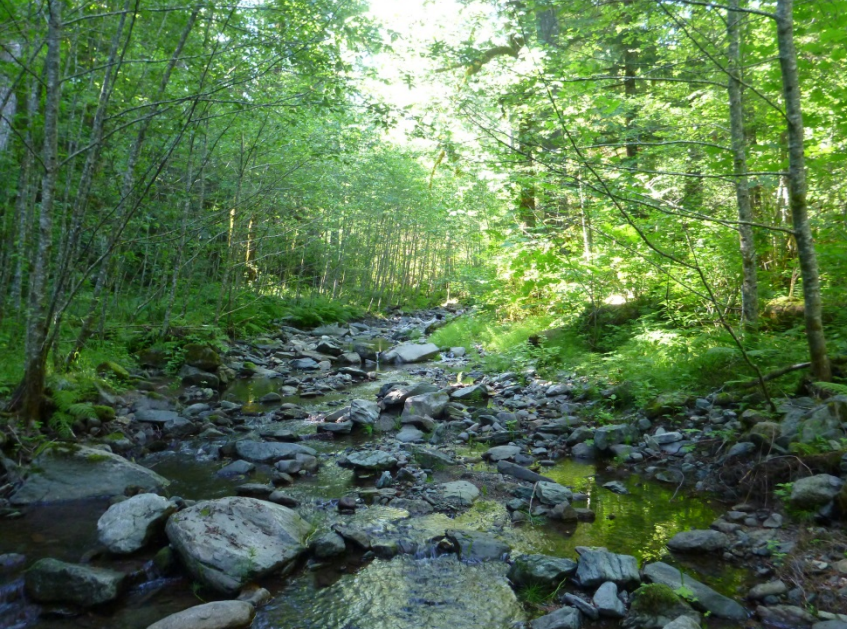
Eightmile	Eightmile	E1	<p>Channel is lacking large wood. Riparian zone at lower and middle is dominated by ≤ 6" alders. The vegetation and channel show evidence of past debris flow (2009?), with some related scouring/incision. The few large pieces of large wood are creating nice pools. There is a large debris flow jam just upstream of the reach. Adding key pieces will help to capture and retain this material as it makes its way downstream, and will help to activate floodplain surfaces. Fell large trees into channel (there are some on hillslope that would reach channel) and/or use helicopter to bring in large wood.</p>	<p>Challenging access for machinery</p>

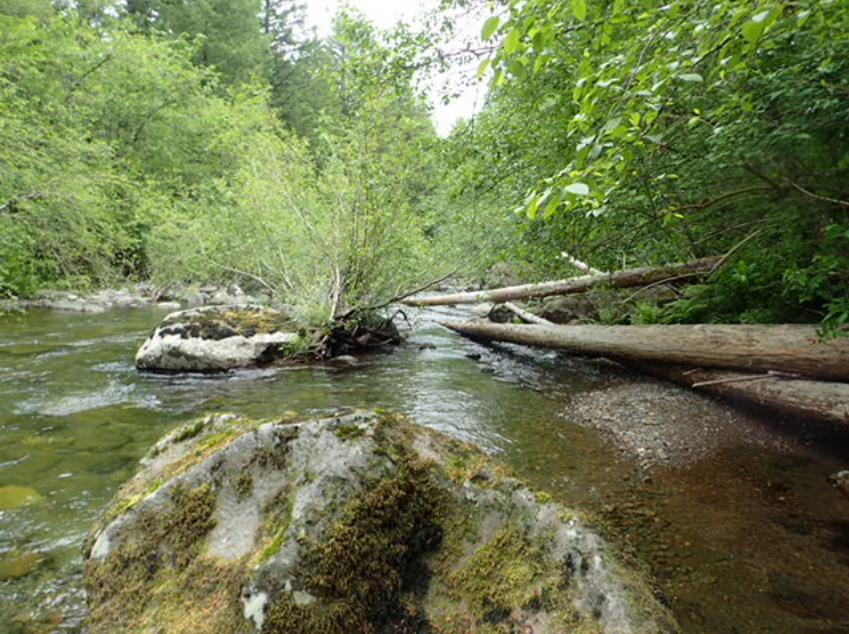
Reach	Project Name	Project Code	Project Description	Considerations	Photo
Trout Creek	Meadow Crest	T1	At top end, both sides of river, especially on the north bank, there is a wide (~100') forested riparian area and stream is continuous riffle. There are no log jams in this reach. Add one or more log jams to capture gravels and provide cover habitat. Existing trees may be able to be used for anchoring. In middle and downstream, also potential sites for log jams, possibly incorporating recent blow down (3-4 logs).	Private lands and potentially challenging access.

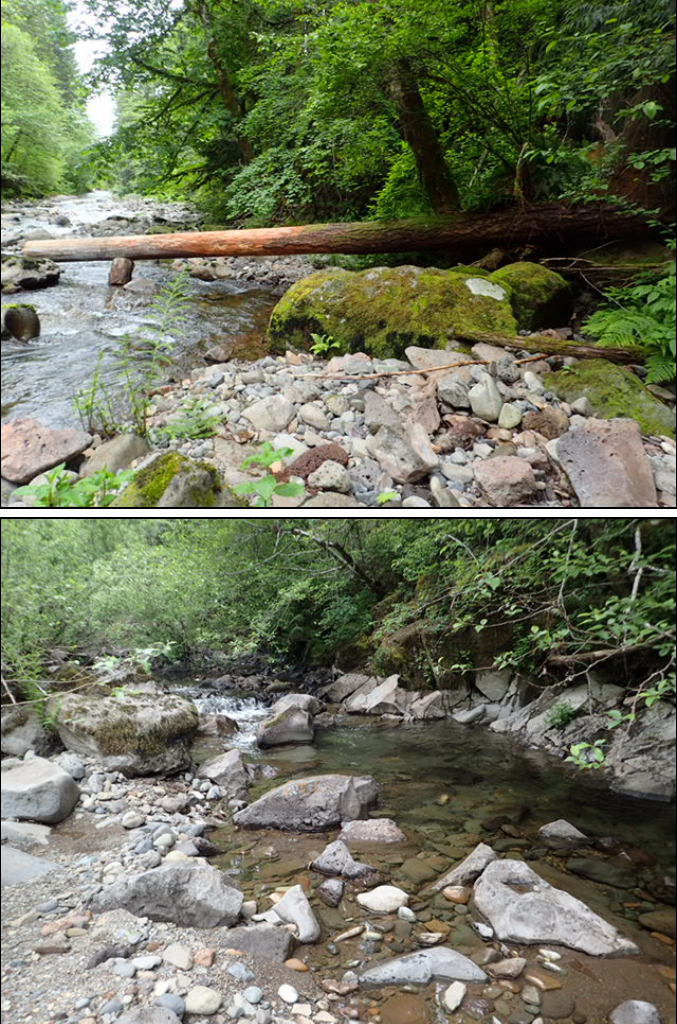
Reach	Project Name	Project Code	Project Description	Considerations	Photo
<p>Trout Creek</p>	<p>Summer's End</p>	<p>T2</p>	<p>This is the most complex area in this reach downstream of Hemlock Bridge. Conditions include a 150ft+ side-channel (left bank), a vegetating cobble bar, a steep south bank with existing mature conifers, and a couple of large logs currently on the south stream bank, plus a small row of alders near these logs. Add one or more engineered log jams in/across the north bank side channel or keyed into the alder screen and existing LWD on south bank. Maybe additional opportunities for log jams downstream.</p>	<p>Private lands and potentially challenging access. Potential access via Summer Road. Top photo shows north bank and existing log and main channel. Bottom photo shows portion of side channel, looking upstream.</p>

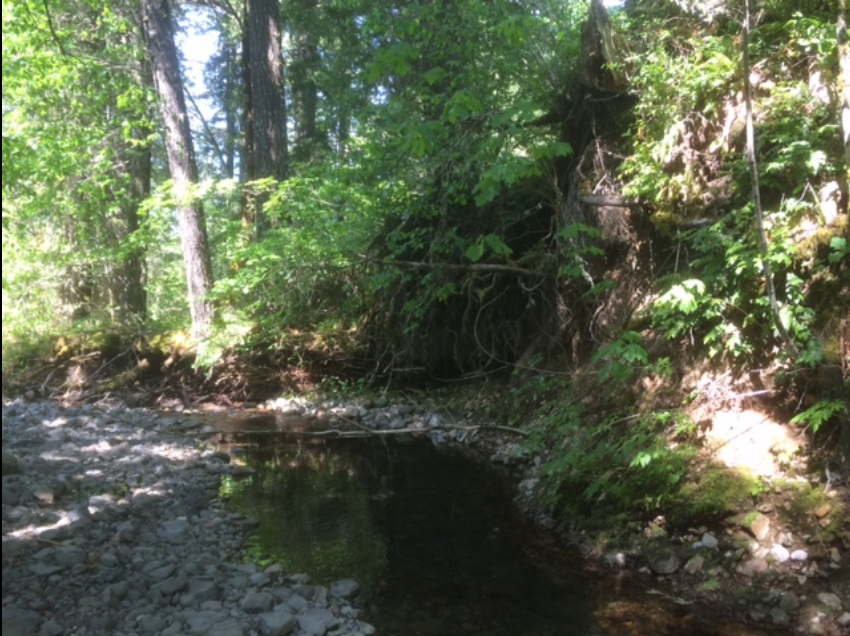
Reach	Project Name	Project Code	Project Description	Considerations	Photo
<p>Martha Creek</p>	<p>Martha</p>	<p>M1</p>	<p>Upstream portion is young riparian forest and downstream portion is older forest. Add wood and jams to scour pools, capture gravels, activate floodplain, and create side-channel habitat. In middle and downstream areas, consider felling trees into channel from the occasional high banks. Place jams strategically to cause erosion to recruit large riparian conifers.</p>	<p>Federal and county property. Good access via nursery property. Seasonal subsurface flow conditions, and impact on fish, should be considered.</p>

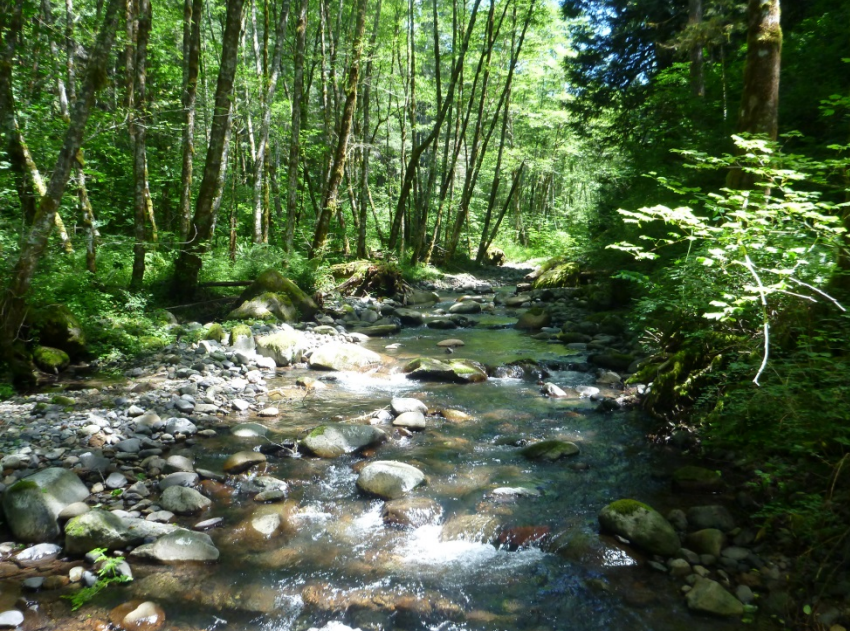
<p>Little Wind 1</p>	<p>Pipeline</p>	<p>L1</p>	<p>Confined valley with narrow alternating floodplain surfaces. Much of it is boulder/cobble plane-bed channel. Low large wood and young alder dominated riparian zone. Add large wood and small log jams, including excavation of scour pools. Similar to past work performed in downstream reach by UCD. This is essentially a continuation of that effort. Wood placements will add direct habitat, maintain scour pools, and help to activate floodplain surfaces and side-channels. Good opportunity for channel spanning jams to activate floodplains and create forced pool-riffle morphology. Could fell fir trees from nearby hillslopes and maneuver into channel.</p>	<p>USFS (Scenic Area) property. The river-right road is too high for access, but can move machinery up-valley by crossing back and forth and tracking up alternating floodplain surfaces. Felling and maneuvering into stream nearby firs using grip hoist may also be an option.</p>

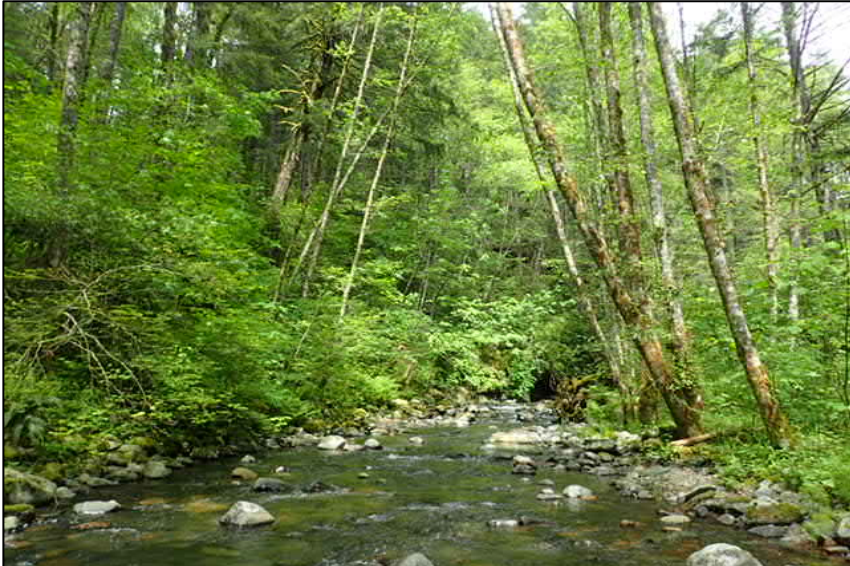
Reach	Project Name	Project Code	Project Description	Considerations	Photo
Little Wind 1	Berge Confluence	L2	Similar conditions as L1. A few long riffles with no habitat complexity. There is more wood through here than in L1, but several stretches are plane-bed with no wood. Selectively fell large firs from nearby hillslopes and maneuver into stream to help build jams to create scour pools, increase complexity, collect gravels, and activate the small floodplain surfaces and short side-channels. There also may be some downed wood (including spanners) that could be maneuvered into the channel.	Machinery access challenging. Likely accomplished using hand crews with grip hoists pulling down firs on hillslopes. Helicopter placement may also be an option.

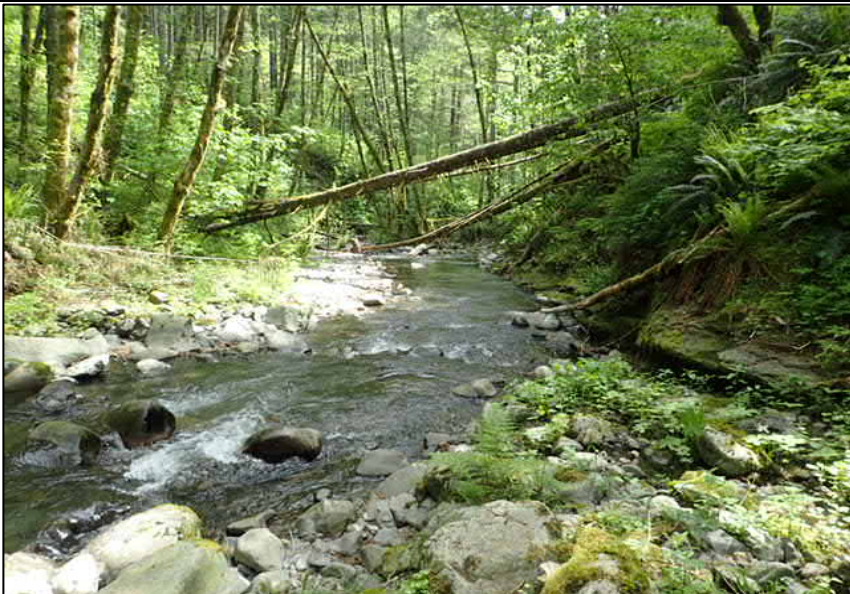
Little Wind 1	Dillon	L3	Similar conditions as L1 and L2. Reach contains some eroding banks with recruited wood spanning the channel. There is a bedrock channel at upstream end. Use grip hoist to maneuver existing downed wood into channel and to fell hillslope firs and place in channel. Good location for helicopter placement as well. At downstream end river-left, there appears to be a small push-up levee, but origin is unclear. Remove if possible or use jams to direct flow into levee to erode levee and activate the left bank low surface.	Machinery access likely not possible. Good location for helicopter placement of wood and/or using hand crews with grip hoists pulling down firs on hillslopes.

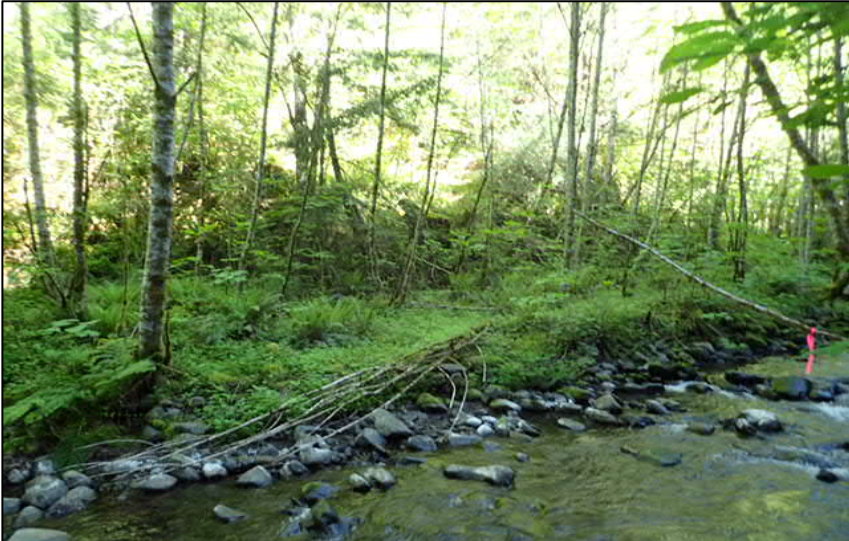
Reach	Project Name	Project Code	Project Description	Considerations	Photo
Little Wind 1	Powerline	L4	This is above a downstream more confined reach with landslides, more abundant large wood, and boulder-bedrock channel. Beginning here, and continuing upstream, is a lower gradient channel with occasional broad floodplains. But the channel has incised into this floodplain in many areas and there are many plane-bed sections and low large wood numbers. The riparian and floodplain is primarily young alders. Place large wood and log jams to activate and reconnect the floodplain, reconnect side-channels, create complexity, trap gravels, force pool-riffle channels, and maintain scour pools.	USFS (Scenic Area) lands. Can obtain machinery access via an old logging road.

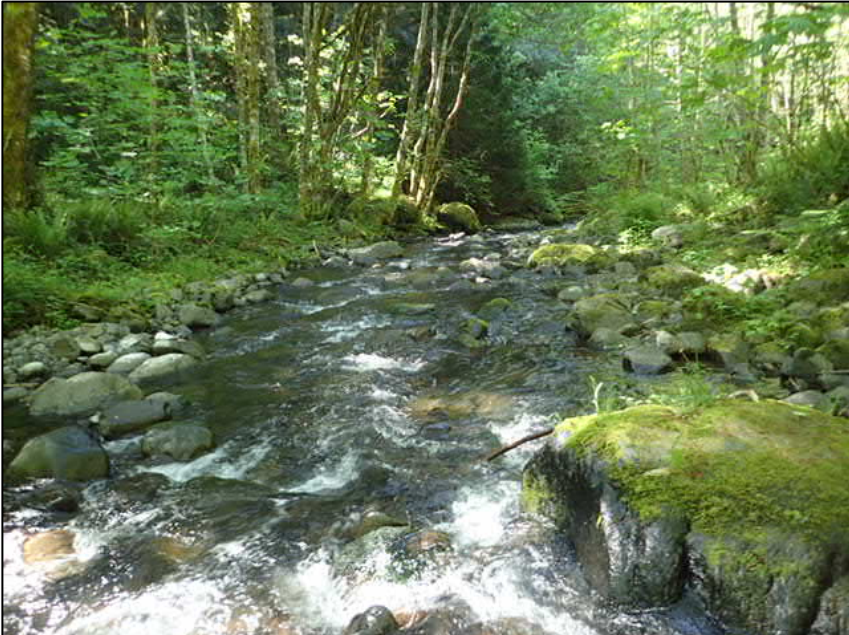
Little Wind 1	Lower Headwater Flats	L5	Similar conditions and opportunities as L4. Long relic side-channels that are relatively disconnected due to channel incision. Channel contains long plane-bed riffles. There are large stumps and logging debris (cables) on site. Place large wood and log jams to activate and reconnect the floodplain, reconnect side-channels, create complexity, trap gravels, force pool-riffle channels, and maintain scour pools. Plant cedar to jumpstart succession under alder canopy; focus on planting along wide benches along stream.	USFS (Scenic Area) lands. Can obtain machinery access via an old logging road.

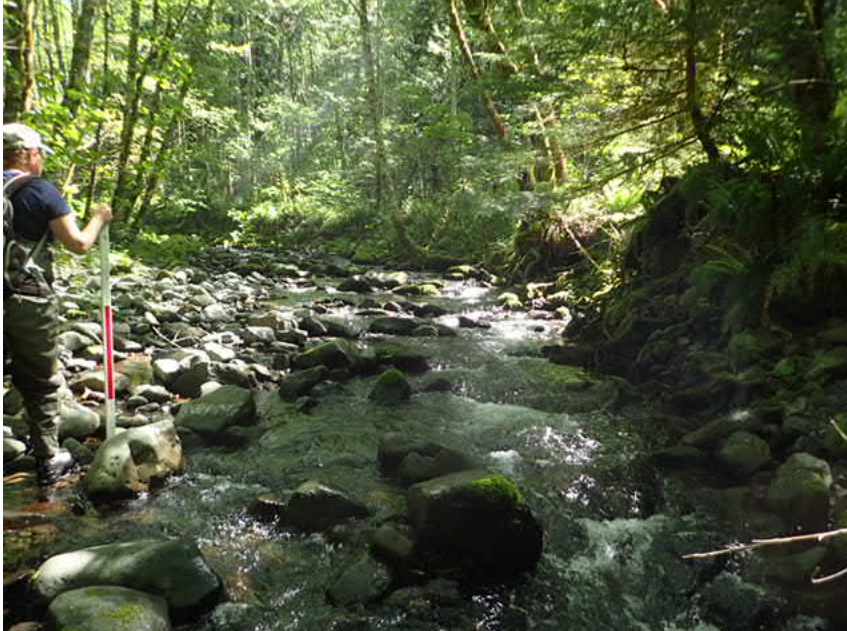
Reach	Project Name	Project Code	Project Description	Considerations	Photo
<p>Little Wind 1</p>	<p>Middle Headwater Flats</p>	<p>L6</p>	<p>Similar conditions to L4 and L5. Wide floodplain benches but stream appears incised and somewhat disconnected. Add jams to activate floodplains and side-channels and to enhance channel complexity. Consider shifting main channel into more complex and sinuous alignment in floodplain. Depending on access conditions, either use helicopter, local felling of trees, or machinery.</p>	<p>USFS (Scenic Area) lands. Potential machinery access via old logging road, or from downstream access point. Otherwise, use hand crews with grip hoists or helicopter placements.</p>

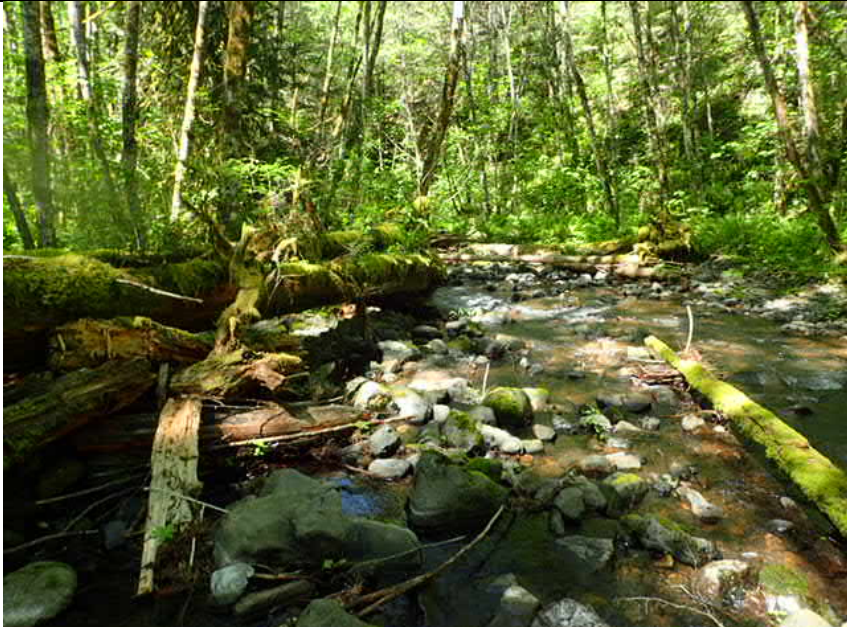
<p>Little Wind 1</p>	<p>Upper Headwater Flats</p>	<p>L7</p>	<p>Similar conditions to L4, L5, and L6. Wide floodplain benches but stream appears incised and somewhat disconnected. Add jams to activate floodplains and side-channels and to enhance channel complexity. There are some areas already exhibiting complexity that would be improved by additional wood. Depending on access conditions, either use helicopter, local felling of trees, or machinery.</p>	<p>USFS (Scenic Area) lands. Potential machinery access via old logging road, or from downstream access point. Otherwise, use hand crews with grip hoists or helicopter placements.</p> <p>Upstream of this site is more confined with more abundant large wood contributed from steep hillslopes.</p>
