Geomorphology and Hydrology Assessment
for
Curtin Creek

Department of Public Works
Clean Water Program
1300 Franklin Street
Vancouver, WA 98666

July 18, 2008

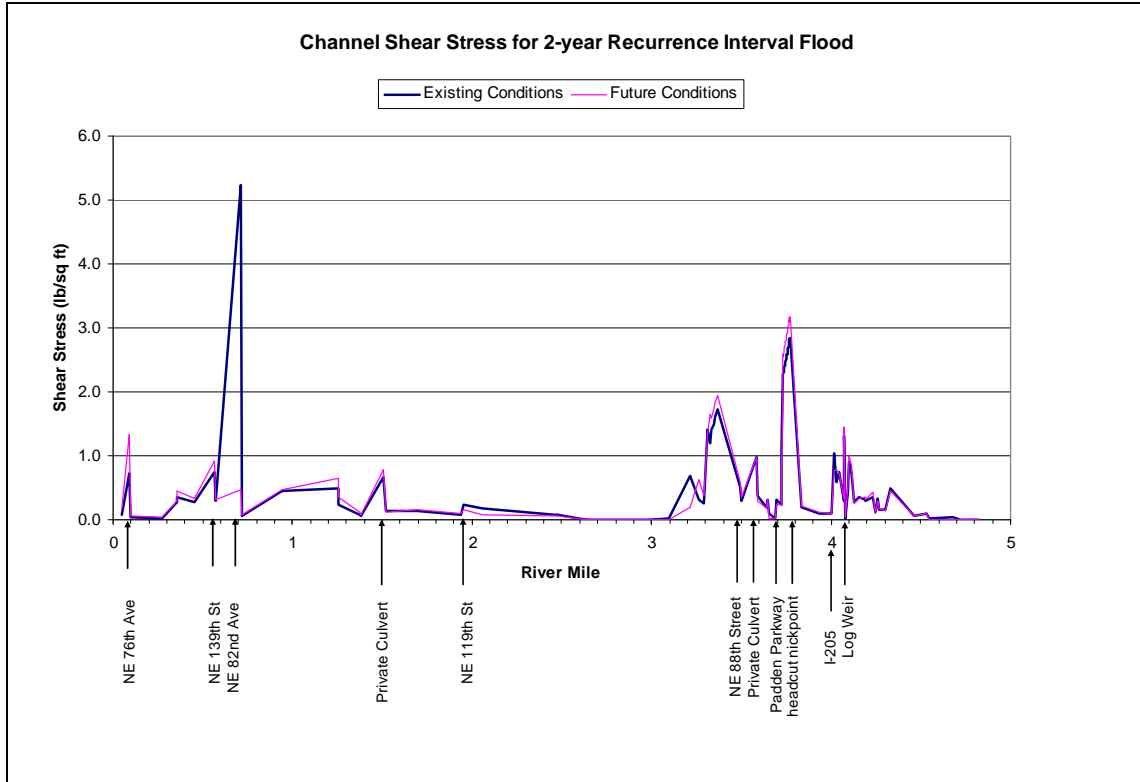
Figure 9 shows a channel shear stress profile of Curtin Creek developed from the existing HEC-RAS hydraulic model (WEST, 2005). The RAS model was modified to include future conditions flows for Curtin Creek based on an available HSPF hydrologic model (MGS, 2002). As seen in the figure, the channel shear stress for the 2-year recurrence interval flood is significantly reduced upstream of and significantly increased downstream of various road crossings, most notably NE 76th Ave and NE 82nd Ave. No significant erosion issues were observed downstream of NE 82nd Ave. Minor scour of the channel and sloughing of the bank downstream of the NE 76th Ave culvert was observed. Also seen in the figure is a significant spike in the shear stress upstream of Padden Parkway where a nickpoint is located. At this location an approximately 6 to 8 foot high waterfall was observed (see Figure 10).

Channel shear stress is also seen to spike just downstream of NE 88th Street. At this location, Curtin Creek descends a moderately steep slope before entering a broad and nearly flat valley bottom located approximately at River Mile (RM) 3.2. As seen in Figure 9, except for immediately downstream of NE 82nd Ave, the future conditions 2-year flow is not expected to significantly alter the magnitude of channel shear stress. Downstream of NE 82nd Ave, channel shear stress is significantly reduced for future conditions flows. Although the magnitude of the 2-year flow for future conditions is greater than for existing conditions, the higher discharge results in greater backwater from the bridge located downstream at NE 139th. The increased backwater elevation reduces channel velocities and shear stress at NE 82nd Ave.

Figure 9. Channel shear stress profile for 2-year flood along Curtin Creek (WEST, 2005).

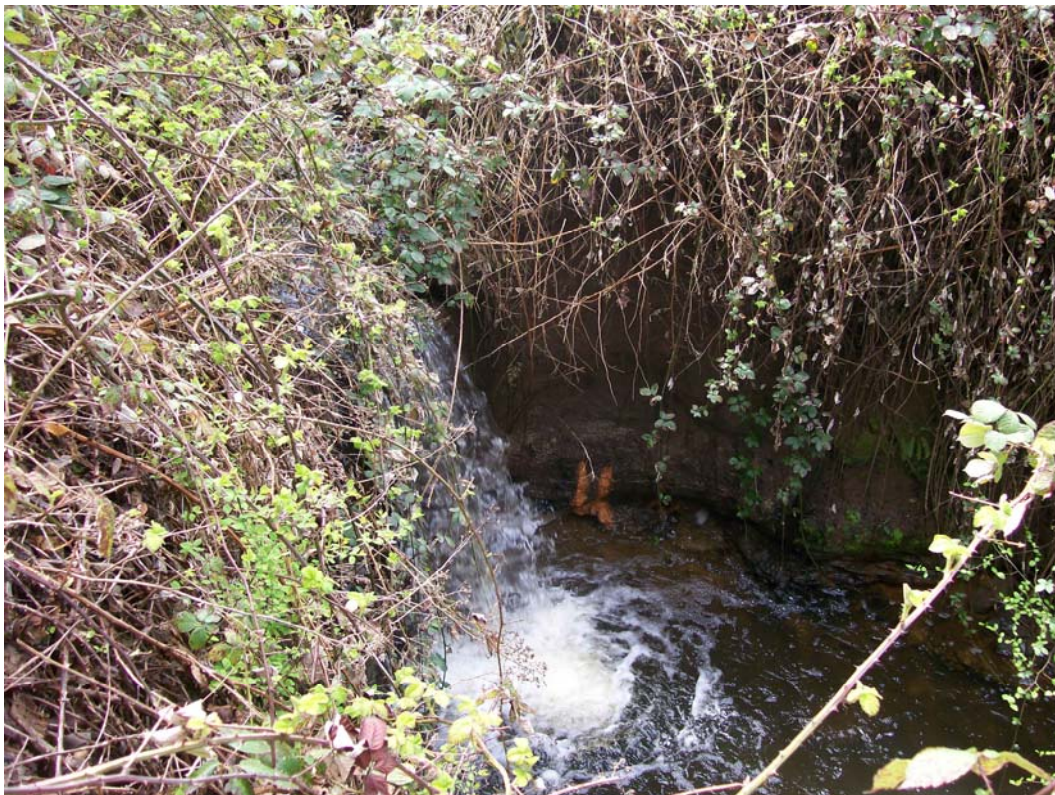
Figure 10. Waterfall at headcut nickpoint locate approximately 100 feet upstream of Padden Parkway.

- Culverts and bridges are altering sediment transport conditions and locally prevent channel migration. Culvert crossings at NE 76th Ave, Padden Parkway and the east parking lot entrance to Crossroads Church were seen to have channel degradation and/or local scour occurring downstream. Unless mitigated, future increases in peak flows and/or flow durations will exacerbate existing scour conditions at these locations.

It should be noted that a significant headcut nickpoint is located on Curtin Creek approximately 100 feet upstream of Padden Parkway. The nickpoint forms an approximately 6 to 8 foot high waterfall. Erosion resistant bedrock layers appear to be controlling the upstream migration rate of the headcut. These erosion resistant bedrock layers may be part of the Cataclysmic Flood Deposits or could possibly be part of the same formation of very coarse hyaloclastite which was observed further upstream as described in Section 3.1.1. Further investigation would be required to determine the long-term stability of the headcut.

- Install energy dissipation devices downstream of culverts where scour has degraded the downstream channel. Culvert crossings at NE 76th Ave, Padden Parkway and the east parking lot entrance to Crossroads Church are exhibiting these conditions.

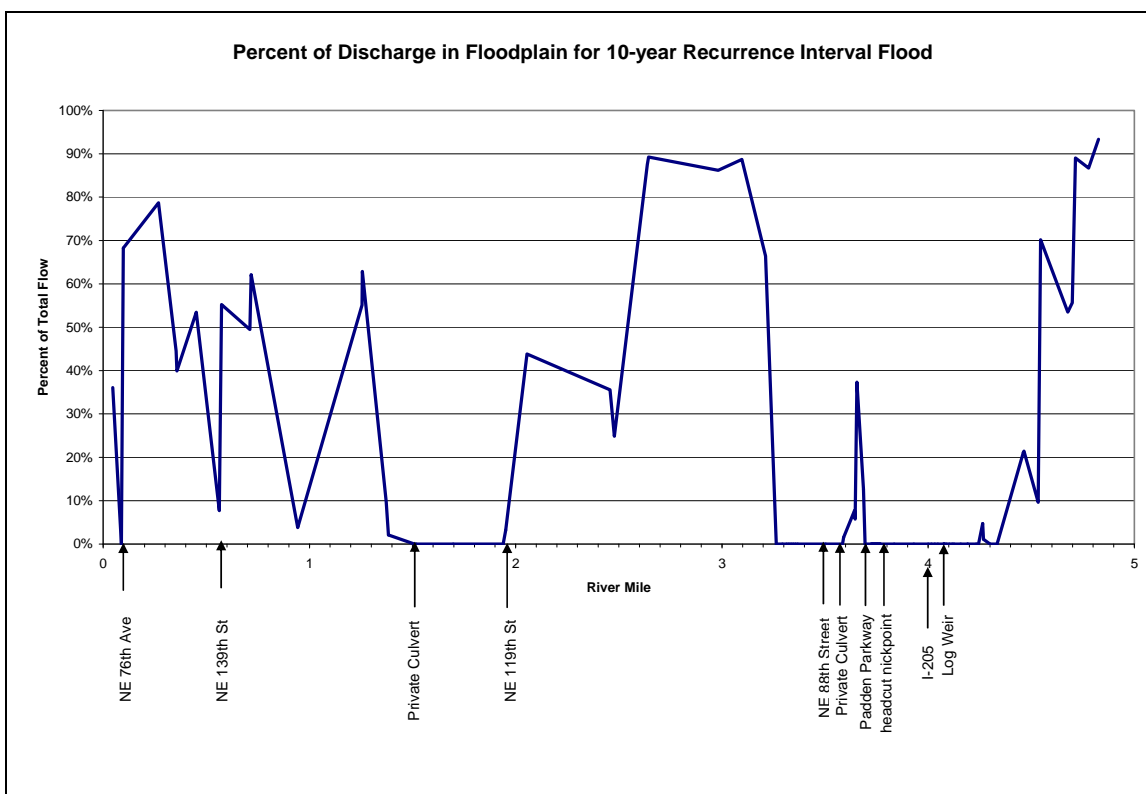
As seen in Figure 11, the relative percentage of the total 10-year peak flood discharge conveyed in the floodplain is influenced by several existing road crossings. Backwater conditions upstream from the road culverts result in a greater portion of the total discharge being conveyed within the floodplain. Downstream of the culverts, the discharge is mostly confined to the channel. It should also be noted that the stream reaches with the greatest percentage of flow in the floodplain shown in Figure 11 are seen in Figure 9 to have the lowest values of shear stress while the more confined reaches which have little or not flow in the floodplain have larger values of shear stress.

Figure 11. Percentage of total existing conditions 10-year peak discharge conveyed in the Curtin Creek floodplain (WEST, 2005)

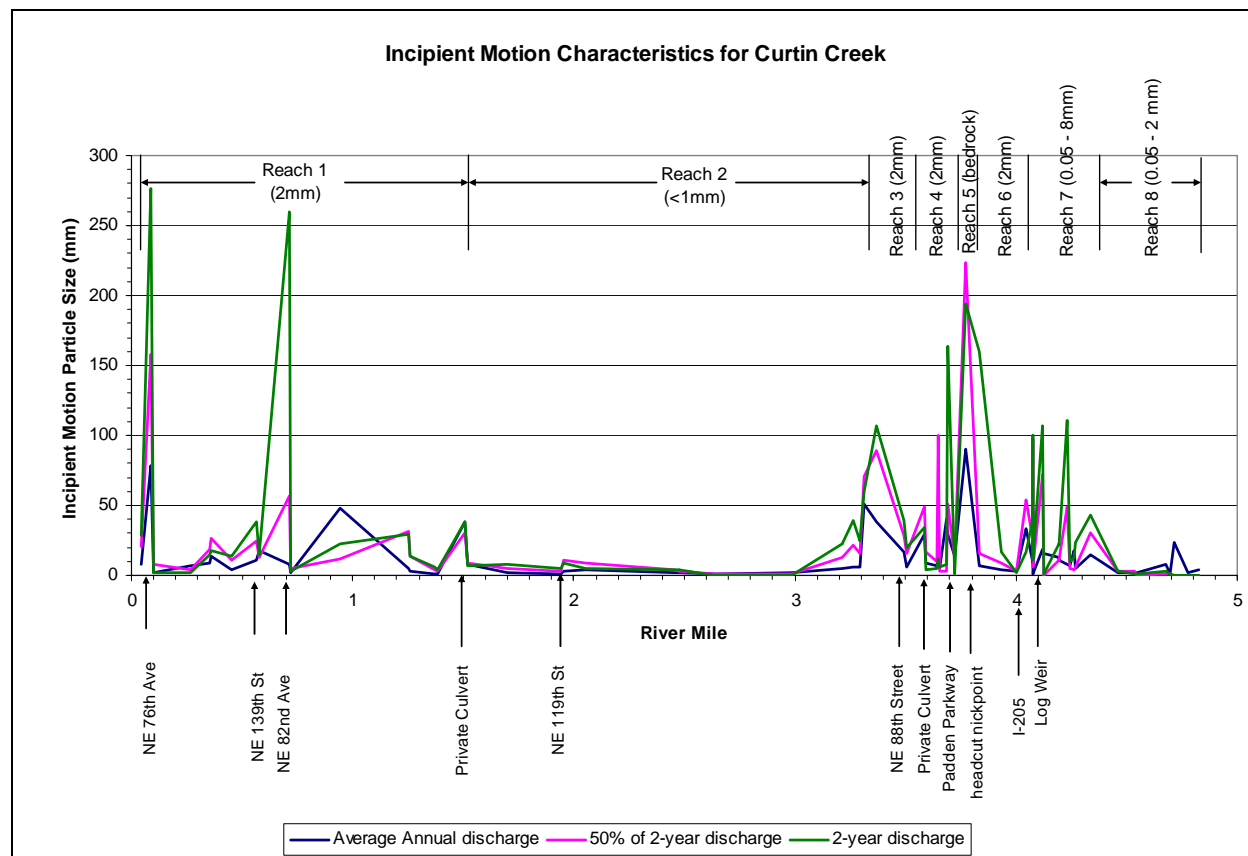
Incipient motion characteristics for Curtin Creek were developed from hydraulic model output (WEST, 2005). The results were compared to the bed material sediment size characteristics observed during the field reconnaissance. Bed material sizes ranged from silt and clay to sand (<2mm). Fine gravel sized material (<8mm) was observed at a few locations, usually immediately downstream of culverts, but was not prevalent in the system. Observed sediment sizes for each reach are shown in Figure 20. The average annual discharge, 50% of the 2-year discharge, and the 2-year discharge were used to calculate the incipient motion sediment sizes along Curtin Creek using Shield's diagram (Vanoni, 1975). As seen in Figure 20, Reach 1 and Reaches 3 through 8 have incipient motion particle sizes that are much greater than the bed material observed in Curtin Creek. At these locations Curtin Creek has the ability to transport the available material for most flow conditions. In Reaches 6 through 8, resistance to sediment movement is provided by grassy vegetation that lines much of the channel bed and banks. In Reaches 3 through 5, resistance to sediment movement is provided intermittently by resistant layers of bedrock. However, these reaches are experiencing both headcutting and channel incision. Reach 2 has incipient motion particle sizes that are nearly the same as the size material that is found in the bed. The ability of Curtin Creek to transport sediment through Reach 2 is much lower than for Reach 1 and Reaches 3 through 8. It should also be noted that the incipient motion particle size increases significantly downstream of several road crossings. These locations are susceptible to scour during high flow events.

Figure 20. Incipient motion particle size characteristics for Curtin Creek.
