# *2009 Stormwater Needs Assessment*

**Woodin Creek  
Salmon Creek (r.m. 08.96)**

Woodin Creek/Salmon Creek (RM 08.96)  
Subwatershed Needs Assessment Report

Clark County Public Works Clean Water Program

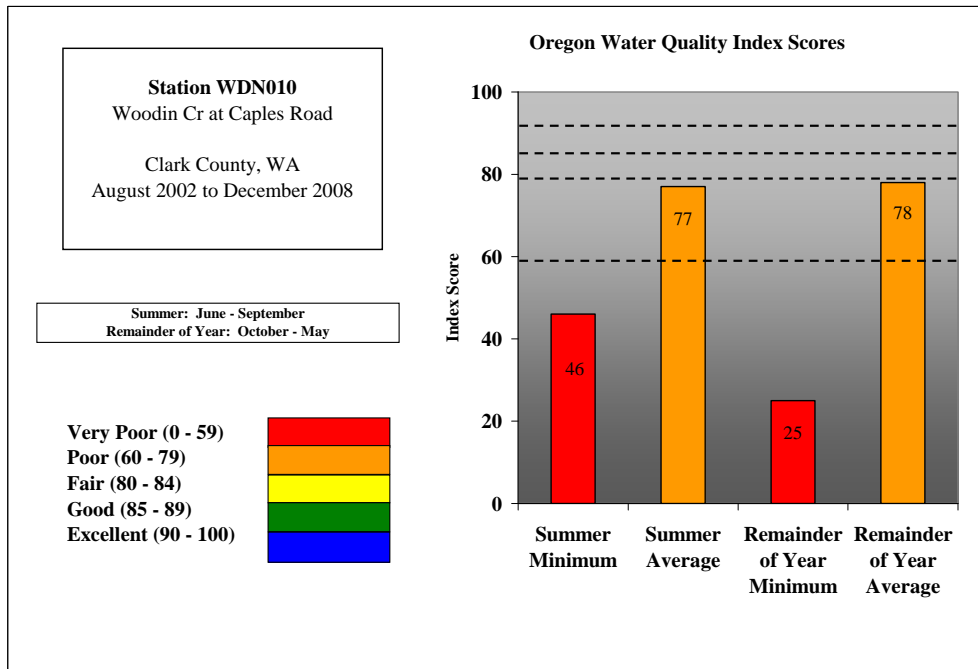
- WDN010: monthly OWQI values ranged from Very Poor to Good, and tended toward the middle of this range, as 58 of 74 months had OWQI values in the poor or fair category. Monthly sub-index scores for total solids were typically poor, and inorganic nitrogen ranged widely. Scores for total phosphorus and fecal coliform also ranged widely, with many scores in the poor to fair range. Scores for water temperature, dissolved oxygen, and pH were excellent with occasional lower scores.

Figure 5: Average Water Quality, Woodin Creek station WDN010, 2002-2008, Oregon Water Quality Index

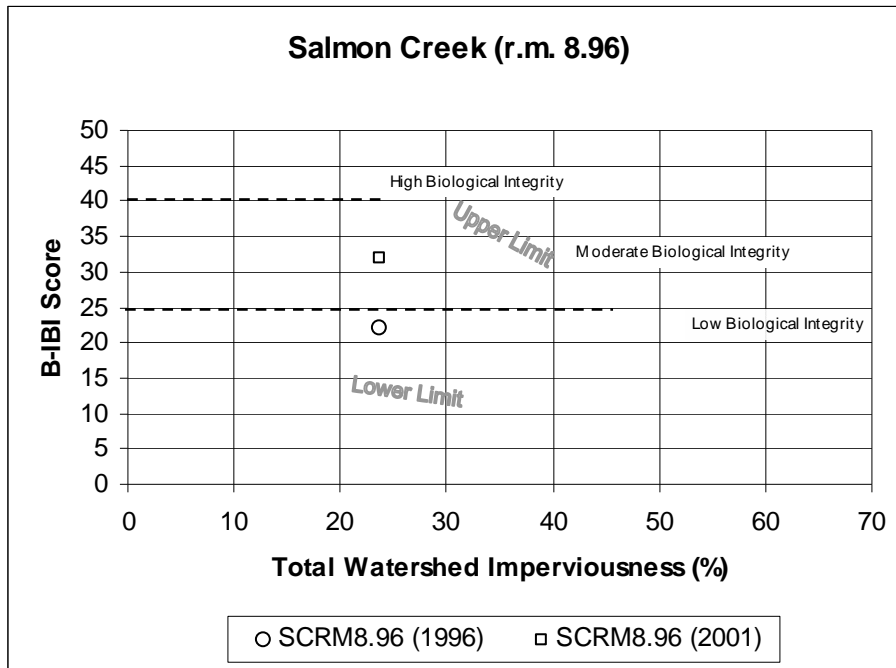
Figure 21 shows that Salmon Creek RM 8.96 B-IBI scores are mostly in the middle third of the expected range for watersheds with about 24 percent impervious area (estimated 2000 Total Impervious Area from Wierenga, 2005). Since these BIBI scores fall close to the middle of the typical range, there is some room for improvement of biological integrity. An opportunity exists to increase the level of biological integrity by improving habitat and stream conditions.

**Figure 21: Approximate range of B-IBI in Puget Lowland watersheds, showing progressive decline with increasing imperviousness in the upstream watershed. Adapted from Booth et. al., 2004. Markers indicate Total B-IBI scores at station within the SCRM8.96 subwatershed for 1996 and 2001 versus estimated 2000 subwatersheds impervious TIA.**
