# 2008 Stormwater Needs Assessment Program

## Lower Burnt Bridge Creek Subwatershed Needs Assessment Report

Clark County Public Works Clean Water Program

April 2009

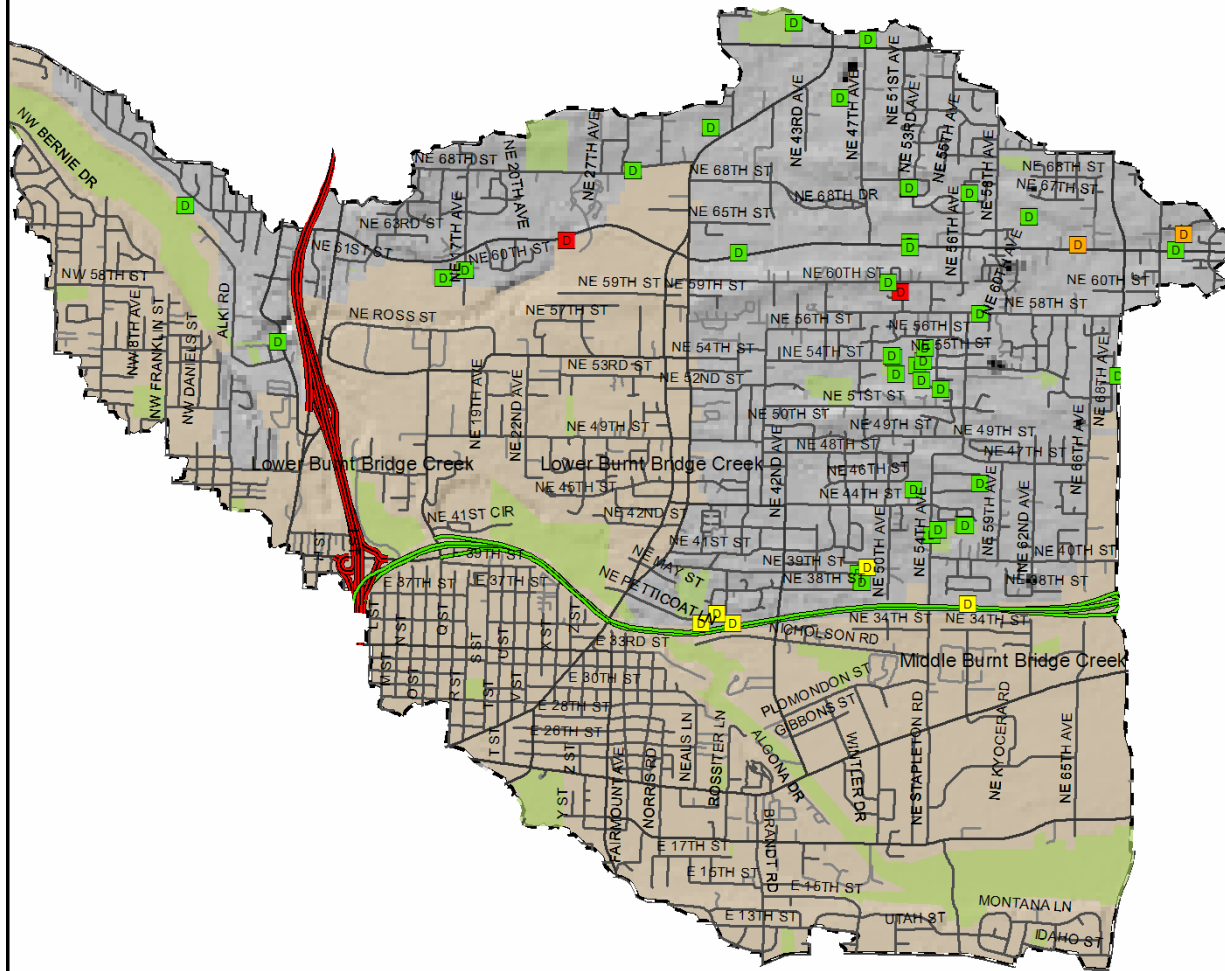
## 2008 Lower Burnt Bridge Creek Screening Activities

As summarized in Table 10, 45 outfalls were screened and samples were collected at seven outfalls. Two mapped outfalls were either not accessible or were mapped incorrectly. Two follow-up investigations were initiated based on laboratory results, and were conducted for two locations. In one investigation, the source area could not be adequately pinpointed, as sequential visits were dry. The other investigation confirmed the presence of an illicit discharge containing fecal coliform and was referred to County Code Enforcement.

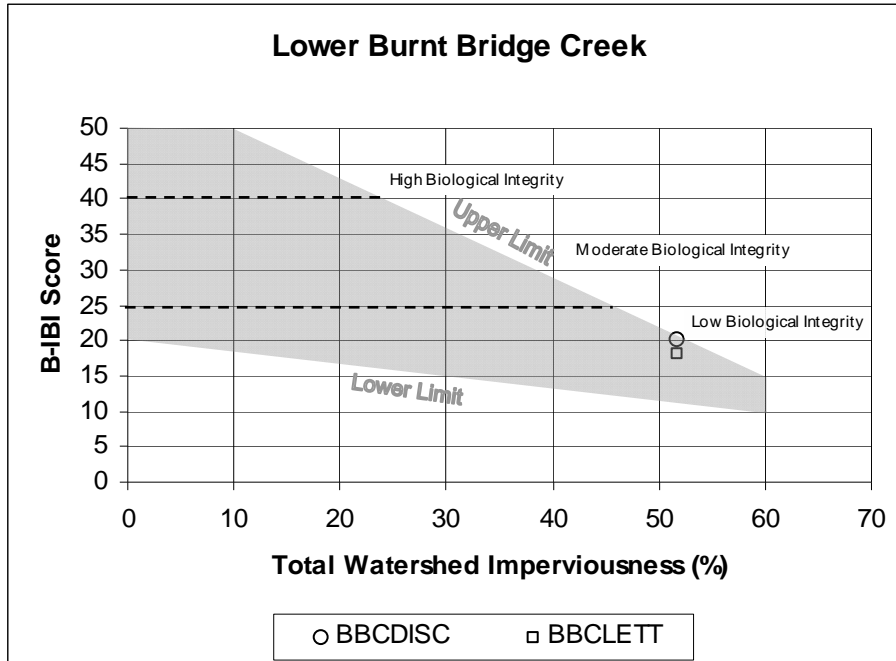
Figure 7: Approximate range of B-IBI in Puget Lowland watersheds, showing progressive decline with increasing imperviousness in the upstream watershed. Adapted from Booth et al., 2004. Markers indicate Total B-IBI scores at BBCDISC and BBCLETT for particular years, versus estimated 2000 subwatershed TIA.

Both of Lower Burnt Bridge Creek's B-IBI scores are at the higher end of those typically expected for sites with 52 percent total watershed impervious area (TIA). These conditions imply a limited ability to increase scores above the low range of biological integrity. Therefore management strategies should focus on stewardship to prevent further harm to such degraded streams.

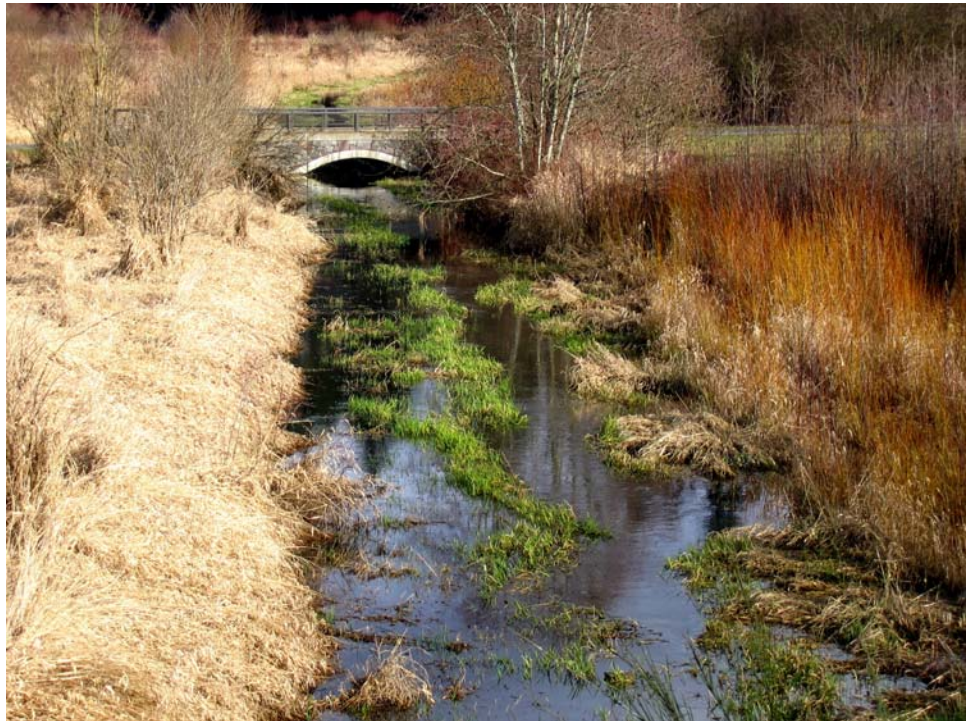
Burnt Bridge Creek – Looking Upstream from Andresen

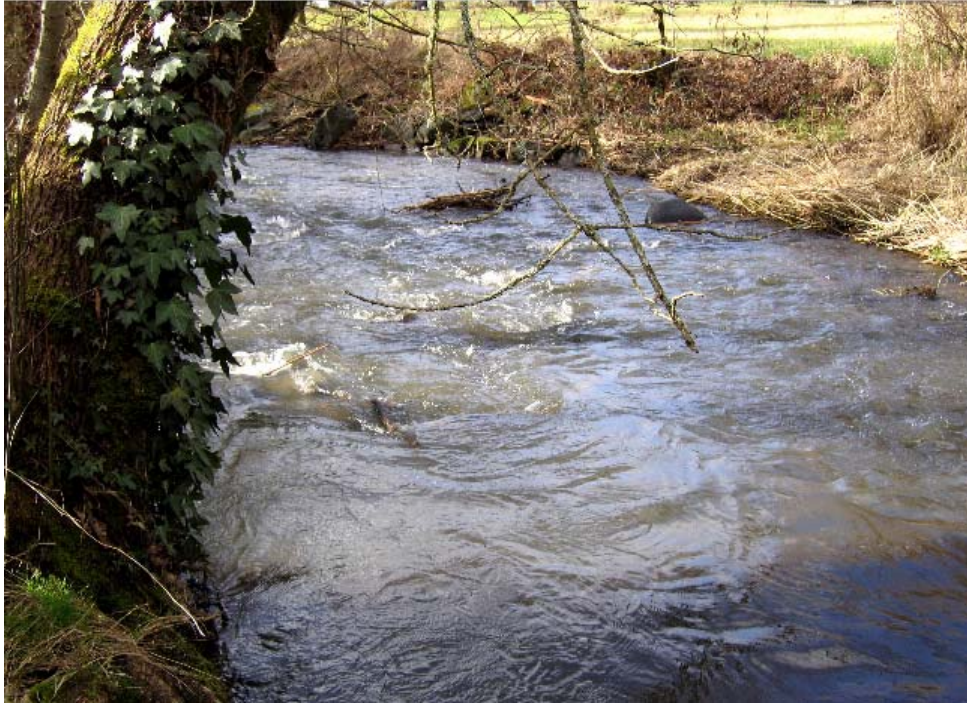
Burnt Bridge Creek – Looking downstream from NE Hazel Dell Avenue

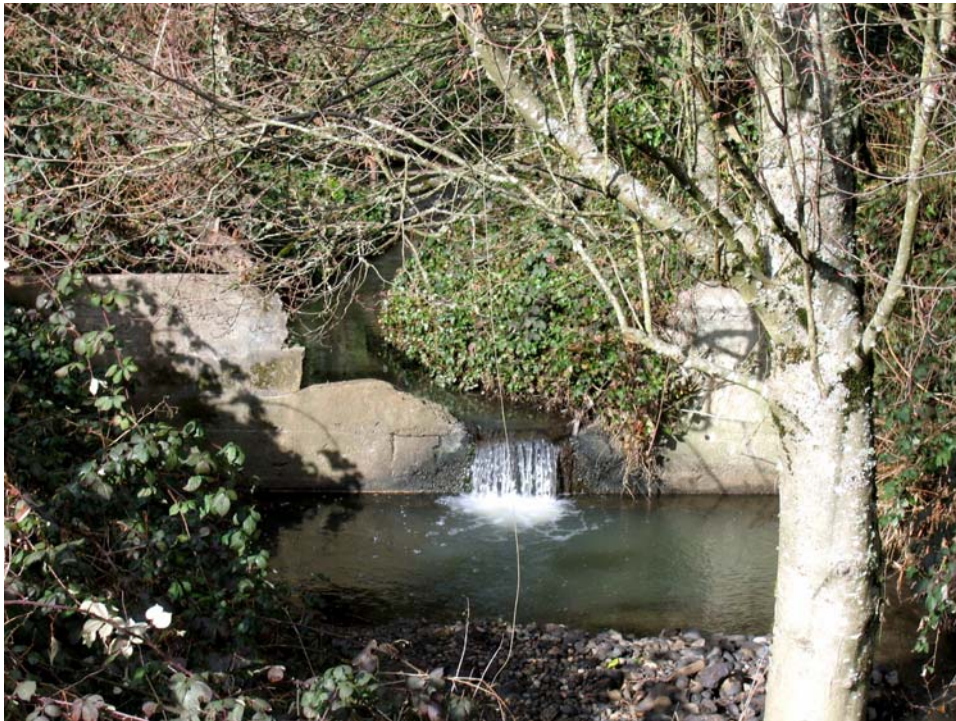
Cold Creek – Immediately upstream of Confluence with Burnt Bridge Creek
