2009 Stormwater Needs Assessment

Lakeshore
Salmon Creek (r.m. 00.60)

Lakeshore/Salmon Creek (RM 00.60)
Subwatershed Needs Assessment Report

March 2010

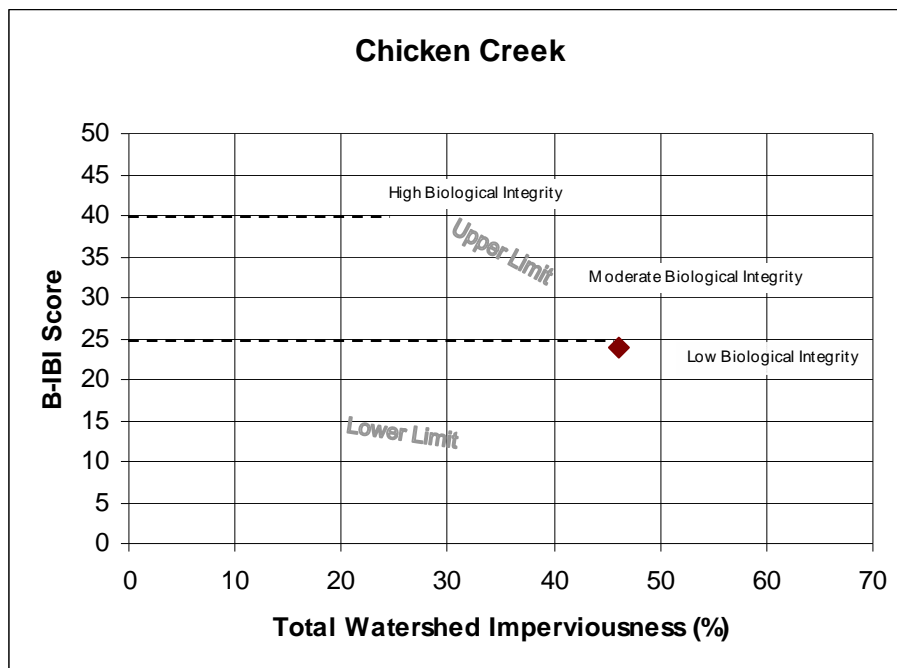
Figure 22 shows the 2008 CHK010 B-IBI score is at the upper limit of the range of expected scores (estimated 2000 Total Impervious Area from Wierenga, 2005).

Given Chicken Creek's B-IBI score falls at the upper limit of those typically found for subwatersheds with impervious areas of about 45 percent, it is unlikely that habitat rehabilitation would result in significant improvement in biological integrity. Management strategies that limit further degradation and promote stewardship are important to at least maintain its biological integrity at near-moderate levels.
