2006 Stormwater Needs Assessment Program

Whipple Creek (Upper)/Whipple Creek (Lower)
Subwatershed Needs Assessment Report

Clark County Public Works Clean Water Program

2006

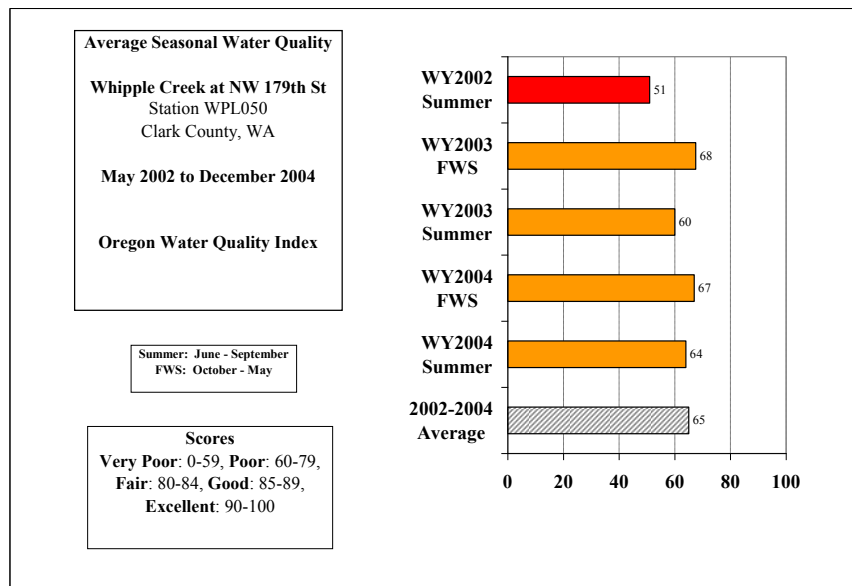
OWQI scores since 2002 rank consistently in the poor category. Individual sub-index scores for total solids, nitrogen, and total phosphorus were consistently poor, while scores for fecal coliform ranged from very poor to excellent and showed wide seasonal variations. Sub-index scores for temperature, dissolved oxygen, and pH were consistently good to excellent.

Figure 2. Average seasonal water quality, Whipple Creek station WPL050. Oregon Water Quality Index.

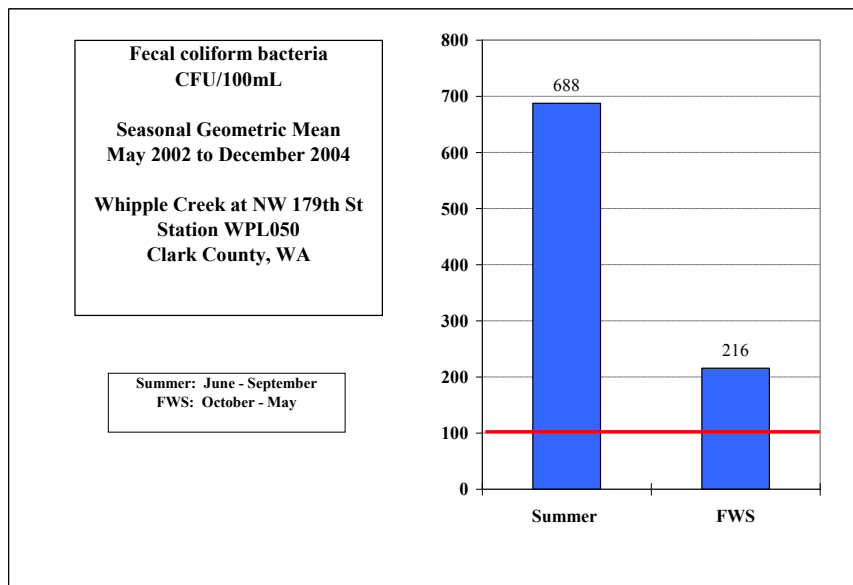
September) geometric mean at station WPL050 was 688 cfu/100mL. Based on 20 sampling events, the FWS (October – May) geometric mean was 216 cfu/100mL. Geometric mean values for both seasons exceed the state criterion of 100 cfu/100mL. One hundred percent of summer samples also exceeded the single-sample criterion of 200cfu/100mL, while 60 percent of FWS samples exceeded this criterion. Individual samples ranged from 30 cfu/100mL to 1600cfu/100mL.

Figure 3. Seasonal geometric mean fecal coliform, Whipple Creek station WPL050, May 2002 through December 2004

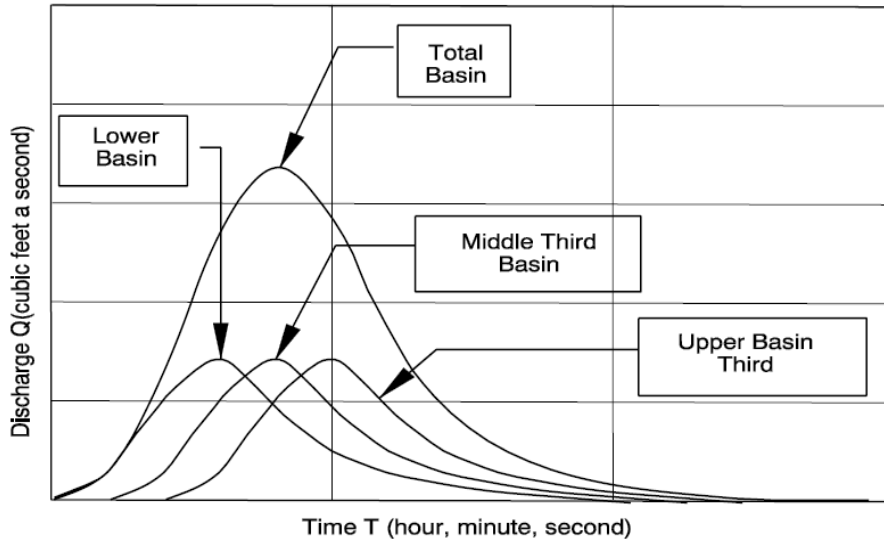
Figure 16. Hypothetical runoff hydrographs for an undeveloped basin. Reprinted from Oregon Department of Transportation (2005).

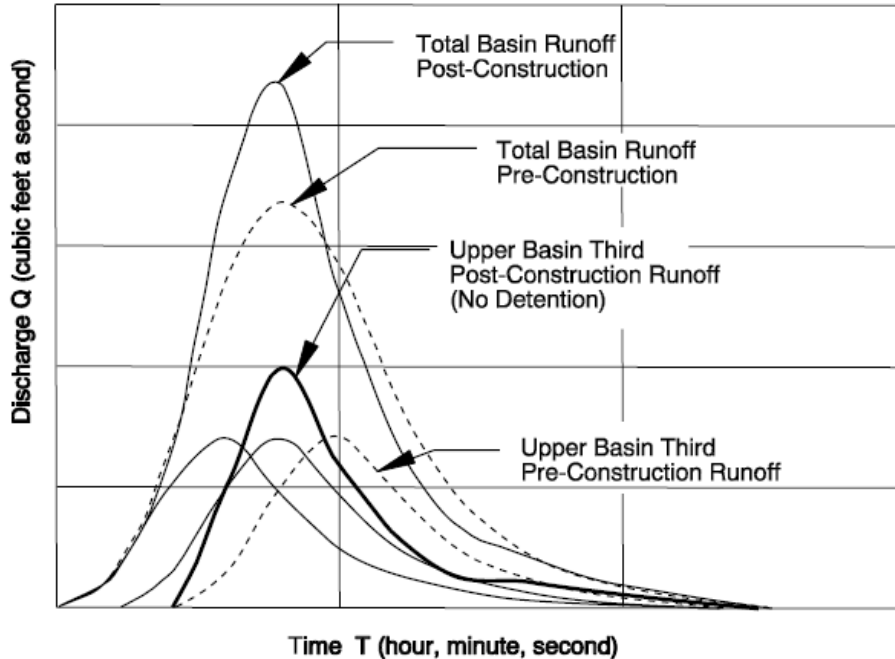
Figure 17. Hypothetical runoff hydrographs for a basin with development in the upper third of the basin. Reprinted from Oregon Department of Transportation (2005).

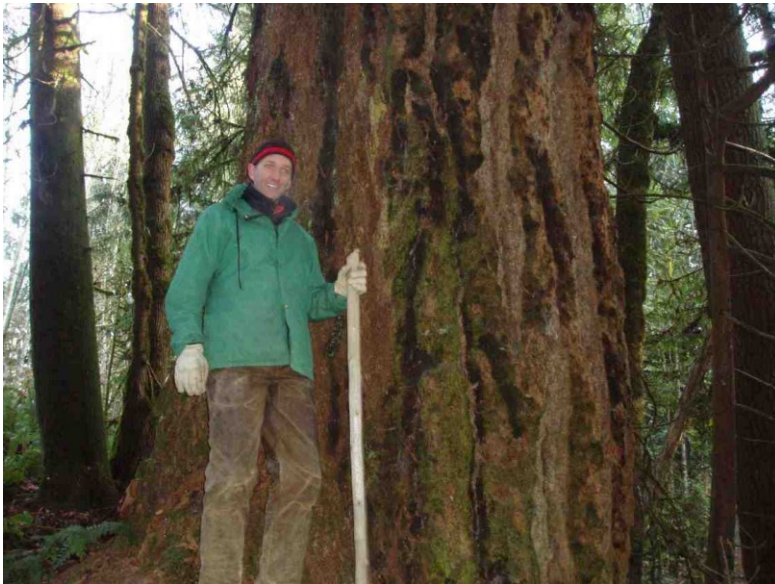
Figure 22. Old-growth fir snag in riparian area of Trib W8.36.

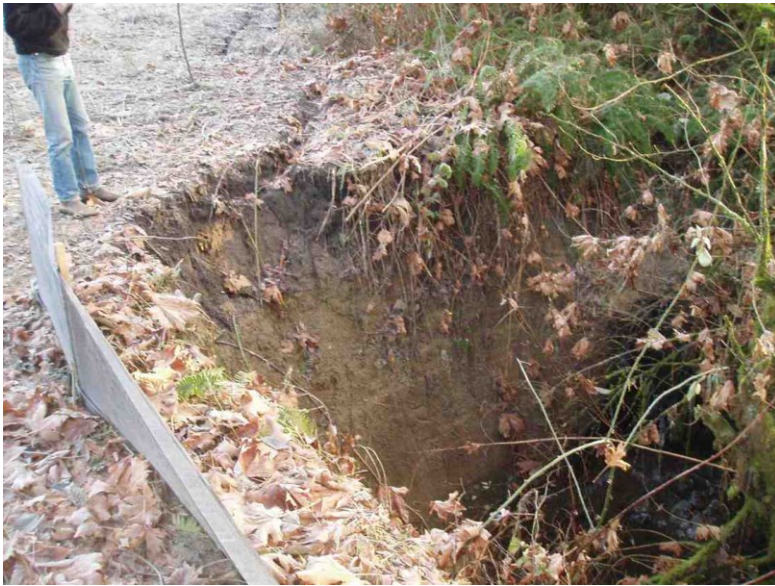
Some of the most severe erosion has occurred near the outlets of stormwater detention facilities or other stormwater outfall locations, where large (up to 15 ft) headcuts have formed in small channels or on valley hillslopes leading to channels. These features are the result of improperly designed or maintained facilities that have failed to control for the effects of flow concentration at discharge locations. Example locations include detention facilities at the fairgrounds site (trib W6.44, Figure 24), Whipple Creek Place (trib W6.26), on trib W5.70 T0.49S, and on trib W8.36 (see Figure 25); and outfalls at the school property (trib W5.70) and on trib P1.06 T0.49W.

Figure 24. Photo of headcut just downstream of outlet of stormwater detention facility at headwaters of Trib W6.44 (Clark County Fairgrounds site). Approximate height of headcut is 12 feet.

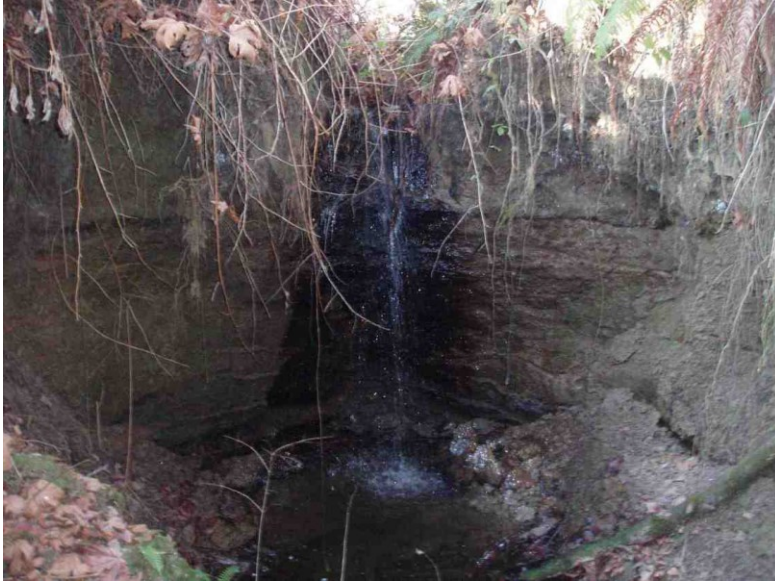
Figure 25. Photo of headcut just downstream of outlet of stormwater detention facility at headwaters of Trib W8.36. Approximate height of headcut is 6 feet.

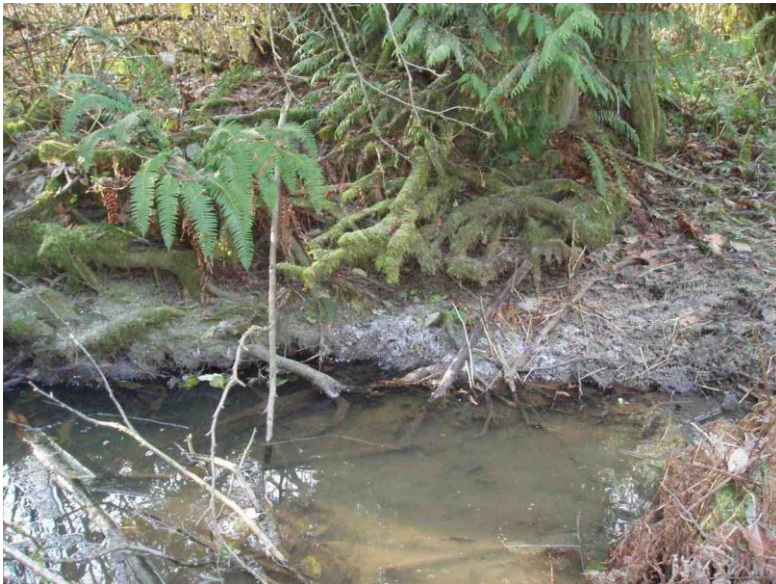
Figure 26. Photo of exposed root mass of Western Red Cedar (covered in moss) adjacent to Whipple Creek upstream of Union Road. Exposure of root mass suggests channel expansion (deepening) has occurred in this area.

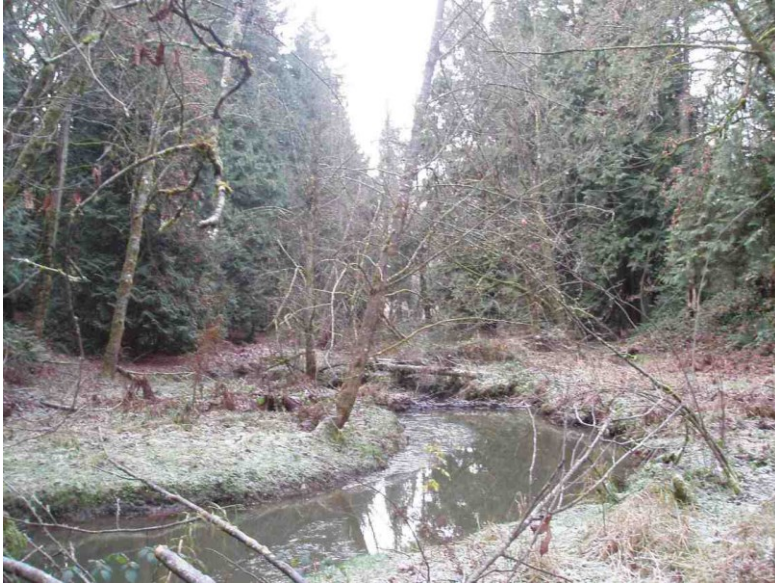
Figure 27. Characteristic middle mainstem reach at approximately RM 7.2.

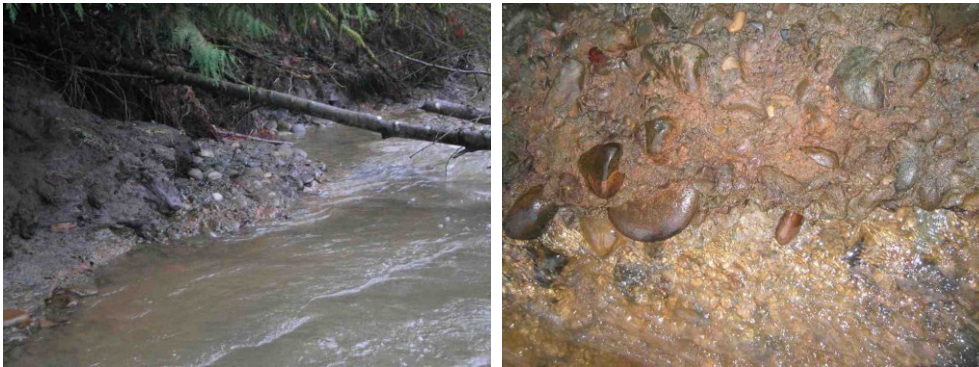
This reach contains a significant quantity of coarse bed material in the form of gravels and cobbles up to 12cm median diameter. Coarse material is sourced from the underlying Troutdale Formation, which can be seen in channel banks as coarse gravels and cobbles in a sandy matrix (see Figure 28). The gradient and flow volume through this reach is sufficient to mobilize this sediment, maintaining good sorting and cleaning of the substrate. Consequently, this reach contains the greatest quality salmonid habitat in the basin.

Figure 28. Outcrop of Troutdale Formation in the mainstem below Packard Creek (approx. RM 2.6).

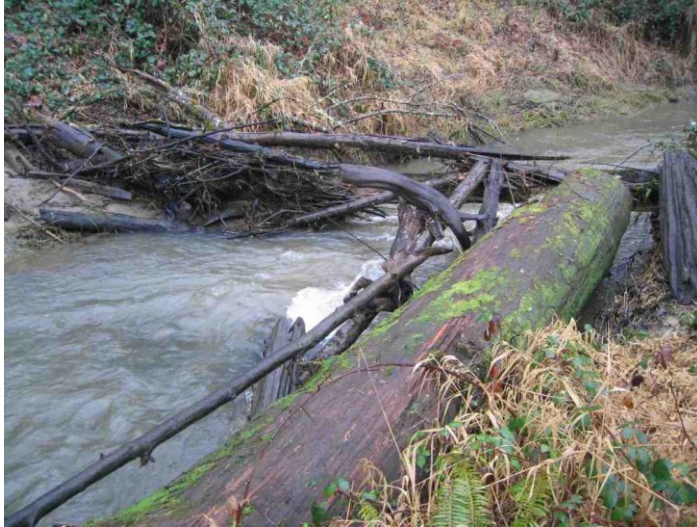
Figure 29. Log jam with large key piece at approximately RM 2.8.

Log jams in this reach are providing important channel functions. Field observations following flood events indicate that jams are trapping fine sediments downstream, within, and upstream of the jams (Figure 30). Overflow channels scour floodplains, increasing floodplain connectivity. Channel adjustments discourage invasive riparian vegetation and create soil conditions favorable to colonization by native vegetation. Figure 31 depicts an area where backwater effects from an upstream log jam created floodplain overflow and subsequent scour and fill of material, allowing for young alders to colonize the site. This is the only location observed in the entire basin where there is any significant new growth of young riparian trees.

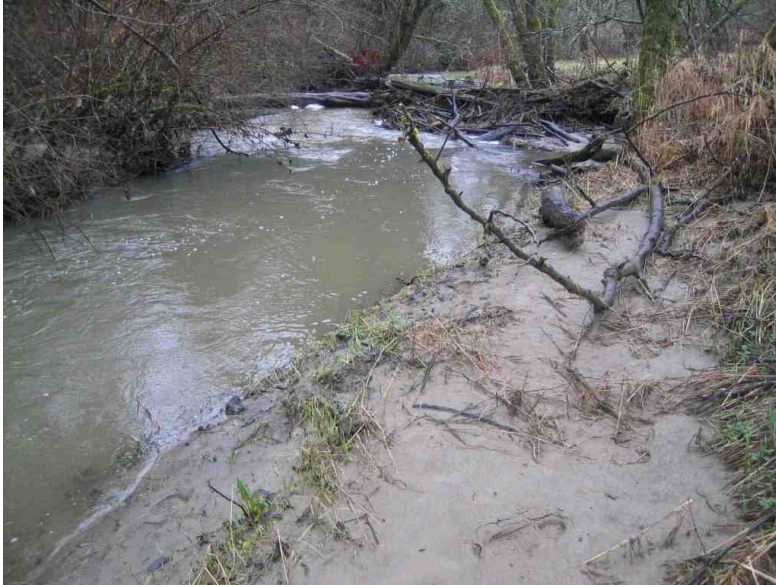
Figure 30. Accumulation of fine sediment as a result of backwater effects of log jam at approximately RM 2.9.

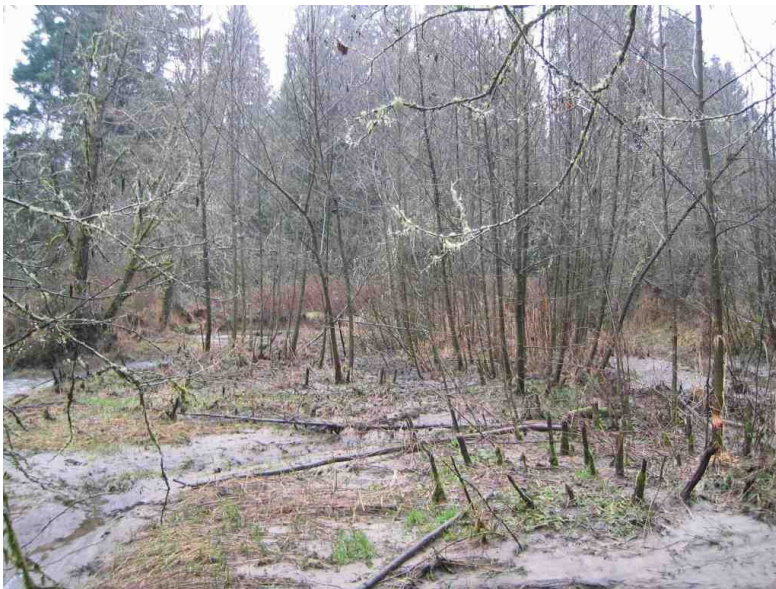
Figure 31. Young alders colonizing fine sediments recently deposited as a result of channel adjustment due to an upstream log jam (approx. RM 2.4).

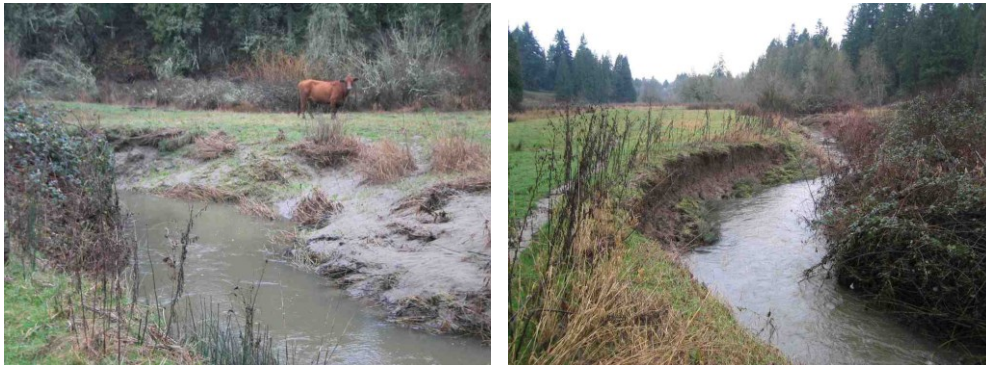
Below approximately river mile 2.4, conditions change dramatically. The gradient lowers and the stream enters a disturbed area. The upstream portion is within a maintained residential lawn, where lack of riparian vegetation and mowing up to the stream edge has caused severe bank instability. Below this, the stream enters a large pasture that extends to the stream edge, with cattle access to the stream channel. The channel here is severely incised and over-widened, with no woody riparian vegetation, and blackberry thickets along the channel (Figure 32). The channel bed is sand and silt.

Figure 32. Whipple Creek in pasture area (near RM 2.2). Removal of riparian vegetation, colonization by invasive plants, and cattle access to the stream has resulted in a severely eroding and incised channel.

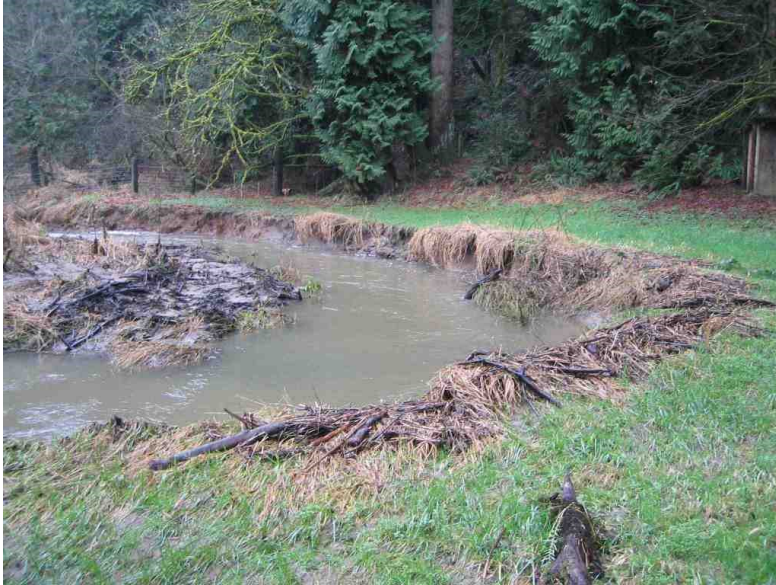
Figure 33. Evidence of recent over-bank flows at lawn area near RM 2.3.

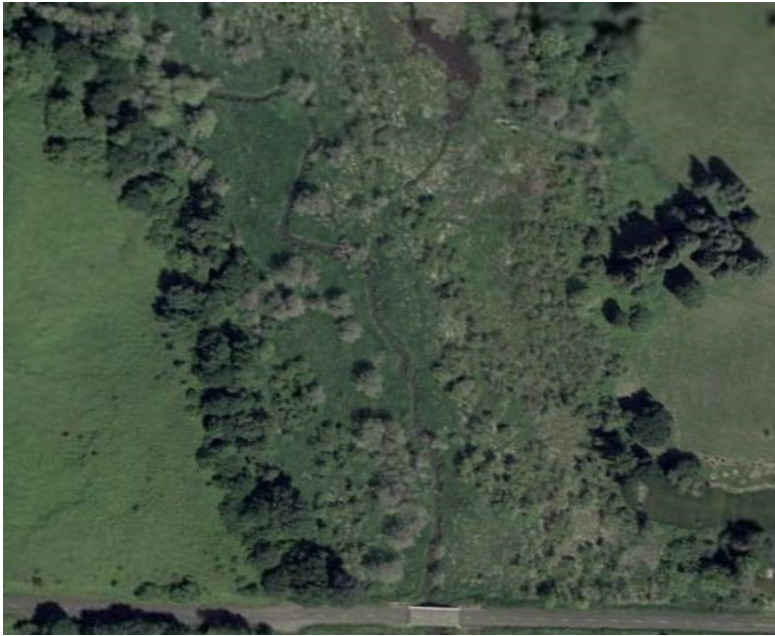
Figure 34. Aerial photograph of lower Whipple Creek just upstream of NW Krieger Road crossing near the mouth.

The lower mainstem below river mile 2 was not surveyed. Given the gradient profile and field observations from the road crossing near the mouth, it is assumed this reach would be similar to the middle mainstem, only with broader floodplain wetlands with less woody riparian vegetation (Figure 34). Channels near the mouth are very low gradient response channels with bed and banks comprised of silty material. Tidal backwater effects appear to extend some distance upstream. Floodplains are wide (approx. 800 feet), have high water tables, and are dominated by reed canary grass. The only trees are sparsely distributed Oregon Ash.

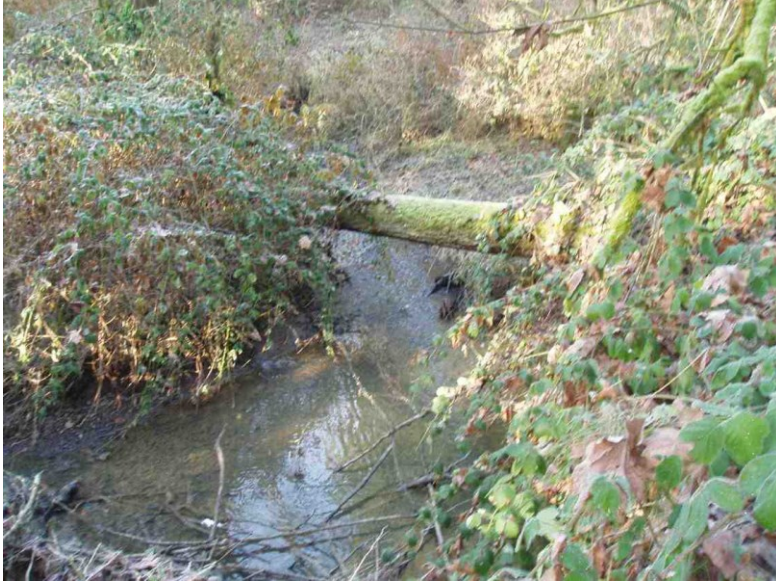
Figure 35. Photo of wood spanning above channel in Packard Creek. This is a common occurrence in Packard Creek and other incised channels.

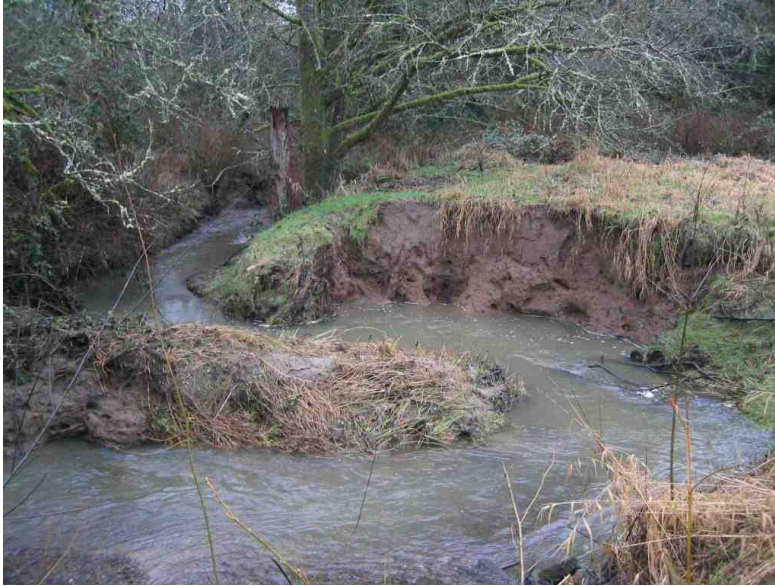
Figure 36. Streambank erosion at lower Packard Creek just upstream of the confluence with mainstem Whipple Creek.

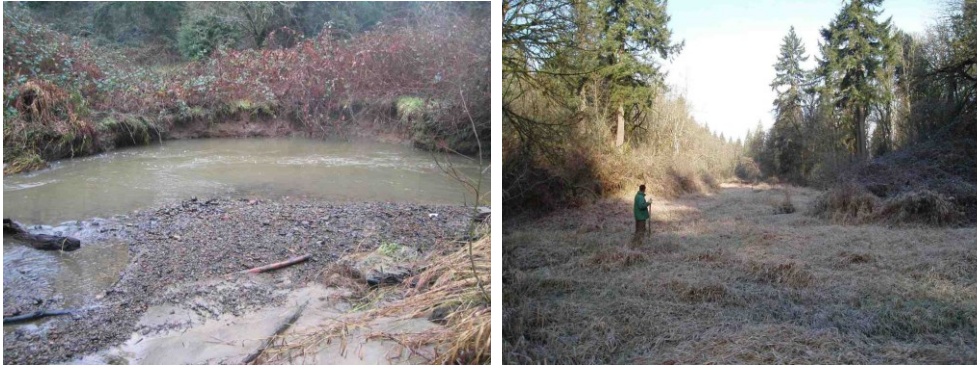
Figure 37. Typical riparian conditions now found in the basin (Left photo: blackberry dominated; Right photo: reed canary grass dominated).

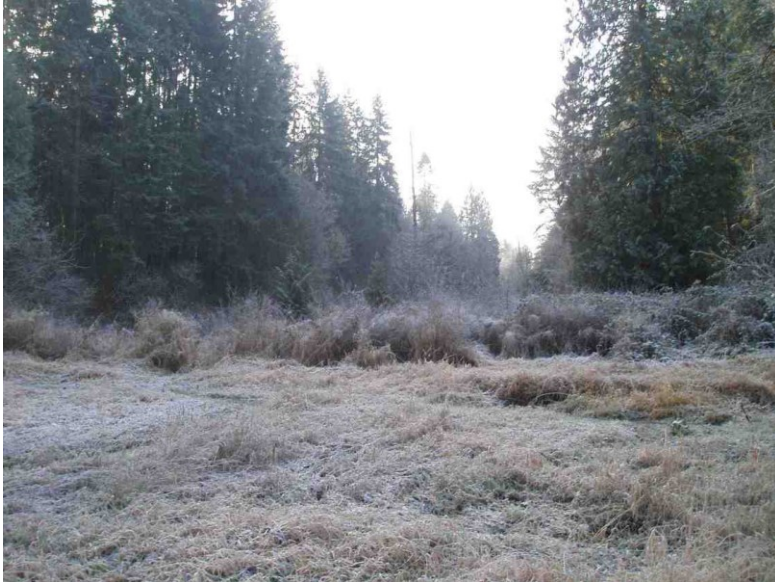
Figure 38. Reed Canary Grass (in foreground) dominates this riverine wetland area. Himalayan blackberry becomes the dominant vegetation as one moves downstream as a result of incision that has drained the floodplain terrace. A headcut is located near the transition from Reed Canary Grass to blackberry.

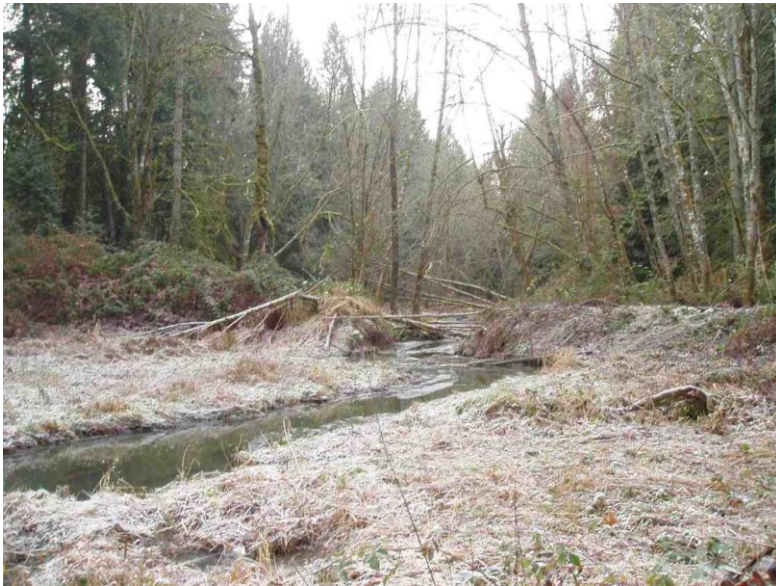
Figure 39. Remnant floodplain fill spanning the floodplain near RM 7.3. The creek currently flows through a break in the fill.

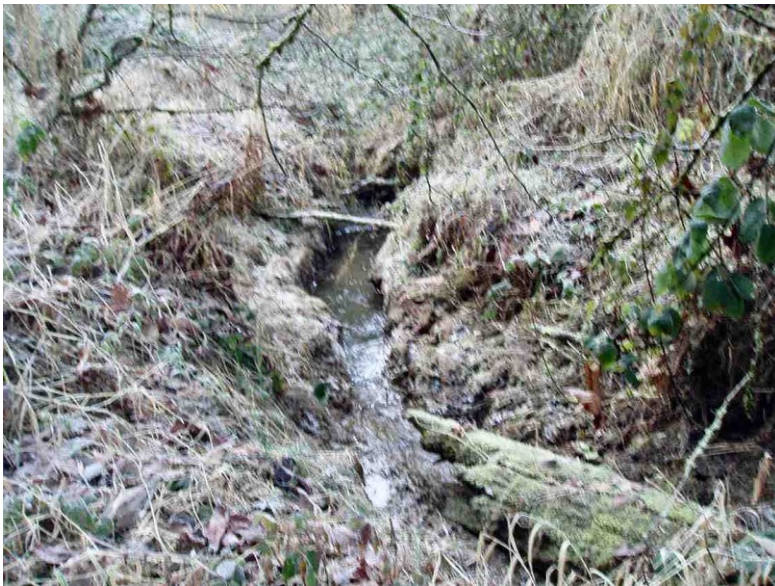
Figure 40. View of incised channel downstream of headcut near RM 8.3.

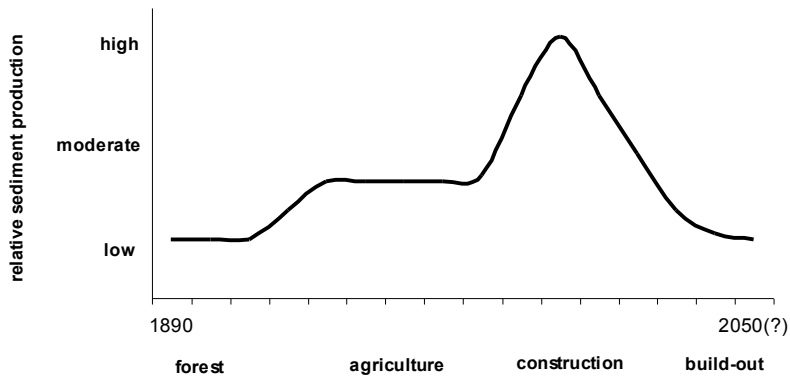
Figure 41. Conceptual diagram of estimated past, present, and future Whipple Creek Basin sediment production volumes.

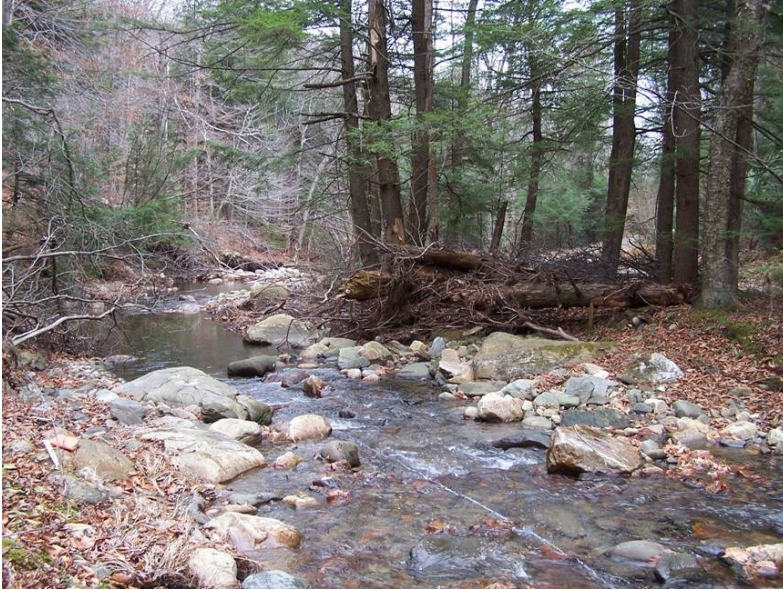
Figure 46. Series of rock steps installed for channel grade control, Tower Brook, Chesterfield, MA.

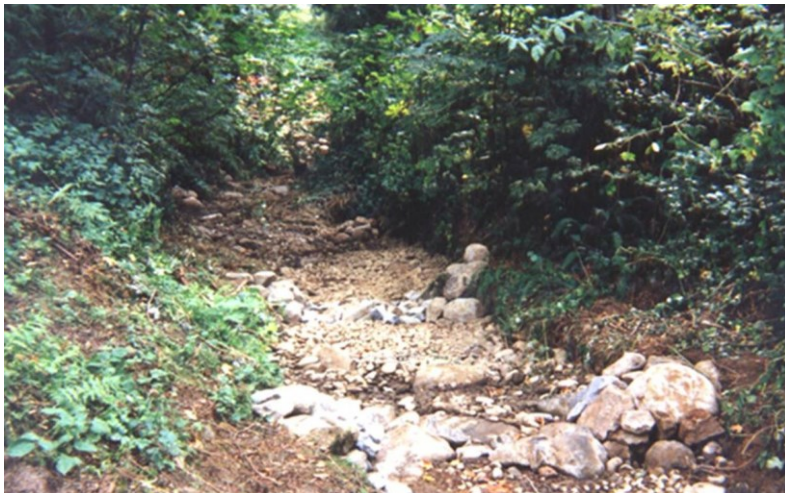
Figure 47. Series of rock grade control/headcut revetment structures placed in Oak Creek, Portland, OR

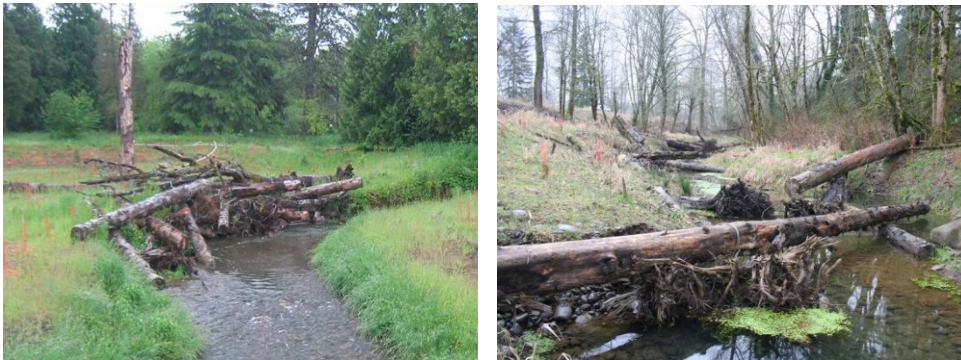
Figure 48. Large wood complexes installed for streambank protection (left, Kelley Creek, Portland, OR) and for habitat enhancement (right, side-channel of Clackamas River, OR).

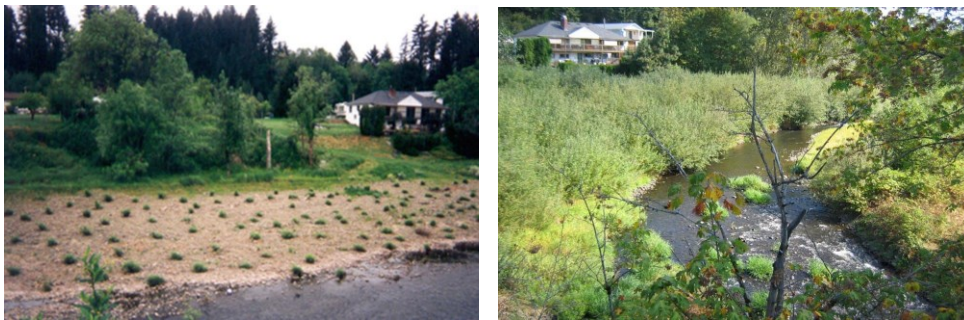
Figure 49. Riparian re-vegetation on Salmon Creek, WA. Photo taken 6 months after planting (left) and 10 years after planting (right).

- See Attachment A – Sheets 5, 6, & 7
- See example photos in Figure 49

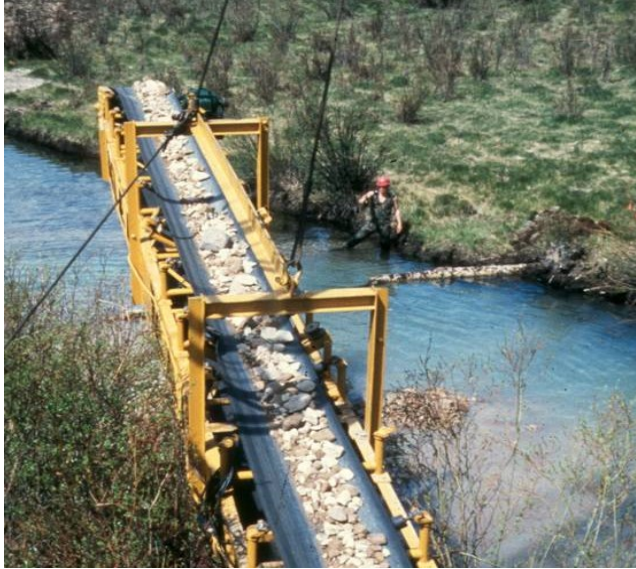
Figure 50. Conveyor placing substrate (cobbles and gravels), Ruby River, Montana.

- See example photo of gravel installation (Figure 50)

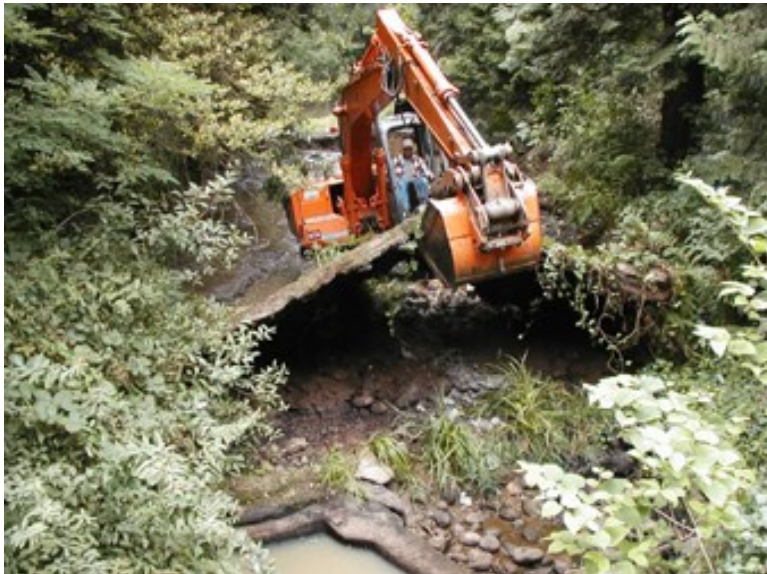
Figure 51. Removal of concrete weir in Johnson Creek, Portland, OR.

- See example of hydromodification removal (Figure 51)

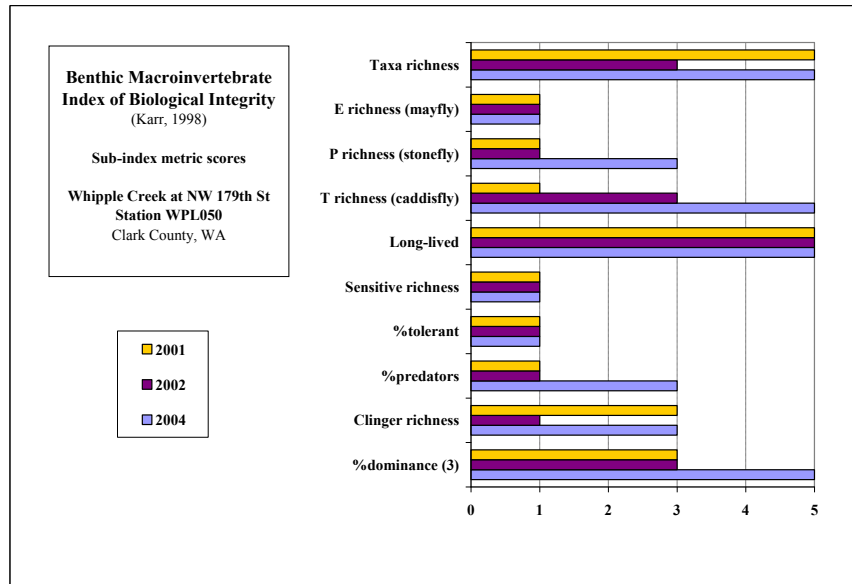
Figure 53. B-IBI metric scores for station WPL050, 2001, 2002, and 2004.
