# 2008 Stormwater Needs Assessment Program

East Fork Lewis River (RM 00.00)/East Fork Lewis River  
(RM 03.19)/McCormick Creek  
Subwatershed Needs Assessment Report

Clark County Public Works Clean Water Program

April 2009

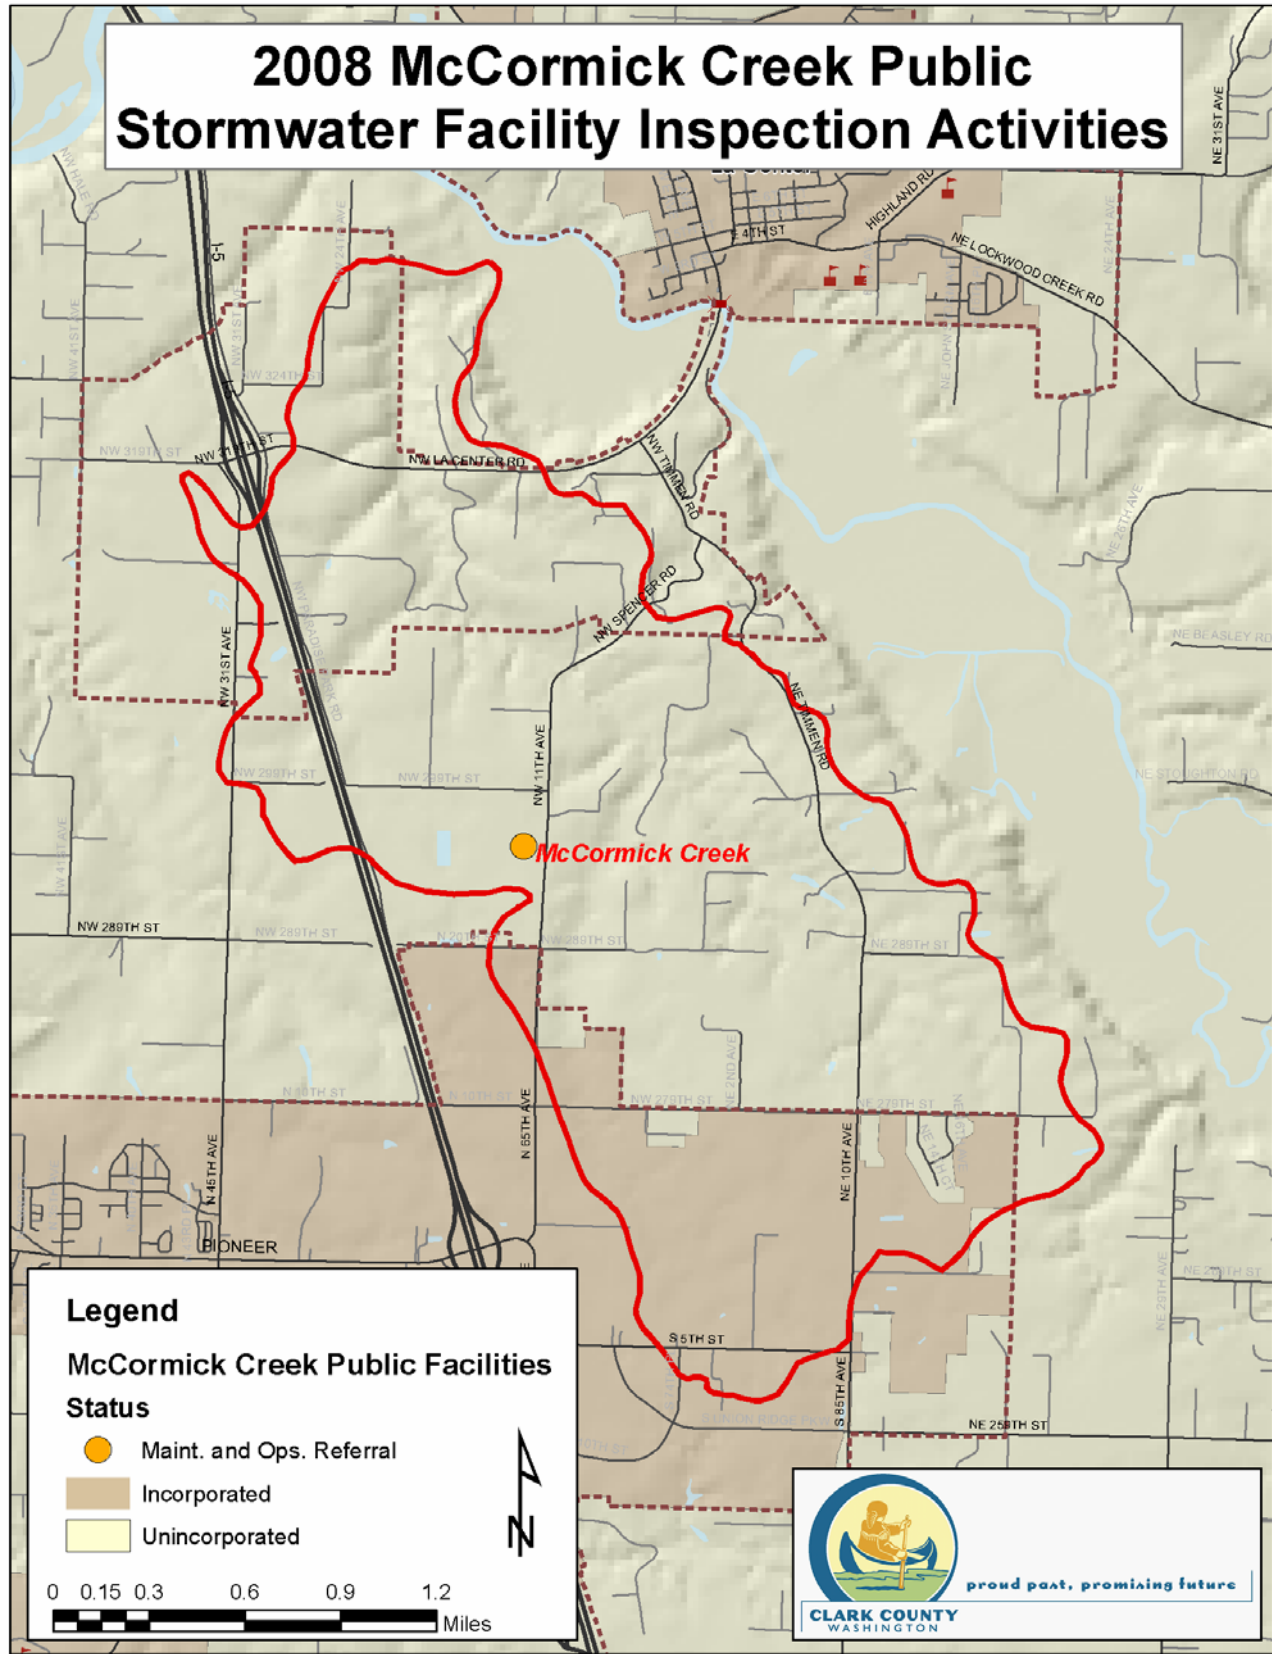
The inspection process in the McCormick Creek subwatershed generated one referral to Public Works Maintenance and Operations for needed maintenance activities. No major defects or hazardous conditions were discovered; non compliant issues included excess sediment depth and grate damage.

Figure 4: Summary of 2008 Public Stormwater Facility Inspection Activities in McCormick Creek Subwatershed

The most common facility objects found out of compliance during the public stormwater facility inspection process overall were bioswales and energy dissipaters. Bioswale defects included either standing water or grasses exceeding 10 inches in height with nuisance weeds and other vegetation starting to take over. Energy dissipater defects included either sediment accumulation on dissipater or missing or moved rock (riprap). Excessive sediment accumulation or missing riprap may cause energy dissipaters to not dissipate stormwater flow evenly, which may lead to channelization of the bioswale and cause standing water to form.

Maintaining vegetation of bioswales on a more frequent basis will allow grasses to become established and out-compete nuisance weeds and other vegetation. Removing excessive sediment from facility objects during maintenance activities will help ensure facilities are functioning as designed.

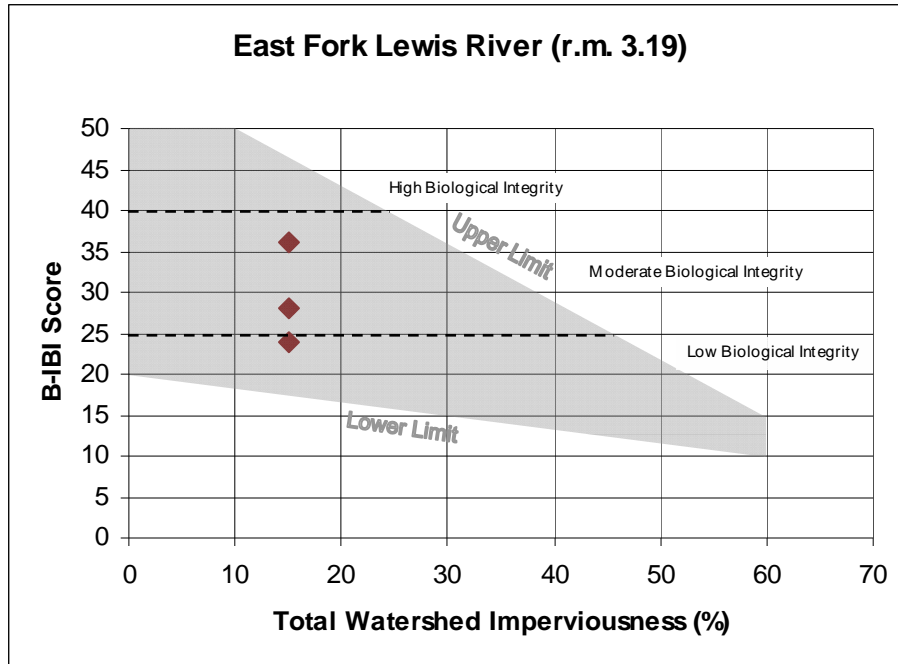
Figure 22: Approximate range of B-IBI in Puget Lowland watersheds, showing progressive decline with increasing imperviousness in the upstream watershed. Adapted from Booth et al., 2004. Markers indicate Total BIBI scores at East Fork Lewis River (RM 03.19) for particular years, versus estimated 2000 subwatershed TIA.

These East Fork Lewis River site's B-IBI scores are in the middle of the expected range for its 15 percent impervious area. This implies an opportunity to increase the level of biological integrity by improving habitat and stream conditions. Management strategies that limit further degradation and promote stream health, such as greater habitat complexity, are important for maintaining or improving biological integrity.

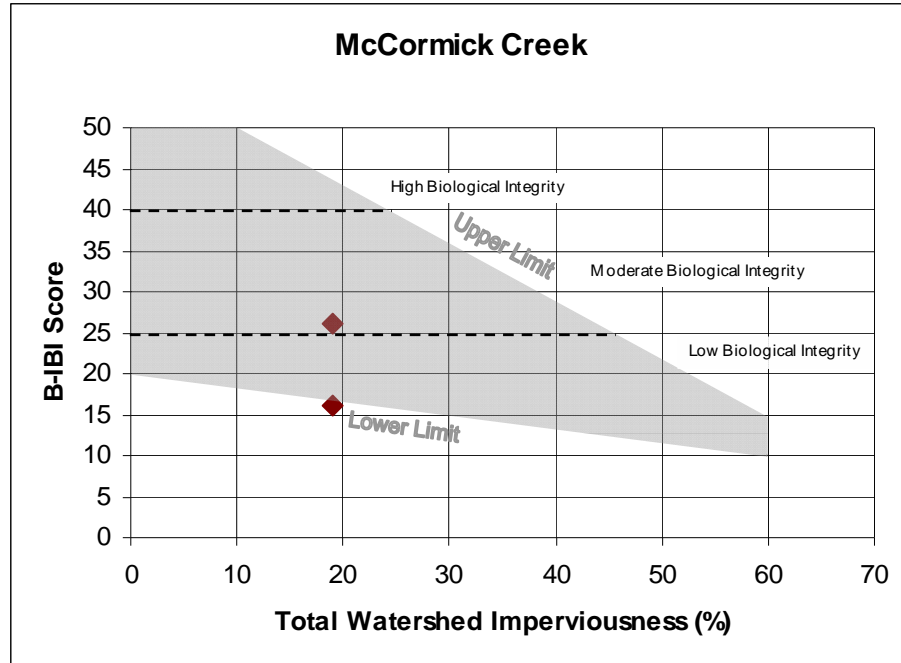
Figure 23 shows that the McCormick Creek station's 2005 and 2007 B-IBI scores fall in the lower portion of the range of expected scores (estimated 2000 Total Impervious Area from Wierenga, 2005).

Figure 23: Approximate range of B-IBI in Puget Lowland watersheds, showing progressive decline with increasing imperviousness in the upstream watershed. Adapted from Booth et al., 2004. Markers indicate Total BIBI scores at McCormick Creek for particular years, versus estimated 2000 subwatershed TIA.

Given that McCormick Creek’s surveyed B-IBI scores fall in the lower portion of the expected range for a watershed with 19 percent impervious area, it is likely that factors other than total watershed impervious area are contributing to the observed degradation of biological integrity. This implies an opportunity to significantly increase the level of biological integrity by improving habitat and stream conditions. Management strategies that limit further degradation and promote rehabilitation are important for improving biological integrity.
