Kalama, Washougal and Lewis River Habitat Assessments

Chapter 3: The North Fork Lewis River Basin

Lower Columbia Fish Recovery Board

December 2004

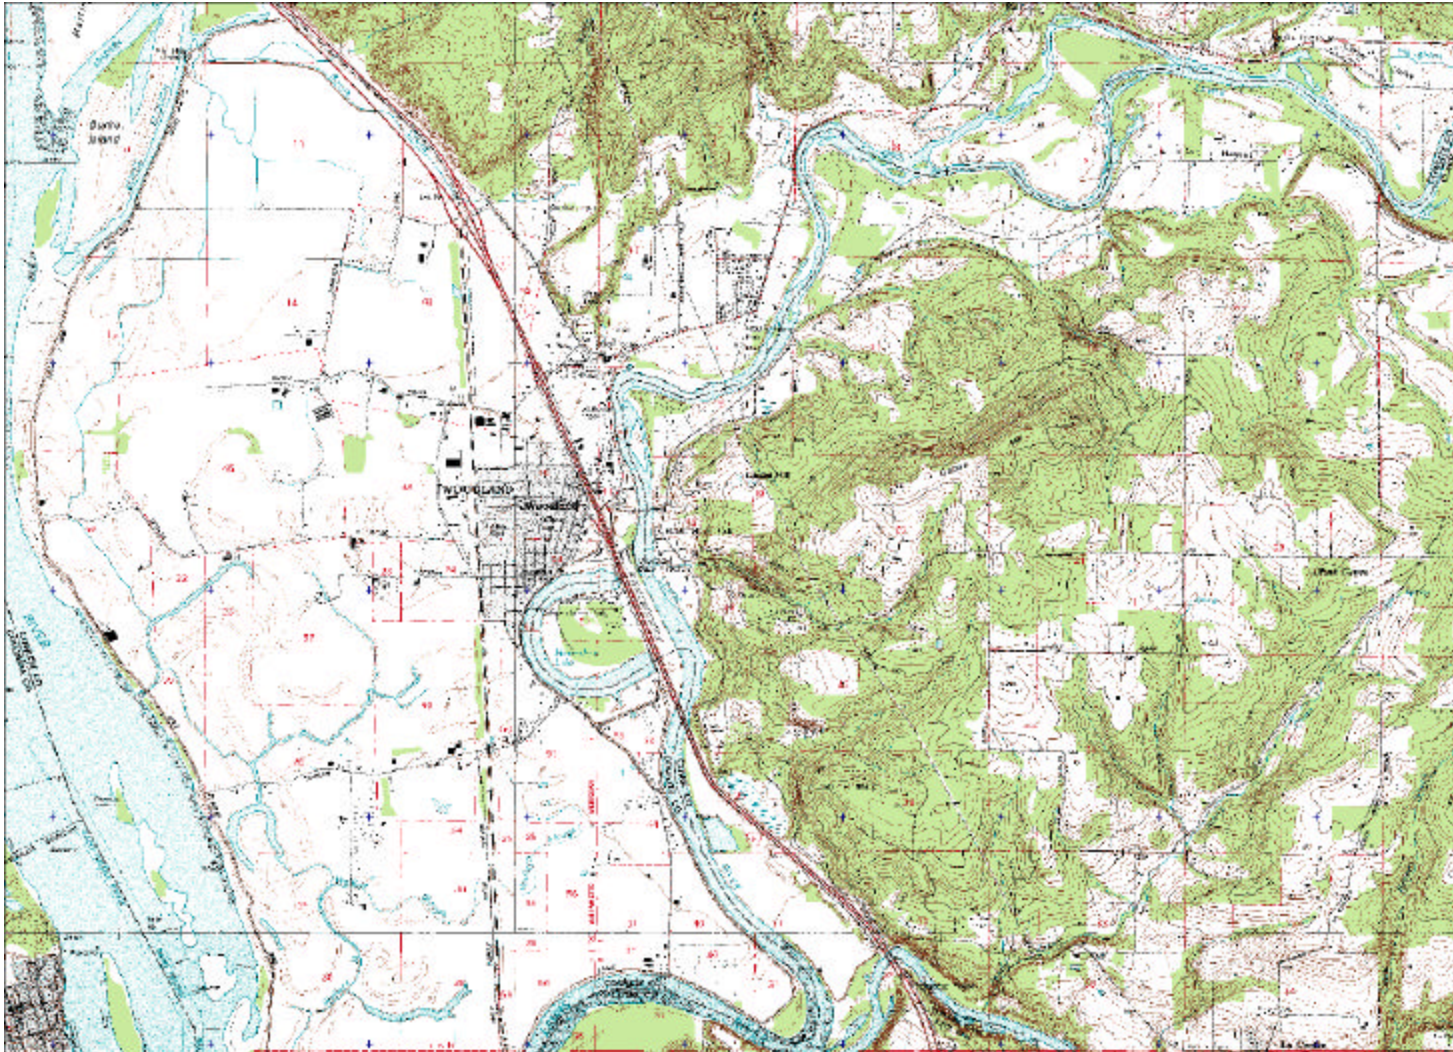
Figure 3-1. USGS 1:24,000 scale topographic map of the hydromodifications study area, (RM 0 to RM 15.5) for the North Fork Lewis basin.

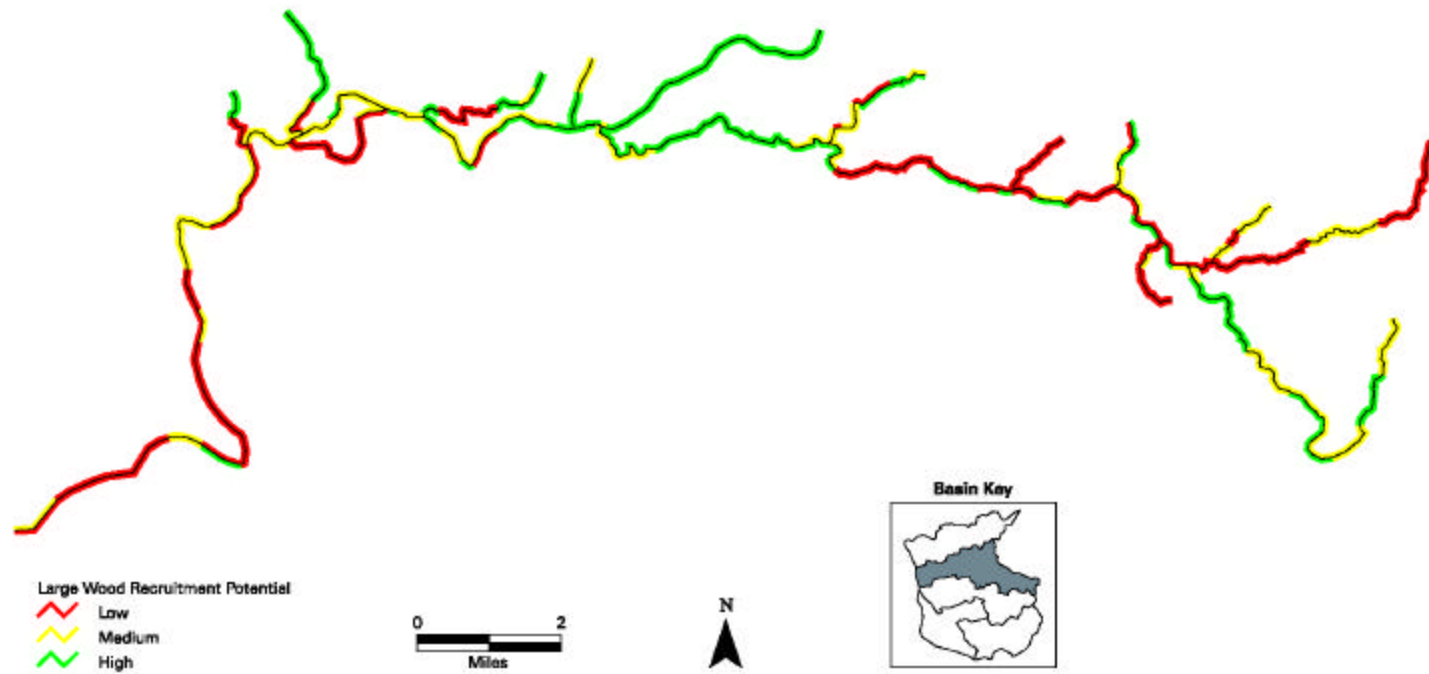
Map 3-2. Large wood condition ratings for EDT reaches in the Nf Lewis Basin.

The riparian recruitment potential of 27 reaches can be divided approximately into equal thirds between good, fair and poor conditions. Portions of Lewis River 5, 6, and 7, Cedar Creek 1a, 1b, and 6, and Houghton, Johnson, Pup, Robinson and Ross creeks offered good current LW recruitment conditions (low recruitment hazard) on both sides of the stream (Map 3-2; Appendix A). Riparian vegetation in these situations consisted of dense stands of either large or medium-sized conifer or mixed species. The existing fair stand conditions were predominately sparse conifer or mixed stands or dense hardwood stands. A second cohort of conifer stand growth will be needed in these areas to support “functional” LW recruitment potential in the future. The poor existing stand situation appeared to be related to both the species composition and size of riparian trees rather than density of the stands. Based on photographic interpretation, approximately 1/3rd of the stands appeared to be dominated by deciduous species, whereas 1/3 of the stands were dominated by mixed (conifer:hardwood) species. Conifer-dominated stands were low in number. Less than 20 percent of the reaches were conifer-dominated

Large Wood (LW) Assessment: The location and current LW recruitment condition of 27 EDT reaches are shown in Map 3-2. The condition rating for each of the reaches is included in Appendix A.

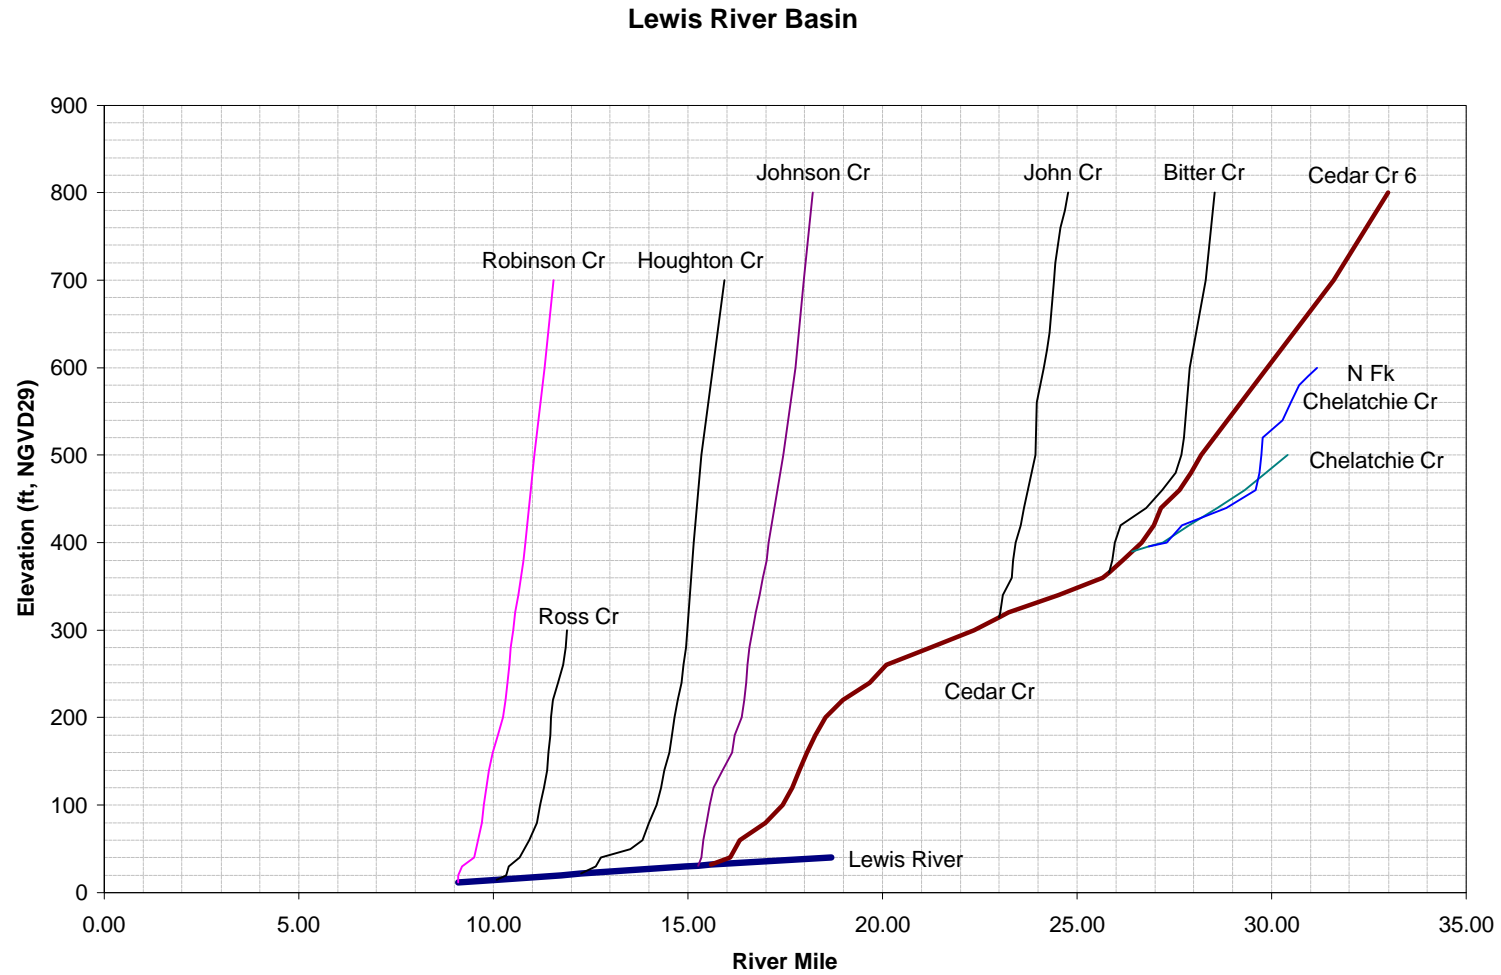
Figure 3-3. Average longitudinal elevation profiles of the mainstem lower North Fork Lewis River and tributaries surveyed for the sediment task.

Lower Cedar Creek cuts steeply through an underlying andesite flow geologic unit (Figures 3-2, 3-3). Cedar 2, 3, 4, and 5 EDT reaches upstream of Pup Creek have comparable gradients to Chelatchie Creek and lower North Fork Chelatchie Creek (Figures 3-3, 3-4). The Cedar Creek 6 EDT reach steepens to a long segment with a relatively consistent gradient around 1 percent above the confluence with Chelatchie Creek. John Creek is relatively steep throughout, except for short segments near its confluence with Cedar Creek and above and below Cedar Creek Road. Bitter Creek is mostly steep but has about a mile long segment extending above and below State Route 503 with a gradient comparable to the Cedar 6 EDT reach.

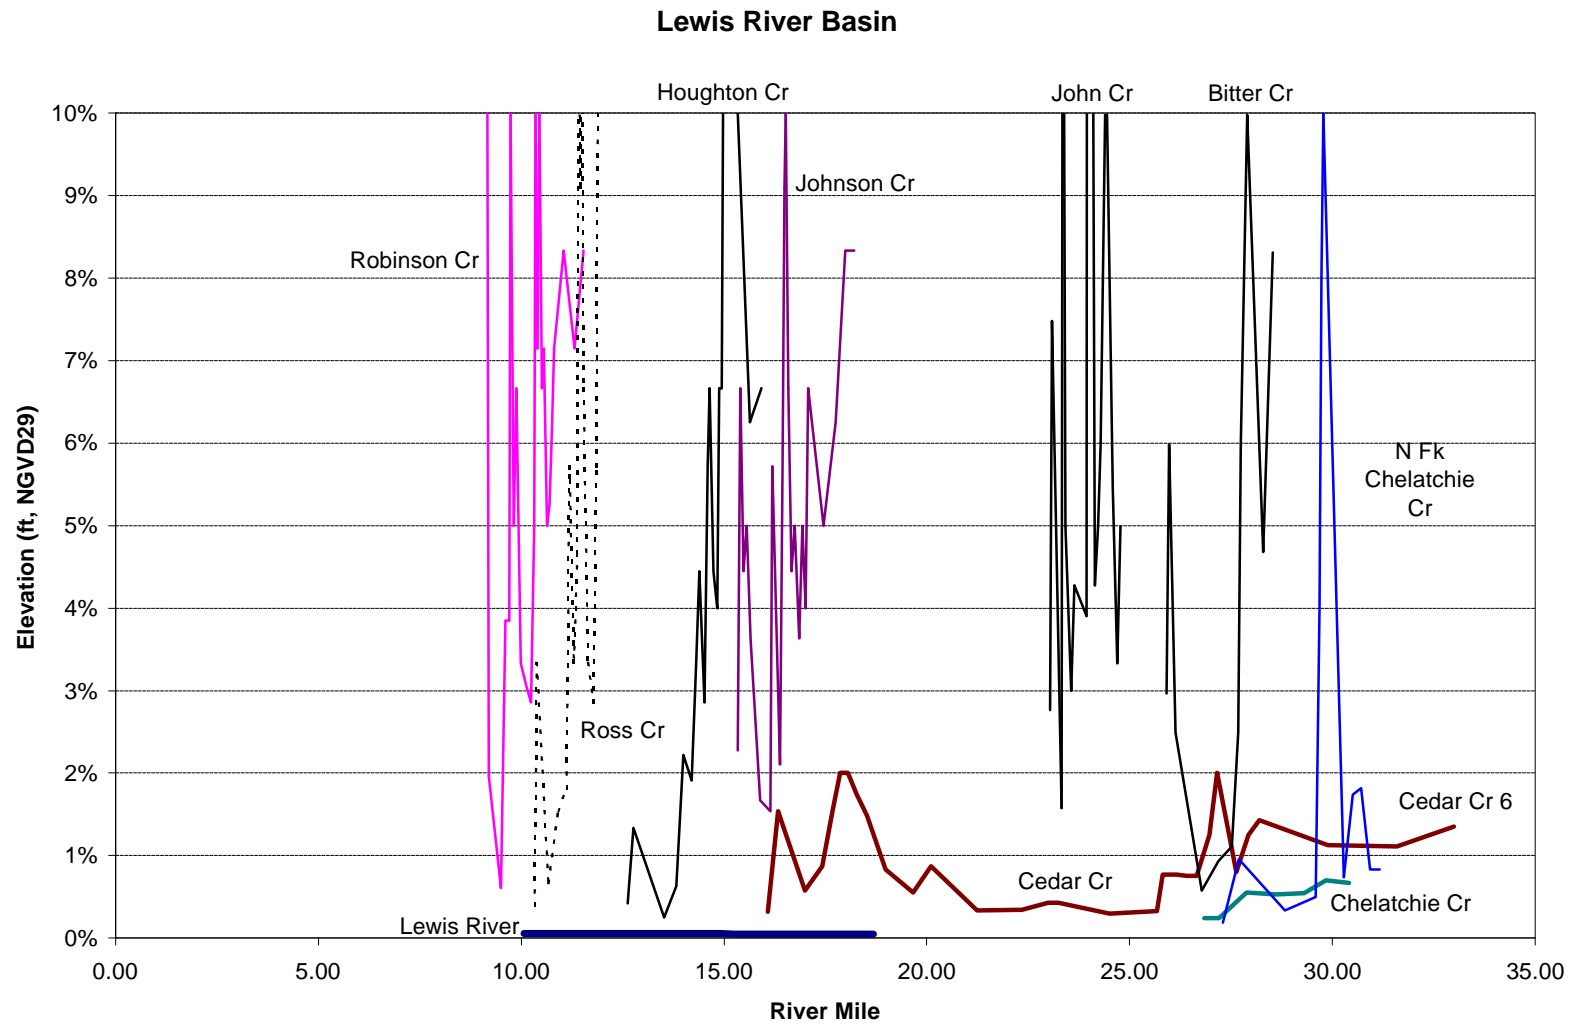
Figure 3-4. Average stream gradients in the mainstem lower North Fork Lewis River and tributaries surveyed for the sediment task.

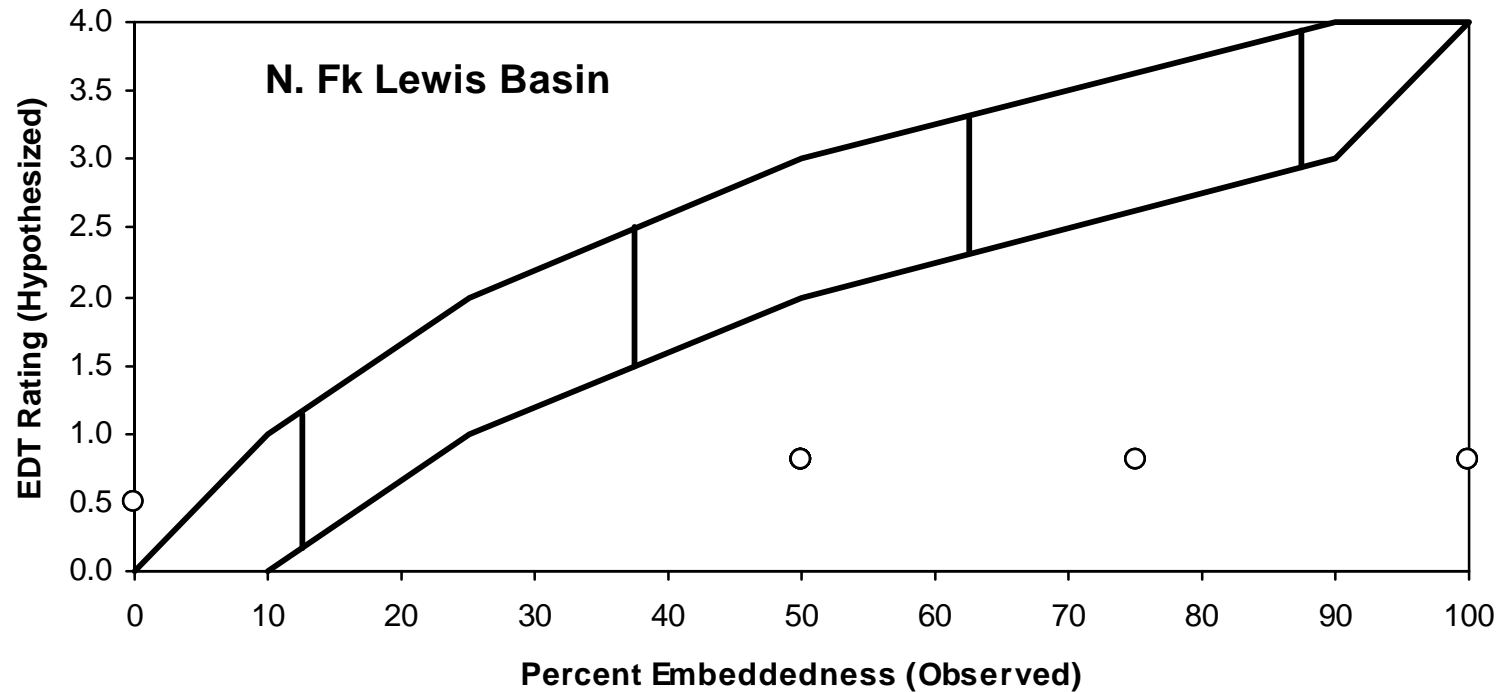
Figure 3-5. Comparison of embeddedness data collected in the lower North Fork Lewis basin for the sediment task (horizontal axis) with ratings assigned to the respective EDT reach (and represented in LCFRB 2004). The hypothesized EDT ratings are accurate when the observed data points fall within the respective diagonal ranges (which define the range of embeddedness values assigned to each EDT rating).

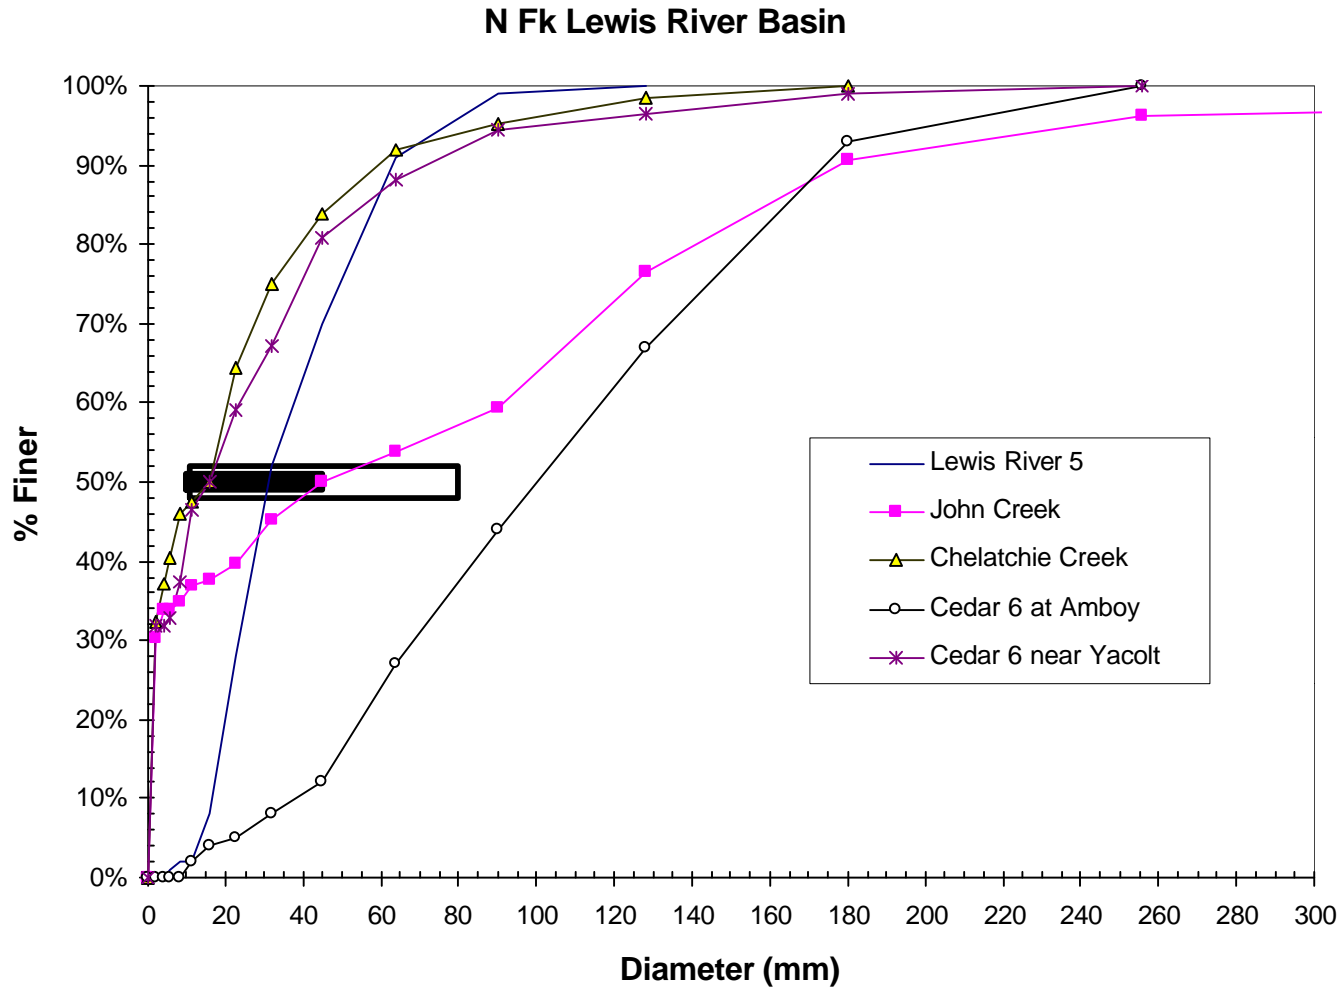
Figure 3-6. Grain size distributions of pebble counts collected in the lower North Fork Lewis River basin for the sediment task. The horizontal bars represent the range of D_{50} s reported by Kondolf and Wolman (1993) as suitable for steelhead trout (filled bar) and Chinook salmon (open bar) spawning.

- Ross Creek had sections with good spawning substrates, although shallow depths associated with relatively low stream discharge may limit the salmon and steelhead spawning.
- Chelatchie Creek had suitable spawning substrates, but they were generally embedded heavily with fines.
- Substrates in the lower Cedar 6 reach channel appeared to be of a suitable size for use by spawning Chinook and steelhead, but riffle bed material may be too coarse in many locations (Figure 3-6).

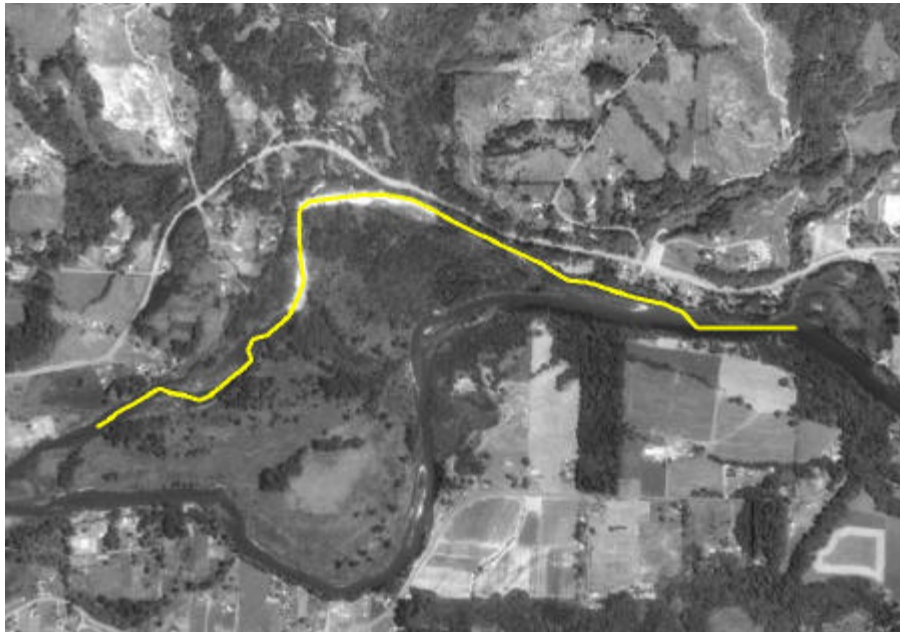
Map B-1. Portion of Lewis 4 surveyed.

North Fork Lewis River 4 is a mainstem reach between Ross Creek (RM 10.05) and Houghton Creek (RM 12.25). This reach is a free-flowing, freshwater reach that is not influenced by tidal action in the Columbia River. This section of the North Fork Lewis River is unconfined, occupying a 0.5 to 0.75 mile wide valley formed by the Lewis River where it cut through glacial outwash and Lake Missoula Flood deposits dating from the Quaternary. Reach 4 consists of a split mainstem channel that developed sometime between 1942 and 1990. Approximately 50 percent of the mainstem flow is transmitted by each channel. The entire length of the north channel was floated during the 2004 survey (Map B-1).

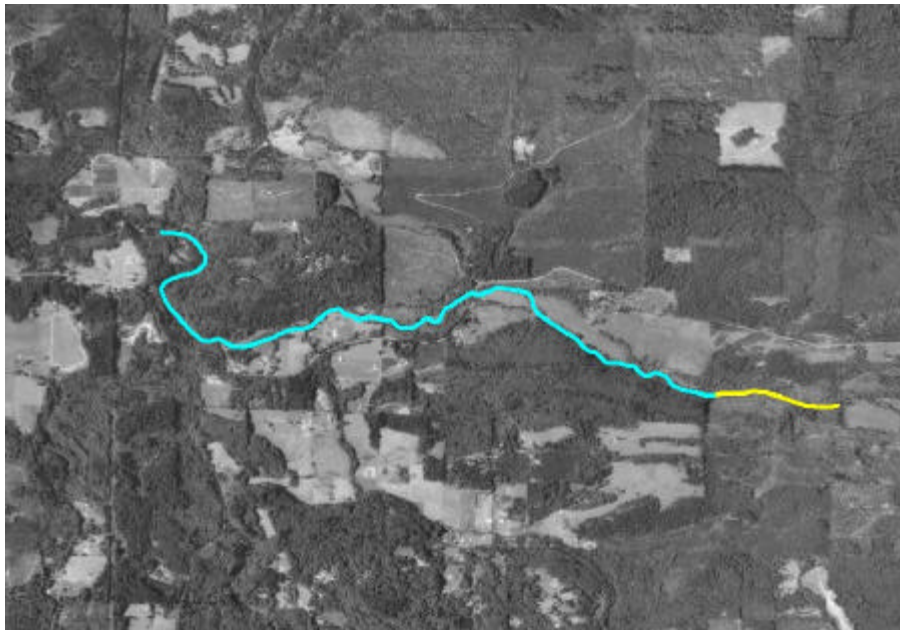
Map B-3. Portion of Cedar 2 surveyed.

Cedar Creek is the major tributary to the North Fork Lewis River downstream of Merwin Dam. Reach 2 of Cedar Creek extends from Pup Creek at RM 4.3 to John Creek at RM 7.7. This portion on Cedar Creek flows through a 100 to 150 meter (0.3 to 0.6 mile) wide valley cut through glacial outwash and is generally unconfined. The uppermost 0.8 km (0.5 mile) segment of the reach was surveyed as highlighted in yellow in Map B-3.

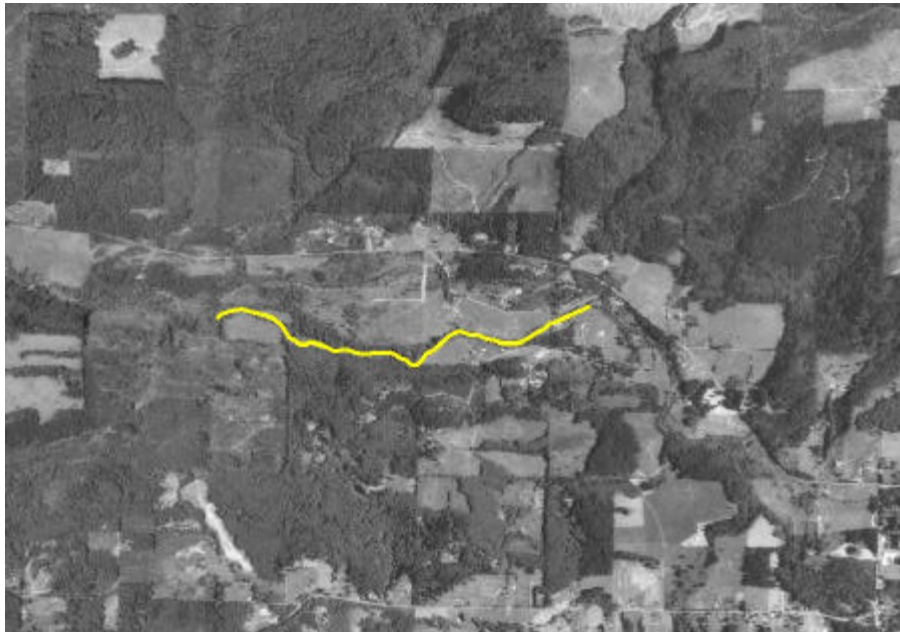
Map B-4. Portion of Cedar 3 surveyed.

Cedar Creek is the major tributary to the North Fork Lewis River downstream of Merwin Dam. Reach 3 of Cedar Creek extends from John Creek at RM 7.7 to Brush Creek at RM 9.3. This portion on Cedar Creek flows through a 100-meter (330 ft.) wide valley cut through glacial outwash. Topographic features suggest large quaternary earthflows may have filled the valley from the north east, pushing Cedar Creek to the south edge of the valley, where it currently flows along a step sideslope. The channel is generally moderately confined and had a map gradient of 0.5 percent. The entire reach of Cedar 3 was surveyed (Map B-4).

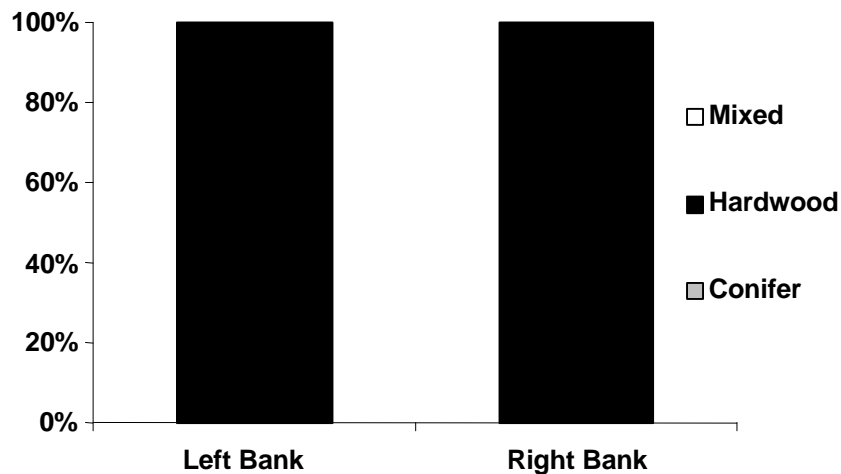
Chelatchie 2 is a narrow channel that was relatively well shaded at the time of the survey in 2004. Riparian vegetation consisted solely of hardwood (Figure B-12). The open channel width to the sky averages 8 m (26 ft) of channel width plus an additional 15 m (49 ft) of open bank or a total of 23 m wide zone without vegetative cover. The mean view to sky is 20 percent open (Table B-50). Long stretches of Chelatchie Creek were observed to flow through agricultural areas or rural residences with little riparian vegetation, thus the surveyed segment may overestimate existing riparian shade for this reach.

Figure B-12. Vegetation type by percent of units observed. Data presented as proceeding downstream.
