# CHAPTER 4: EAST FORK LEWIS RIVER BASIN – HABITAT ASSESSMENT

*Survey on Rock Creek (upper) in the East Fork Lewis River Basin – October 2004*

## **Lower Columbia Fish Recovery Board**

## **SP Cramer & Associates, Inc.**

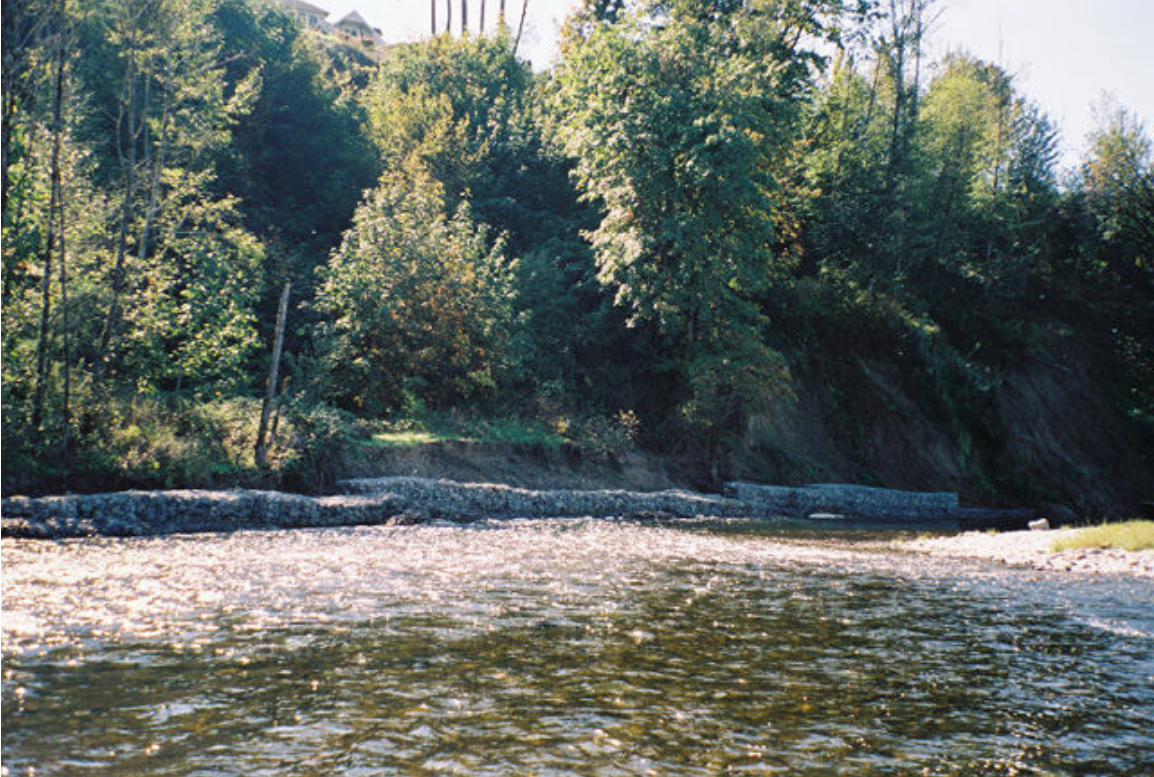
**Figure 4. 5. Rock filled wire basket gabions protecting toe of eroding streambank at river mile 8.7 on the East Fork Lewis River. Photo taken September 2004**

From river mile 9.5 to 8, there are remnant levees on the north bank that limit channel movement and floodplain connection. These levees protect the Clark County maintenance facility and a pair of old gravel mining ponds. Aerial photos show that gravel mining in the form of gravel bar scalping was occurring as early as 1939. Evidence of active gravel mining can be seen in the 1939 photos near the current County maintenance facility north of the Mill Creek confluence. Evidence of gravel mining can also be seen in the Ridgefield Pits area. The river shifted position to the south in 1995 between river mile 9 and 8.5 as a result of avulsion into a streamside gravel pit (the “Mile 9” Pit) (Norman et al. 1998). The river is now eroding the 80-100 foot high bank of the south valley wall that is composed of erodable sediments. Rock filled wire basket gabions have been placed at the toe of this wall in an effort to curb erosion, presumably to protect private residences on the bluff above (Figure 4. 5); however, these gabions appear to be experiencing undermining by scour.

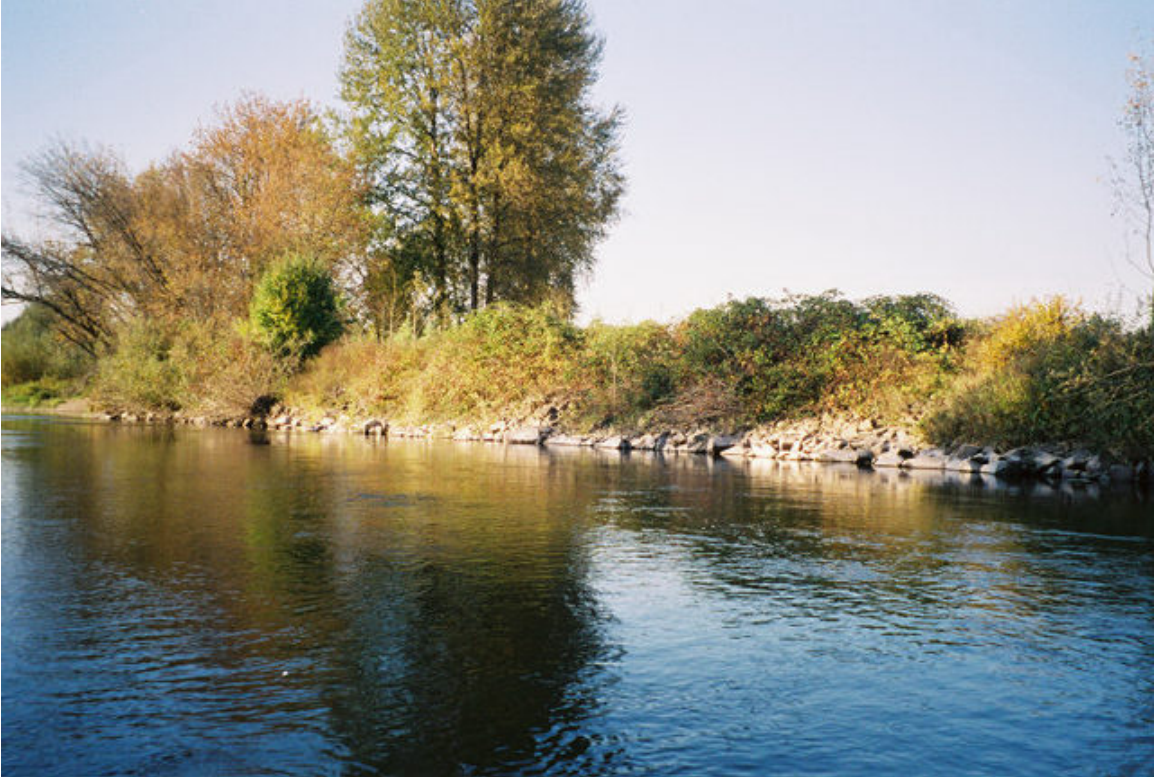
**Figure 4. 6. Riprap bank protecting the airstrip on the lower mainstem East Fork Lewis River. Photo taken September 2004.**

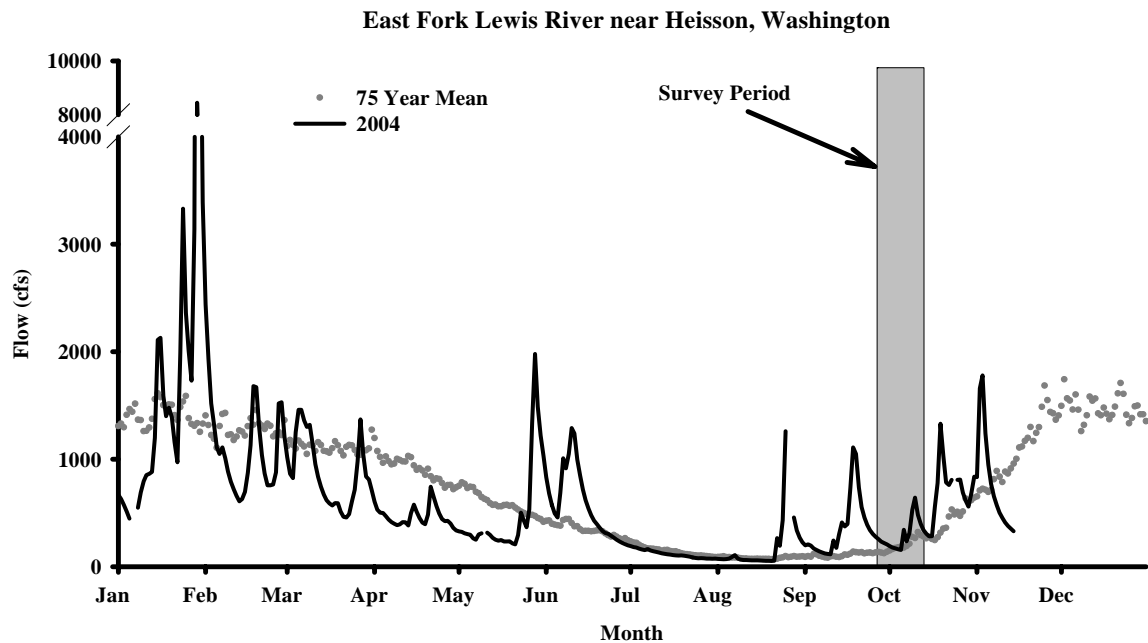
**Figure 4. 14.** Hydrograph of the East Fork Lewis River near Heisson, Washington displaying the 75 year mean flow and 2004 flow. The 2004 stream survey period is highlighted in gray. USGS gage number 14222500.

Flow conditions during surveys were somewhat elevated above late summer low flow conditions, but were far below annual high flow (Figure 4. 14). Flow in the East Fork Lewis near Heisson, Washington ranged from 157-643 cfs during the survey period compared to the mean August (low flow) of 83 cfs. Temperatures recorded via a hand held thermometer throughout the survey period ranged from 9.7-16.1°C, but typically varied between 11.0-13.0°C. Visibility was generally excellent with the exception of LW Rock Creek where turbidity inhibited visibility of the substrate. Deep pools and turbulence inhibited visibility in some units in the mainstem East Fork Lewis.

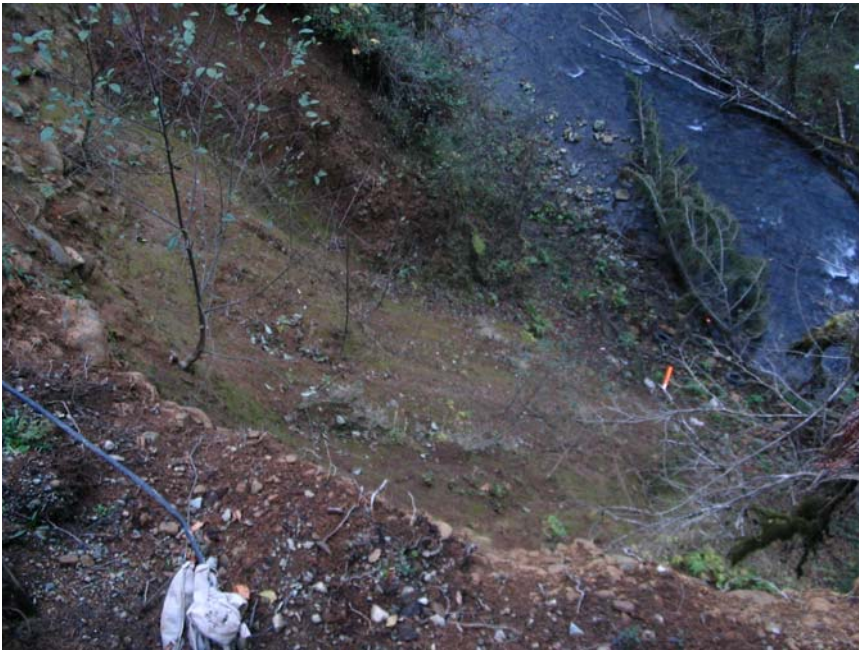
**Figure 4. 23. Landslide from road failure (Dole Valley Road) directly entering Rock Creek.**

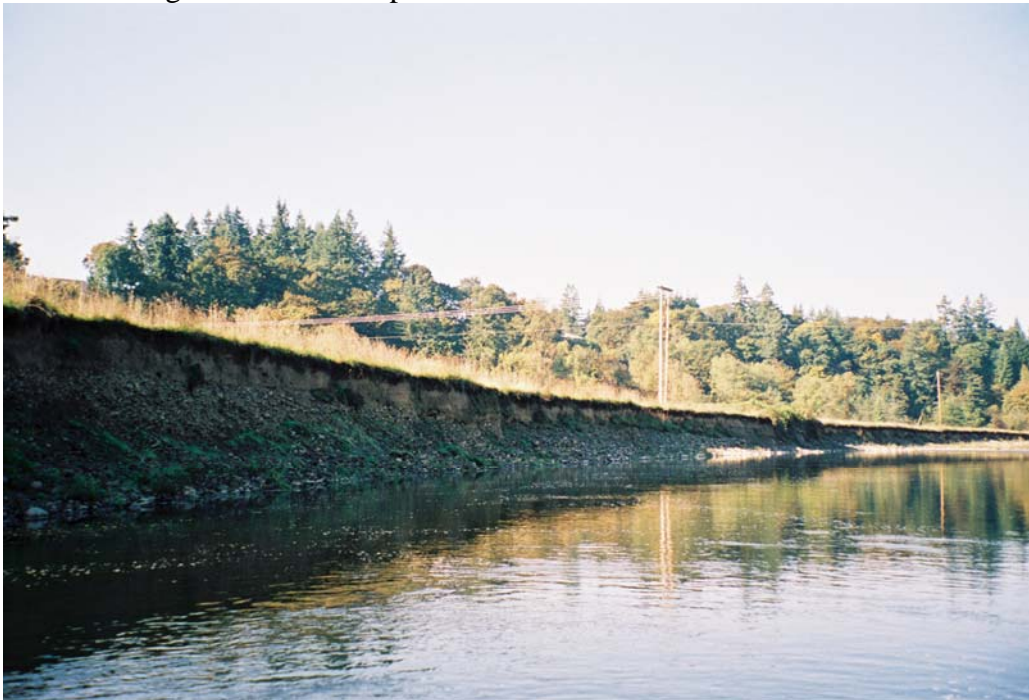
**Figure 4. 27. Erosion of alluvial terrace at downstream end of Reach 8A (RM 9.7). This property has been acquired by the Columbia Land Trust and offers good restoration potential.**

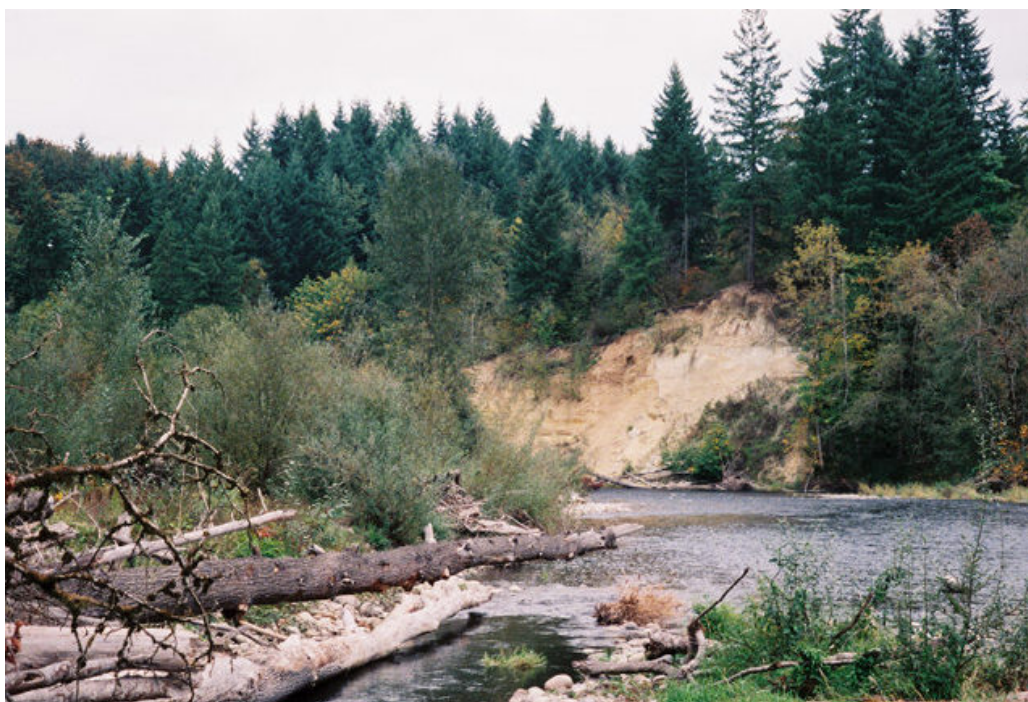
**Figure 4. 28. Erosion of fine sediment on the high valley wall at river mile 10.6 - upstream of Daybreak Park on the north bank of the East Fork Lewis River.**

side of the river upstream of Daybreak Park and on the south side of the river between Daybreak Bridge and the Ridgefield Pits. The high banks upstream of Daybreak Park consist primarily of the lower Troutdale Formation (Figure 4. 28). The high banks further downstream consist of the Troutdale Formation overlain by glacial drift and Pleistocene alluvium (Figure 4. 29 and Figure 4. 30). Active slumping and surface erosion is occurring on most of these high banks though migration of the river into these high terraces occurs much more slowly than into the low fluvial terraces described previously. Nevertheless, houses located at the top of these banks may be at risk of being undermined in coming decades. Rock filled wire basked gabions have been placed under the high bank at river mile 8.7 in attempt to slow the rate of erosion, but these measures appear to be failing as the gabions are undermined by the river. Erosion of these high banks is largely a natural process that has served to broaden the lower river valley bottom over the centuries. The only measures that would effectively prevent continued erosion at these areas include either river re-alignment or large bank armoring and/or deflection structures. These measures are expensive, contain substantial risk, and are not recommended for these areas. Removal of existing hydromodifications may reduce erosion of high banks in a couple of locations.

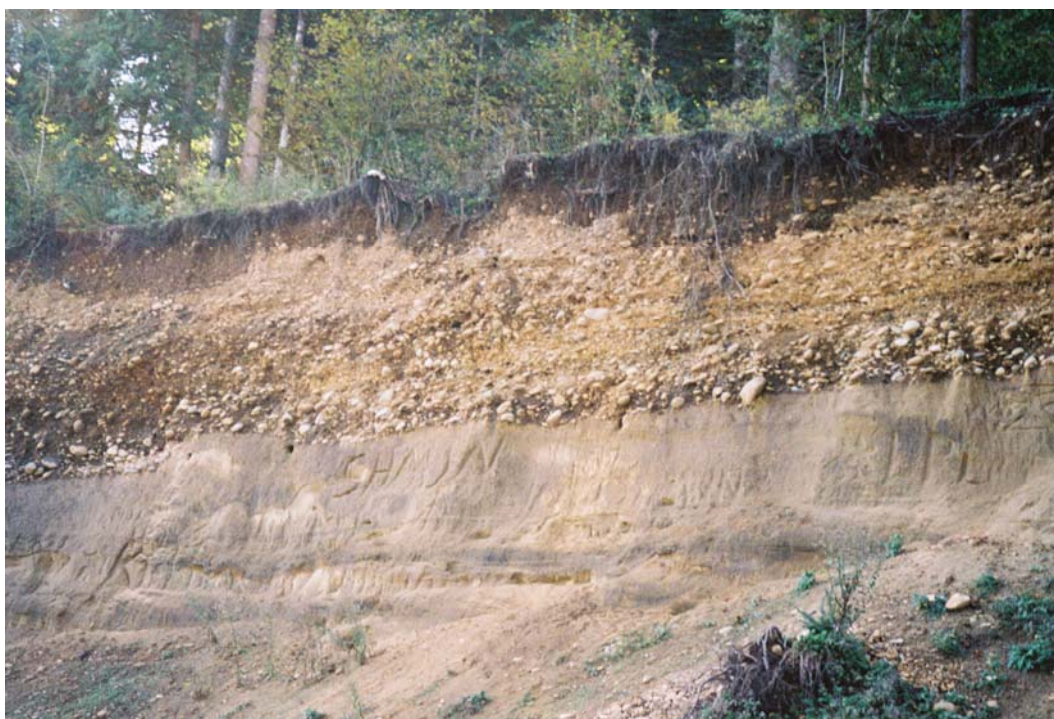
**Figure 4. 30. Close-up of the right side of photo in Figure 4. 29, depicting the fine grained material of the Lower Troutdale Formation overlain by alluvium.**

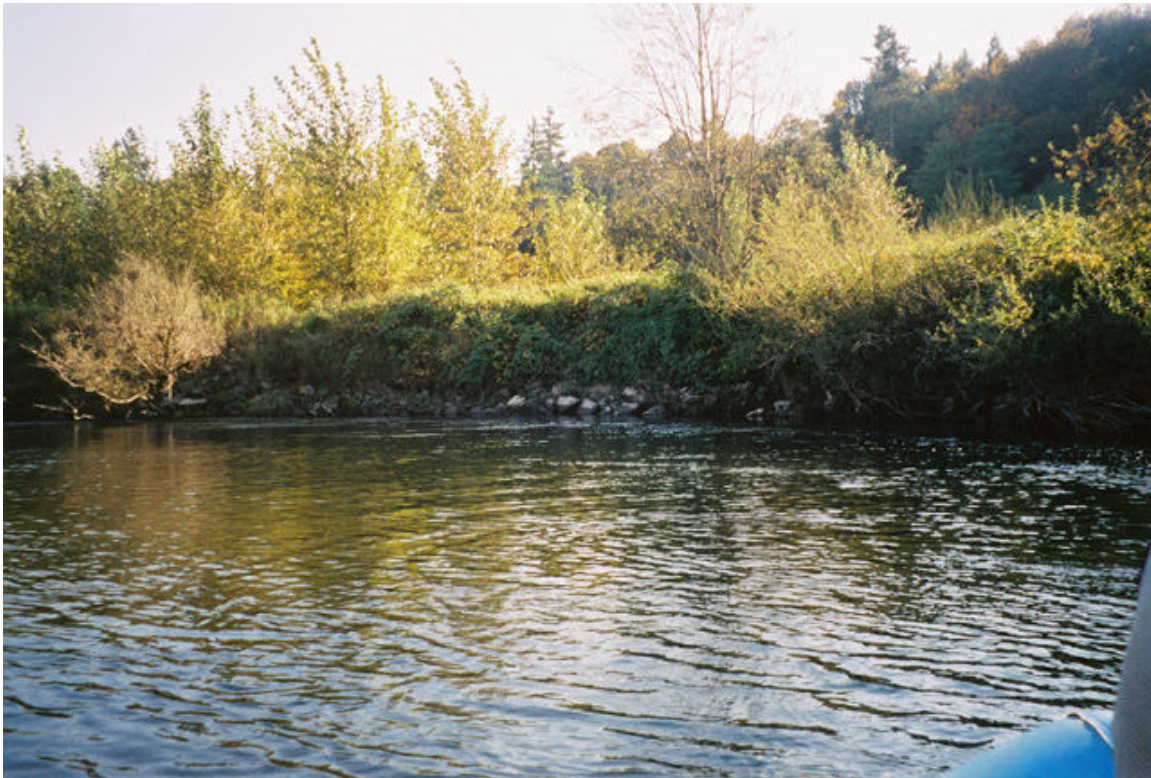
**Figure 4. 31. Rip-rap bank on south bank at RM 6.8.**

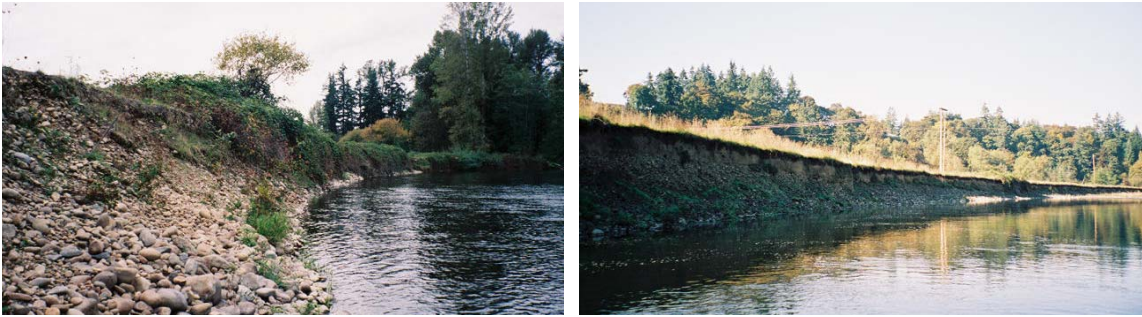
Figure 4. 32. Rapidly eroding terraces at RM 10.9 (left) and RM 9.5 (right). These rapidly eroding banks present good restoration opportunities.

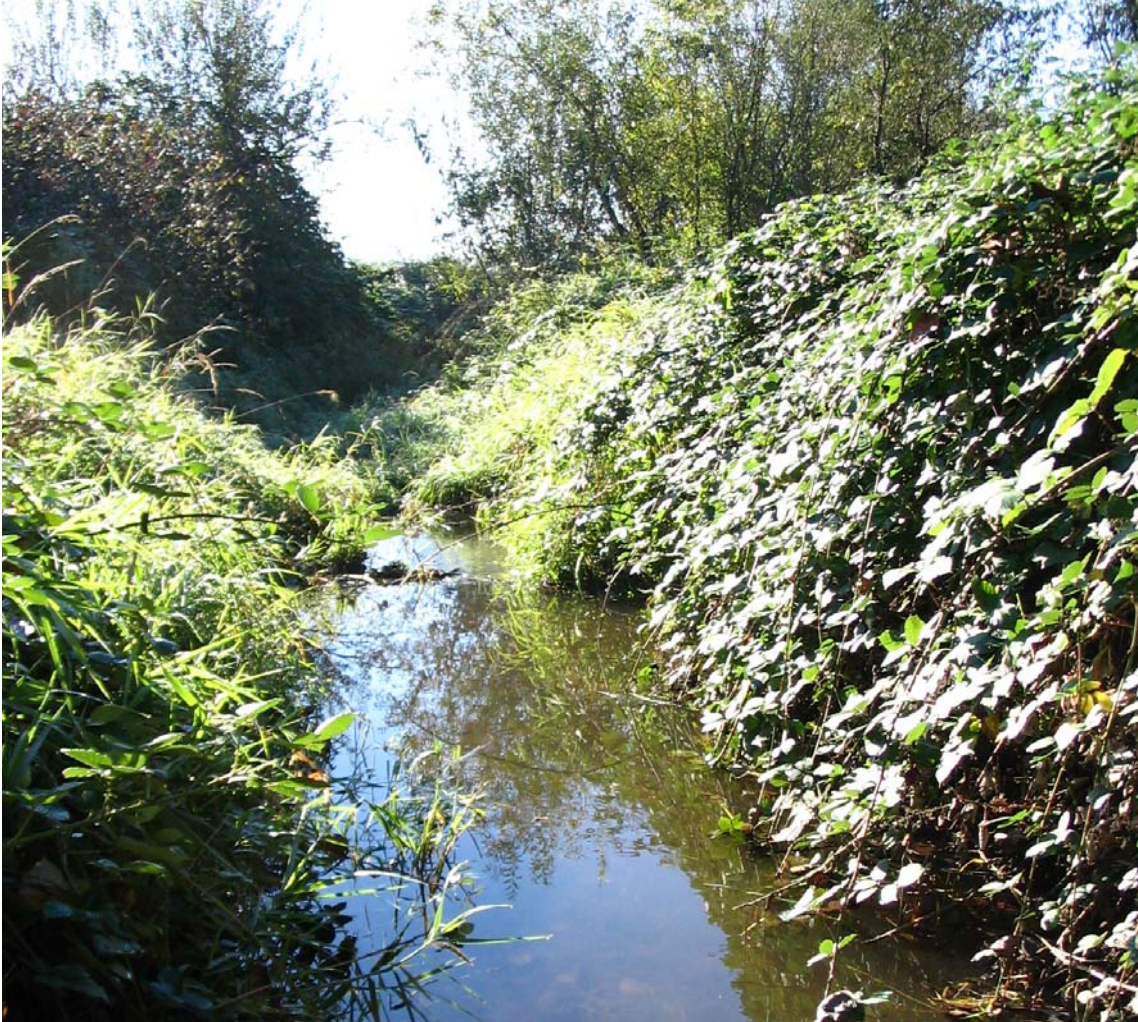
**Figure 4. 34. Photo looking downstream in Dean Creek showing dominance of invasive vegetation including Reed Canary grass and Himalayan blackberry.**

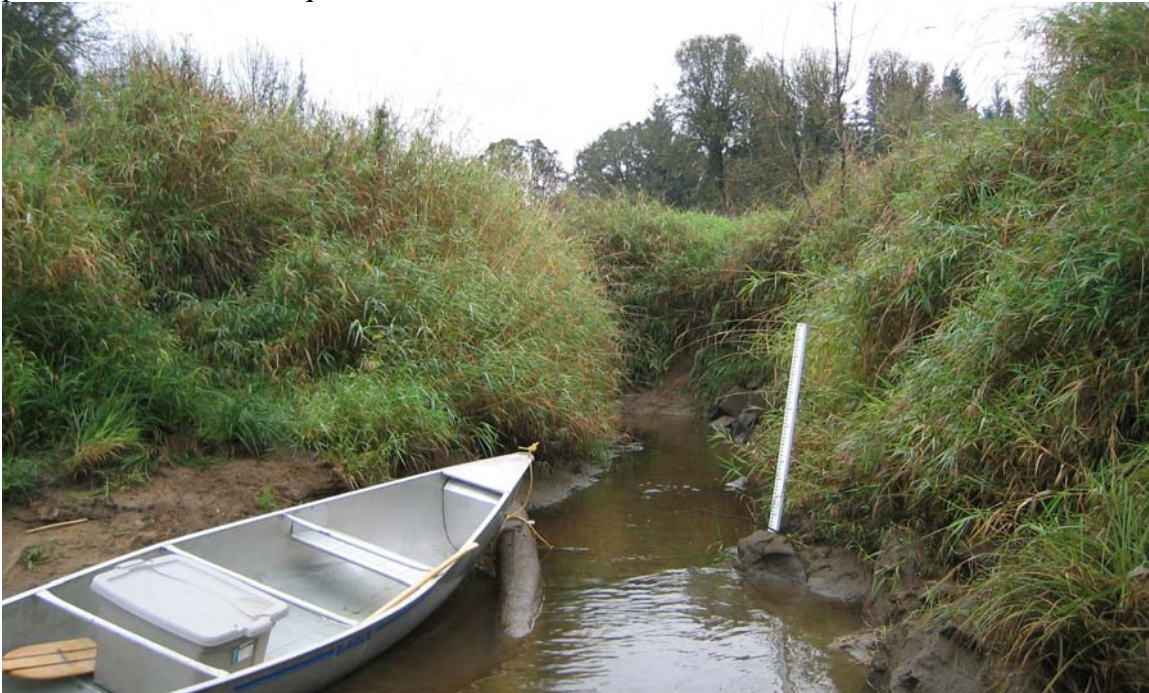
**Figure 4. 35. Photo of mouth of McCormick Creek illustrating severe entrenchment and predominance of reed canary grass. Entrenchment here is approximately 1.7m. Entrenchment drops to 1.0m at upper end of survey.**

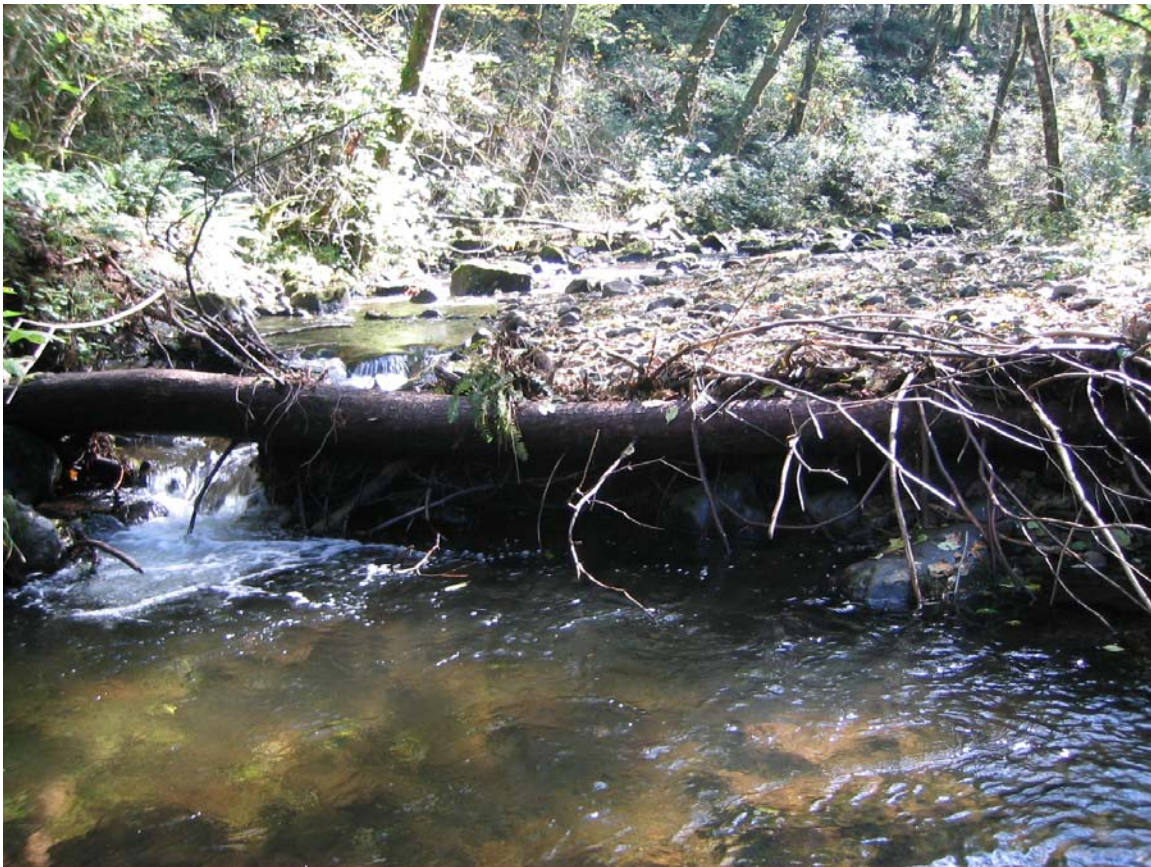
**Figure 4. 36. Photo of conifer felled by beavers creating a plunge pool and storing spawning size substrate above (King Creek).**

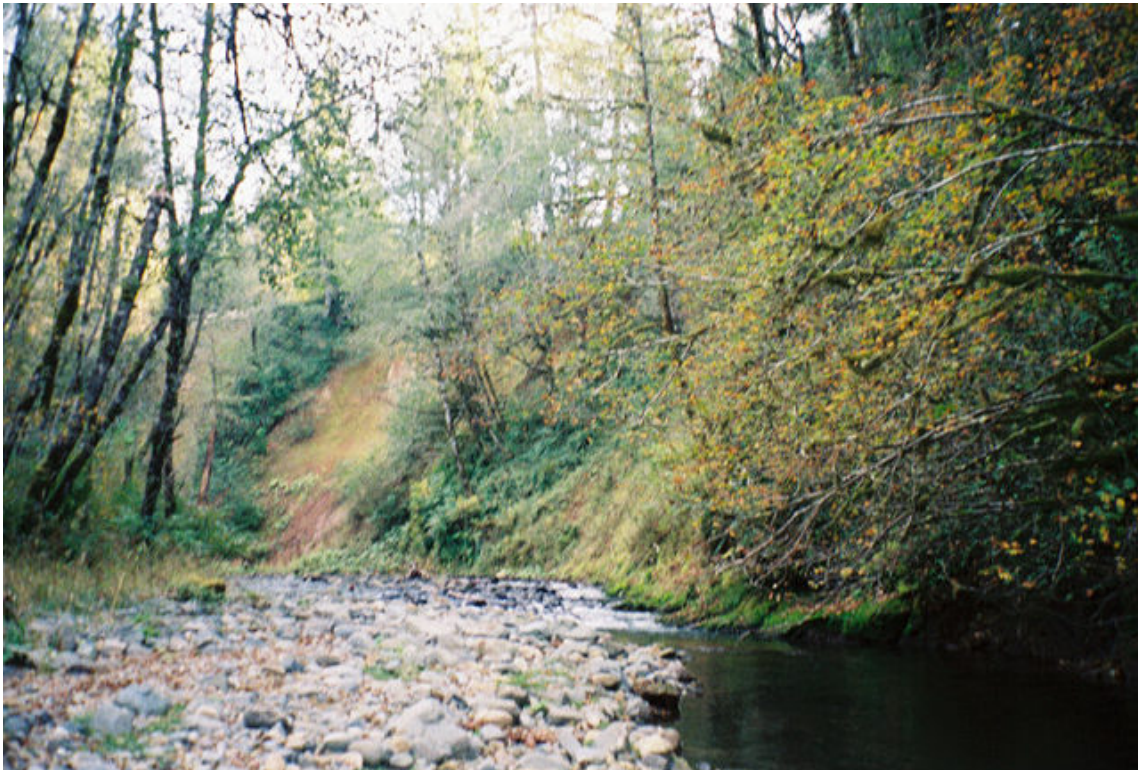
**Figure 4. 37. Looking upstream at a road related landslide (left) on Rock Creek upstream of the Dole Valley Road crossing. The slide is the result of the failure of the Dole Valley Road bed and is actively contributing fine and coarse material to Rock Creek.**

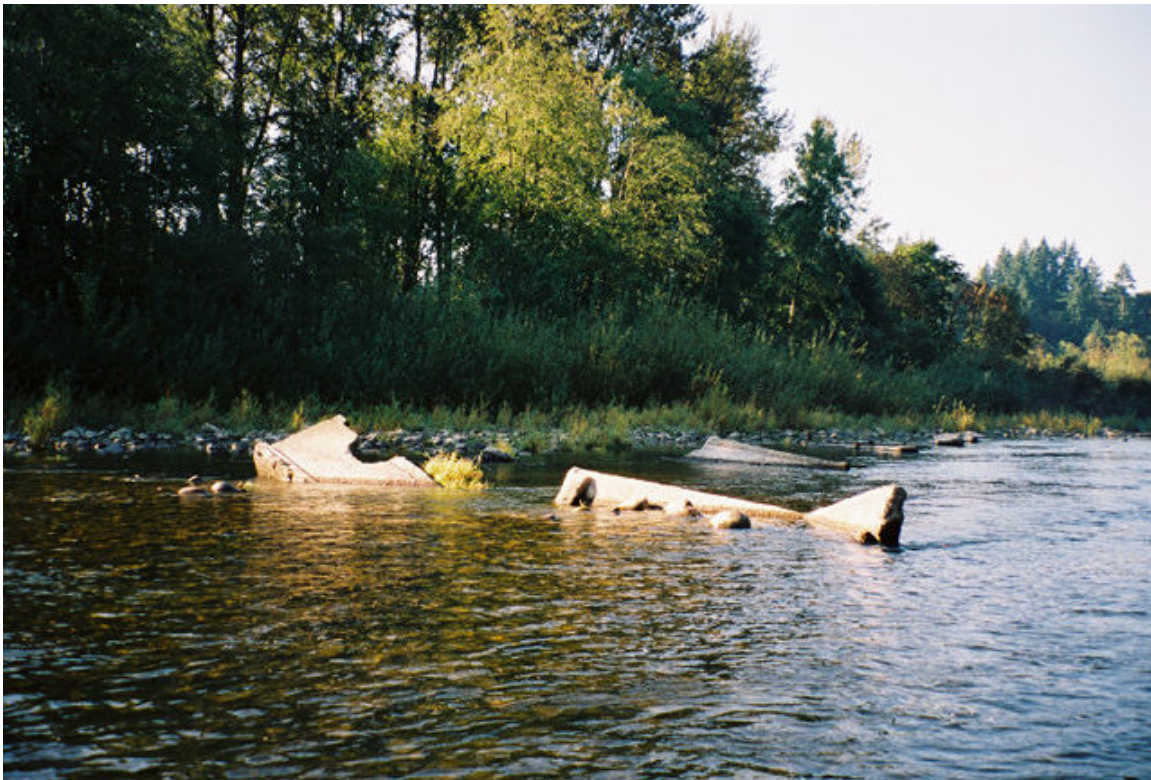
**Figure 4. 38. Sections of concrete in mainstem EF Lewis River just downstream of Daybreak Bridge.**

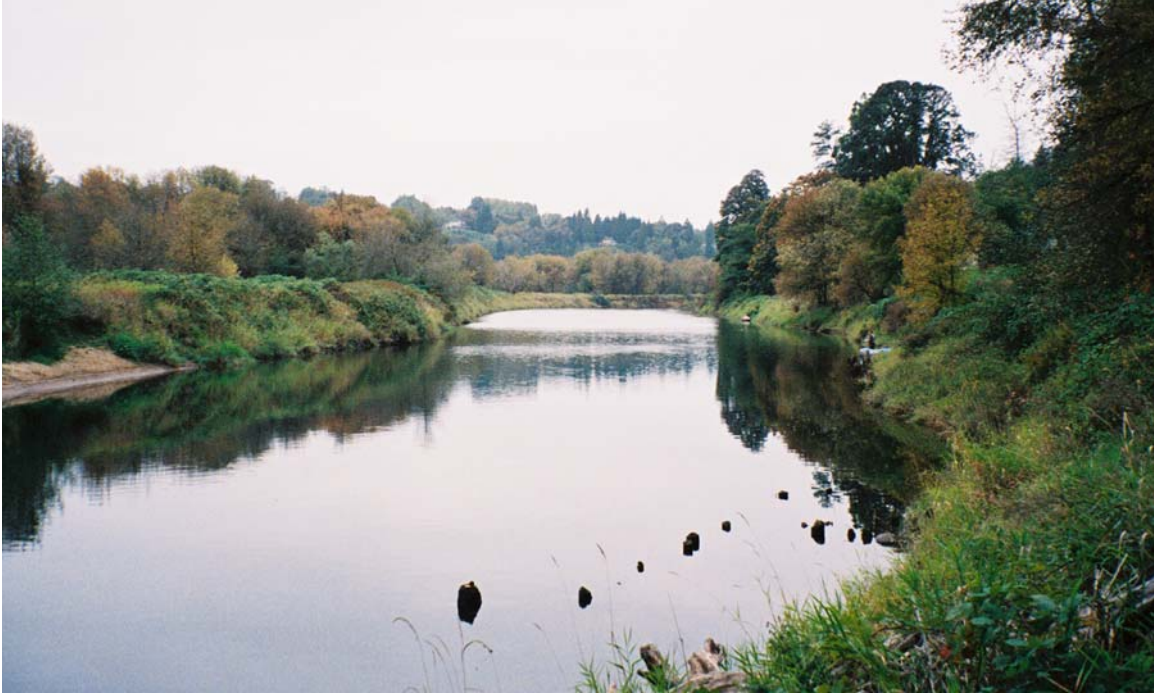
Figure 4. 40. Photo of the lower East Fork Lewis River. This type of habitat is typical of the tidally influenced reaches (EF Lewis 1-4). Photo taken September 2004.

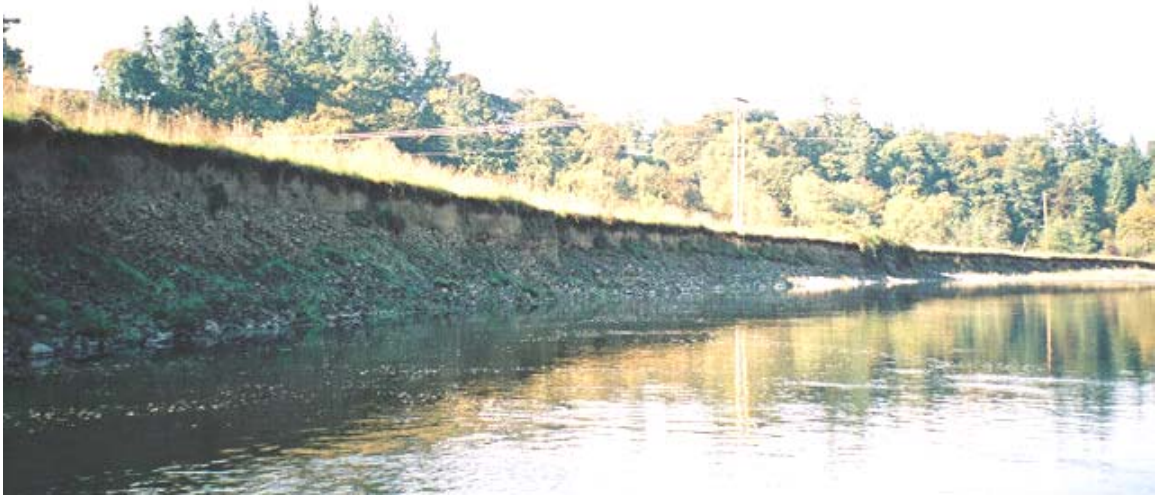
**Figure 4. 48. Photo of eroding streambank in reach 8A (RM 9.7).**

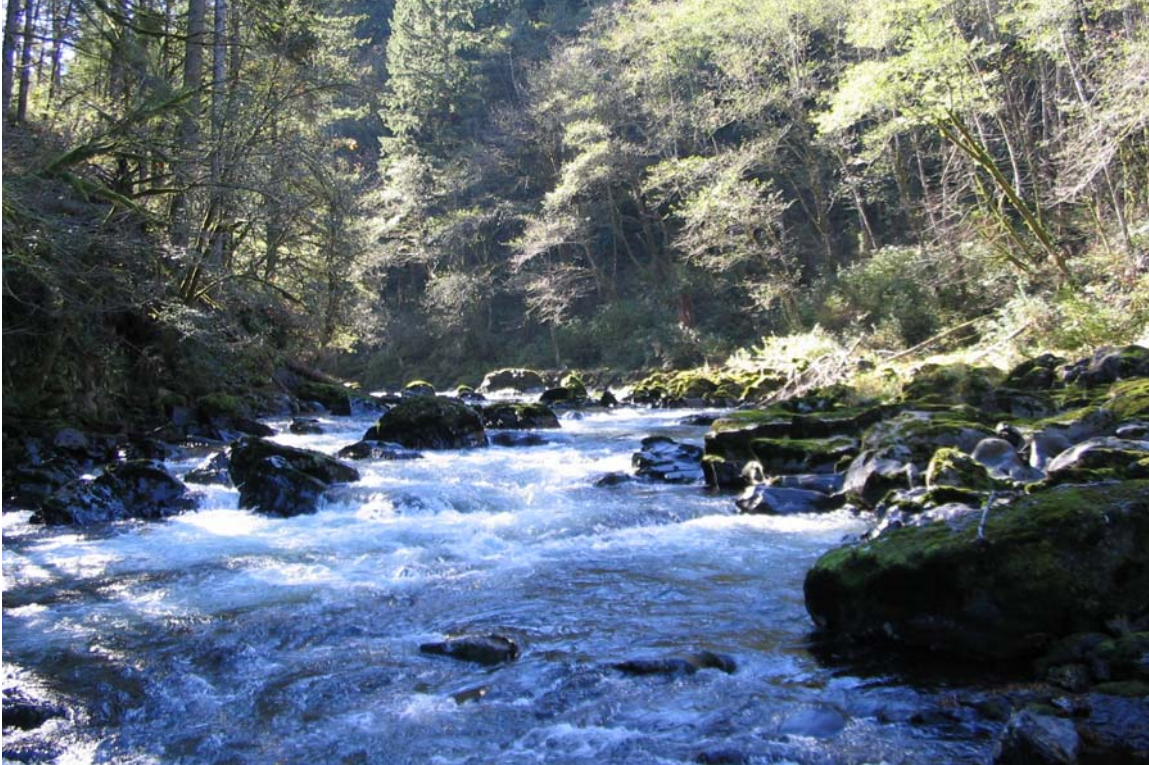
**Figure 4. 52. Photo of the East Fork Lewis River reach 13.**

The East Fork Lewis River in reaches 11, 13, and 15 is moderate gradient (0.8 – 1.7%) and is confined in many places by bedrock walls or steep valley walls. Mean widths range from 16.8m to 24.0m and average riffle depth ranges from 0.9m to 2.4m (Table 4. 44). Pools are most frequent in reach 15 and all of the pools are greater than 1.0m deep. The confinement of the reaches inhibits the formation of side channels.

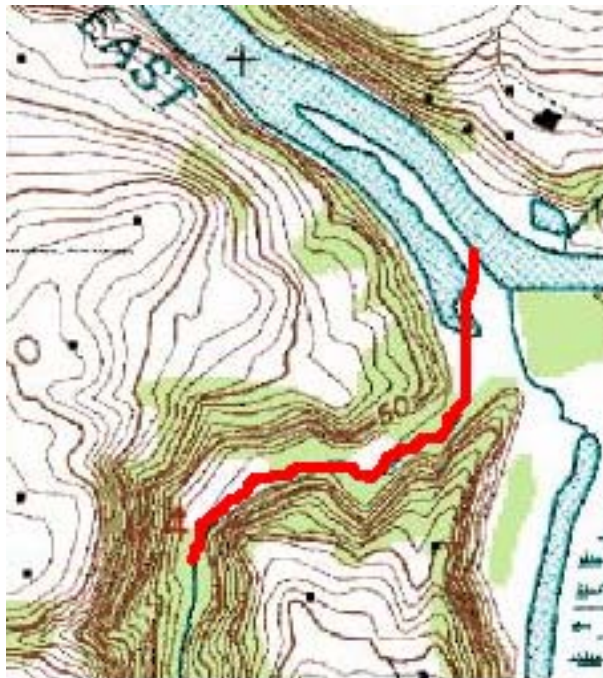
**Figure 4. 58.** USGS topographic map of McCormick Creek highlighting the stream survey area. Survey length is 0.9 kilometers. The stream channel no longer enters the East Fork Lewis as depicted by the USGS map, which shows the stream entering the large back channel. The highlighted survey area more accurately reflects the location of the stream, which bypasses the back channel and enters the main channel of the East Fork Lewis directly.

McCormick Creek is located in Clark County approximately 1.5 km west of the town of La Center, WA and enters the East Fork Lewis at Rkm 3.7 (RM 2.3). McCormick Creek was surveyed on October 8 from the mouth upstream 0.9 km, representing 22% of the EDT McCormick Creek reach (Figure 4. 58). A modified version of the USFS Region 6 Level II Stream Survey Protocol was used for the survey (USFS 1999). A stream temperature of 13.6°C was recorded at 09:30 AM. Clark County owns the property along the survey reach and land-use is unmanaged grassland and timber.

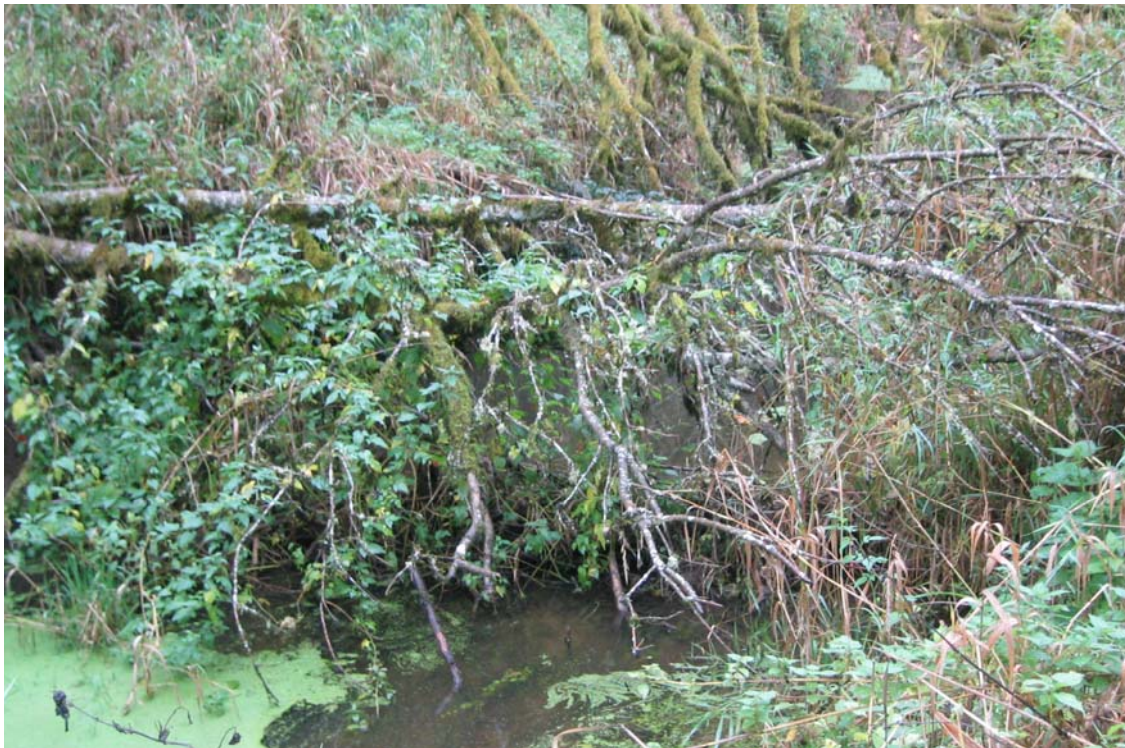
**Figure 4. 60. Photo of a tree that has fallen but is perched above the active channel due to the entrenchment of the stream.**

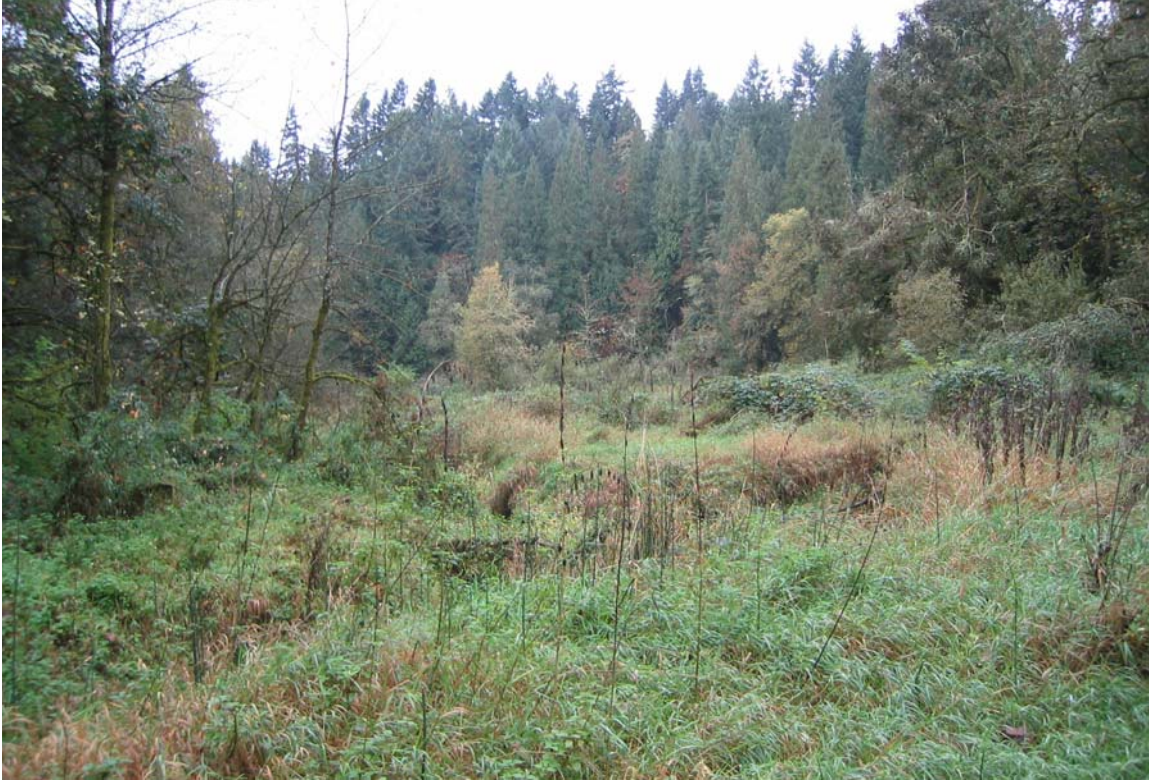
Figure 4. 64. Photo looking upstream at the McCormick Creek valley. Notice the dominance of grasses on the valley bottom and mixed hardwoods and conifers beginning at the valley walls.

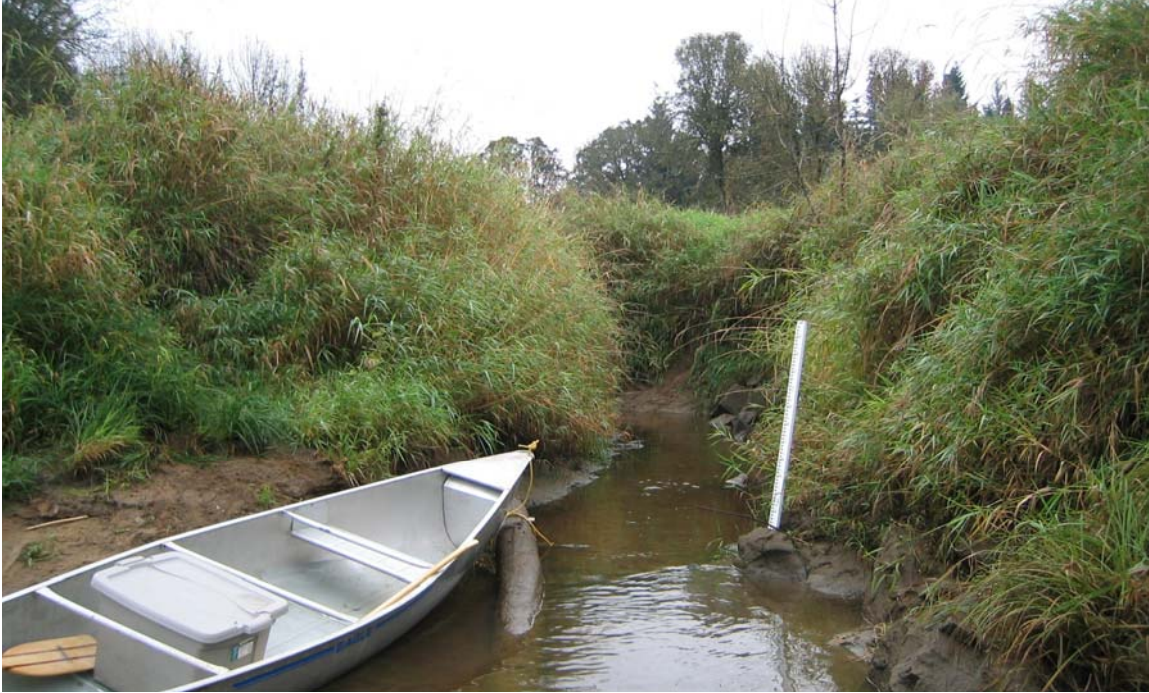
**Figure 4. 65.** Photo of mouth of McCormick Creek illustrating severe entrenchment and dominance of reed canary grass. Entrenchment here is approximately 1.7m. Entrenchment drops to 1.0m at the upper end of the survey.

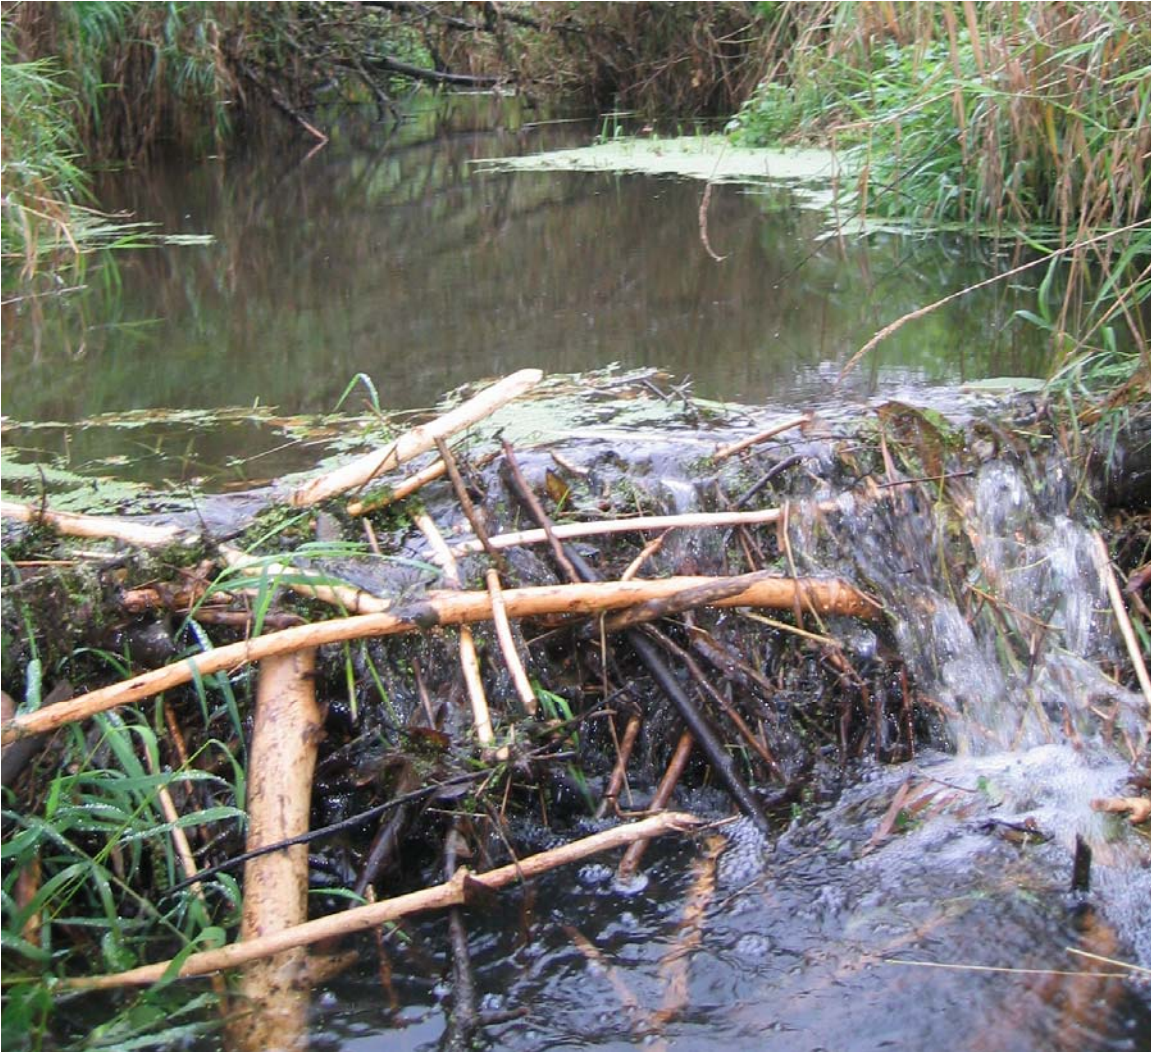
**Figure 4. 66.** Typical beaver dam in McCormick Creek. Dam height above wetted surface is 0.4m.

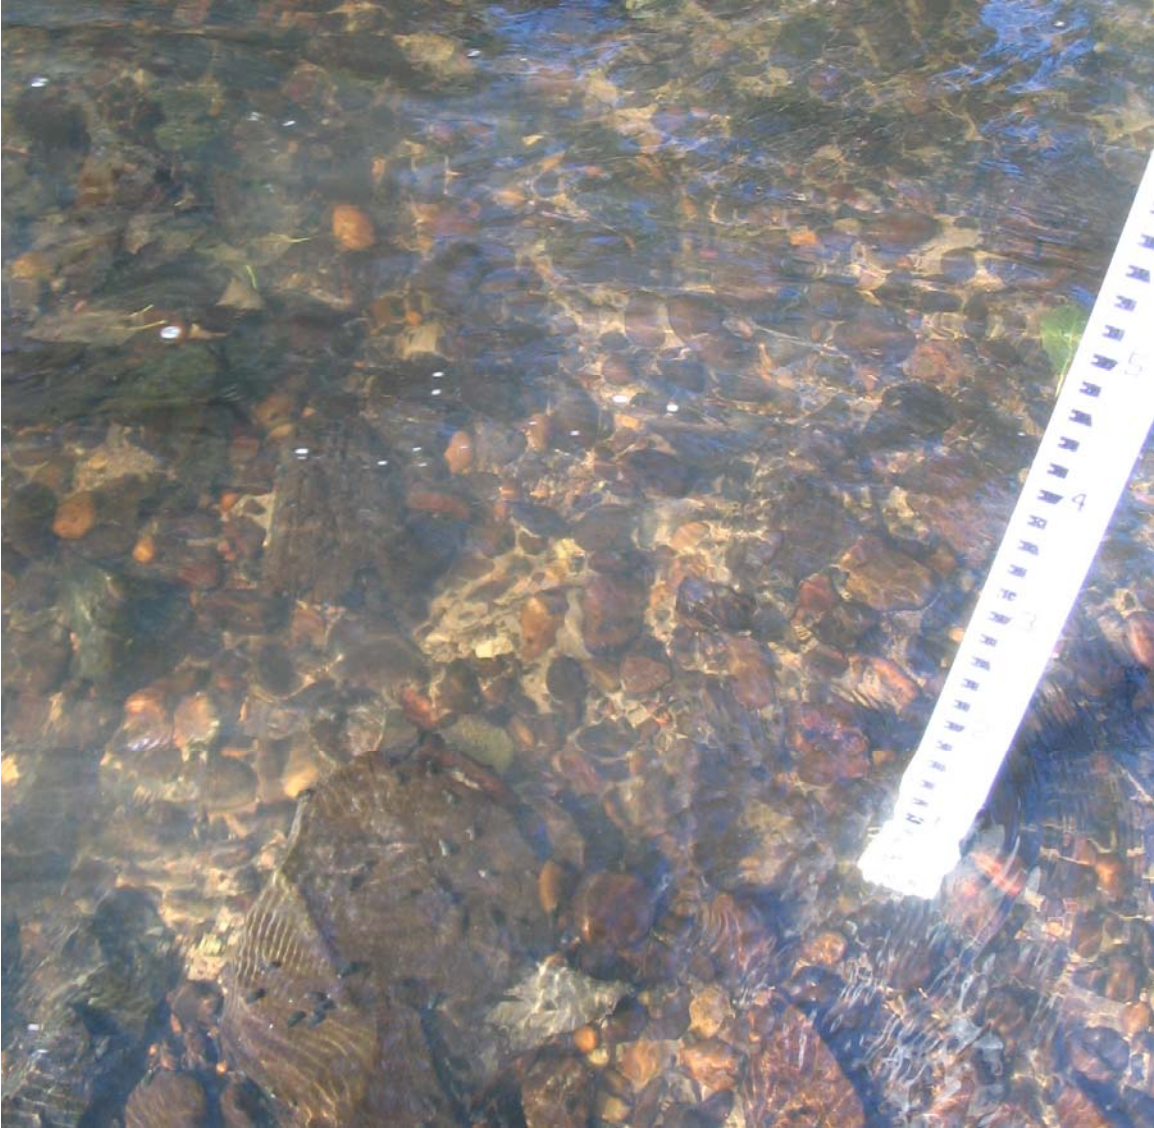
**Figure 4. 71. Photo of substrate in Lockwood Creek showing gravel and cobble substrate embedded with sand.**

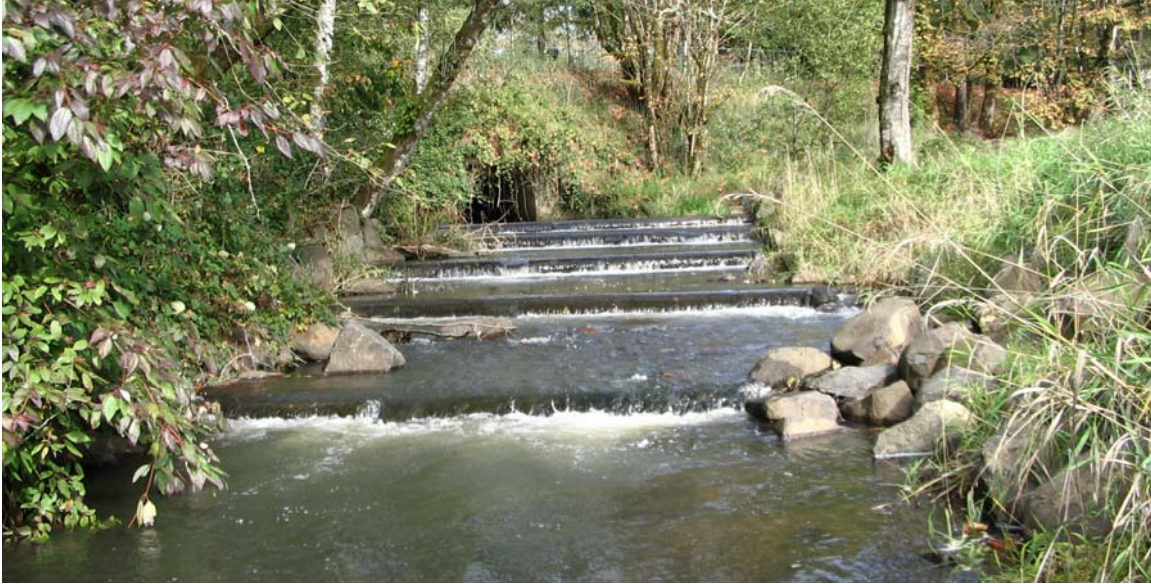
**Figure 4. 74.** Set of weirs set up to improve passage through the County Road 42 culvert. Note rip rap on both banks.

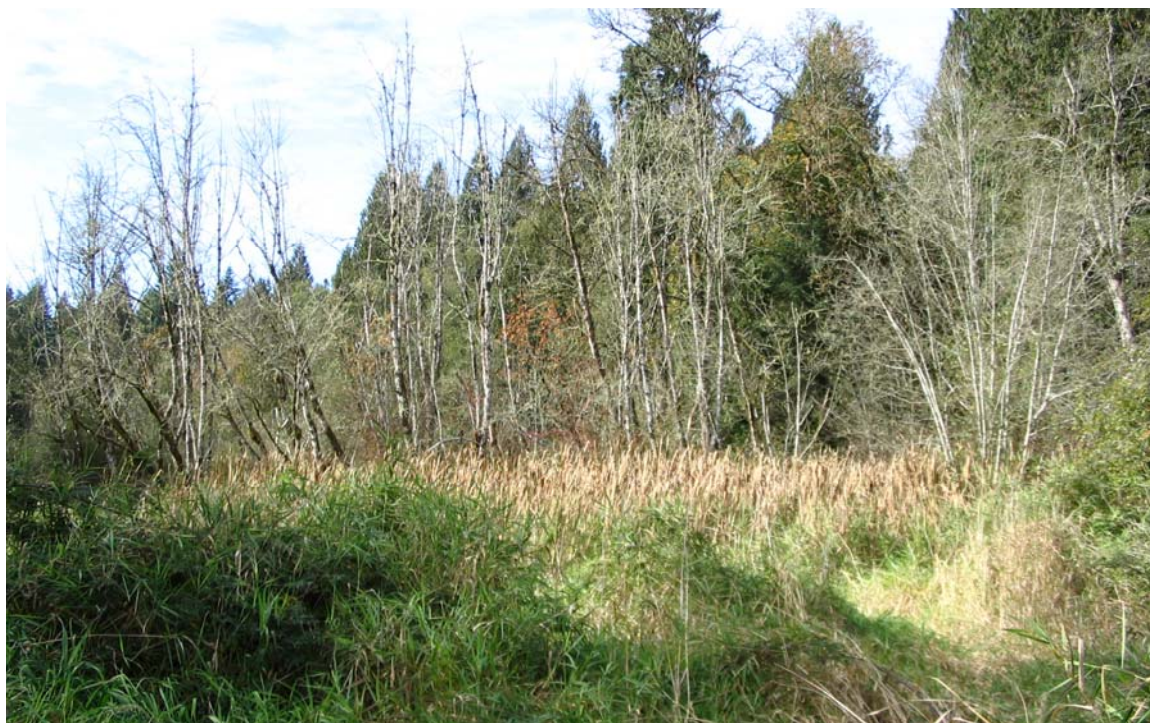
Much of the surveyed area of Lockwood Creek is entrenched. Along the right descending bank, where the valley is broad, there is a significant lowland/wetland area. This area is characterized by vegetation including skunk cabbage, horsetail, cattails, reed canary grass, and alder (Figure 4. 75). Historically, this area was probably frequently inundated and provided important winter rearing habitat. Currently, the entrenchment of Lockwood Creek prevents it from reaching this area in all but the highest flows.

**Figure 4. 75. Photo of wetland area off the right bank along the surveyed section of Lockwood Creek.**
