# CHAPTER 4: EAST FORK LEWIS RIVER BASIN – HABITAT ASSESSMENT

*Survey on Rock Creek (upper) in the East Fork Lewis River Basin – October 2004*

## **Lower Columbia Fish Recovery Board**

## **SP Cramer & Associates, Inc.**

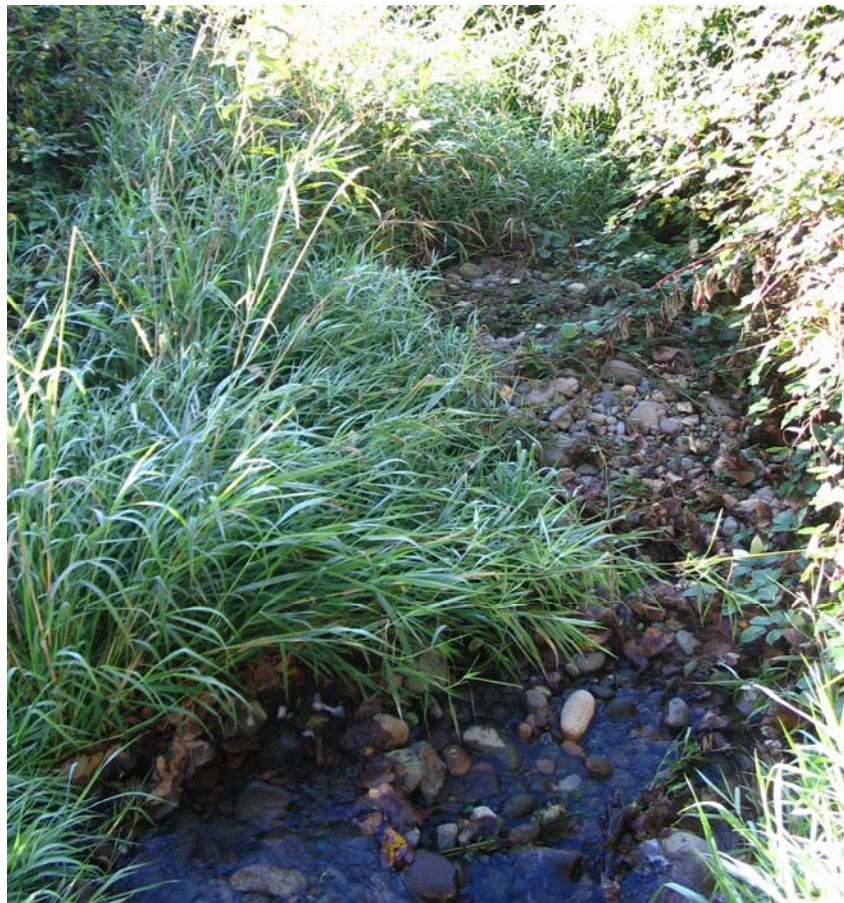
**Figure 4. 83. Photo showing Dean Creek at the upstream end of the survey. Note the prevalence of reed canary grass and Himalayan blackberry. The stream is flowing underneath the Himalayan blackberry on the right side of the picture.**

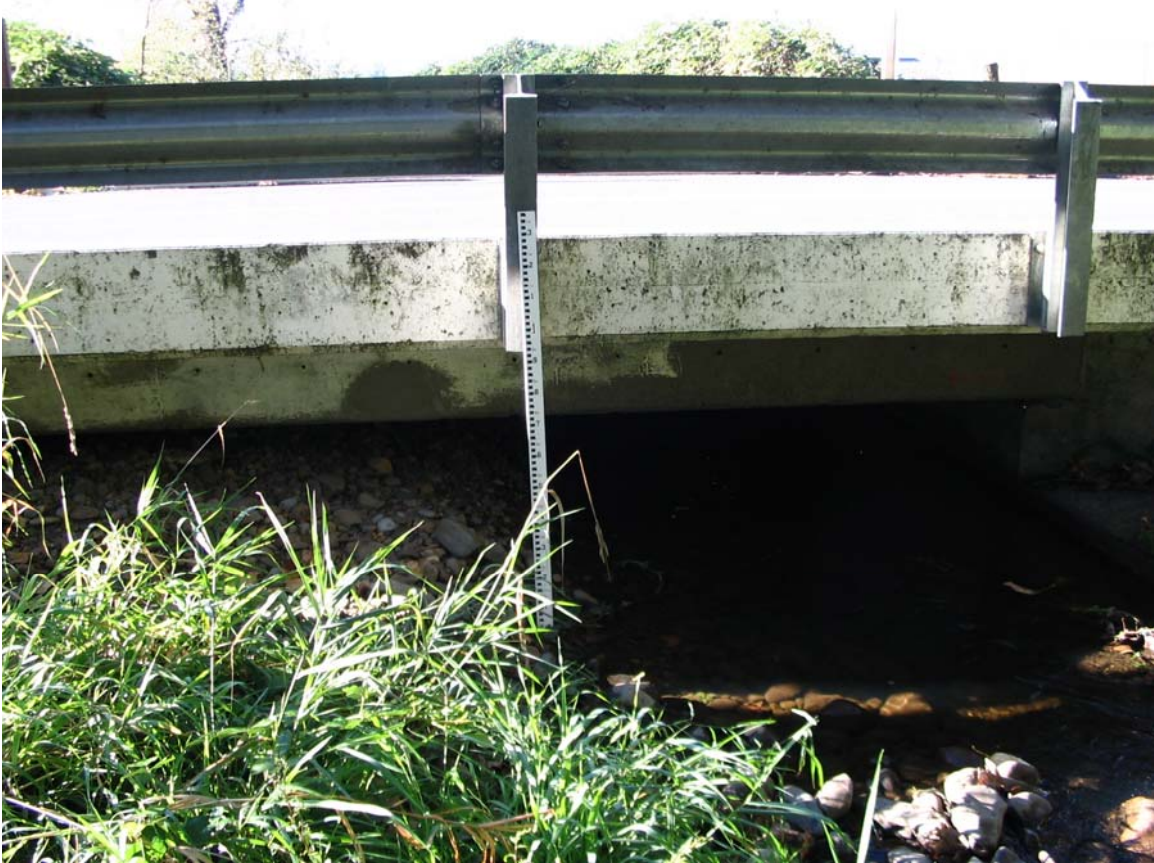
There is a bridge crossing at the upstream end of the survey area that may be too small for the stream. At the time of the survey, the bridge was only 0.6m above the wetted surface of the stream, and only 0.2m above the bankfull mark. (Figure 4. 84).

**Figure 4. 84.** Picture of bridge over Dean Creek at the upstream end of the survey area.

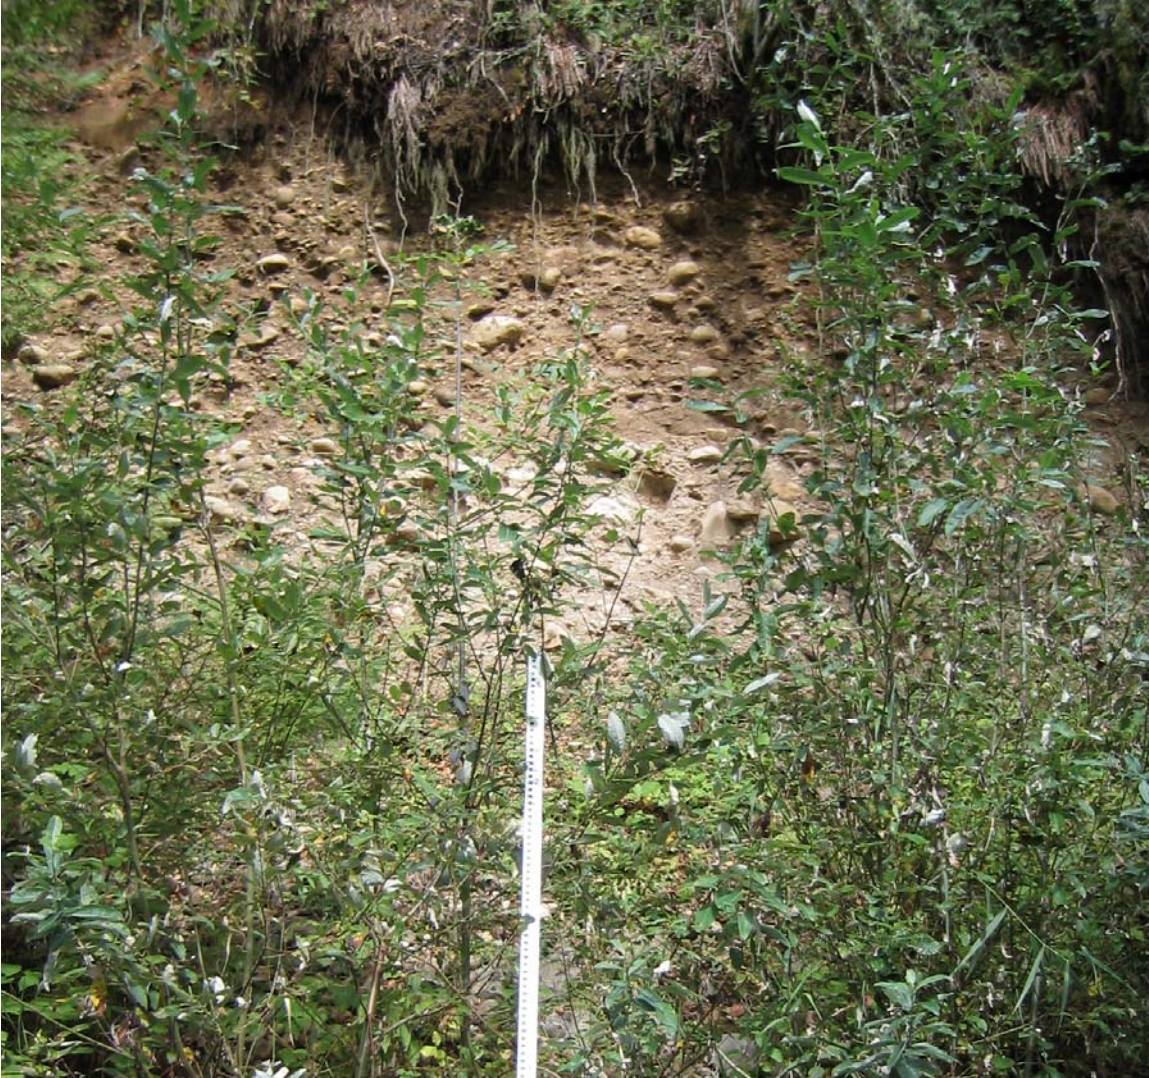
Figure 4. 91. Actively eroding bank of Lower Rock Creek contributing fines, gravel and cobble to the stream.

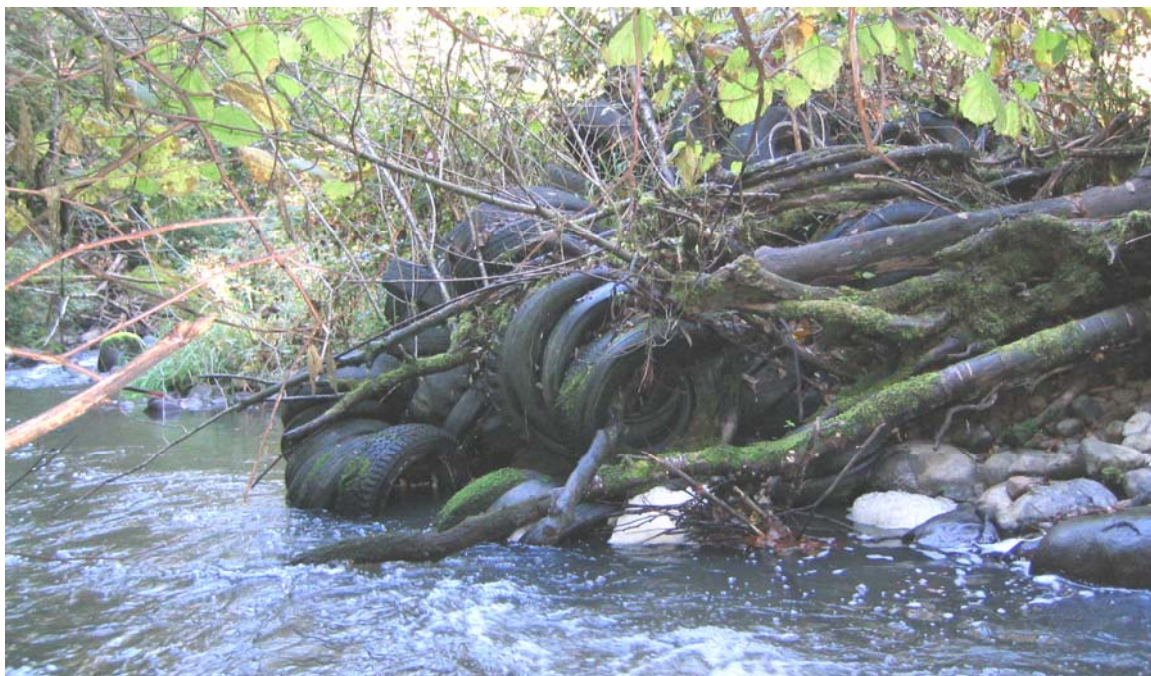
**Figure 4. 92.** Photo of tire mass in Lower Rock Creek. Mass has formed the pool along the left side of the picture, and an ephemeral side channel off to the right side of the picture.

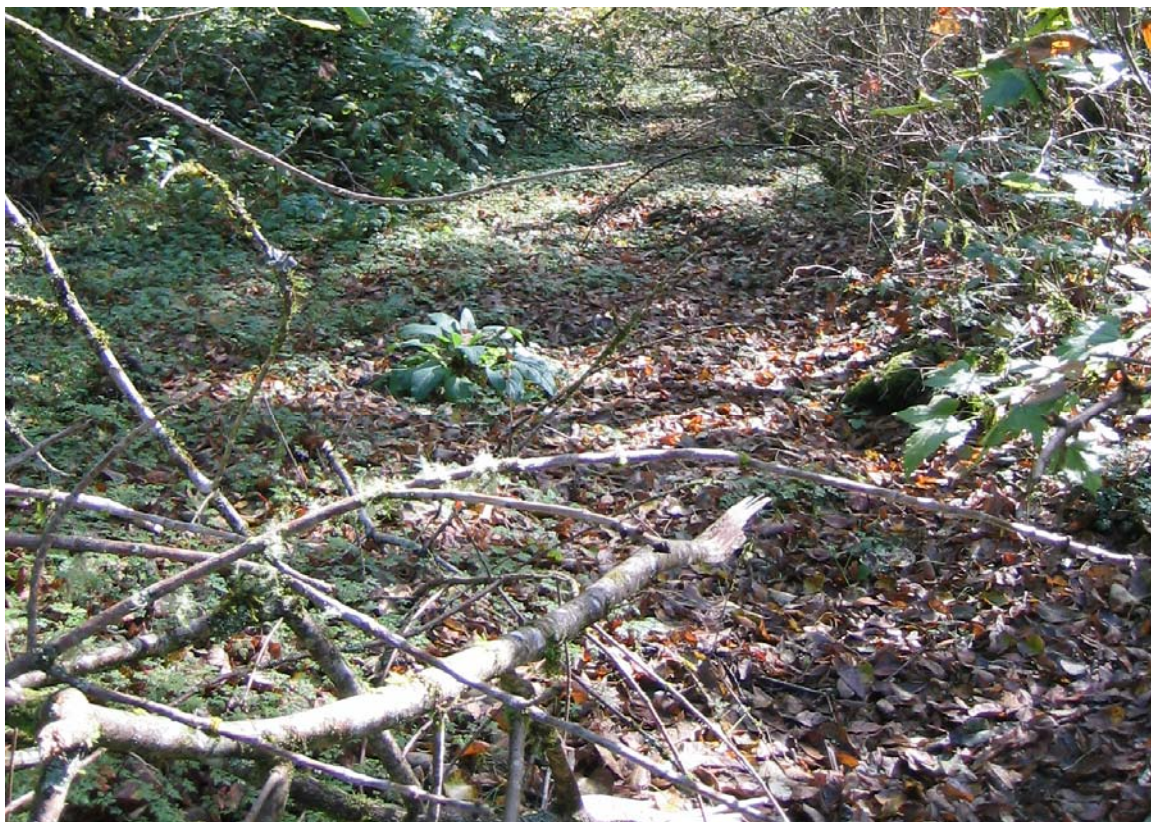
**Figure 4. 93.** Lower end of newly forming side channel created by tire mass.

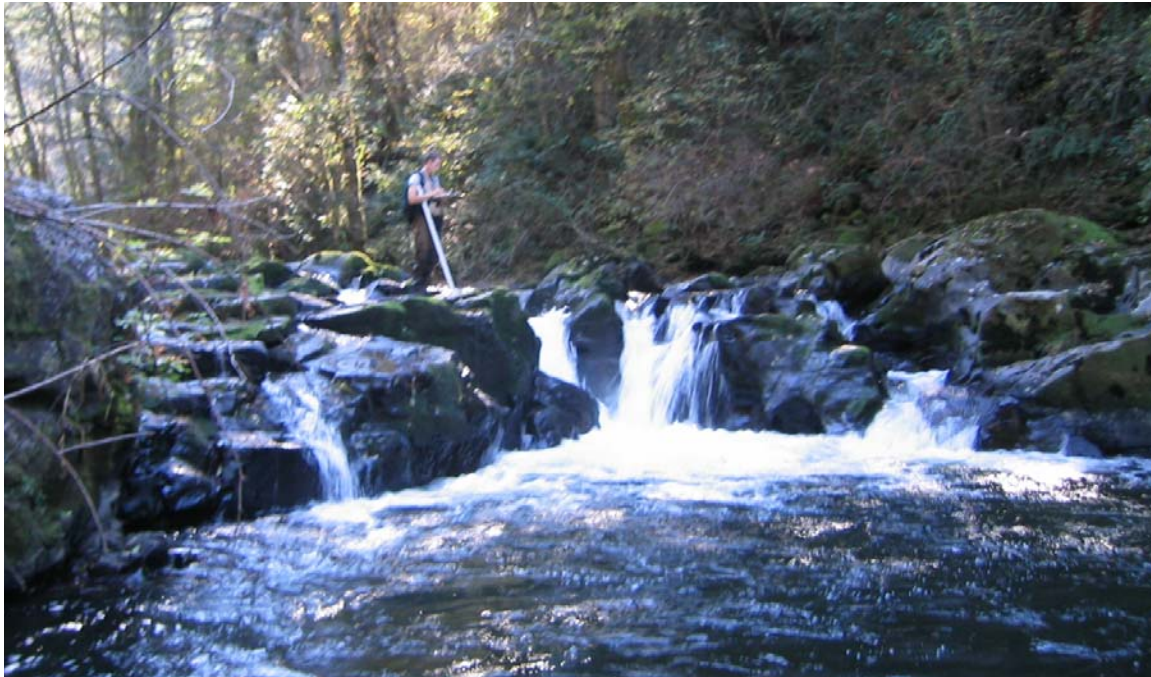
**Figure 4. 103. Two meter high falls in Rock Creek reach one between NSOs three and four.**

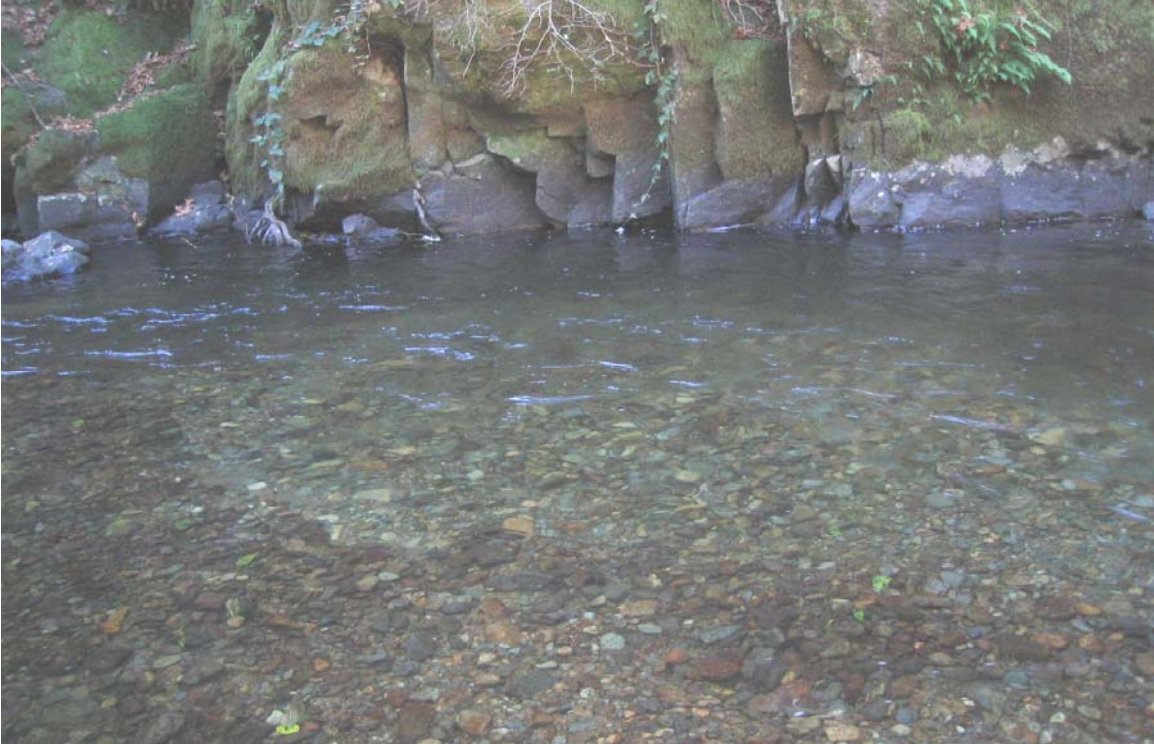
**Figure 4. 104. Redd observed in the tailout of the pool below the falls in Rock Creek reach 1. Redd measures 3.5m long and 2.5m wide. Photo taken in October 2004.**

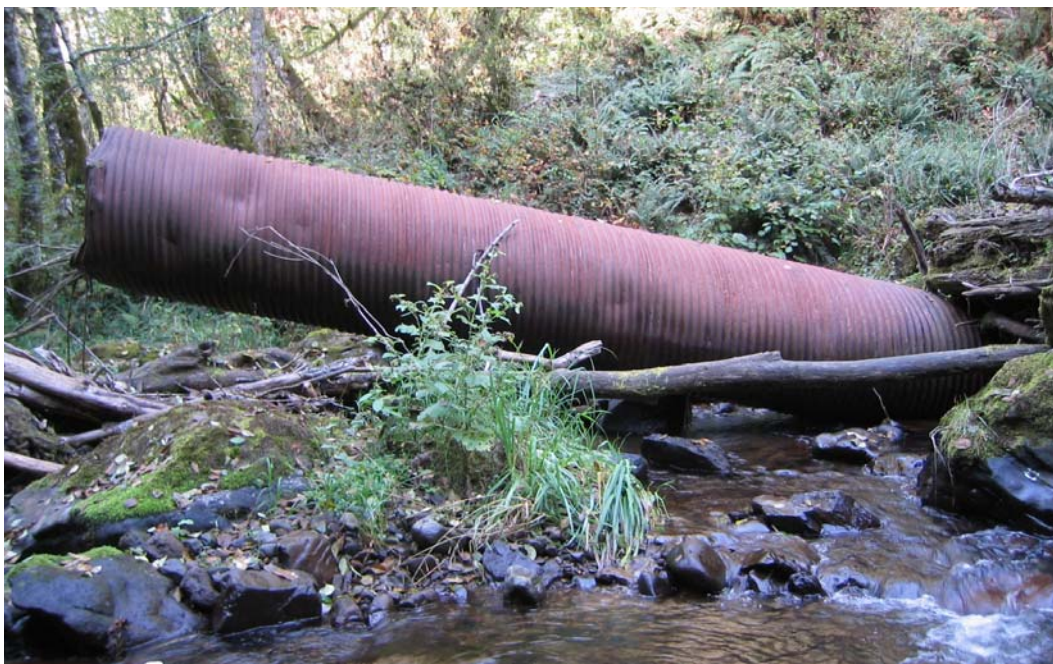
**Figure 4. 111.** Photo of washed out culvert in the stream channel approximately 1000m from the mouth of King Creek.

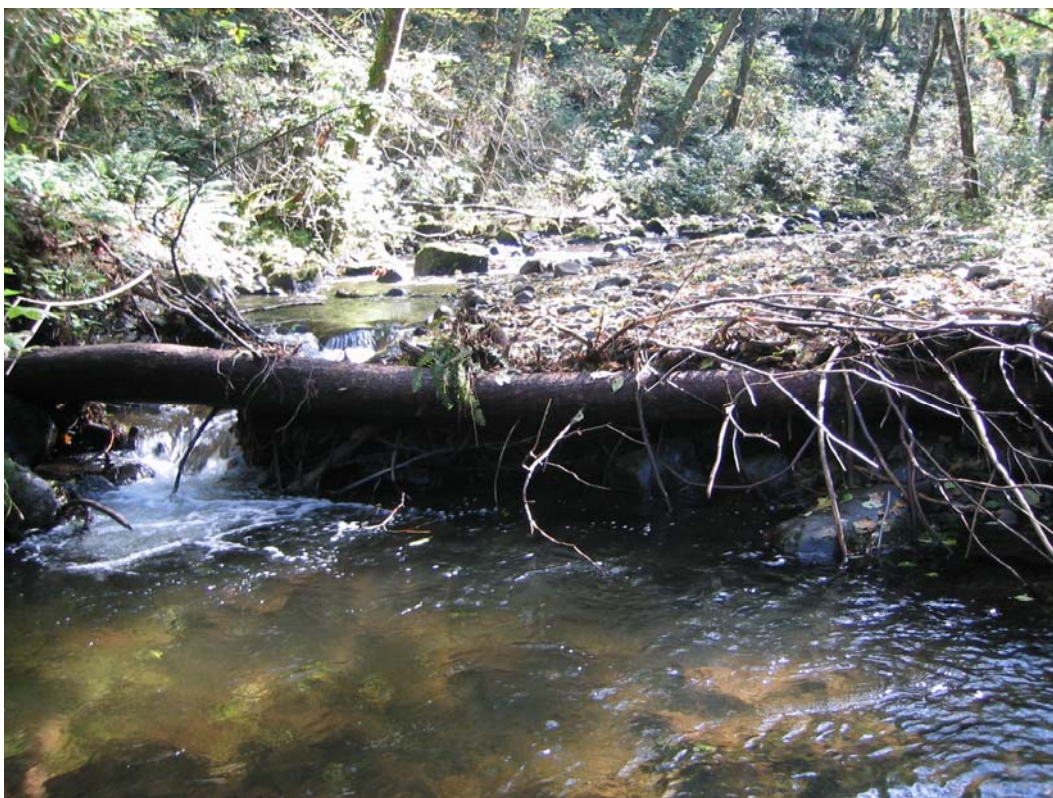
Three adult steelhead (*O. mykiss*) and beaver (*Castor canadensis*) activity were seen in the reach. Near one tributary junction, beavers had felled a conifer that spanned the channel and has created a plunge pool below the log, which has held spawning size substrate above the log (Figure 4. 112).

**Figure 4. 112.** Photo of conifer felled by beavers creating a plunge pool and storing spawning size substrate above.

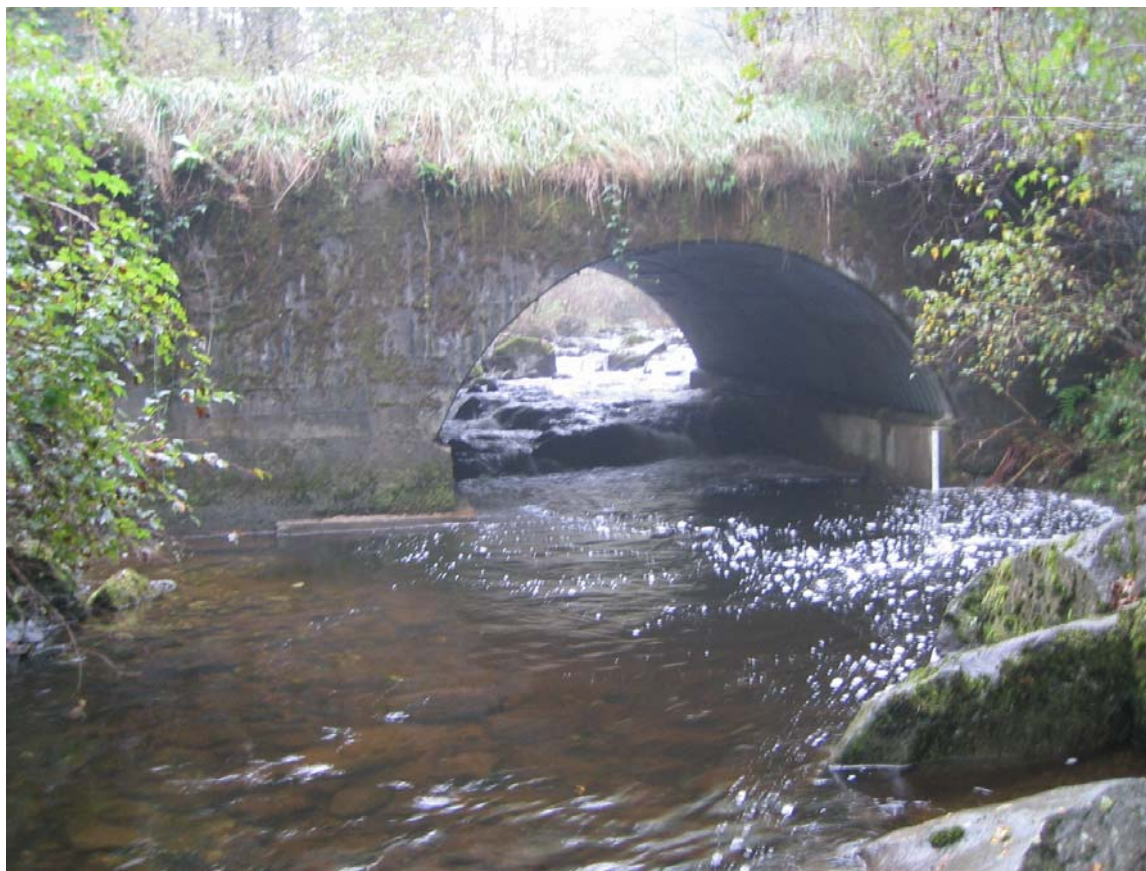
**Figure 4. 120.** Picture of culvert beneath USFS Road 42, 66m upstream from the mouth of Slide Creek.

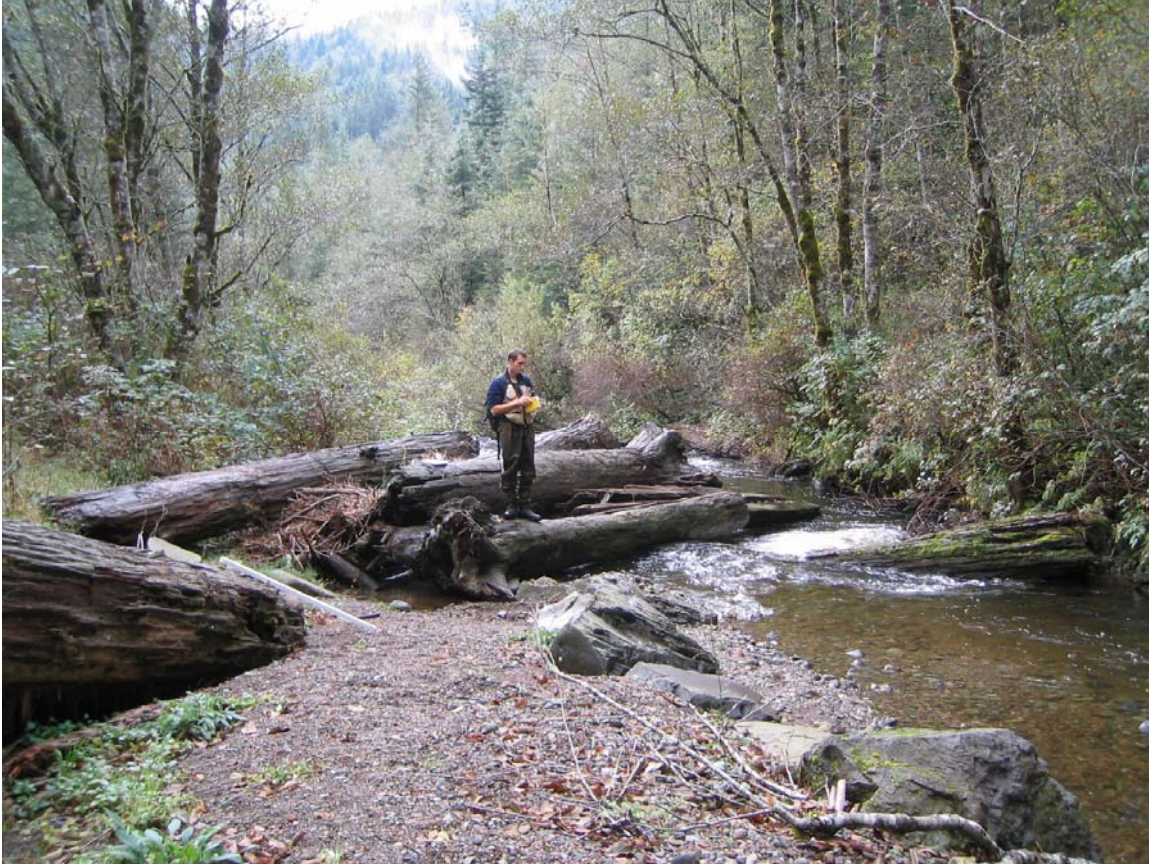
**Figure 4. 121. Photo of stream restoration activity in lower Slide Creek (view looking downstream). Note buildup of cobbles and gravels upstream of engineered jam and formation of pools both above and below the jam. The de-commissioned road is approximately 5m off to the left of the picture.**
