2009 Stormwater Needs Assessment

**Upper Burnt Bridge Creek
Middle Burnt Bridge Creek**

Upper Burnt Bridge Creek/Middle Burnt Bridge Creek
Subwatershed Needs Assessment Report

March 2010

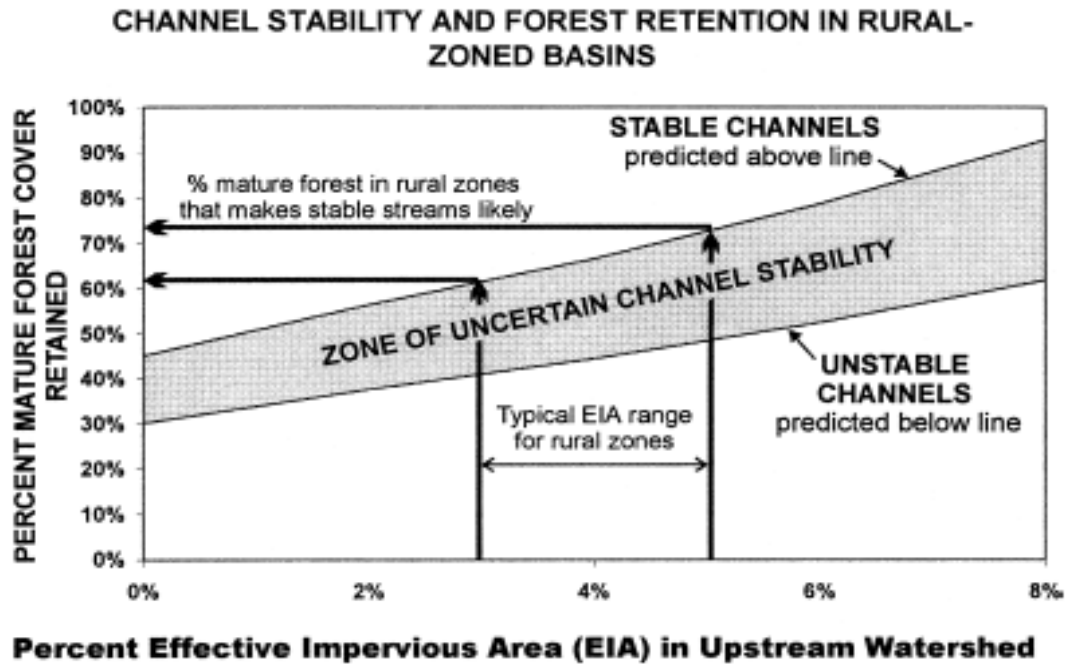
Figure 2: Channel stability in rural areas (Booth, Hartley, and Jackson, June 2002)

In a recent publication by Booth, Hartley, and Jackson (June 2002), a relationship between forest and percent EIA was presented as a graphic (Figure 2). According to this figure, streams in both subwatersheds would be expected to have very unstable channels.

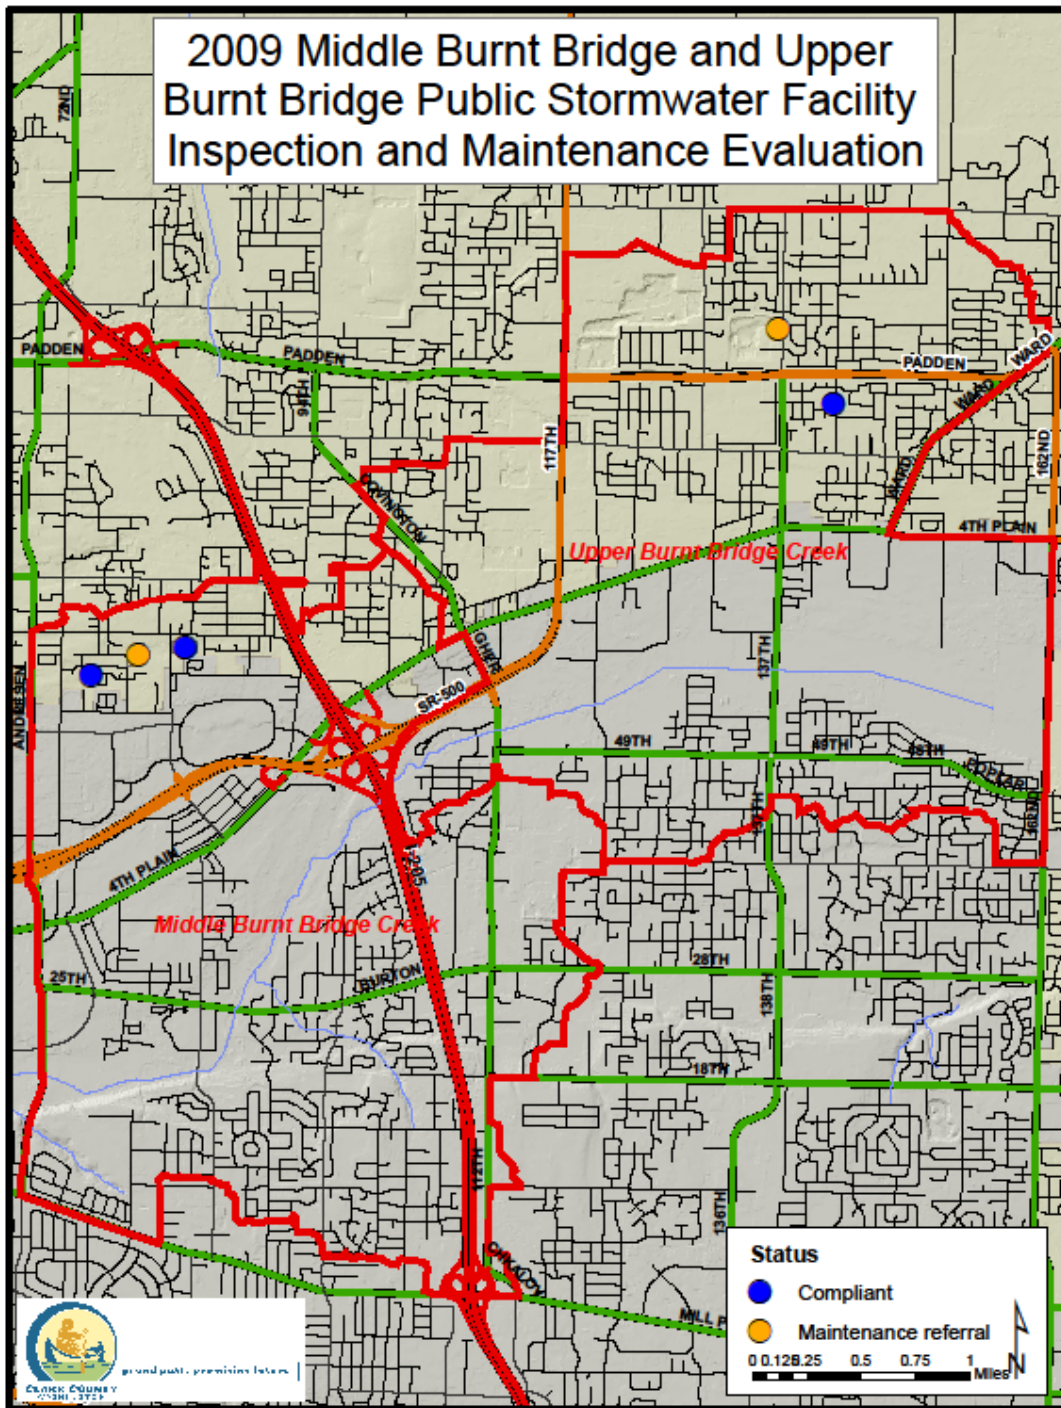
Figure 4: Summary of 2009 Public Stormwater Facility Inspection and Maintenance Evaluation Activities in the Middle and Upper Burnt Bridge Creek subwatersheds

Figure 4 summarizes notable inspection and maintenance evaluation activities in the Middle and Upper Burnt Bridge Creek subwatersheds, including general facility location, compliant facilities, and referrals of noncompliant facilities.

Five public stormwater facilities were inspected in the Middle and Upper Burnt Bridge Creek subwatersheds. Two facilities were found to be out of compliance and three facilities were found to be in compliance. As listed in Table 8, these facilities included a total of 35 facility objects, of which 33 (94 percent) were in compliance.

No major defects or hazardous conditions were discovered in the Middle and Upper Burnt Bridge Creek subwatersheds; non-compliant issues included excess sediment depth and lack of signage.

The inspection process in the Middle and Upper Burnt Bridge Creek subwatersheds generated 2 referrals to Public Works Maintenance and Operations for needed maintenance activities.

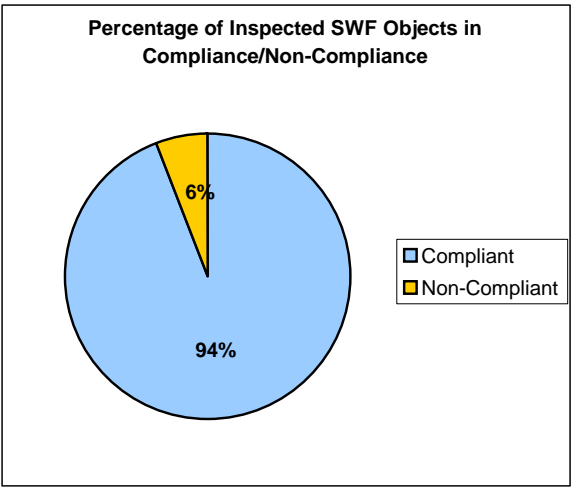
SNAP Public Stormwater Facility Maintenance and Inspection Evaluation		Percentage of Inspected SWF Objects in Compliance/Non-Compliance

Subwatershed: Middle Burnt Bridge Creek and Upper Burnt Bridge Creek				
Public SWF Inspected	5			
Stormwater Facility Objects Inspected	35			
% Compliant SWF Objects	94			
% Non-Compliant SWF Objects	6			
Facility Objects Inspected	Initial Inspections		Most Common Defect	Maintenance Trigger
	Compliant	Non-Compliant		
Access Road or Easement	5	0	n/a	n/a
Catch Basin	2	0	n/a	n/a
Control Structure / Flow Restrictor	1	0	n/a	n/a
Conveyance Stormwater Pipe	7	0	n/a	n/a
Detention Pond	5	0	n/a	n/a
Energy Dissipater	3	0	n/a	n/a
Facility Discharge Point	1	0	n/a	n/a
Fence, Gate or Water Quality Sign	2	1	sign unreadable	water quality sign is missing or 20% of the surface is unreadable
Field Inlet	2	0	n/a	n/a
Open Channel	1	0	n/a	n/a
Sediment Trap	1	0	n/a	n/a
Typical Biofiltration Swale	1	1	sediment	sediment depth exceeds 2 inches on grass

Wetpond	2	0	n/a	n/a
Total	33	2

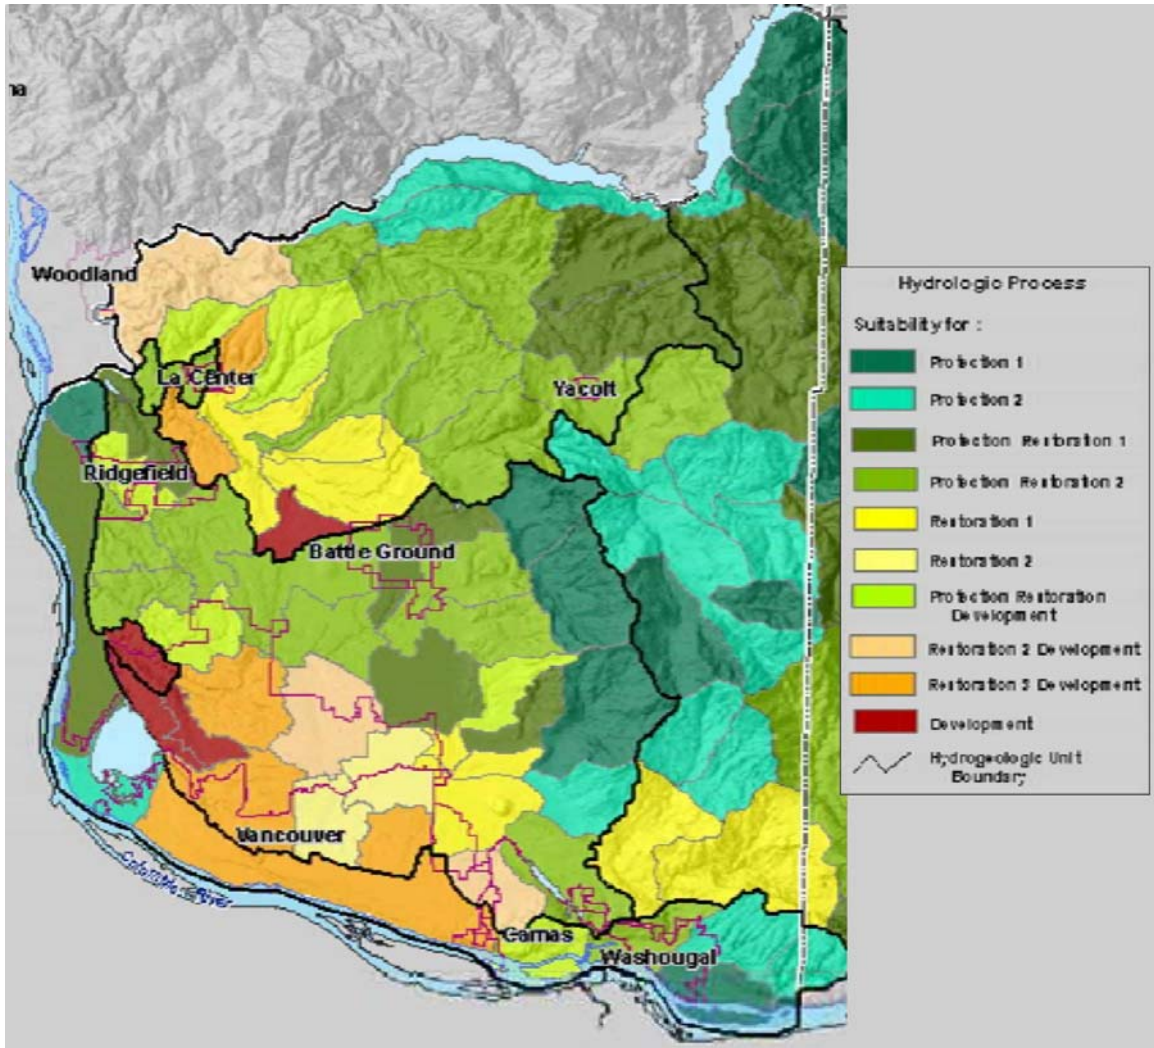
Figure 6: Priorities for suitability of areas for protection and restoration for the hydrogeologic process (from Watershed Characterization and Analysis of Clark County (Ecology, 2009))

Figure 6 depicts priority areas for protection and restoration of hydrologic processes county-wide based on an analysis of the relative importance and level of alteration in each subwatershed.

In general, blue and green areas have higher levels of importance for watershed hydrologic processes and limited alteration and should be considered for protection. Yellow areas have a higher level of importance for watershed processes and a higher level of alteration and should be considered for restoration unless watershed processes are permanently altered by urban development. Orange to red areas have lower levels of importance for watershed processes and higher levels of alteration and should be considered as more suitable for development. Because orange areas represent a transition from restoration areas, planning measures employing both restoration and appropriately sited development should be considered (Ecology, 2009).
