**NORTH FORK TOUTLE RIVER FISH PASSAGE
AND SEDIMENT ASSESSMENT**

Lower Columbia Fish Recovery Board

AMEC Earth & Environmental, Inc.

February 12, 2010

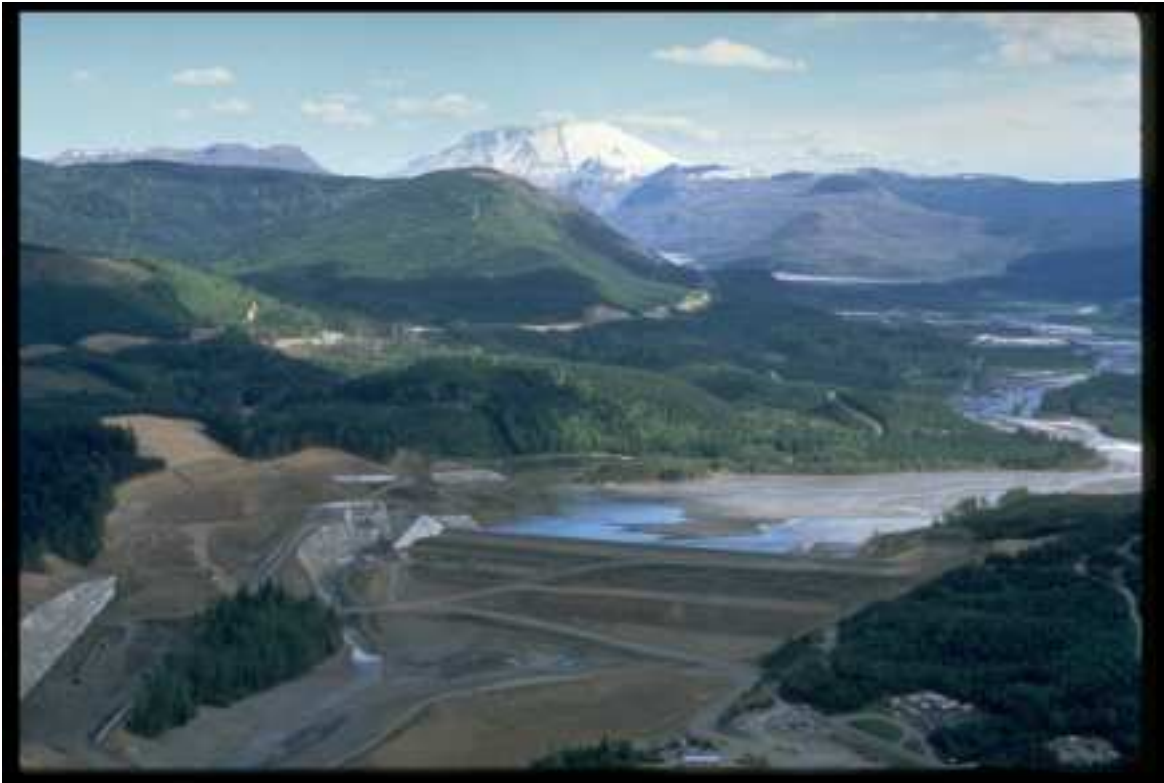
Figure 2 USGS Photograph of the Sediment Retention Structure (SRS) taken in 1989. Photo by Steve Brantley, available from the USGS Cascade Volcano Observatory (<http://vulcan.wr.usgs.gov/Volcanoes/MSH/Images/MSH80/framework.html>).

In 1987, construction began on the North Fork Toutle Sediment Retention Structure (hereafter referred to as the SRS) approximately 5 miles downstream of the original N-1 structure. The SRS consists of a 125-ft high, 1,800-ft long earthen dam (Figure 2), that was designed to impound water, creating a stilling action that allowed sediment to settle out behind the dam. Water was discharged through an outlet structure at the SRS that consisted of six rows of pipes. The rows were successively closed as sediment levels rose. By 1998, the uppermost row of outlet pipes had been closed, and a large sediment plain comprising progressively finer layers of silt and sand formed upstream of the dam. From then on, the North Fork Toutle River was routed through the spillway located at the north end of the SRS.

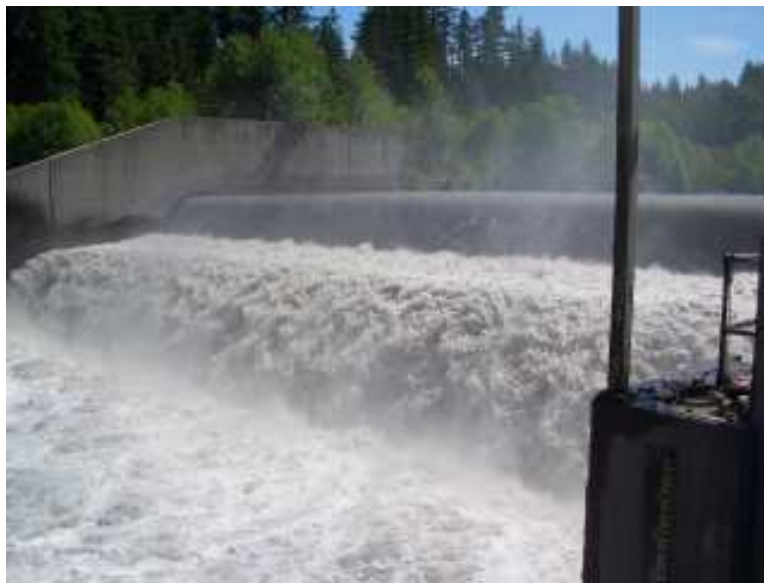
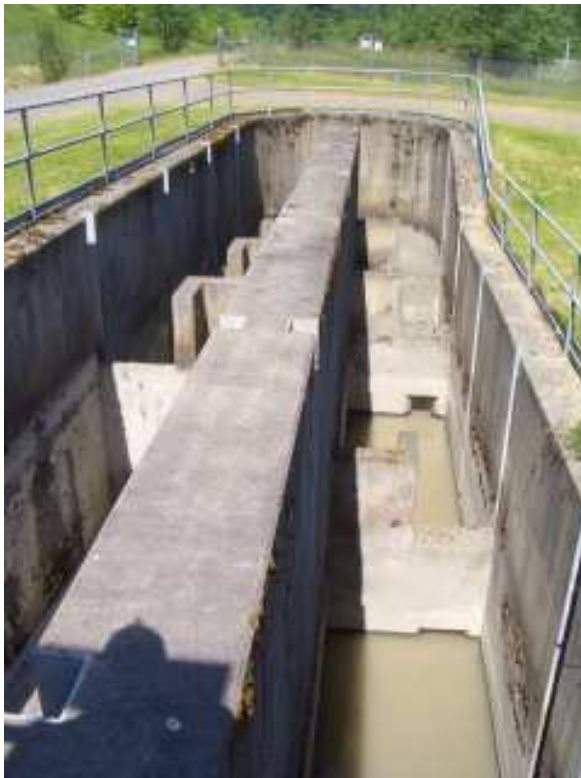
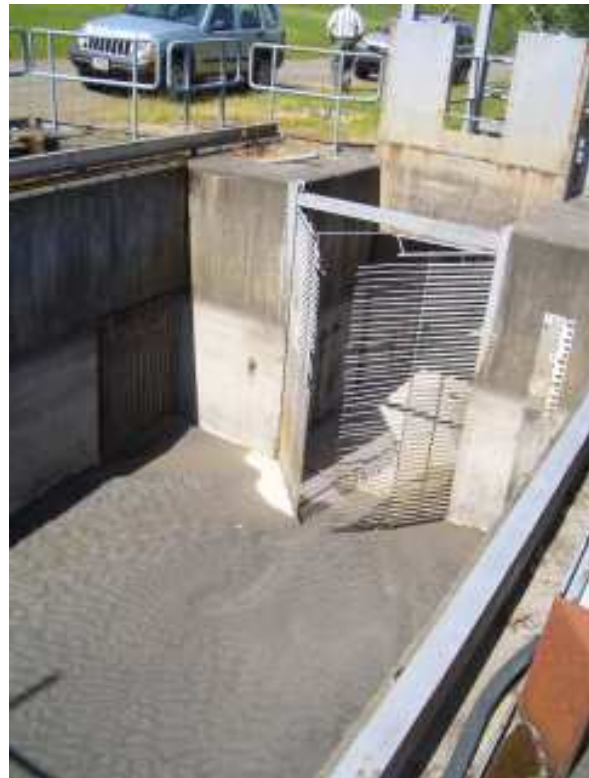
Figure 3 Components of the Fish Collection Facility (FCF). Counter-clockwise from top: the fish barrier dam; fish ladder; and terminal trap.

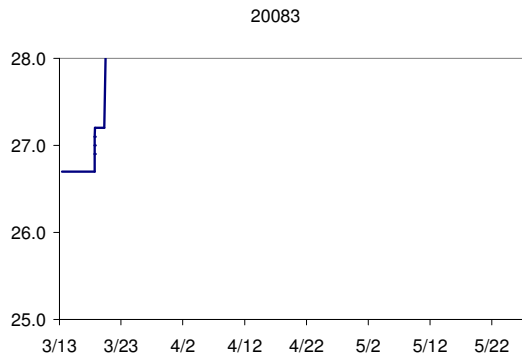
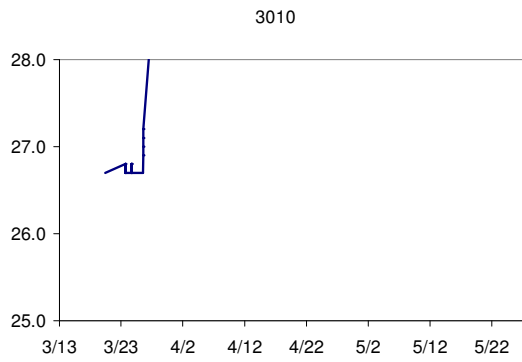
Figure 9 Upstream migration timing of steelhead as shown by River Mile location (y-axis) according to date (x-axis). For illustrative purposes, the relatively short distance between the FCF Pool (RM 26.7) and the FCF holding vault from which fish are recaptured, is represented in the following way: Ladder Entrance = RM 26.8; Ladder Step 1 = RM 26.9; Ladder Bend 1 = RM 27.0; Ladder Bend 2 = RM 27.1; Ladder Holding Vault Entrance = RM 27.2; Holding Vault = RM 27.9; Recapture = RM 28.0.

Eight tagged steelhead were not recaptured at the FCF. The upstream extent of these fish was as follows: two never re-entered any part of the FCF, three re-entered the FCF but did not ascend beyond the ladder entrance, and three ascended back up to the holding vault but were not recaptured. We did not determine the ultimate fate of tagged fish that were not recaptured because it was outside of the project scope. It is possible that these fish either ascended the Green River, migrated back downstream, or were captured in the recreational fishery. Three of our study fish were last detected at the Green River confluence, and five were last detected at locations downstream of the confluence (Figure 9).

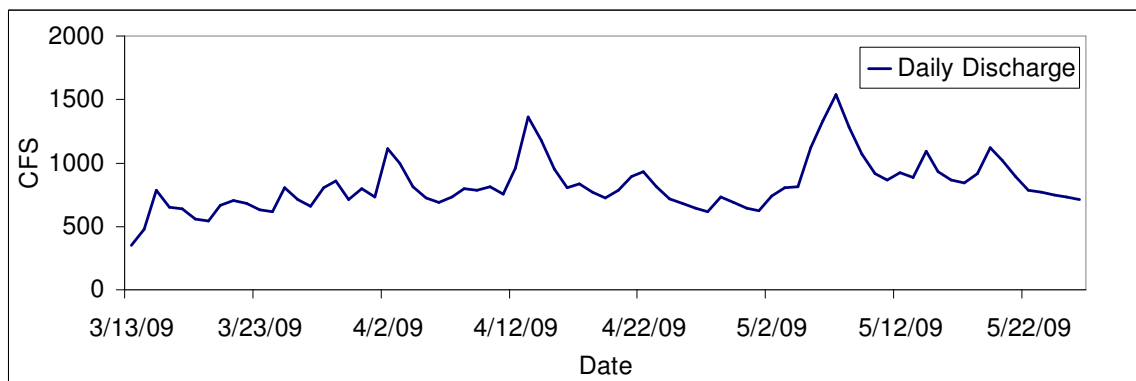
Figure 10 Daily Mean Discharge during the steelhead study period: 13 March – 26 May, 2009

During the steelhead study period (75 records between 13 March and 26 April), daily mean discharge for the North Fork Toutle River averaged 822 cfs, slightly lower (13.5% less) than the 950 cfs long-term average for this period. The minimum and maximum daily mean discharge during the steelhead study period was 353 cfs and 1,540 cfs, respectively. Flows during this time period generally increased, with repeated spikes in the hydrograph occurring on a period of approximately 4-5 days (Figure 10).

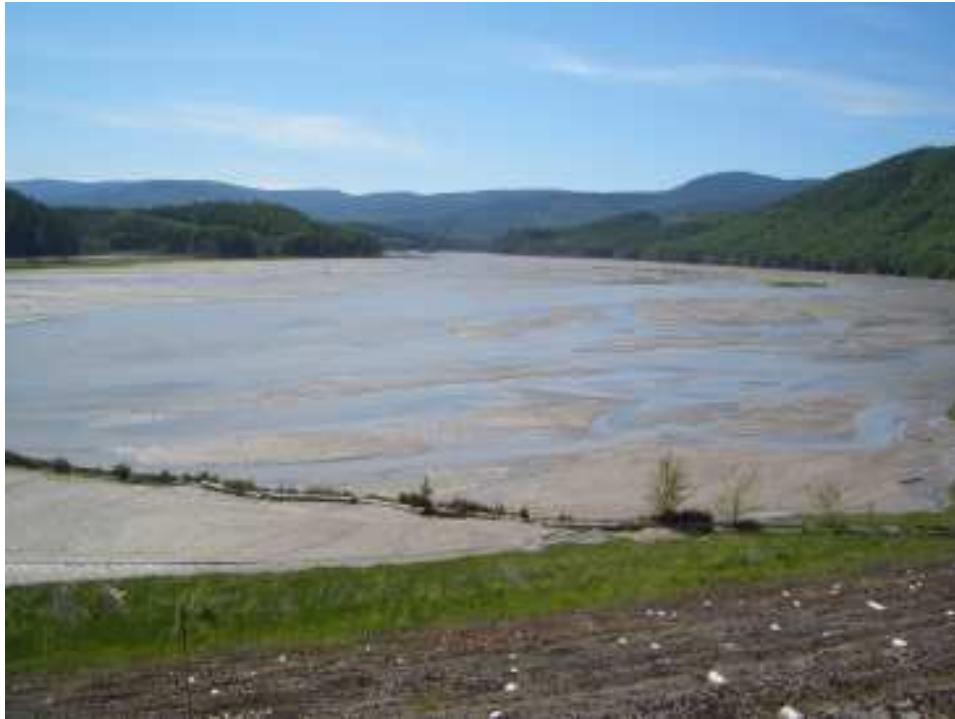
Figure 13 Photograph of Sediment Plain at RM 28.1, looking east.

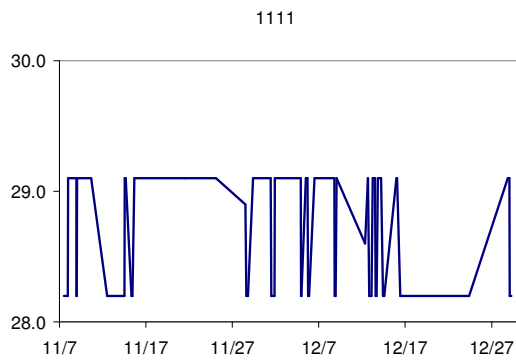
Figure 14 Movement over time of tagged coho salmon released above the SRS. River mile location shown on the y-axis; date shown on the x-axis.

Coho were detected at the SRS and Ecopark fixed sites regularly throughout the study period (Figure 14). In fact, seven of our 10 study fish exhibited repeated movement between the two fixed sites until the end of December. One fish was never detected above the release site; one was detected with mobile tracking equipment slightly above the release site; and one fish was detected at RM 30.0 with mobile tracking but had not been detected by any fixed sites. A total of four tagged coho were able to reach locations upstream of the Ecopark fixed site (all of them up to RM 30.0) but later fell back downstream. We had difficulty determining the final locations of tagged fish due to accessibility and concluded our tracking efforts in late December. Since none of the tagged coho were detected in the mainstem above the sediment plain, in Alder Creek, or at the Green River site below the dam, it is likely that they were trapped somewhere within the sediment plain or SRS spillway. Thus, we conclude that none of the tagged coho successfully ascended beyond the sediment plain.

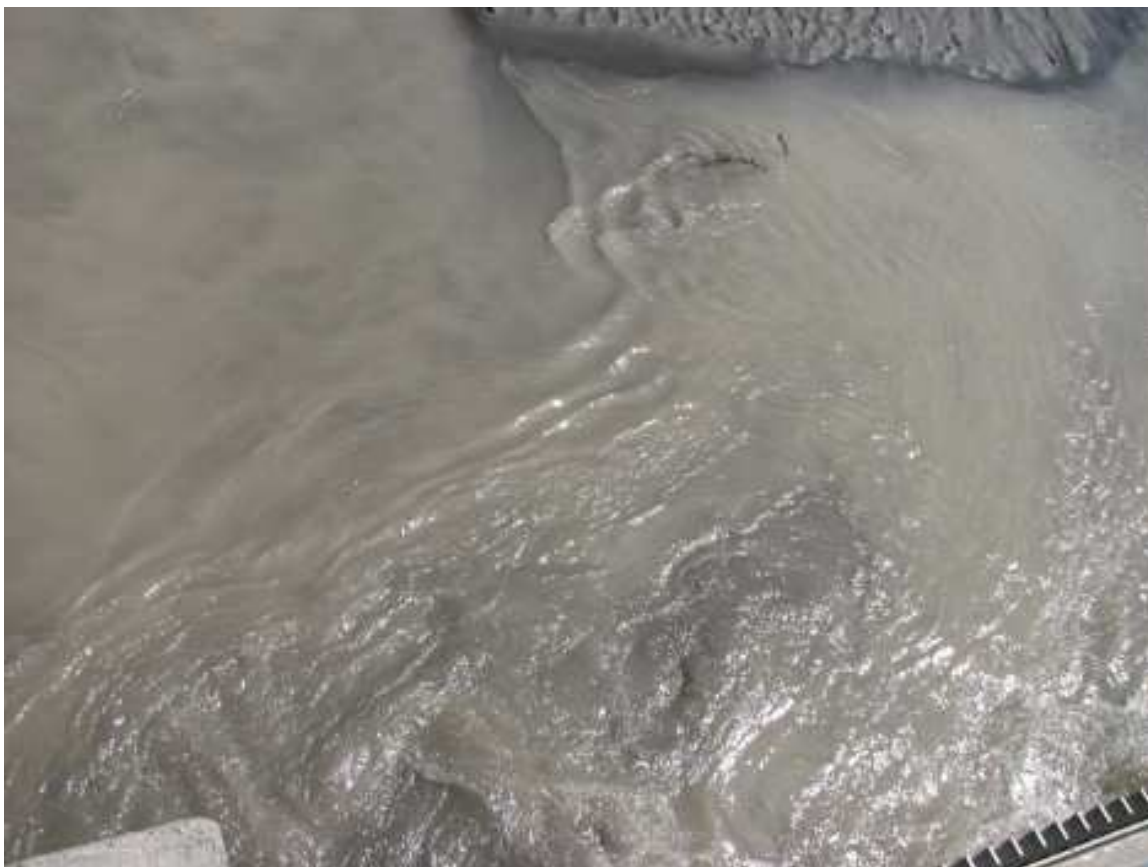
Figure 18 Suspended sediment and re-suspension of sediment accumulated in front of the intake being pulled into the intake.

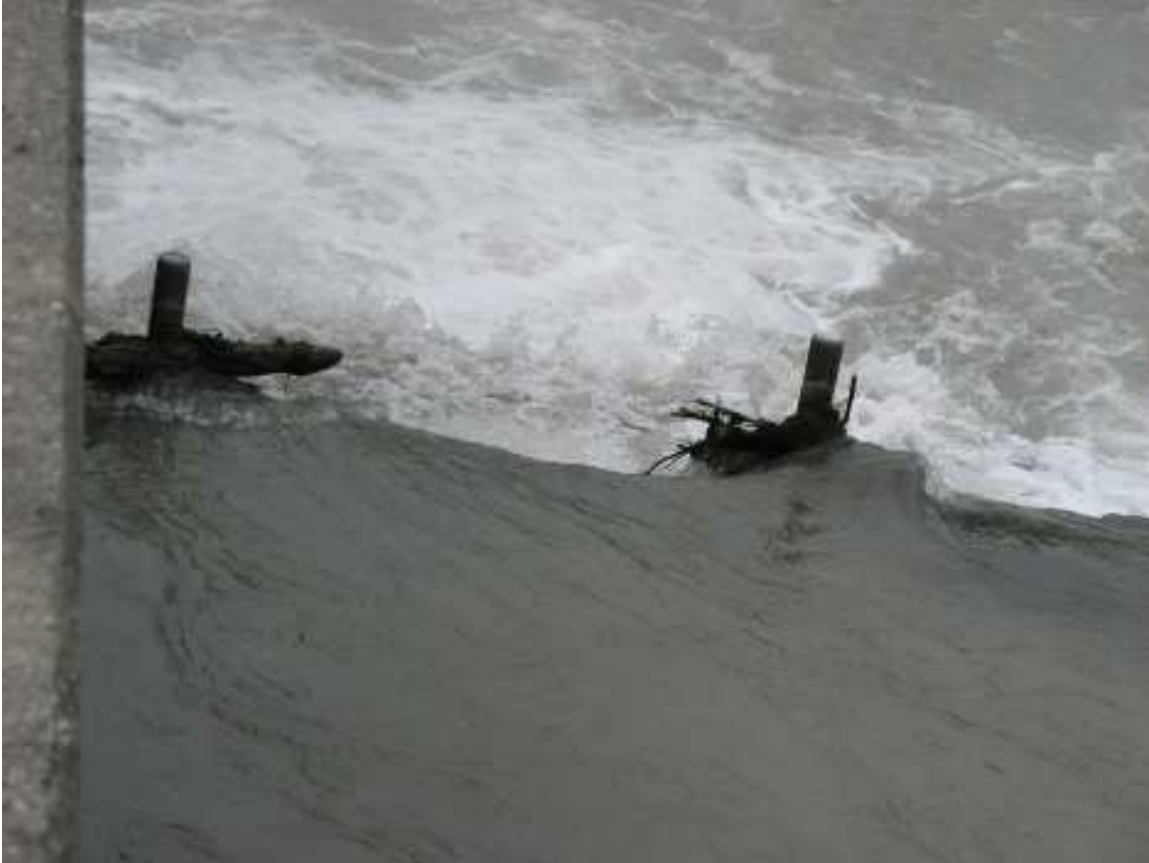
Figure 19 Existing stoplog bay obstructed by debris accumulating on opening and stoplog supports.

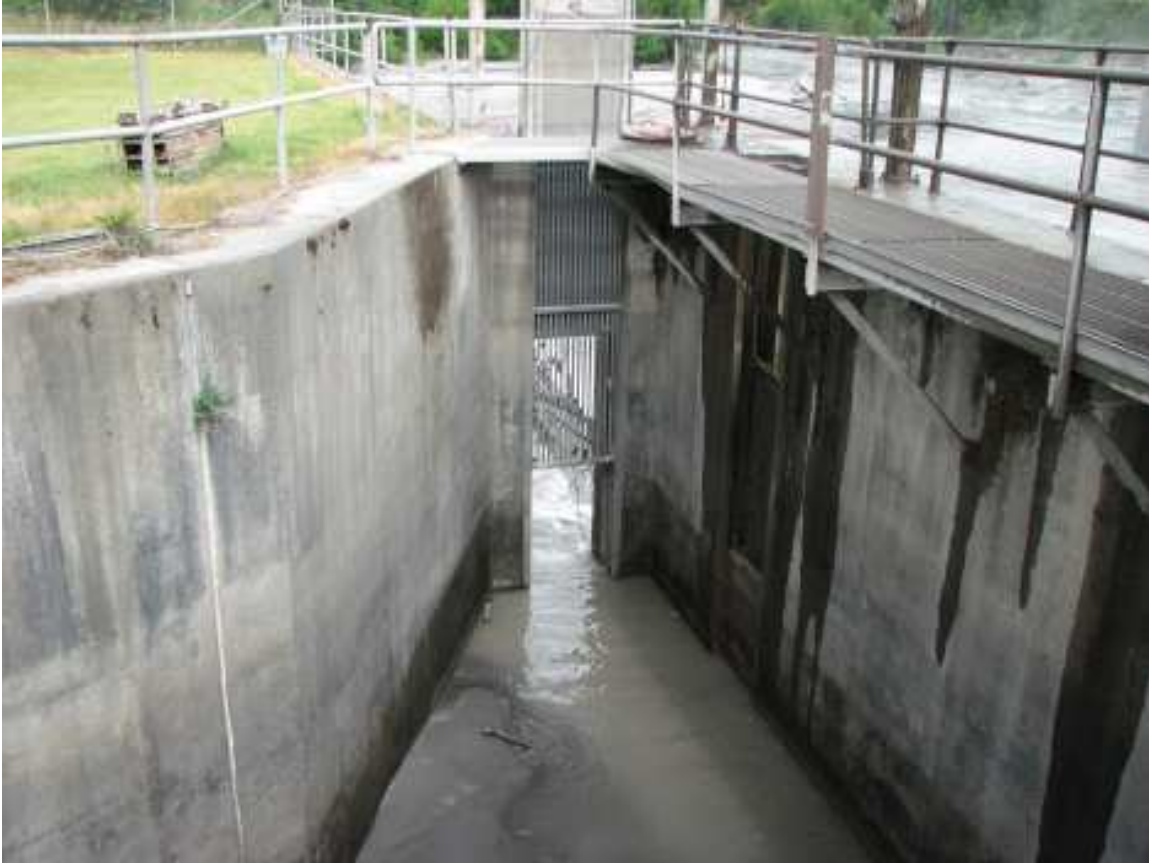
Figure 20 Two of the three gates: the existing single-functional gate and the currently blocked off gate to its right.

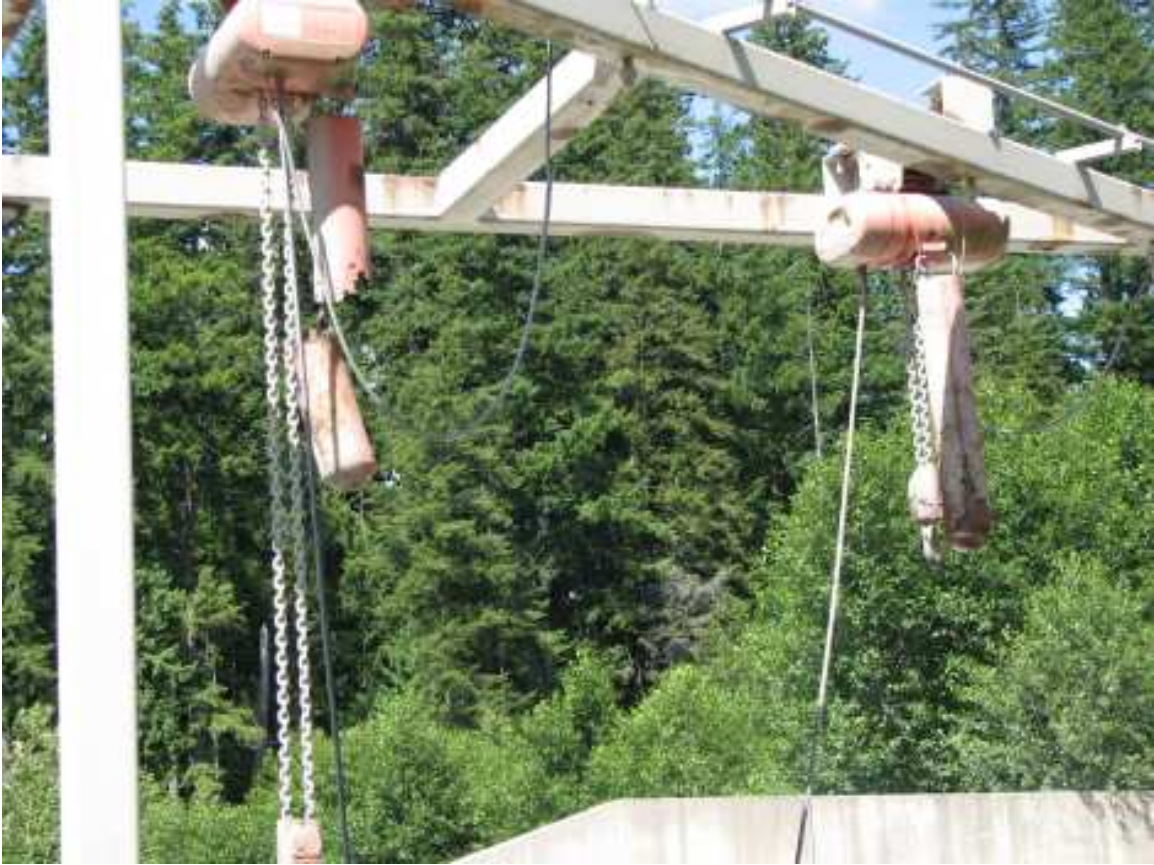
Figure 21 Marginally functional gate lifts and chain cans.

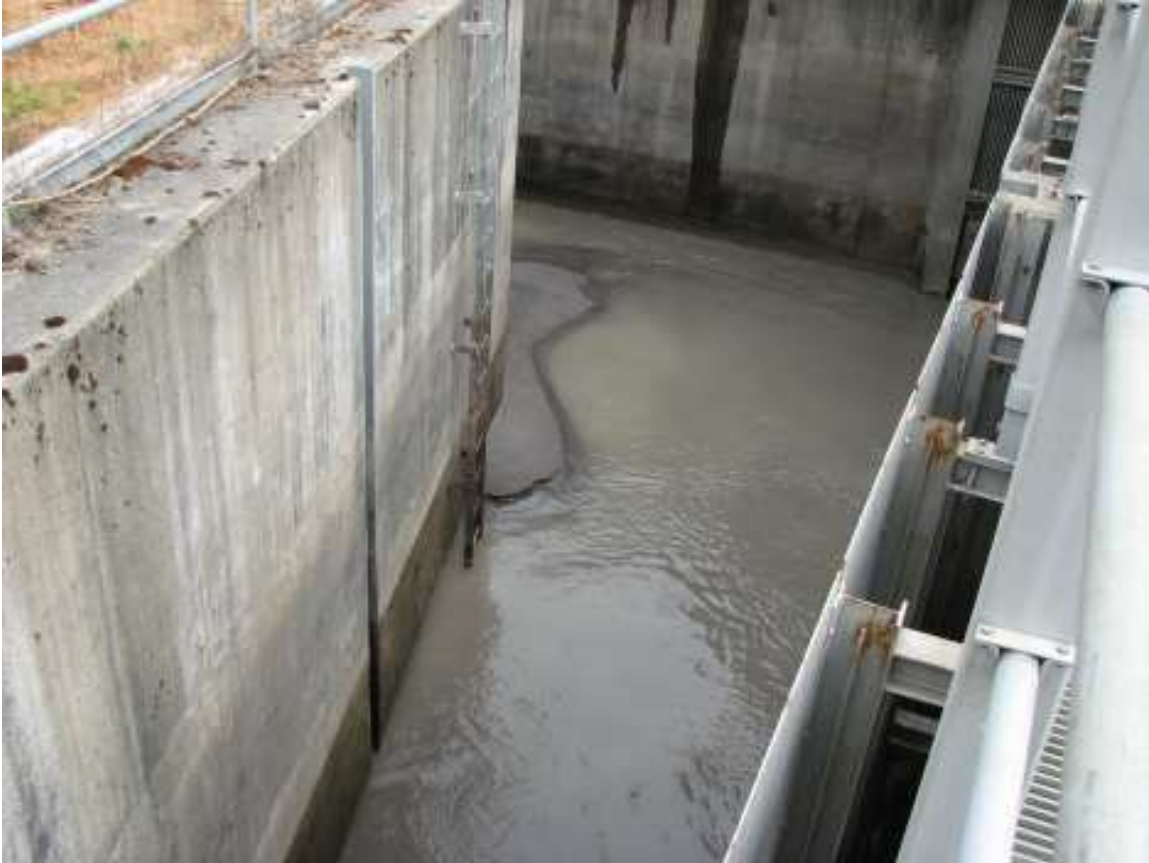
Figure 22 Sediment accumulation in the channel and the third gate at the channel edge.

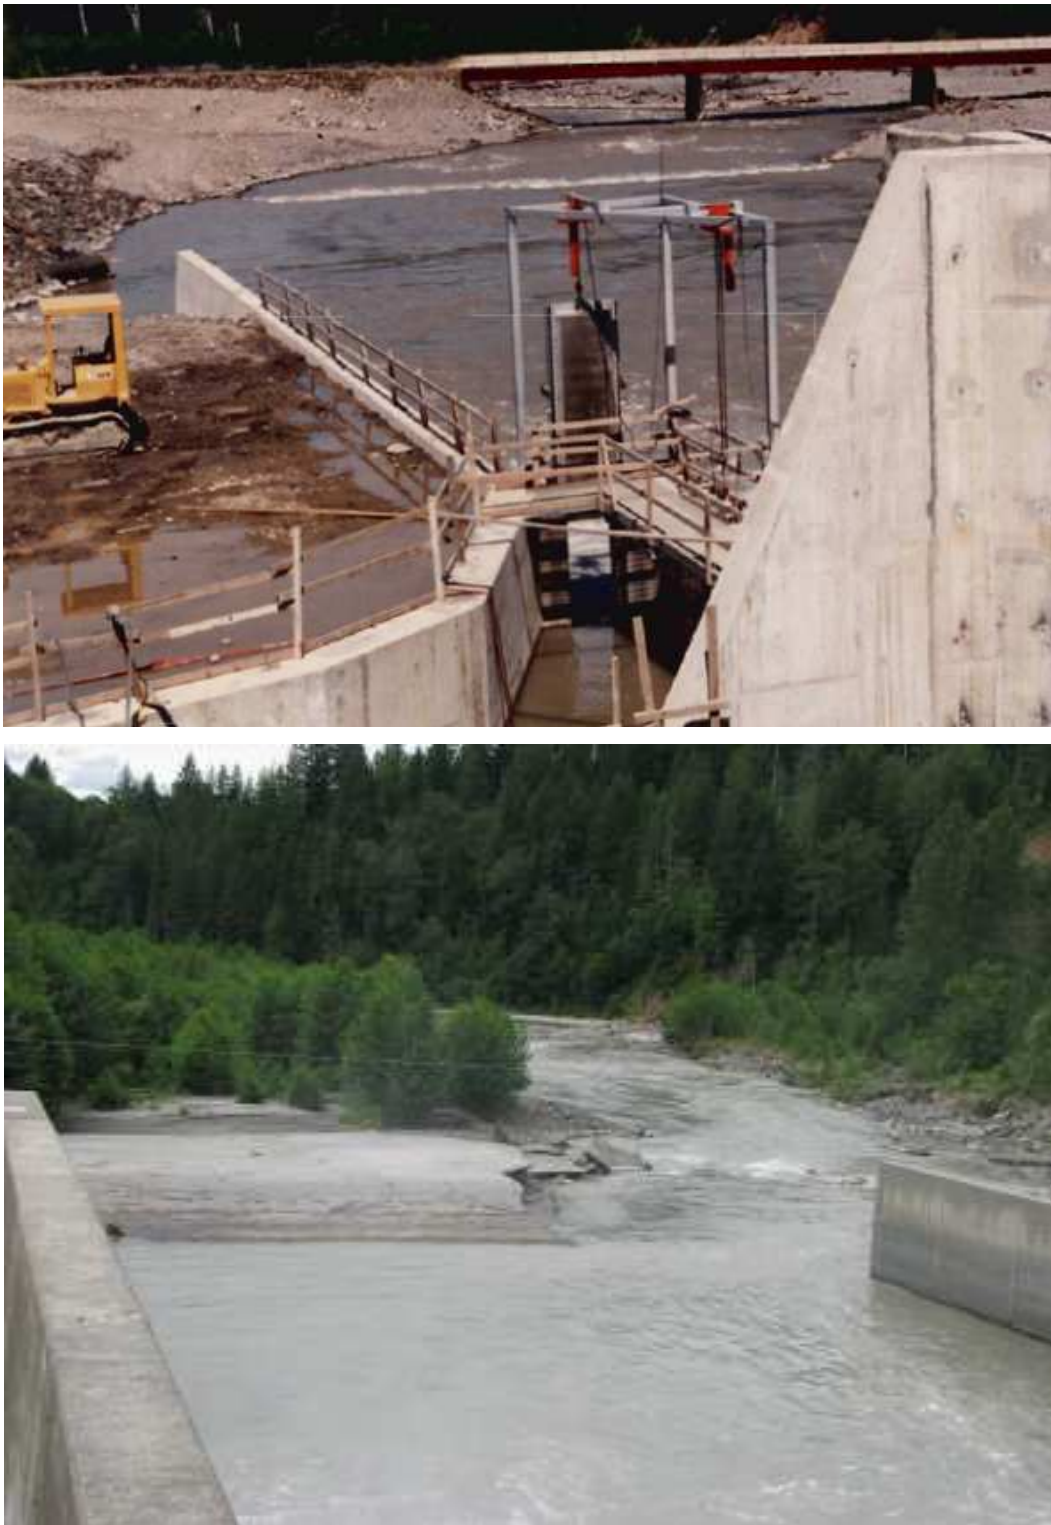
Figure 25 Photographs of original construction (5/89) (top) (Source: USACE) and current conditions (6/09) show the tailwater feature from the upstream side.

The aforementioned improvements to the functionality of the FCF will only be effective if fish are able to ascend to the holding pool and enter into the FCF. Based on our observations of the holding pool and downstream channel (Appendix B), along with results from the fish behavior study (Chapter 2), this ability appears to be limited. Tailwater degradation due to downstream erosion and failure of the holding pool sill needs to be arrested to ensure that the approach to the FCF remains passable to fish (Figures 25 and 26). In addition, the tailwater control needs to be at least partially restored by approximately 2 ft to create a minimum tailwater level on the fishway to both enhance fish access and protect the fish barrier infrastructure from undermining. Constructing a stabilized tailwater gradient and weir-pool type fishway with six to eight steps through the tailwater riffle is likely necessary (Figure 27).

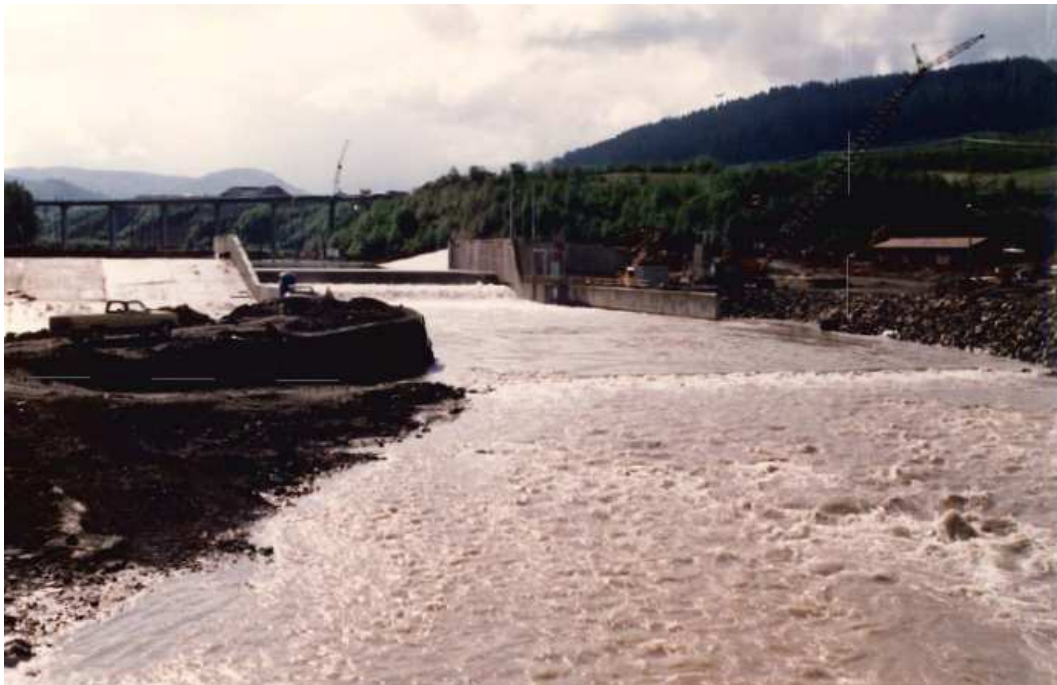
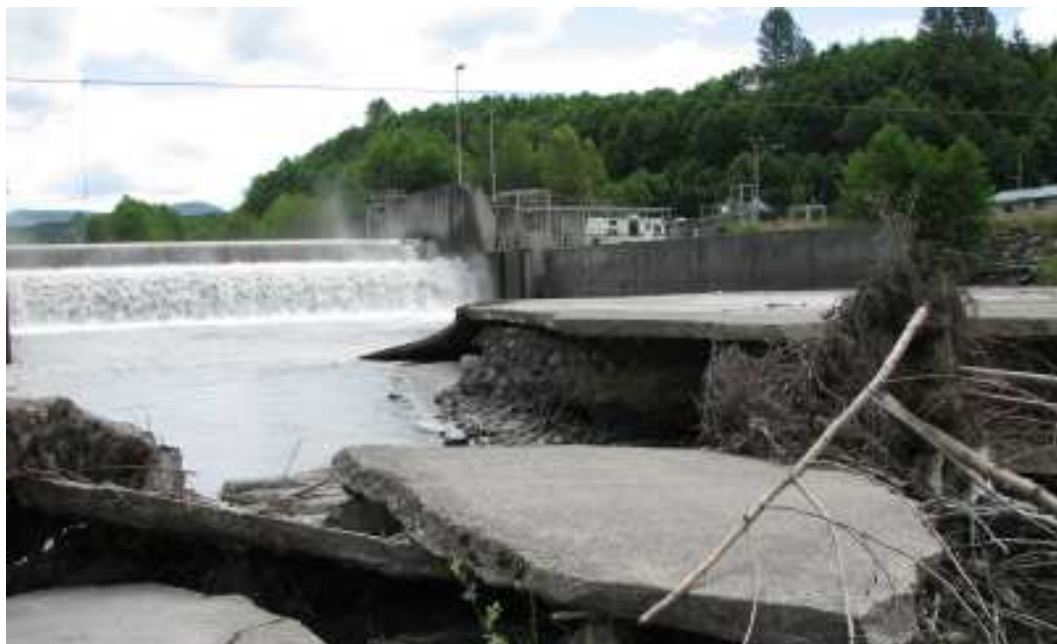
Figure 26 Photographs of the original construction (6/89) (top) (source: USACE) and of current conditions (6/09) show the tailwater feature from the downstream side. These pictures show very graphically the downstream sill degradation and breach of the right end and the lower resulting tailwater.

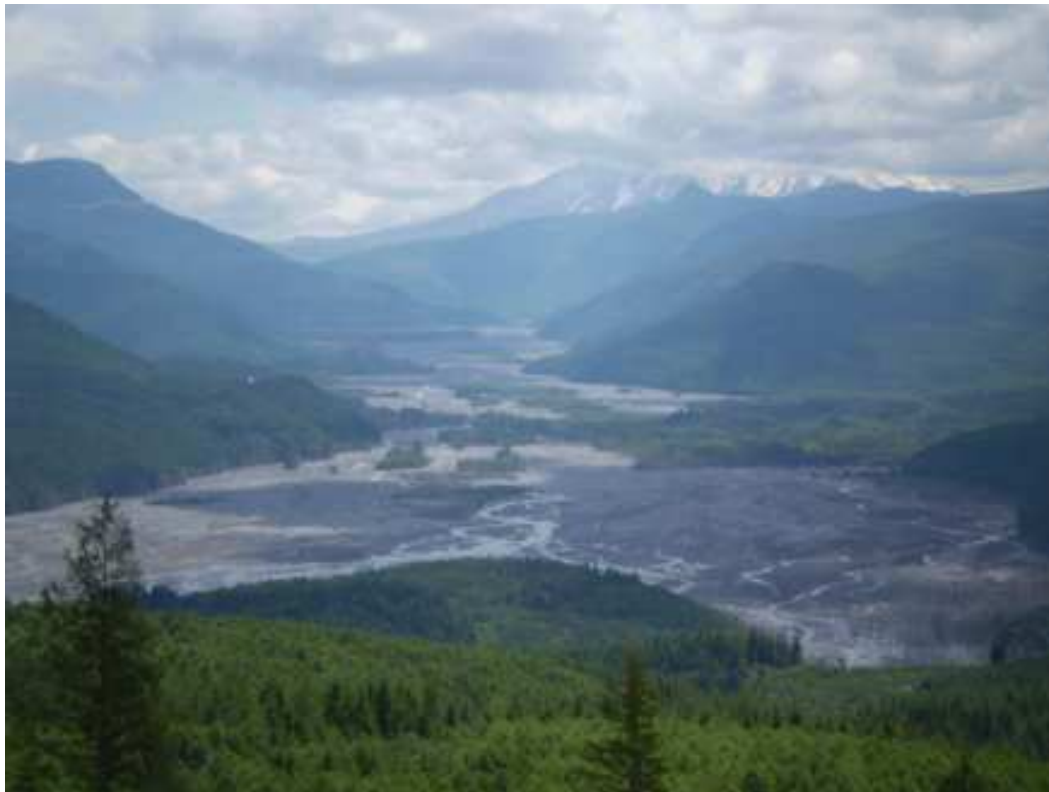
Figure 29 North Fork Toutle River Sediment Plain storing over 100 million cubic yards of sediment.

The Toutle River basin has thus been dramatically altered by the eruption of Mount St. Helens. Measures were quite rapidly implemented to protect the public from flood, a hazard that continues to be exacerbated by changes to basin hydrology and reduced channel capacities as a vastly increased volume of sediment moves through the system. The Mount St. Helens (MSH) Project was designed to control the transport of large amounts of sediment downstream from the debris avalanche. The *Sediment Retention Structure* (SRS – Figure 28 above) of the MSH was constructed on the North Fork Toutle River in 1987, and has since provided a significant reduction in sediment volumes moving downstream and into the Cowlitz River. Operated as a reservoir, the SRS from 1987 to 1998 trapped over 100 million cubic yards of sand and silt eroded from the debris avalanche, this material now stored behind the SRS as a large sediment plain (Figure 29).

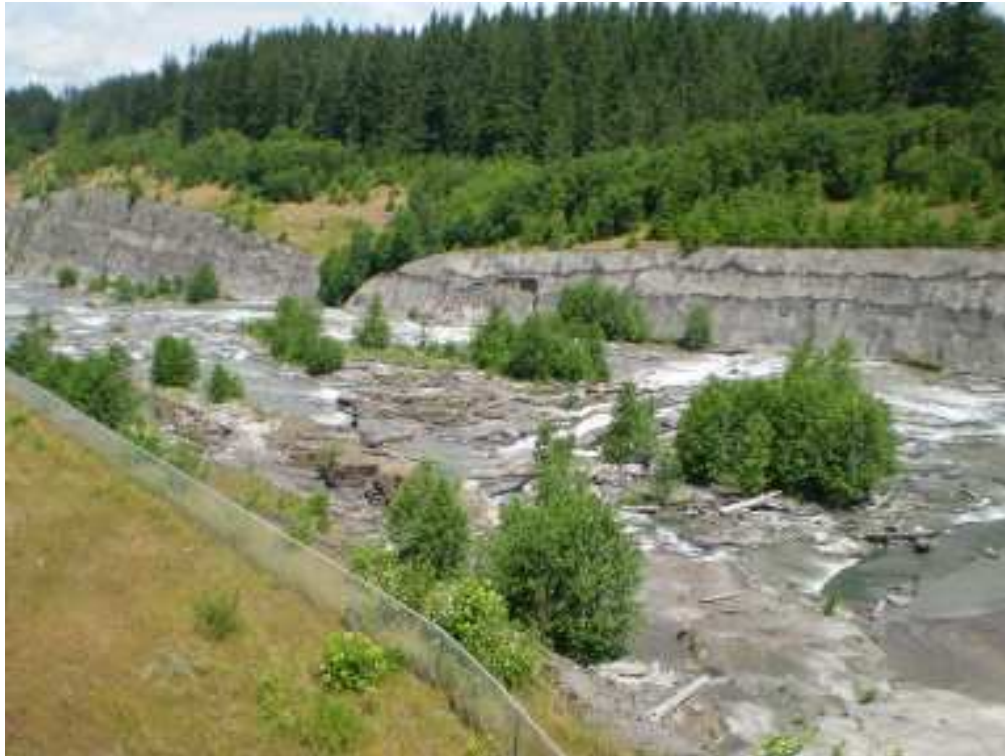
Figure 30 Spillway (note fractured concrete apron) and rock ramp at SRS.

In maintaining a congressionally authorized level of flood protection along the lower Cowlitz River, the SRS has itself presented a significant, anthropogenic, alteration to the North Fork Toutle River basin. The river now meanders through the lower four miles of the sediment-filled reservoir pool, exiting through a spillway and rock ramp (Figure 30).

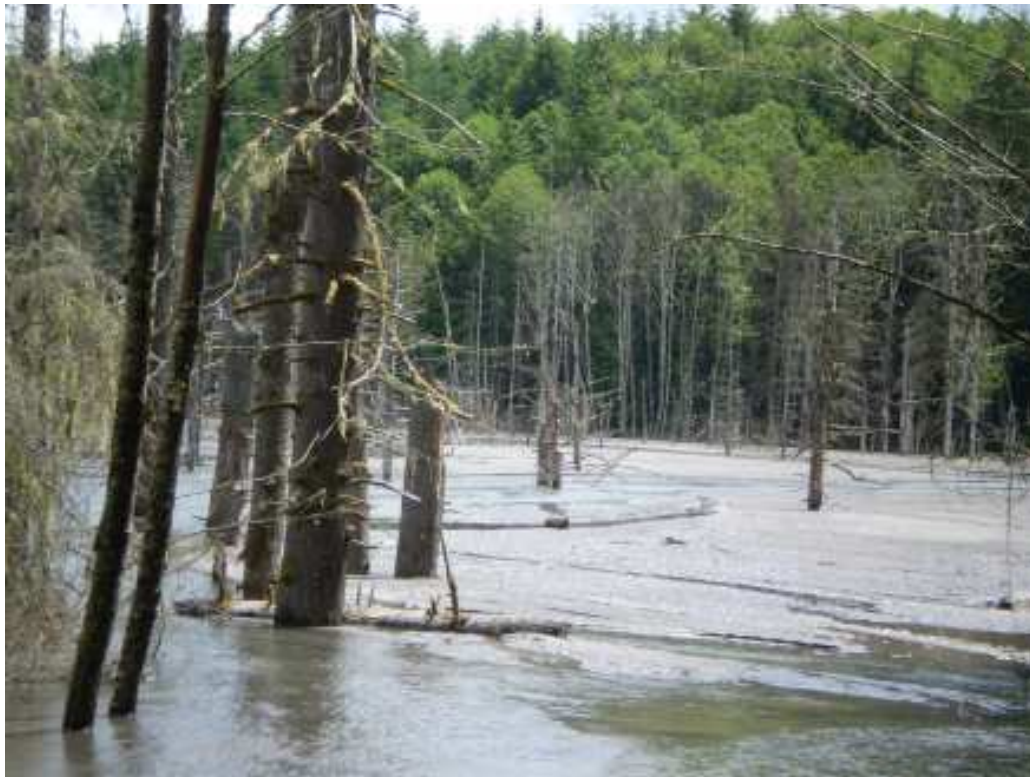
Figure 31 Evolution of the sediment plain has restricted fish access to tributary channels.

While stream systems around Mount St. Helens are slowly recovering, elevated sediment loads, channel widening, and a lack of vegetation cover and large woody debris in the North Fork Toutle River all remain serious problems today. Fish gaining access to the sediment plain are currently faced with a complex system of meandering and often braided channels that frequently do not have sufficient depth and/or cover to facilitate safe passage to spawning tributaries. An additional challenge for fish is that while the sediment plain continues to aggrade, entrances to tributary systems are increasingly plugged (Figure 31).

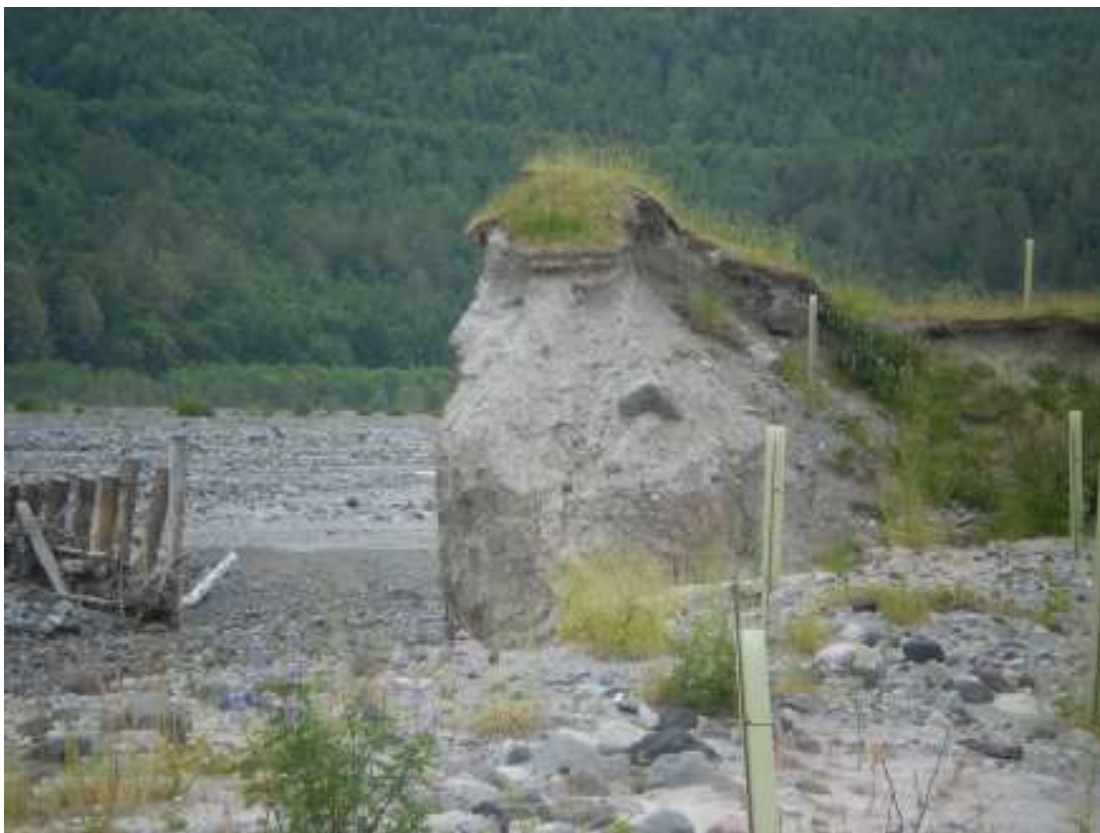
Figure 32 Incised lahar mound on the North Fork Toutle River (note Pile-Dike sediment stabilization structures to left, and tree plantings to right).

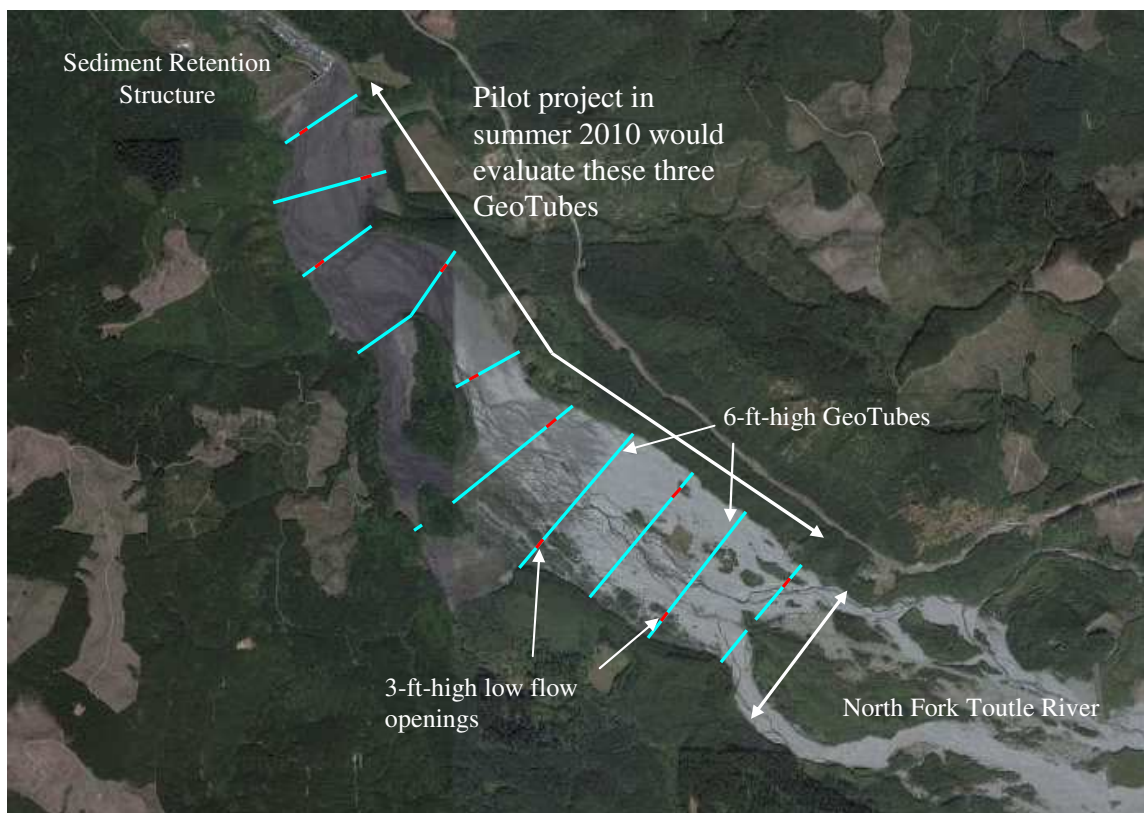
Figure 37 Possible deployment of low head sediment retaining dams using GeoTube Technology (Source: U.S. Army Corps of Engineers, Portland).
