# 2010 Stormwater Needs Assessment Program

## Cedar Creek (Middle)/Cedar Creek (Lower)/Pup Creek Subwatershed Needs Assessment Report

Clark County Department of Environmental Services

March 2011

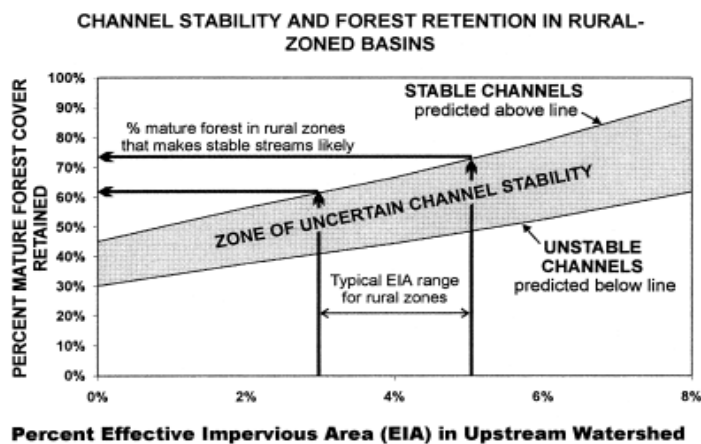
In a recent publication by Booth, Hartley and Jackson (June 2002), a relationship between forest and percent EIA was presented as a graphic (**Error! Reference source not found.**). According to this figure, streams in the subwatersheds would be expected to have stable channels.

Figure 2: Channel stability in rural areas (Booth, Hartley and Jackson)

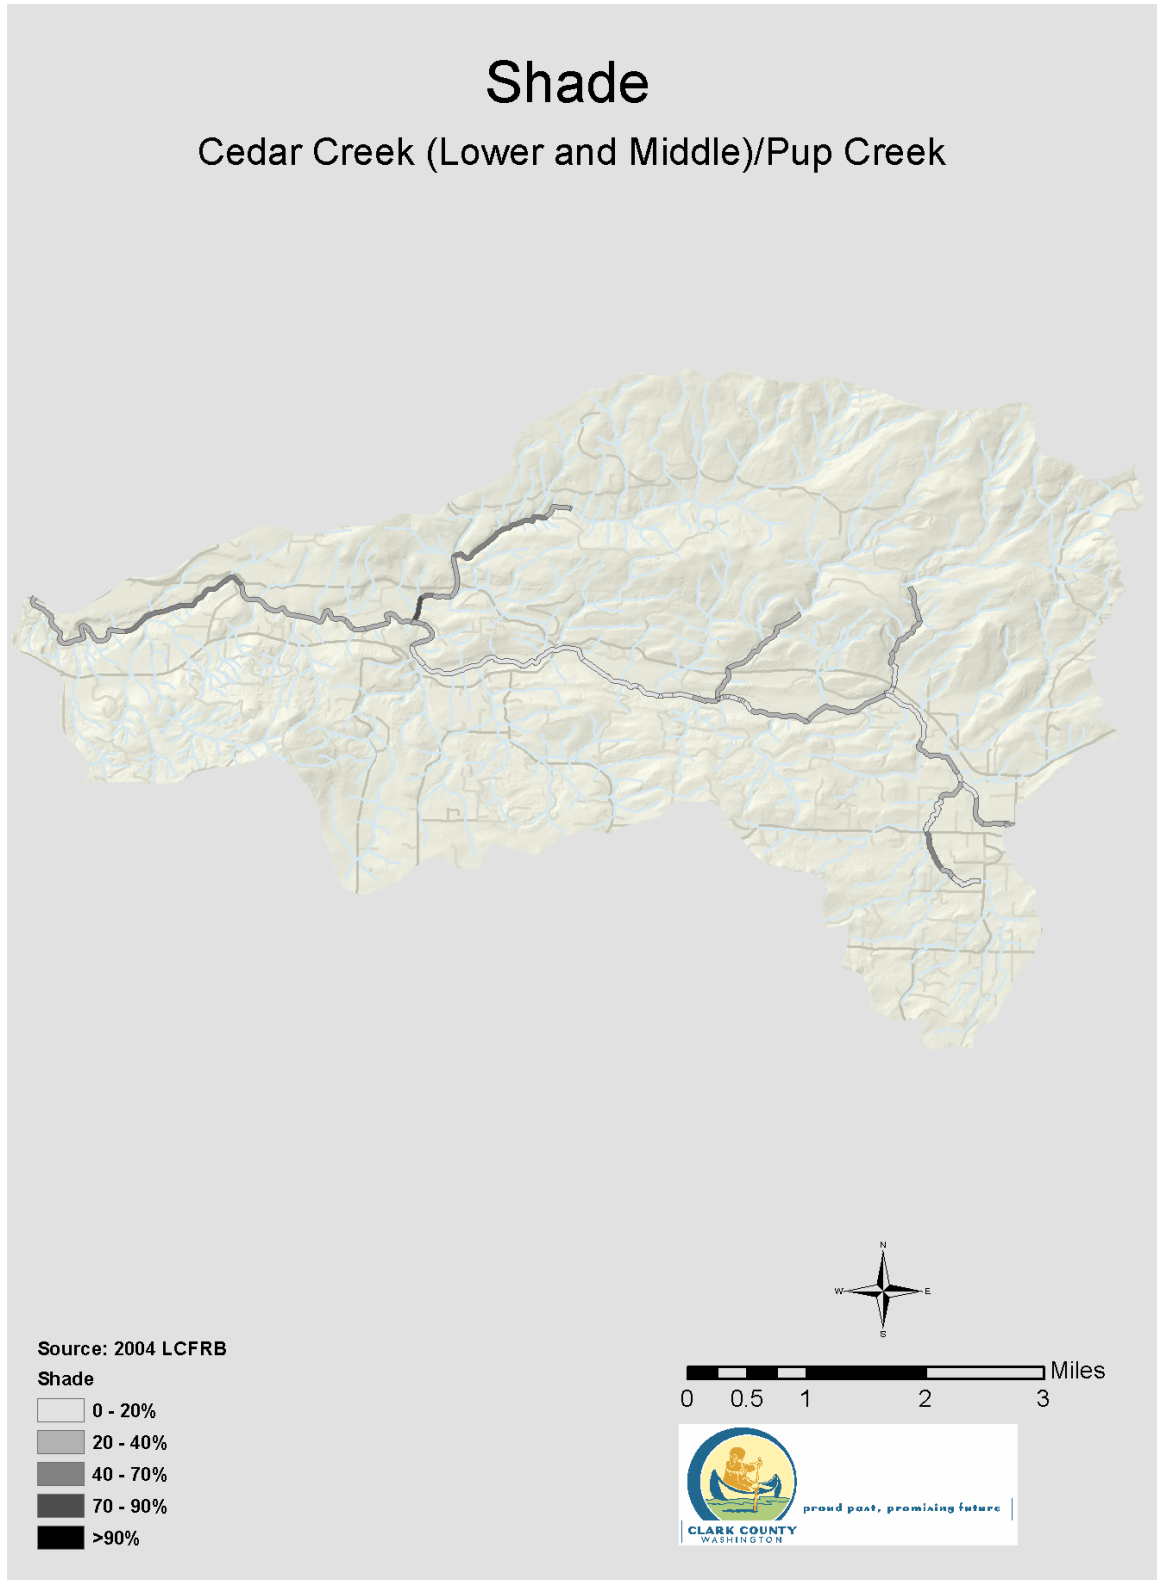
**Figure 4: Cedar Creek (Middle), Cedar Creek (Lower), and Pup Creek Shade Values (adapted from R2 Resource Consultants, Inc, 2004)**

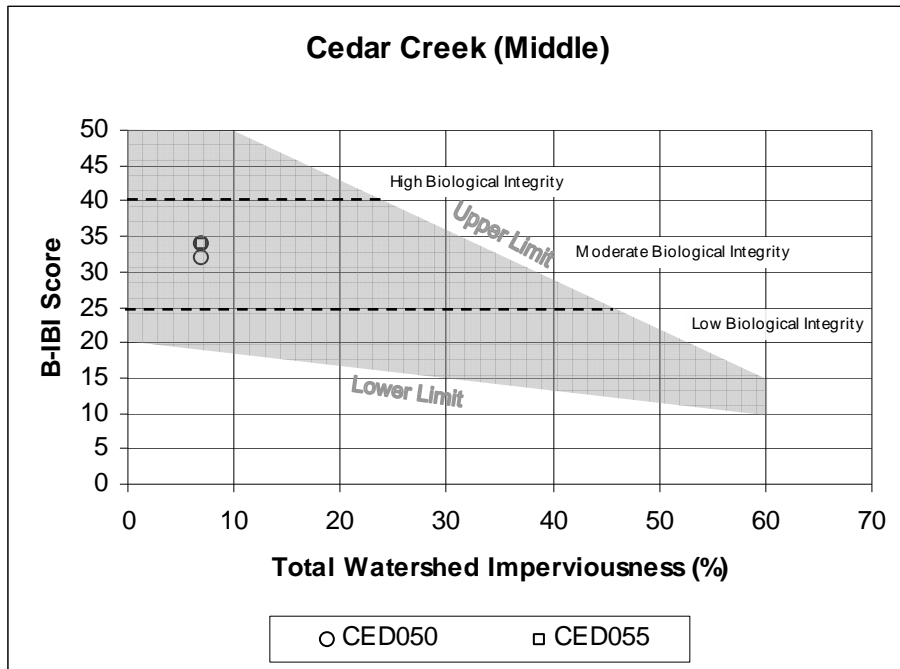
Figure 7 indicates that scores for both Cedar Creek stations are in the middle of the range of expected scores for subwatersheds with relatively low amounts of impervious area (estimated 2000 Total Impervious Area from Wierenga, 2005). This suggests that factors other than impervious area are contributing to poor biological integrity. This implies an opportunity to increase the level of biological health by improving habitat and stream conditions. Management strategies that limit further degradation and promote stewardship are important to realizing that opportunity.

Figure 7: Approximate range of B-IBI in Puget Lowland watersheds, showing progressive decline with increasing imperviousness in the upstream watershed. Adapted from Booth et. al, 2004. Markers indicate B-IBI scores at Station CED050 and Station CED055 for particular years, versus estimated 2000 subwatersheds TIA.

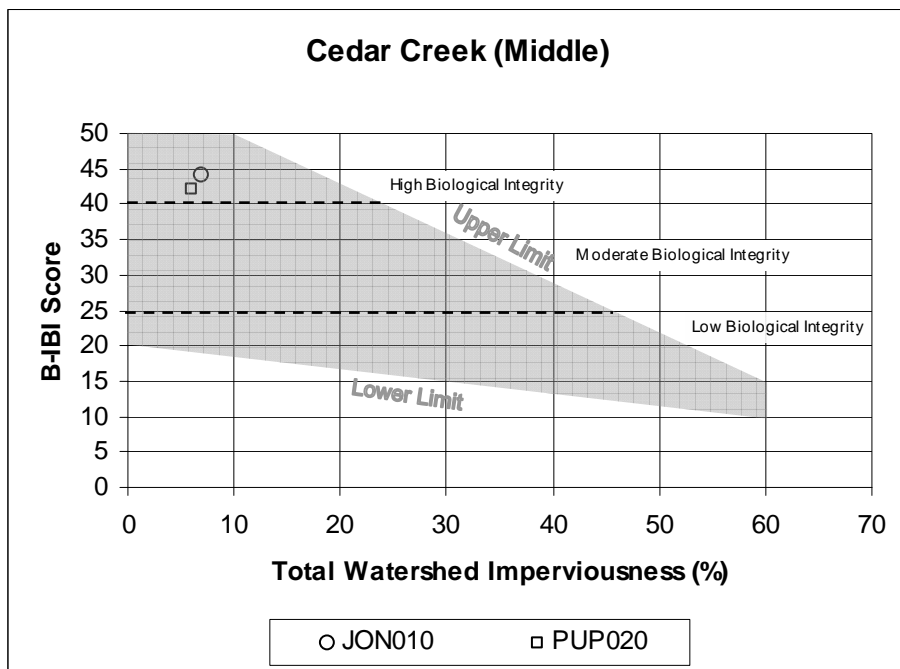
Figure 8 indicates that scores for Pup Creek and John Creek are near the upper end of the range of expected scores. It is unlikely that scores could be improved significantly in these areas. However, management strategies that limit degradation are critical to preventing eventual deterioration of biological health at these sites. Sub-metric scores suggest these streams may be starting to show impacts.

Figure 8: Approximate range of B-IBI in Puget Lowland watersheds, showing progressive decline with increasing imperviousness in the upstream watershed. Adapted from Booth et. al., 2004.
