Woodward Creek Habitat Restoration Project Siting and Design Project

Final Report

November 2007

*Tetra Tech, Inc.
Portland, Oregon*

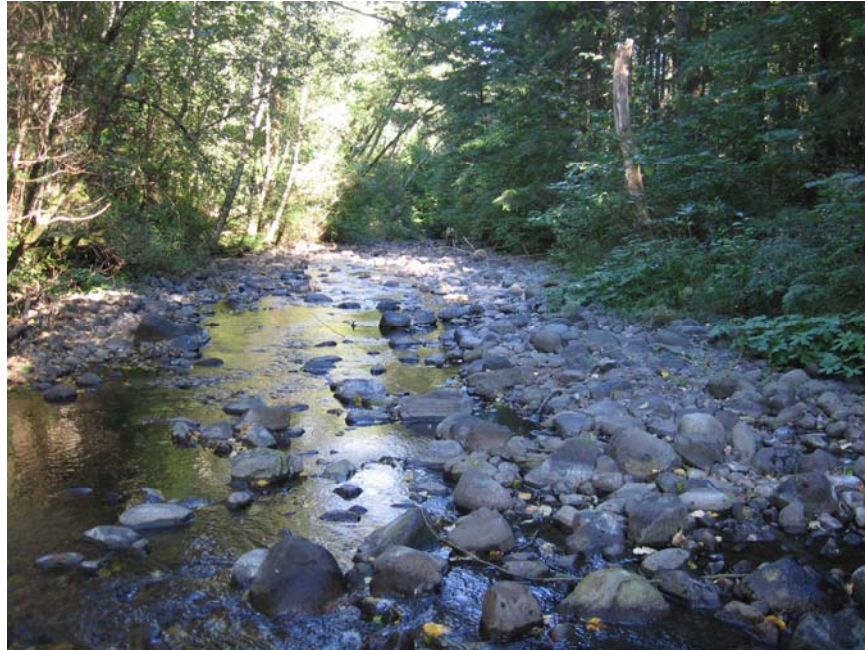
This reach extends from the railroad crossing up to the bridge at SR-14. This reach is highly channelized between the left naturally high bank and a dike along Moorage Road on the right bank. The SR-14 bridge opening is about 40 feet in width, which is about half the width of the channel in the upstream Reach 3. The channel was directed to this left side of the floodplain more than 60 years ago. The upper portion of the reach transports sediment quite effectively, whereas the lower portion of the reach widens out somewhat at the end of the dike and also has to enter the culvert at an angle. The widened channel and debris deposition at the culvert has caused sediment deposition in the 200 feet or so upstream of the culvert. During the flood in November 2006, the sediment build-up caused the creek to jump out of the channel and flow down Beacon Rock Moorage Road. The culvert and channel are a maintenance problem for the Park, and the debris may block fish passage after large depositional events. This reach is dominated by large cobble and has essentially no pools or other habitat diversity. The riparian zone is in fairly good condition with mature trees and good canopy cover except near the confluence of Little Creek (RM 0.25) and in the immediate vicinity of the culvert where frequent maintenance occurs.

Figure 8. Reach 2, Typical Uniform Channel.

The channelization of this reach limits restoration opportunities in the short-term. The immediate problems are the constriction of the culvert and the deposition of sediment and debris at its upstream end. One or more wood or rock vanes could be placed upstream of the culvert to direct the channel in a more direct alignment into the culvert; although this would only provide temporary benefits. Control of sediment upstream of SR-14 and reconnection of the floodplain in Reach 2 will be the most effective and long-term opportunities to reduce sediment and debris deposition and allow the creek to migrate in a more natural alignment. One or more LWD jams could be placed immediately upstream of the SR-14 bridge to capture wood from Reach 3 before it reaches the bridge. In the long-term, removal or setback of the dike and Beacon Rock Moorage Road and reconnecting the creek to its floodplain would allow the channel to migrate without damaging infrastructure, thus creating off-channel and other habitats and providing a floodplain for sediment and debris deposition. These modifications would also increase the channel length and decrease the slope which, along with log jams create improved spawning habitat. If another road is eventually planned to connect potential future camping or other uses to the new road to the boat ramp, the road under the railroad could be abandoned and the culvert could be removed to allow the creek to flow through the railroad opening without a blockage. The railroad grade would still limit the channel width to 38 feet, the length would be very short and channel design features upstream would improve sediment transport through the crossing.

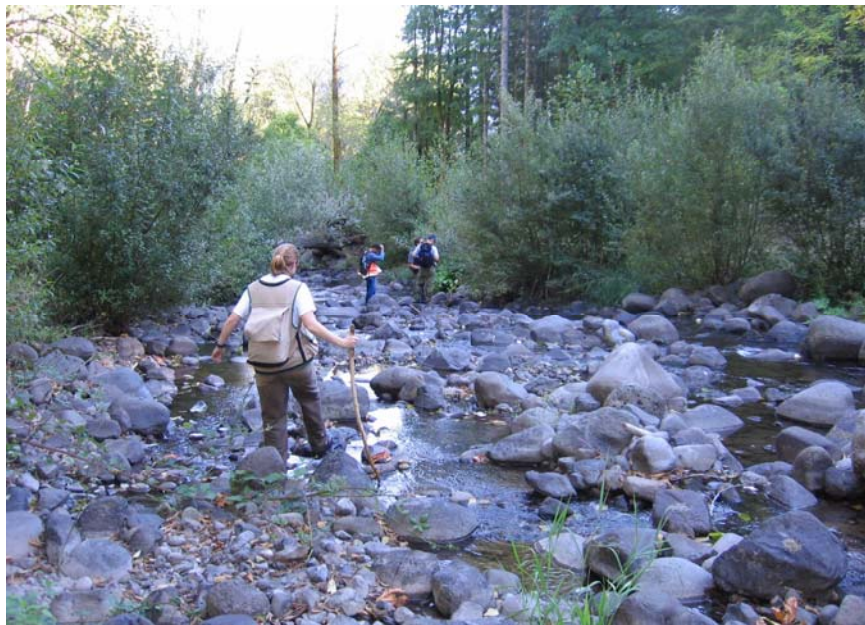
The flow goes subsurface through portions of this reach in the coarse material. There is some wood in this reach in small clumps. There are few pools in this reach. The right bank for much of this reach is a high fractured basalt cliff. A dike has been placed at the end of this cliff to cut off the former right bank floodplain, and probable location of the historic main creek channel, and now diverts all flows towards the left bank and under the bridge at SR-14.

Figure 10. Reach 3; Typical Wider Floodplain Section before November 2006 Flood.

This reach would be an excellent location to place additional wood and LWD jams. The wood could be used to protect the existing high quality side-channel from sediment deposition and could also be used to trap sediment in the floodplain, and to create further spawning areas as well as providing scouring of pools and providing cover. Many juvenile fish (trout and coho) have been observed in the upper end of this reach. This reach also could benefit from the removal of non-native vegetation and plantings of native species. Removal of the dike along the right bank and reconnection of the floodplain would further trap sediments and provide the opportunity for the natural creation of off-channel habitats. This reach is easily accessible from SR-14 and an old road in the right bank floodplain. Because the dike currently protects the highway and bridge from erosion, a longer-term solution would be to widen the SR 14 bridge to 150 feet and reduce the need for the channel diversion dike and then provide protection for the road with rock set back closer to the roadway.

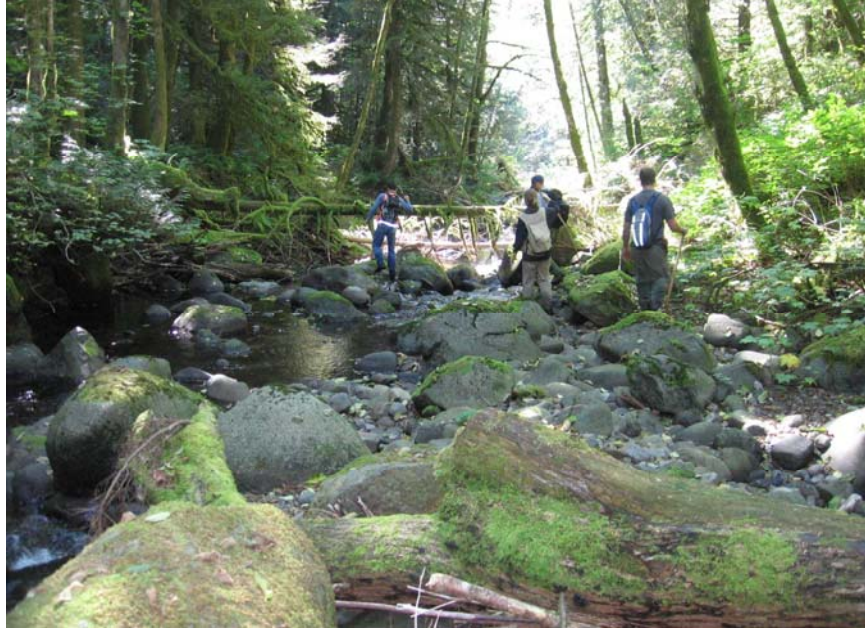
This reach extends about ½ mile in length from about RM 2.0 to 2.5. The gradient increases in this reach (~11%) with several boulder drops of 6 to 8 feet in height. The boulders in this reach are large, with some up to 6 feet in diameter (**Figure 13**). There are small pocket floodplain areas in this reach, typically only on one side of the channel that may reach up to 100 feet in width for a short distance. The wetted width during low flow averaged about 13-15 feet and the bankfull width is about 40 feet. A slide is present in this reach contributing compacted clays and other fine materials to the channel. This slide has temporarily filled in the channel for up to 1000 feet downstream. The riparian and floodplain vegetation is primarily alder and cedar approximately 20-30 years old, although there are remnant large cedars up to 6 feet in diameter or greater and the riparian zone generally provides 100% canopy cover. There are scattered individual pieces of wood in this reach and a couple of channel spanning jams. The large boulders and wood trap some gravels and steelhead have been observed spawning in this reach by the LCFEG.

Figure 13. Reach 5; Typical Boulder Section.

This reach is high gradient and has limited construction accessibility. Placement of wood upstream in Reach 6 may slowly contribute additional wood to this reach which would help trap sediment and promote the formation of scour pools. Additionally, wood could potentially be placed in this reach via helicopter. There are no other feasible restoration opportunities.

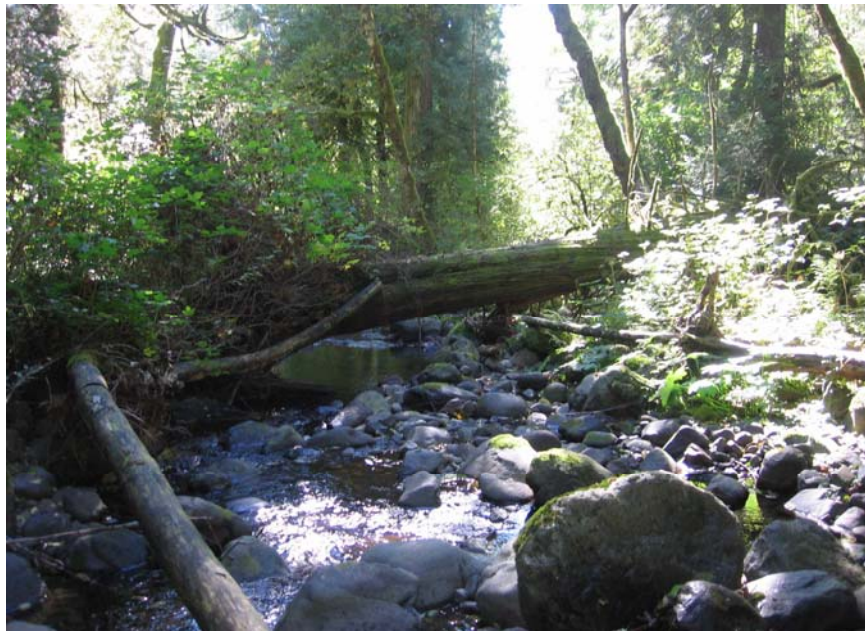
This reach extends for about ½ mile from RM 2.5 to 3.0 and the Woodward Creek Road bridge is approximately in the middle of this reach. This reach is lower gradient (less than 5%) and is dominated by large cobbles with some boulders. The wetted channel width during low flows averaged about 18-20 feet; the bankfull width is 30-32 feet. There is an approximately 100 foot wide floodplain in this reach and then 30-50 foot high ravine side slopes. The US Forest Service (USFS) installed log weirs in this reach in the 1990s, likely to prevent or reduce channel incision and/or to trap sediment coming down the channel (there is an eroding bluff at the upper powerline crossing in this reach). It appears from the tags at the structures that about 25 of these weirs were installed. Only about 7-8 of them are still visible. Some of the weirs may have been buried and others have been undermined and were likely transported downstream. The weirs that remain in place are effectively trapping gravel and also creating scour pools, and more importantly keeping the channel connected to the floodplain. It appears that the channel may have been incised in the 1980s perhaps as a result of timber harvest and/or high flows in the upper watershed. However, since then, either as a result of the weirs or from recent large sediment inputs, the channel has filled back in. The riparian vegetation shows signs of burial in some locations. The riparian and floodplain vegetation is primarily alder and cedar approximately 20-30 years old, although there are remnant large cedars 4 feet in diameter or greater. Canopy cover is 100% throughout most of the reach. There is a natural log jam near the downstream end of this reach (**Figure 14**). Boulders and wood trap small patches of gravel in this reach that provide spawning habitat; they also create scour pools and large numbers of juvenile trout were observed in the few pools in this reach during the September 2006 reconnaissance.

Figure 14. Reach 6, Showing Channel Spanning Logs.

The primary limitations with this section of the creek are the limited areas of spawning gravel and rearing habitat. The placement of additional wood in this reach would trap spawning gravel and create additional scour pools and cover, which would likely increase the carrying capacity and production of steelhead from this reach. Flows are steady year-round in this reach and water temperatures are low. This reach could provide high quality spawning and rearing habitat for steelhead and resident trout near the upper end of accessibility in the creek. It is unlikely that coho can access this reach due to the large drops towards the downstream end of this reach.

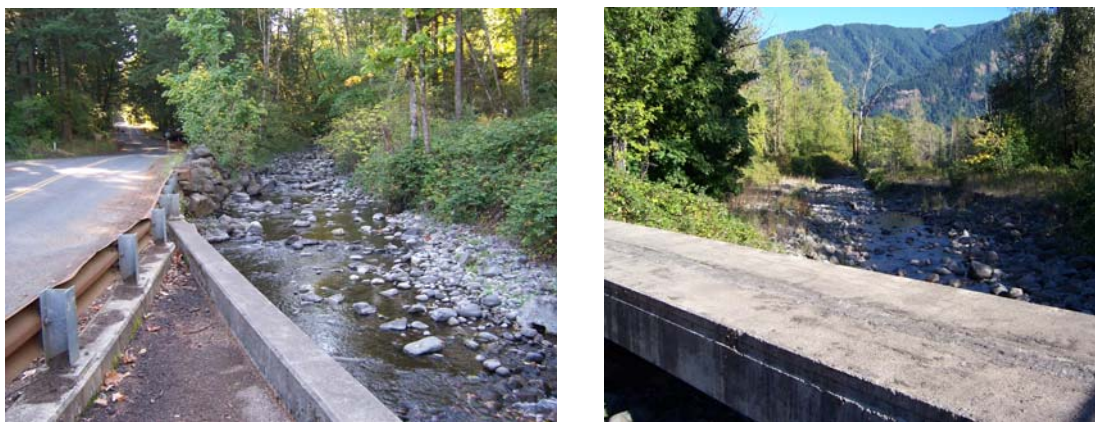
Reach 2 can best be described as a transitional plane bed reach (Montgomery and Buffington 1998) with a generally featureless gravel/cobble bed (**Figure 15**). The upper section of Reach 2 is confined and the lower reach unconfined. This transition, the proximity of Moorage Road and the bridge downstream is the reason sediment builds up here during a channel threshold disturbing event. Herein is a key opportunity for habitat restoration via the installation of LWD and by reducing the channel confinement to transition the current reach from a plane bed to a pool/riffle type channel, thus providing improved fish habitat features.

Figure 15. Channel in Vicinity of Moorage Road. *Left, looking upstream; right, looking downstream into Reach 1 (September 2006).*

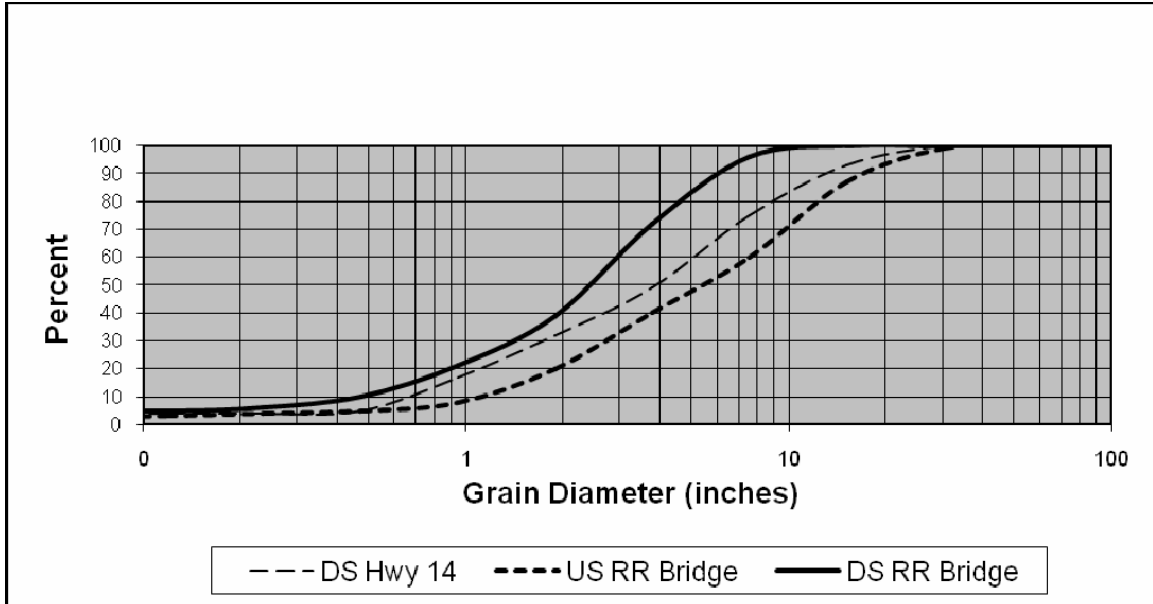
Pebble counts from Reach 1 and Reach 2 are shown in **Figure 18**. The D₅₀ value for Reach 2 varies between 4 and 6 inches. Comparing these values to the critical threshold values calculated for Reach 2, shows that the Reach 2 channel may become unstable around the 10 to 20 year flood event. This result seems reasonable based on past experience with the frequency of bed load transport in the channel as described by Washington State Parks staff.

Figure 18. Grain Size Distribution from Pebble Counts in Reaches 1 and 2.

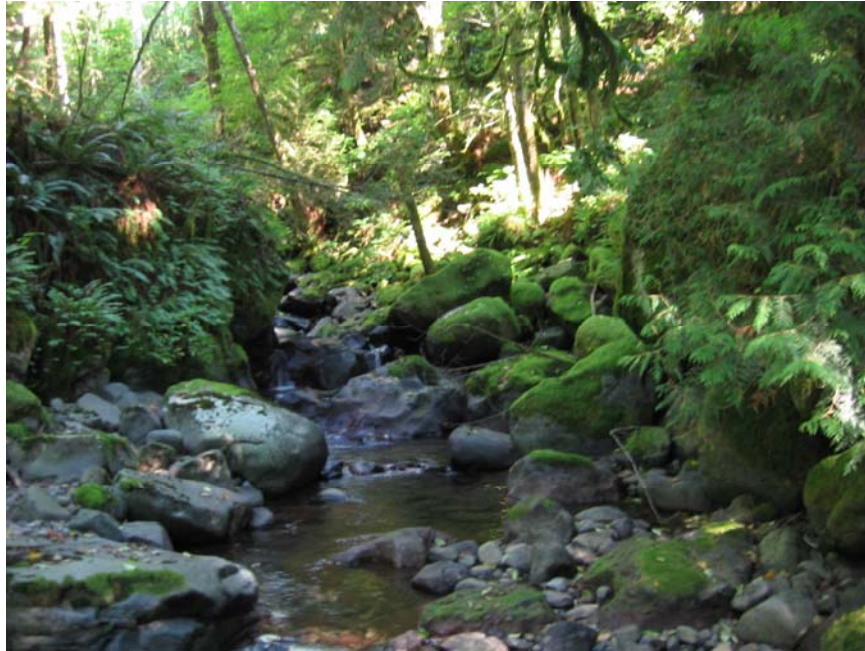
1. At the upstream limit of the reconnaissance, a steep reach of 15 percent or more that contains large boulders and a series of drops and pools starts (Photo 1).

Photo 1 – Looking upstream into downstream end of steep (> 15%) boulder drop/cascade and pool reach at upstream limit of the reconnaissance

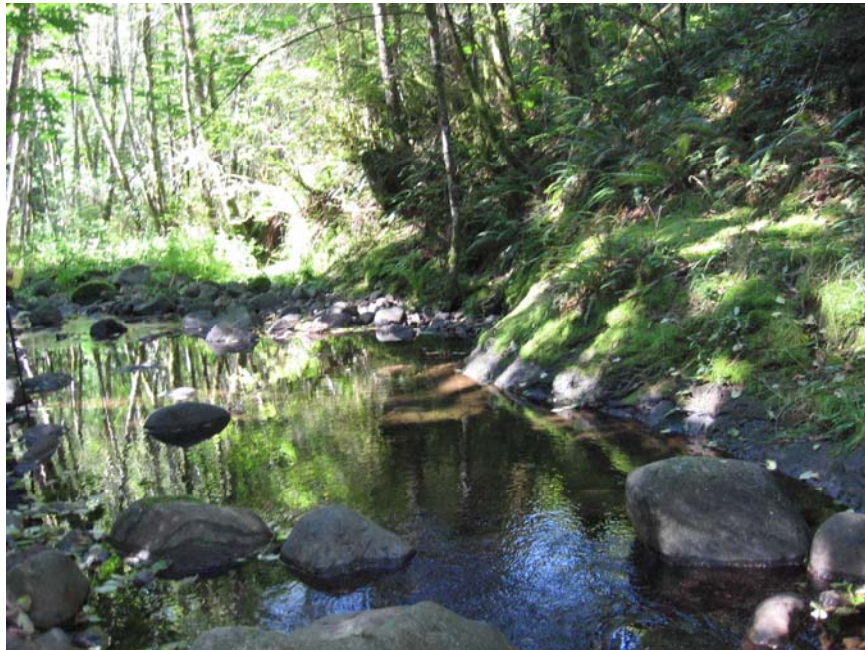
2. Below the upstream limit to the Woodward Creek Road bridge, the channel is contained within a ravine with bank slopes approximately 40-50 feet high. Narrow floodplain areas are present in some locations, and in other locations the bedrock or large boulders confine the creek to a narrow channel. The gradient is typically on the order of 5 percent. Some pools exists in areas where large boulders are present. There is a small area of bed rock outcrop along the right bank about 100 feet below the upstream limit of the reconnaissance (Photo 2).

Photo 2 – Bedrock outcrop along right bank about 100 feet downstream of recon limits

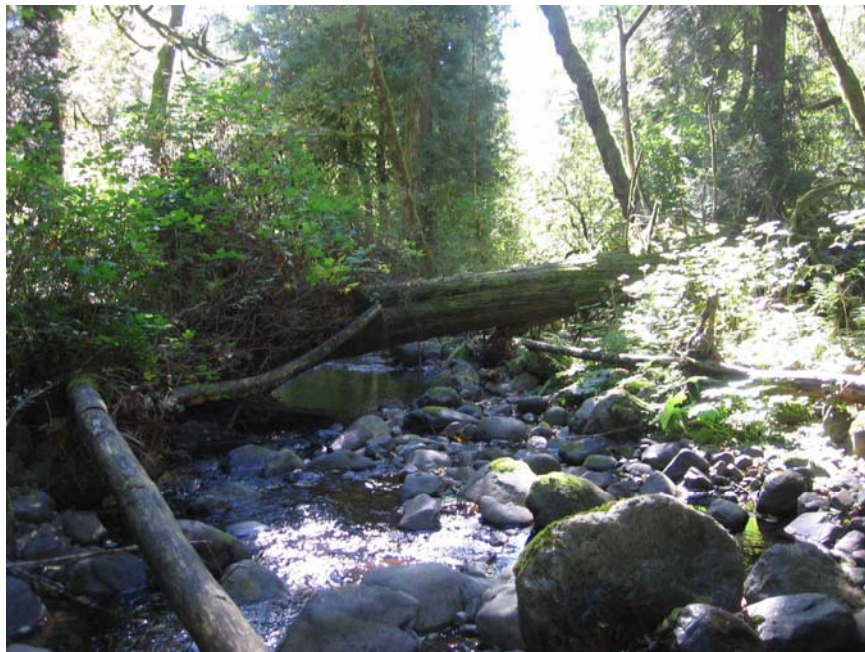
4. A measurement of wetted width and bankfull width approximately 150 feet upstream of the bridge was 18 feet and 30 feet, respectively. Photo 4 shows the creek in the area of the width measurements.

Photo 4 – Large fallen cedar spanning creek near area where channel was measured with wetted topwidth of 18' and bankfull topwidth of 30 feet (Note: such LWD is scarce in Woodward Creek)

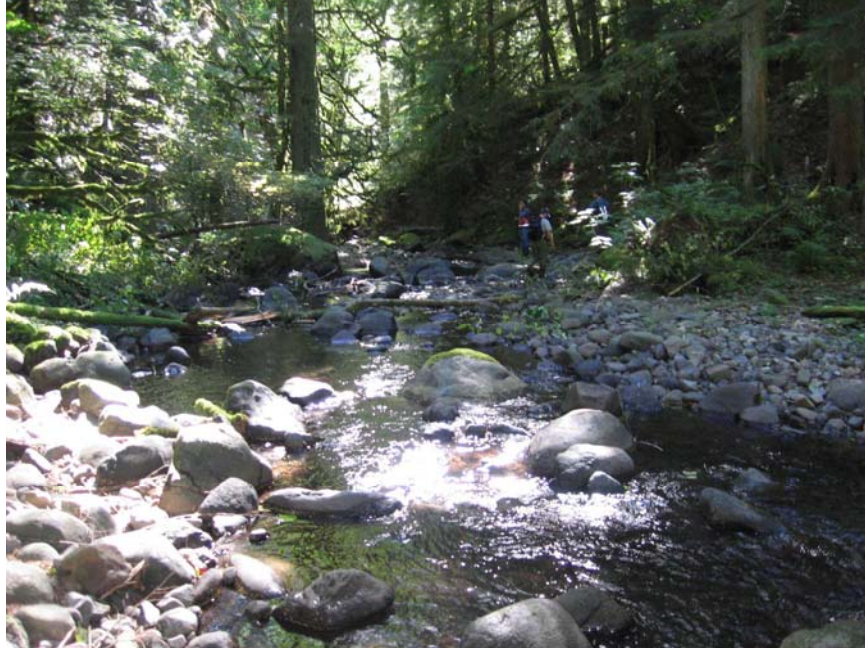
6. About 2,000 feet below the bridge, the channel becomes steeper and more confined. Additionally, large boulders become more frequent and dominate the bed (Photos 7 and 8). The gradient in this third reach ranges from 7 to 11 percent.

Photo 7 – Looking downstream into start of steeper more confined reach of Woodward Creek with gradient of 7 to 11 percent (about 2,000 feet downstream of bridge)

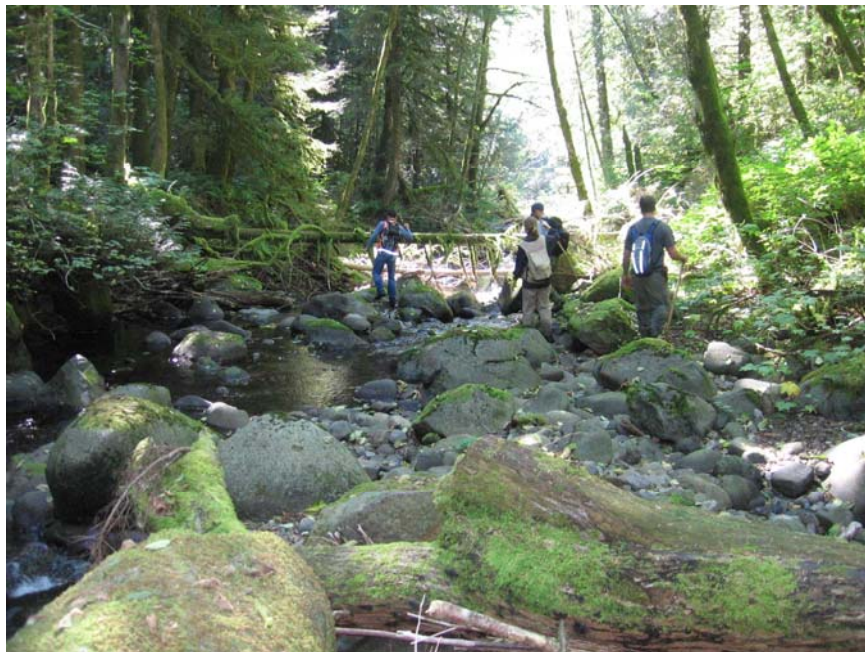
Photo 8 – Area dominated by larger boulders in the 7 to 11 percent gradient reach, channel is confined to about 20 to 25 feet by hillsides

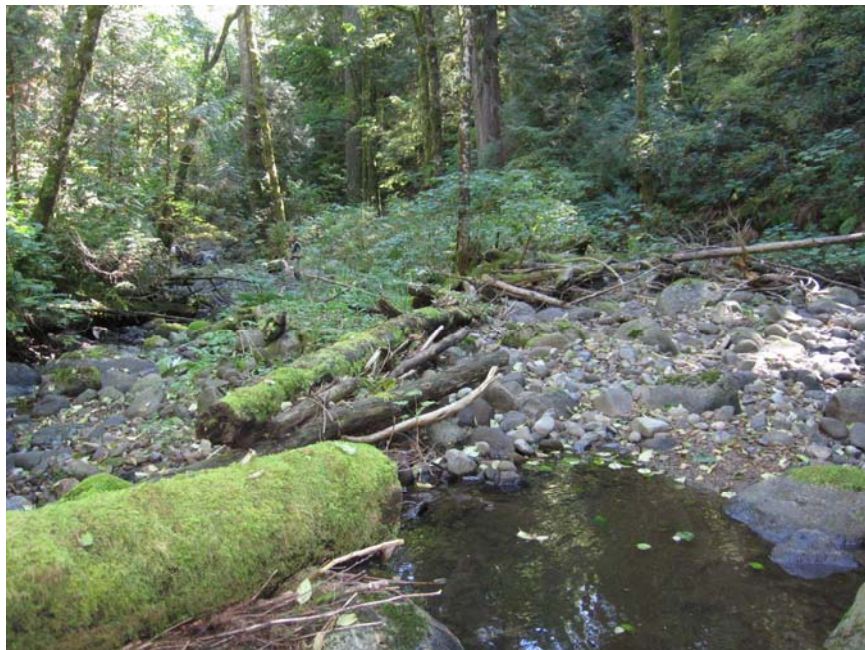
8. Within the third reach, the local gradient varies. In the flatter portions, the bed material is generally cobbles and small boulders. In the steeper portions, large boulders become more frequent. The flatter portions typically have a wider channel. Photo 10 shows one of the flatter portions of the third reach. In some of these flatter areas of the third reach, as well as in portions of the second reach there are locations where there is an approximately 100 foot wide floodplain.

Photo 10 – Wider (approximately 40 foot wide channel) and flatter area within 7 to 11 percent gradient reach, bed is smaller boulders and cobbles with some gravels, channel steepens up several hundred feet upstream and downstream

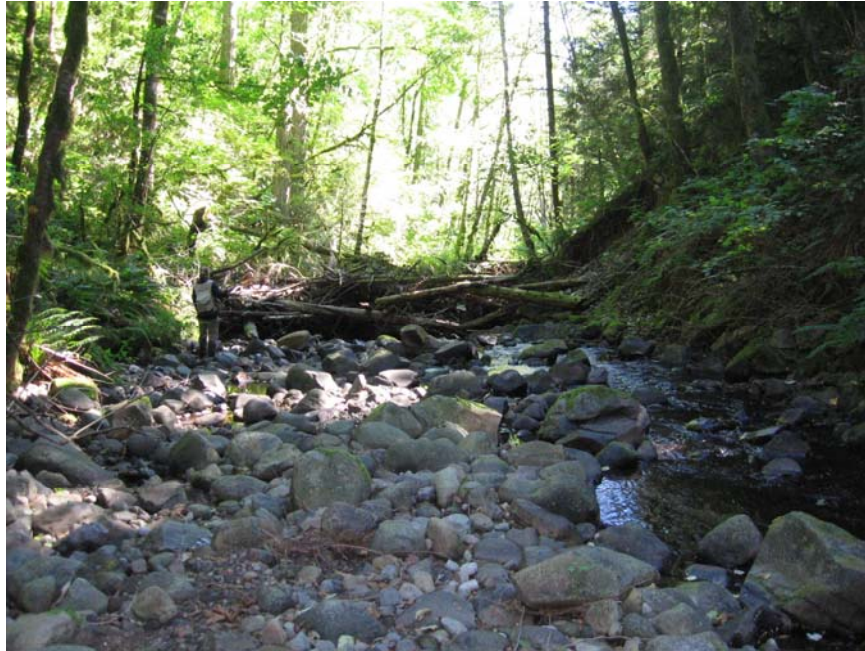
9. There are some larger cedars, including one approximately 6 feet in diameter in the second and third reaches. There is natural LWD present in single logs and clumps, and a couple of LWD jams that span the channel (Photo 11). However, in the 2.5 miles there are approximately 100 pieces, which would average out to 40 pieces per mile. This is much less than what is considered properly functioning for coastal streams (80 pieces/mile), but may be within the realm of natural variation for the Columbia Gorge.

Photo 11 – Channel spanning log jam in the third reach

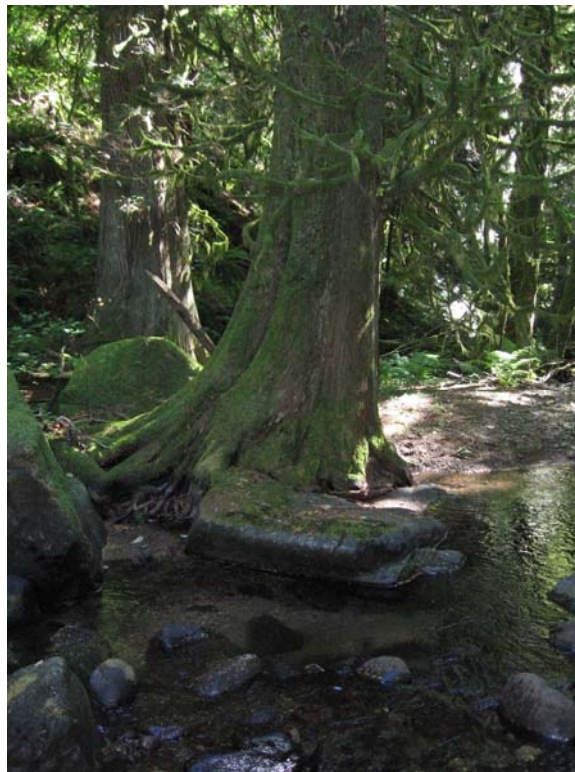
Photo 12 – Six foot diameter cedar growing at bed level in the third reach, some gravels deposited upstream and in bar downstream

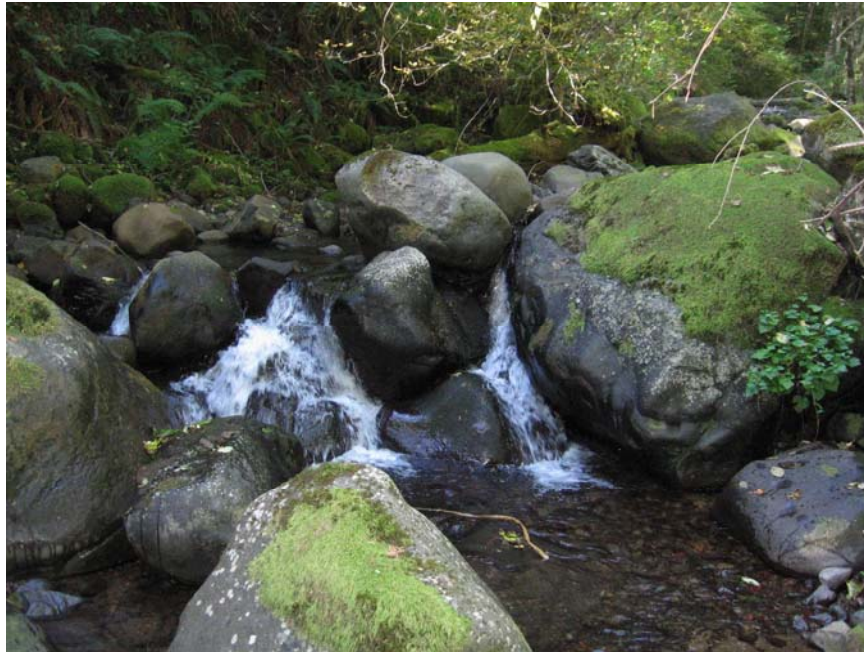
Photo 13 – Three foot boulder drop in 11 percent portion of third reach

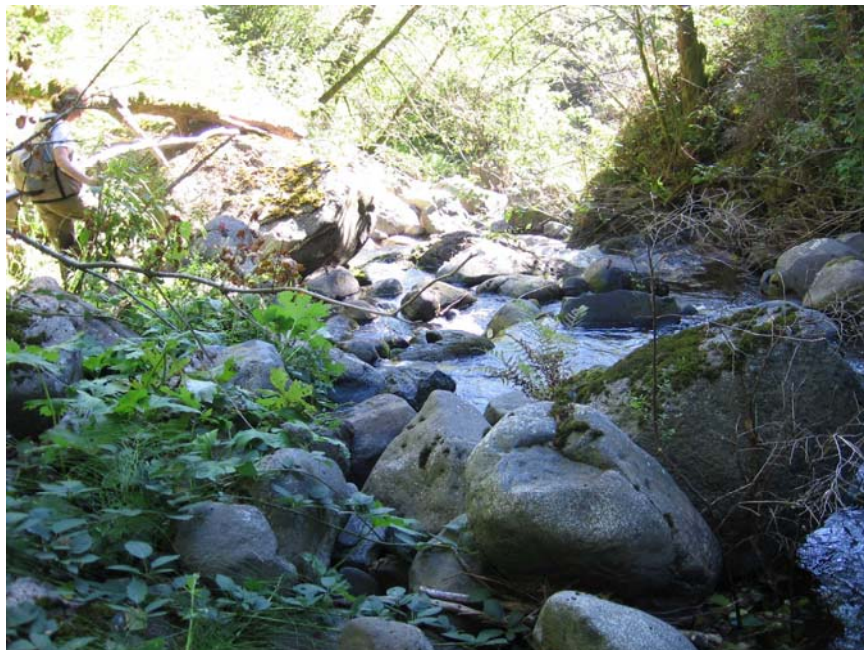
10. Near the middle powerline crossing, the valley walls become steeper and the stream becomes more confined. This is considered the fourth reach. The creek flows through a narrow canyon for approximately ½ mile that is dominated in many areas by large boulder (greater than 4 feet in diameter) and cascades and step pools (Photo 14). There are intermittent areas of exposed bedrock on either side of the creek. The channel steepens up to 20 percent in some locations, though there are also areas of this reach with a gradient of 6 to 10 percent .

Photo 14 – Steep boulder dominated portion of the fourth reach

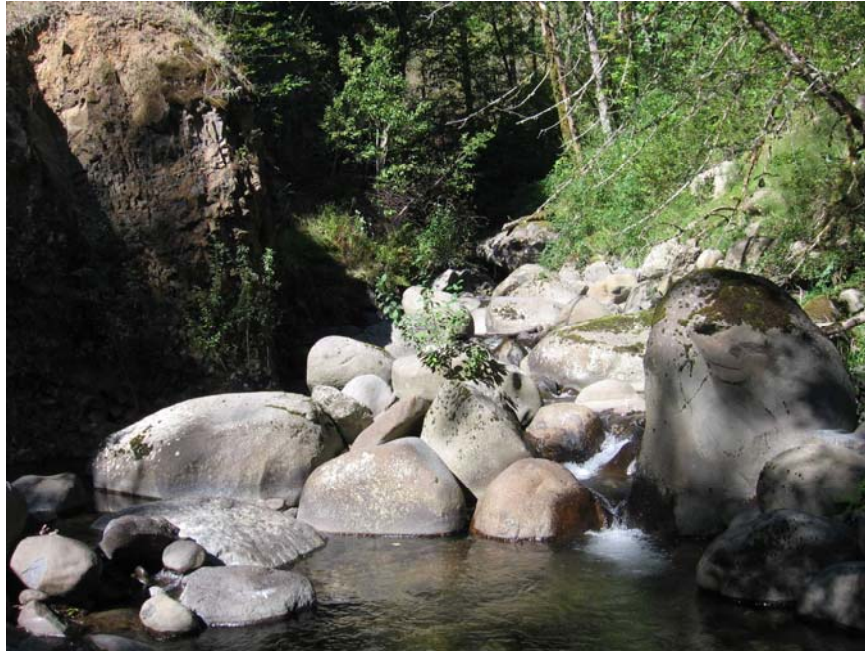
12. Wetted width generally varies from 10 to 20 feet, where boulders constrain the flow, the bankfull width would be equal to the wetted width.
13. At the confluence of the East Fork tributary, the right bank is bedrock of highly fractured basalt entablature (Photo 15), likely corresponding to the Steever-Rock outcrop soil association that also becomes much more prevalent further downstream of the East Fork confluence (Photo 16). Just upstream of the East Fork confluence, the basalt outcrops in the bed and creates a falls with about 6 feet of drop (Photo 17)

Photo 15 – Bedrock on right bank near east fork confluence

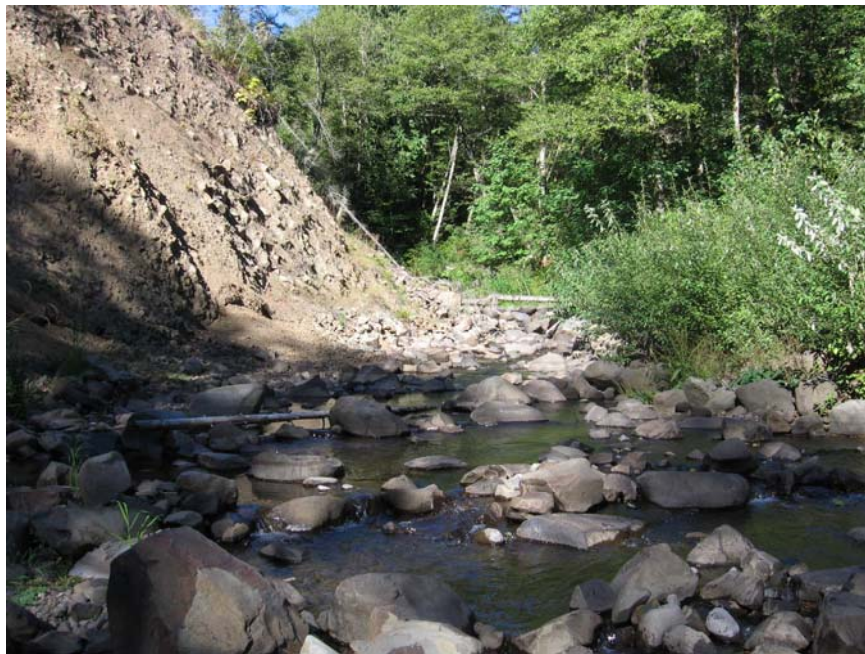
Photo 16 – Bedrock on left bank near downstream end of fourth reach

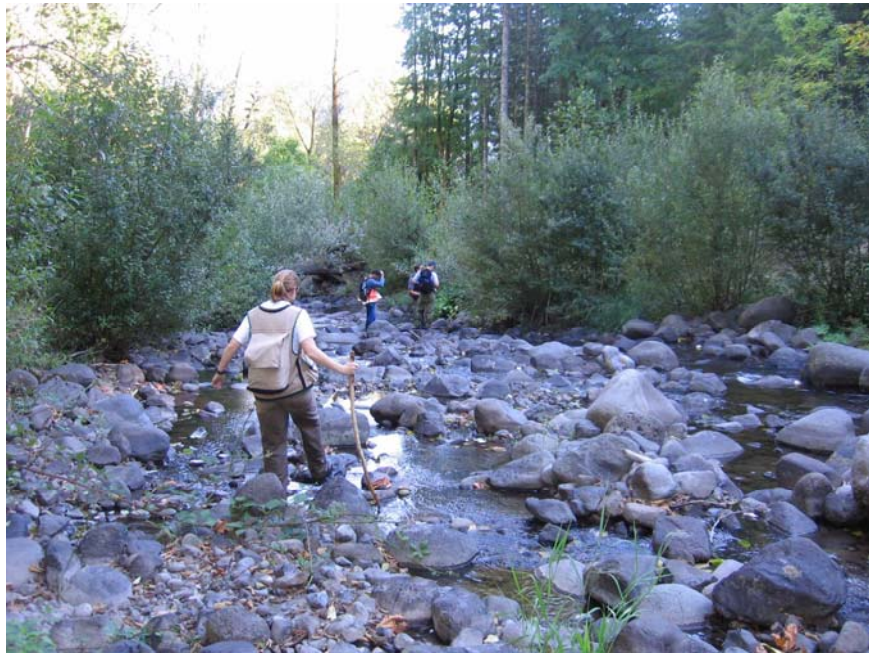
14. The channel and floodplain widen out approximately 3,500 feet below the powerline crossing and there is evidence of braiding and cobble bar deposition in many locations. The gradient in this reach lessens ranging from 3 to 5 percent. The large boulders in excess of three feet become infrequent and there are more frequent areas of coarse gravel and small cobble, though the bed is still largely dominated by large cobbles and small boulders (Photo 18). This

Photo 18 – Wider, lower gradient channel with floodplain, typical of the fifth reach

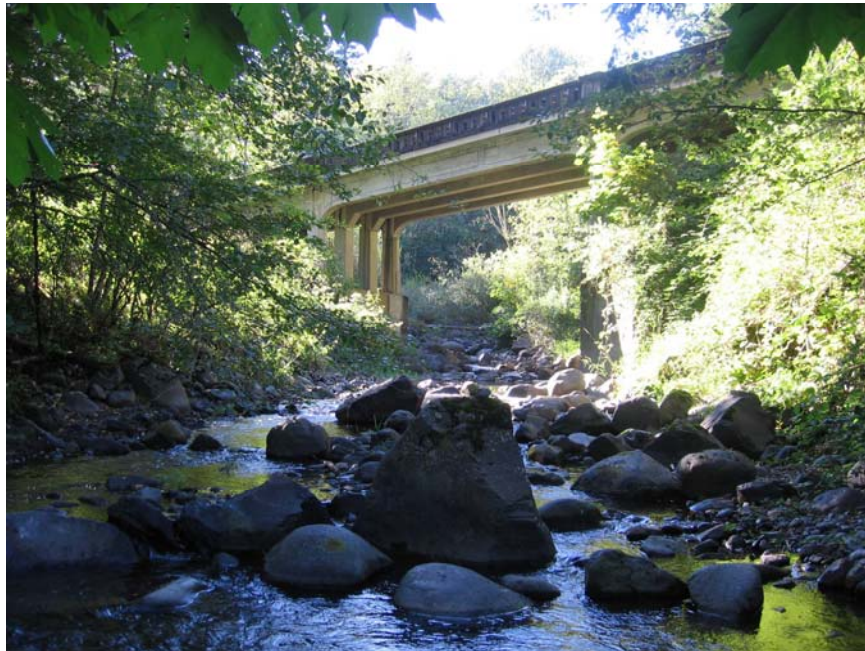
15. The Highway 14 bridge does not appear to constrain the channel, it is 40 feet wide, similar to many locations upstream in the bedrock outcrop areas (fourth reach). The bridge was placed at a natural constriction in the stream corridor formed by a high terrace on the right bank and valley wall near the left bank (Photo 20).

Photo 20 -- Looking upstream at Highway 14 Bridge

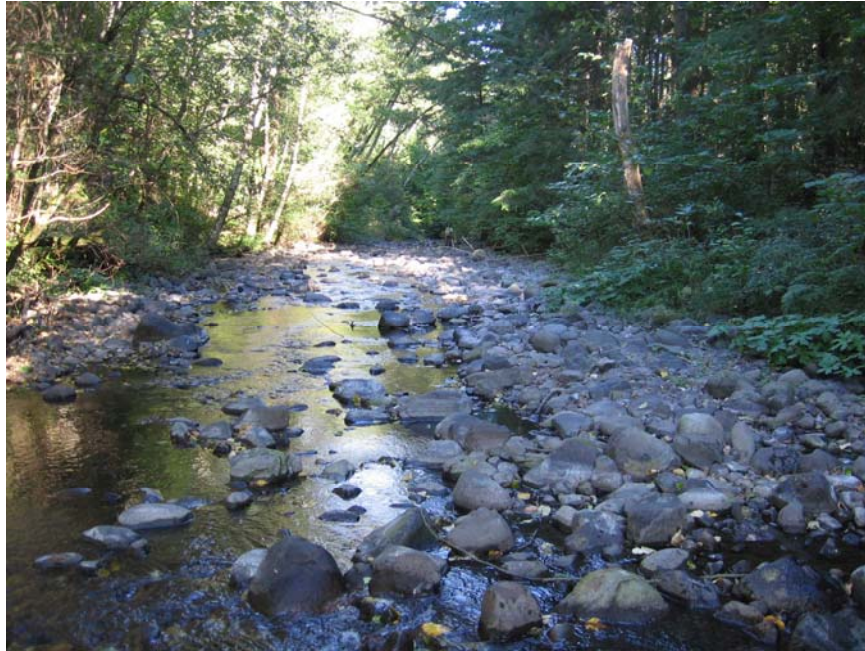
17. The bed profile through the sixth reach is very uniform and the channel is extremely straight (Photo 21). The bed is dominated by large cobbles and small boulders, though small cobbles and gravel are present on the surface between the coarser bed material.

Photo 21 – Typical straight channel with uniform profile between Highway 14 and Beacon Rock Moorage Road culvert. Bed material is mostly large cobble and small boulder with some gravel and small cobble.

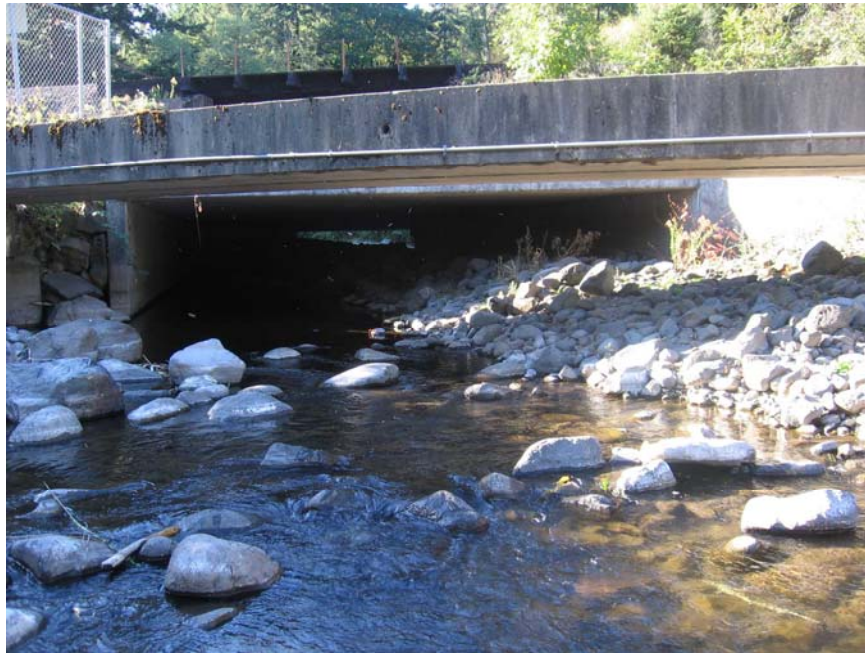
19. This reach of the creek may transport sediment more efficiently than the historic channel crossing the alluvial fan because of the artificial confinement. However, when the channel takes a 90 degree bend and enters the Beacon Rock Moorage Road culvert, some of the bed load is deposited (Photo 22 and Photo 23).

Photo 23 – View into Beacon Rock Moorage Road culvert from the downstream side

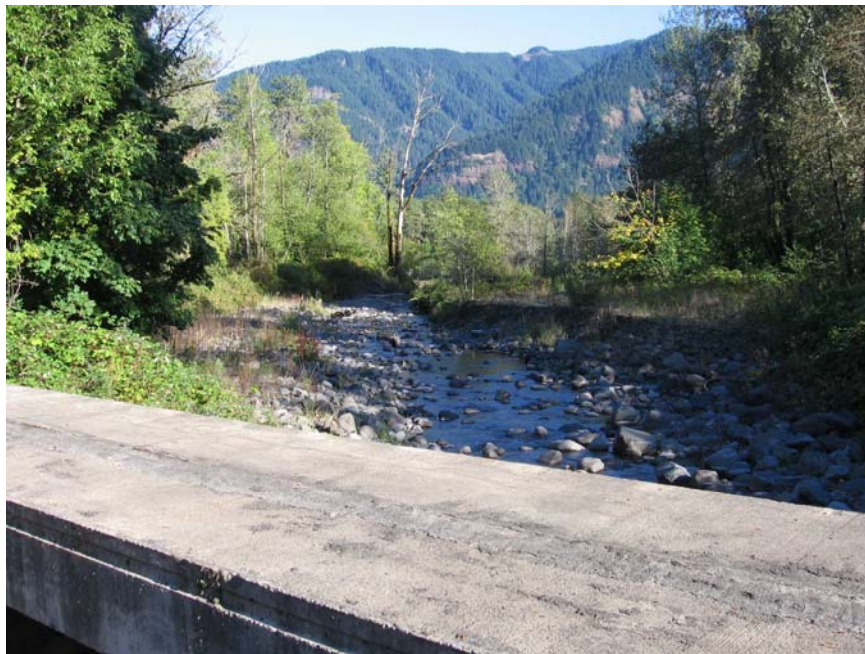
20. The seventh and final reach starts below the Beacon Rock Moorage Road culvert and continues downstream for approximately 2,000 feet. The gradient in this reach averages about 1 percent based on the USGS maps. The bed material in the reach starts as coarse cobble and boulders (Photo 24), but decreases to have some areas with significant gravels and small cobbles (Reach 25) as the gradient decreases. This is a natural deposition zone and there is evidence of extensive braiding and channel changes. Large deposits of cobble and gravels are present (Photo 26). The channel changes based on the presence of LWD, channel aggradation/bars or other features that may block one channel and cause it to divert to another channel. There are several small beaver dams that have recently been constructed in the lower creek and are forming nice pools (Photo 27). The creek flow goes partially or completely subsurface in some locations where the bed material is very coarse. At the date of the visit the Columbia River was quite low and there was a definite drop from Woodward Creek into the Columbia with partial subsurface flows that was not passable by salmonids (Photo 28).

Photo 24 – Looking downstream from Beacon Rock Moorage Road culvert into the seventh reach, bed is primarily coarse cobble with some small boulders

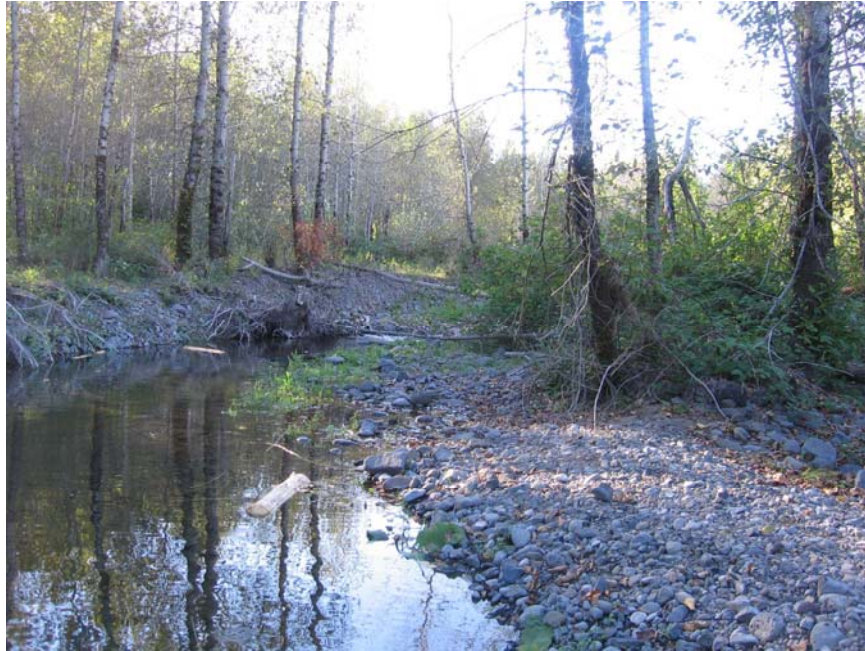
Photo 25 – The bed is primarily large gravel and small cobble in this area several hundred feet above the Columbia River confluence. A beaver dam creates the pool in the foreground of the photo. Banks are comprised largely of gravels and cobbles with sand.

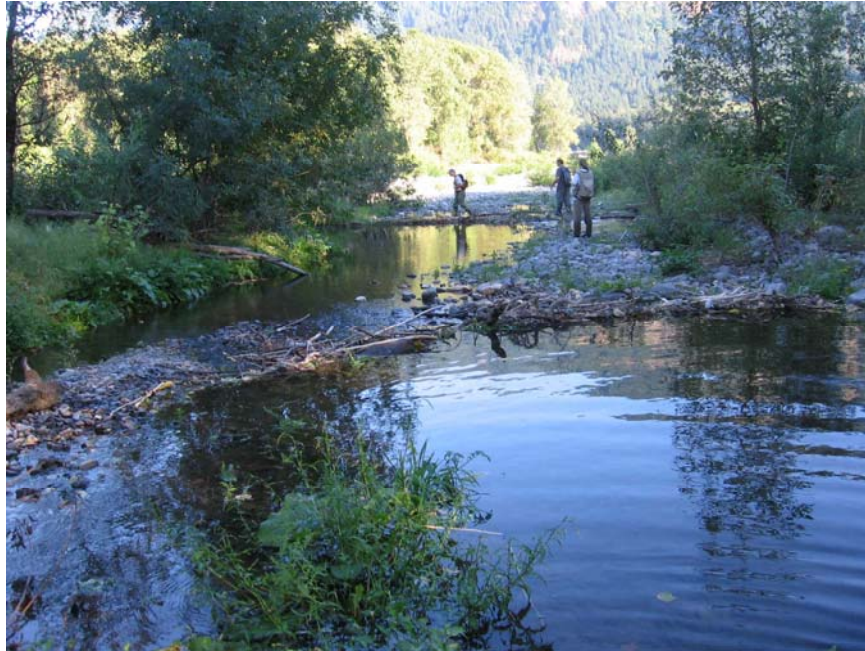
Photo 27 – Small beaver dams and ponds several hundred feet upstream of the Columbia River Confluence
