2008 Stormwater Needs Assessment Program

Salmon Creek (RM 03.83)/Cougar Creek
Subwatershed Needs Assessment Report

Clark County Public Works Clean Water Program

April 2009

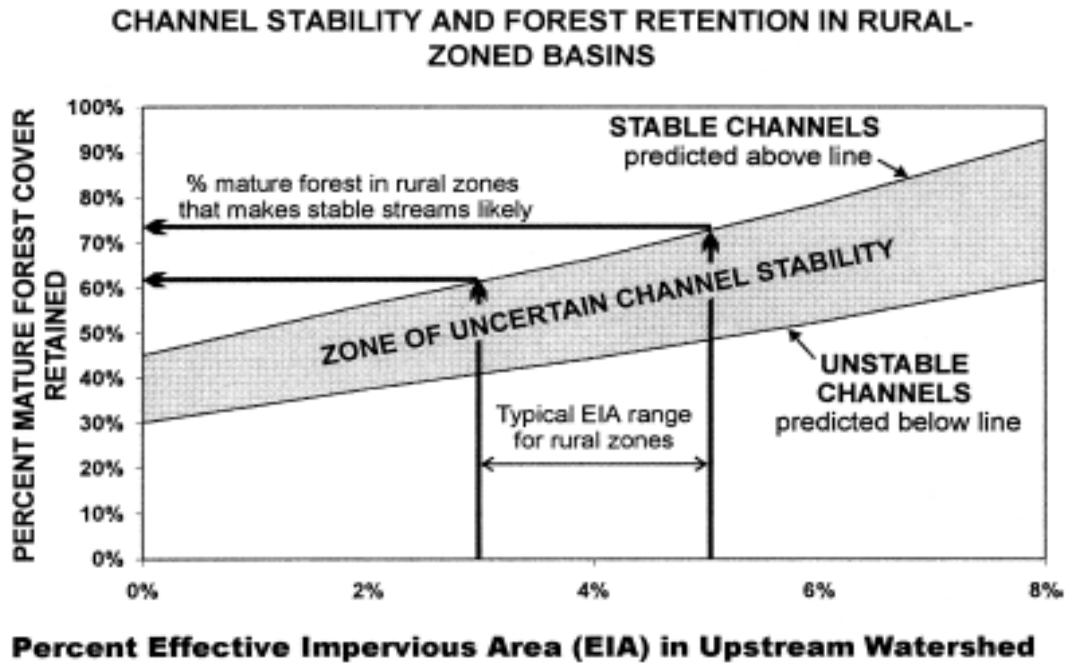
Figure 2: Channel stability in rural areas (Booth, Hartley, and Jackson, June 2002).

In a recent publication by Booth, Hartley, and Jackson (June 2002), a relationship between forest and percent EIA was presented as a graphic (Figure 2). According to this figure, streams in both subwatersheds would be expected to have very unstable channels.

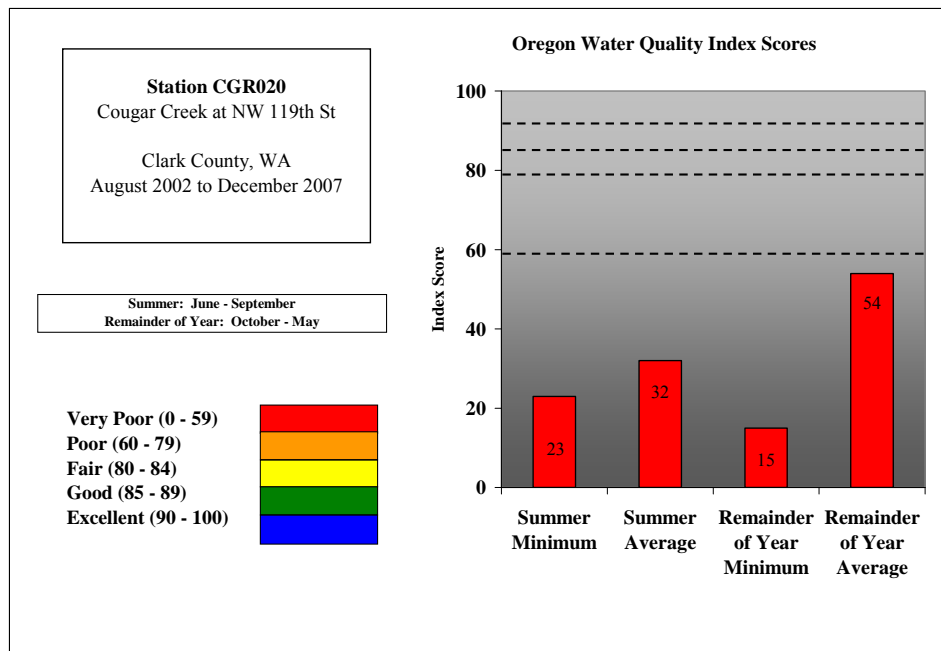
Figure 3: Average Water Quality, Cougar Creek station CGR020, 2002 through 2007, Oregon Water Quality Index

Figure 3 shows seasonal mean OWQI scores for Station CGR020 from 2002 through 2007. Among 15 long-term monitoring stations county-wide, Station CGR020 ranked second worst in overall water quality during this time period (Hutton and Hoxeng, 2007).

Monthly OWQI values since 2002 ranged from Very Poor to Fair, although for most months (43 out of 62 months sampled) OWQI values were in the Very Poor category. Monthly sub-index scores for total solids and inorganic nitrogen were consistently very poor, while scores for total phosphorus were typically in the poor range. Fecal coliform scores ranged widely, from very poor to excellent. Scores for water temperature, dissolved oxygen, and pH were consistently excellent.

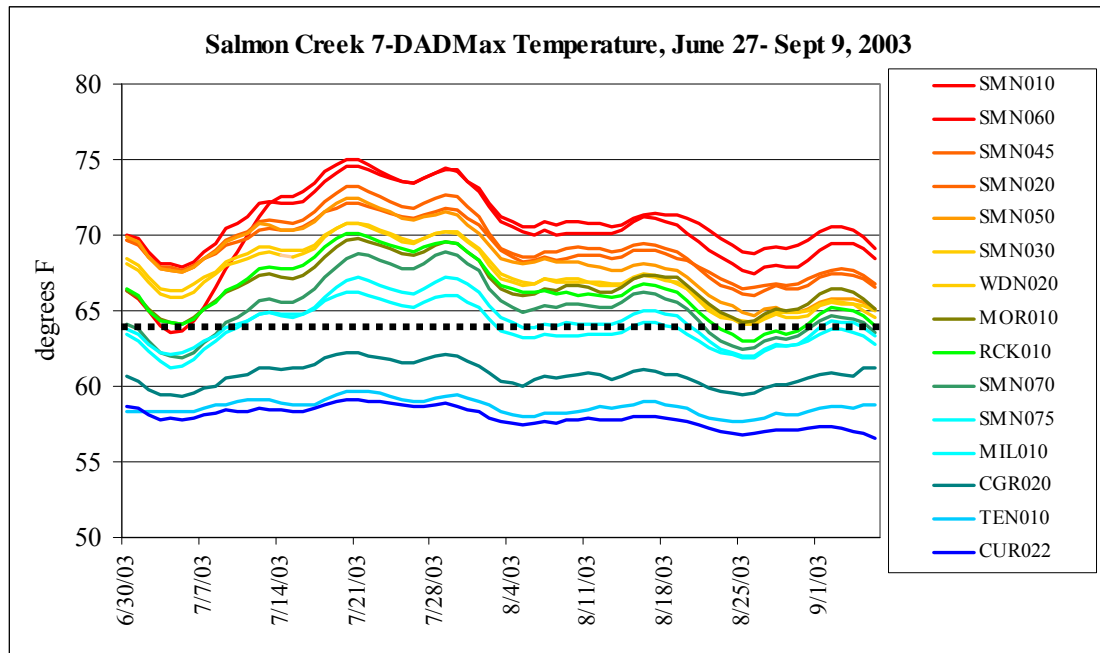
Figure 4: Time-series plot of 7-DADMax temperatures, Salmon Creek, summer 2003. (from Schnabel, 2004). Dotted line at 64° F represents the pre-2006 Washington state stream temperature criterion. The current criterion is 60.8° F.

Figure 4 shows 7-DADMax temperatures during the summer of 2003 for 15 stations throughout the Salmon Creek watershed. The 7-DADMax is the maximum of the 7-day moving average of daily maximum temperatures. Ecology standards utilize this metric to determine temperature compliance (criterion for this assessment area is 60.8 degrees F).

Based on current state criteria for Salmon Creek, Tenny Creek was the only station meeting criteria within this assessment area; though Cougar Creek exceeded the criteria only slightly. Despite the addition of cool tributary flow from Tenny Creek and Cougar Creek, mainstem Salmon Creek within this assessment area remains very warm, substantially exceeding the state criterion.

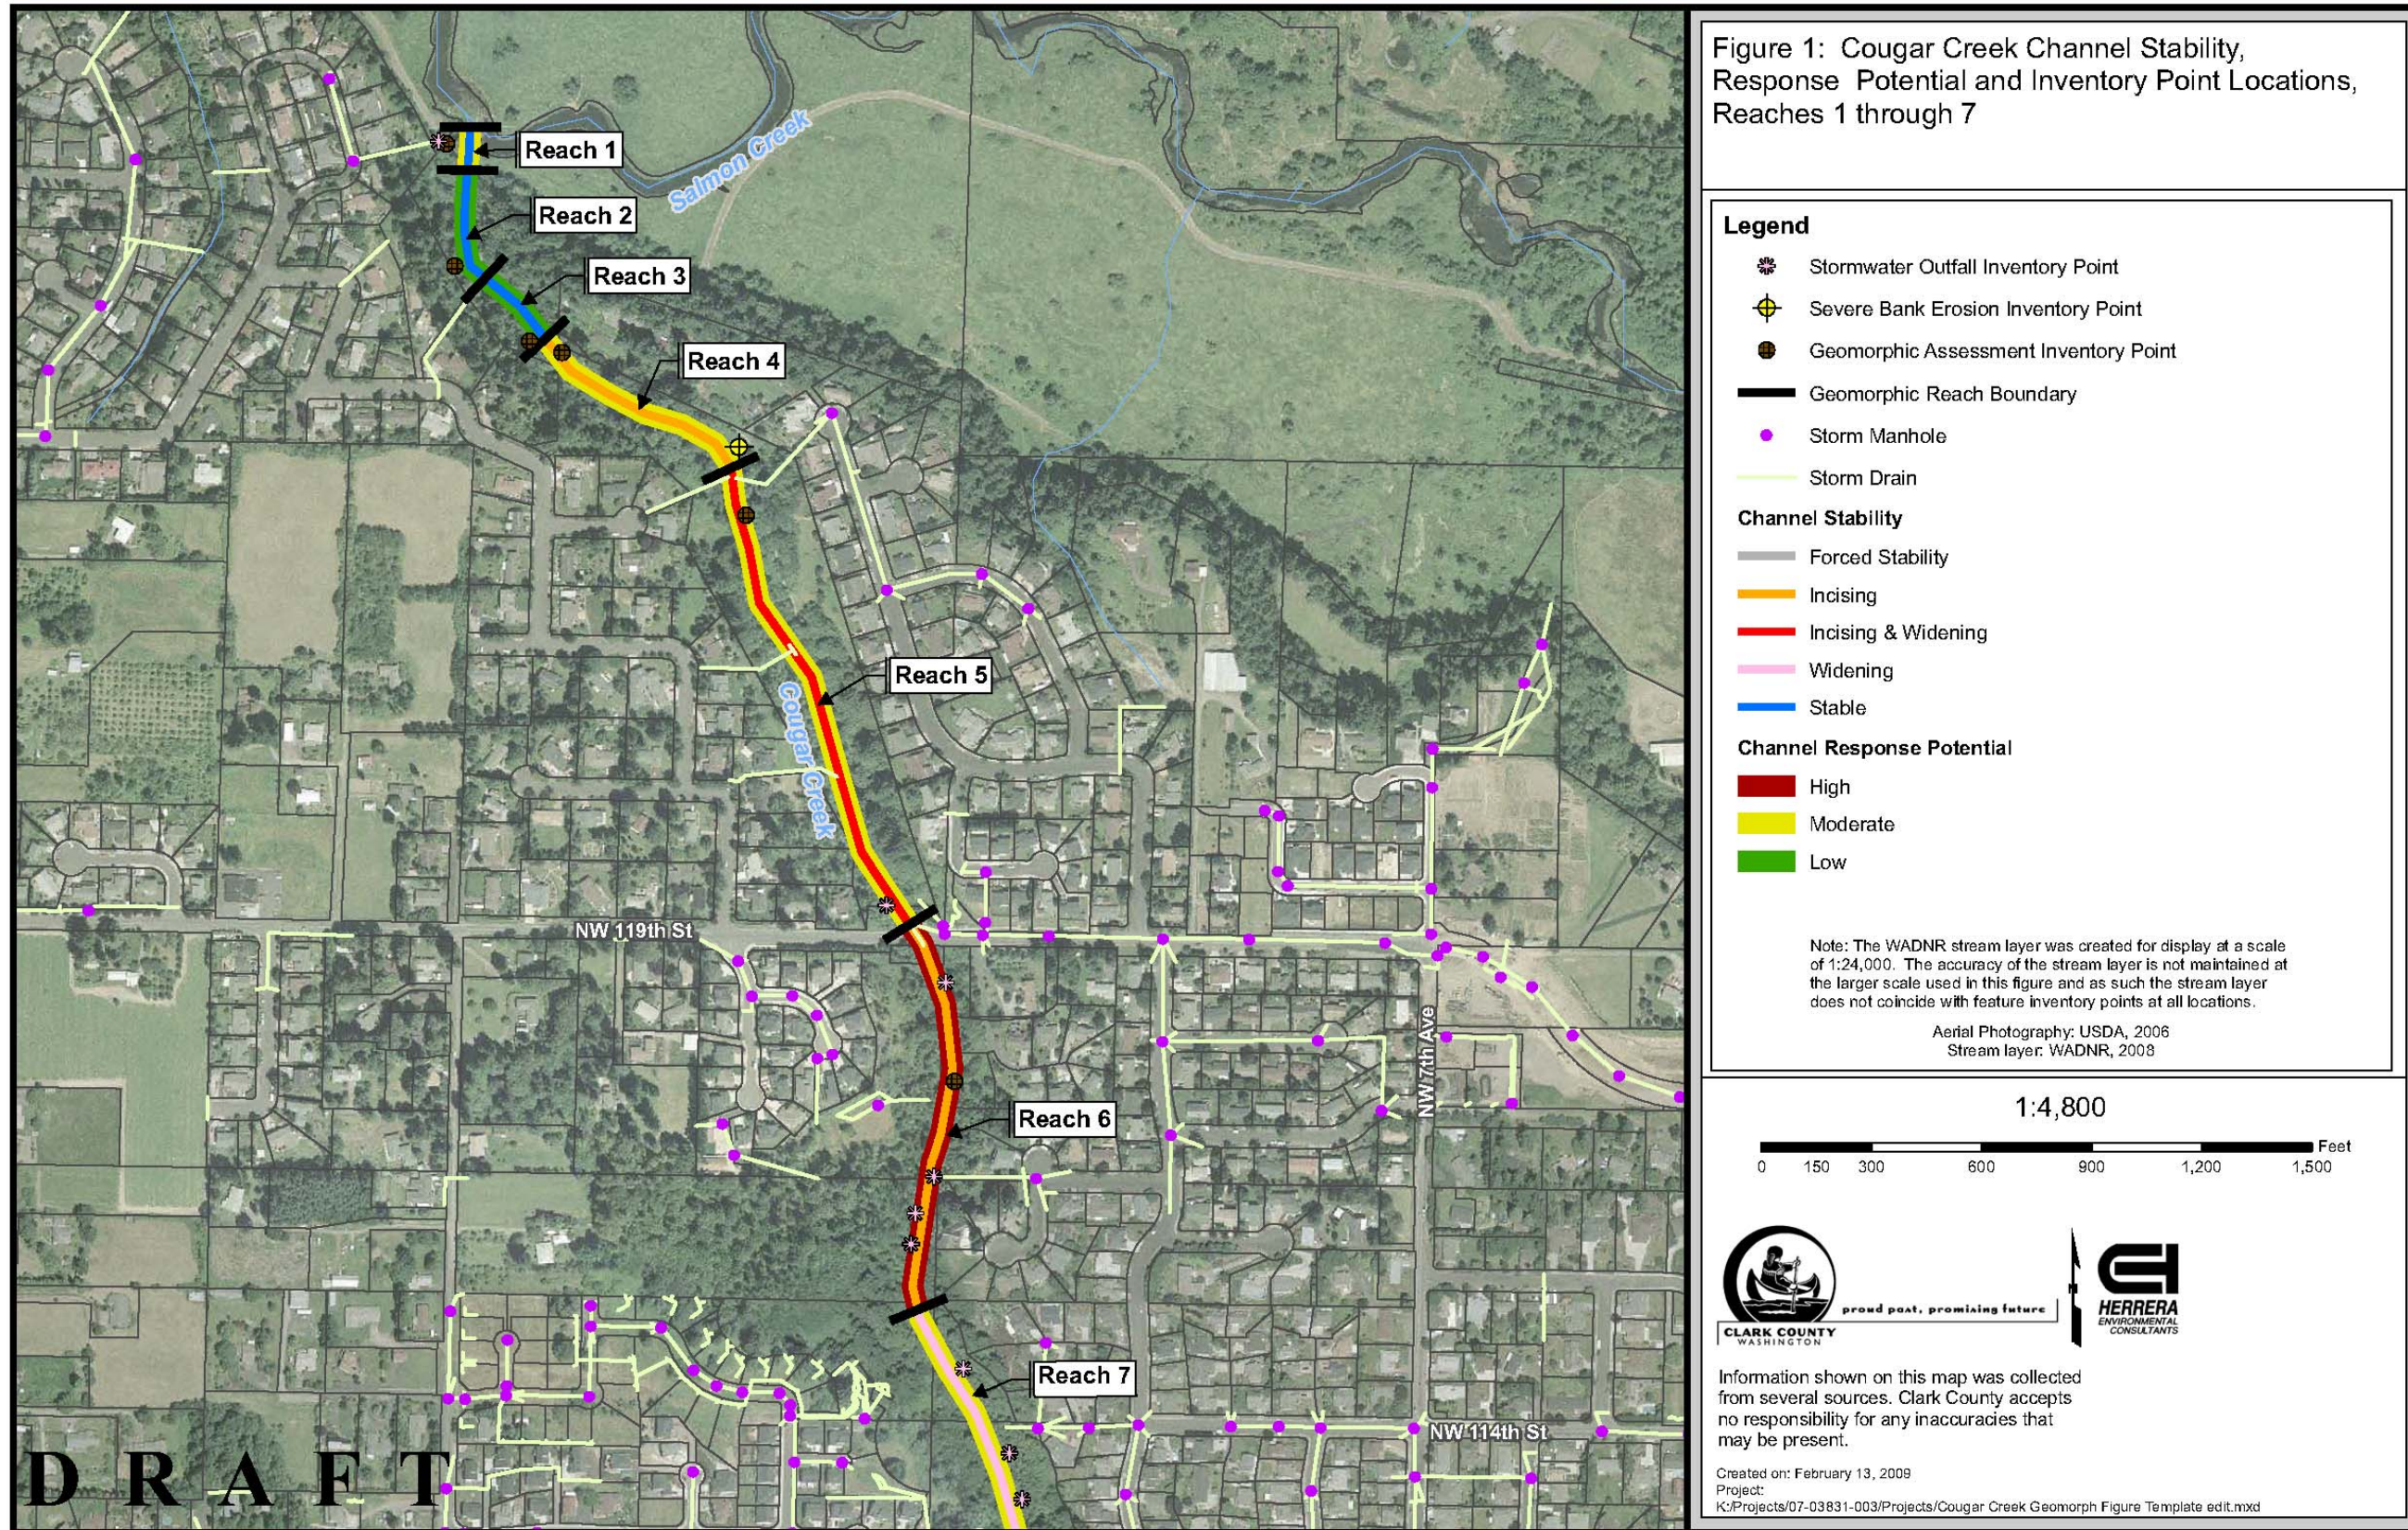
Figure 12: Cougar Creek: Channel Stability, Response Potential and Inventory Point Locations, Reaches 1 through 7.

The upstream end of Reach 1 begins at the Salmon Creek floodplain valley wall and becomes gradually less confined as it extends toward the confluence with Salmon Creek (Figure 12). Reach 1 is located within the Salmon Creek Park system and the historical Cougar Creek alluvial fan. As indicated by the ample gravel and cobble in the substrate material, this reach has the potential to be an alluvial, aggrading reach. A gravel bar at the mouth of Cougar Creek at its confluence with Salmon Creek is evidence of the ongoing sediment delivery. Reach 1 is characterized by a plane-bed channel, with a simplified rectangular cross-section; there is a pedestrian bridge associated with the Salmon Creek Park Trail mid-way along the reach. Angular riprap and rock are present along the banks, extending approximately 75 feet both upstream and downstream of the bridge abutments. This riprap inhibits floodplain connectivity, and there is very little channel complexity or diversity in channel form. Because of the potential for future channel aggradation and the rapid avulsion that can occur with alluvial floodplain settings, Reach 1 is characterized as having moderate response potential.

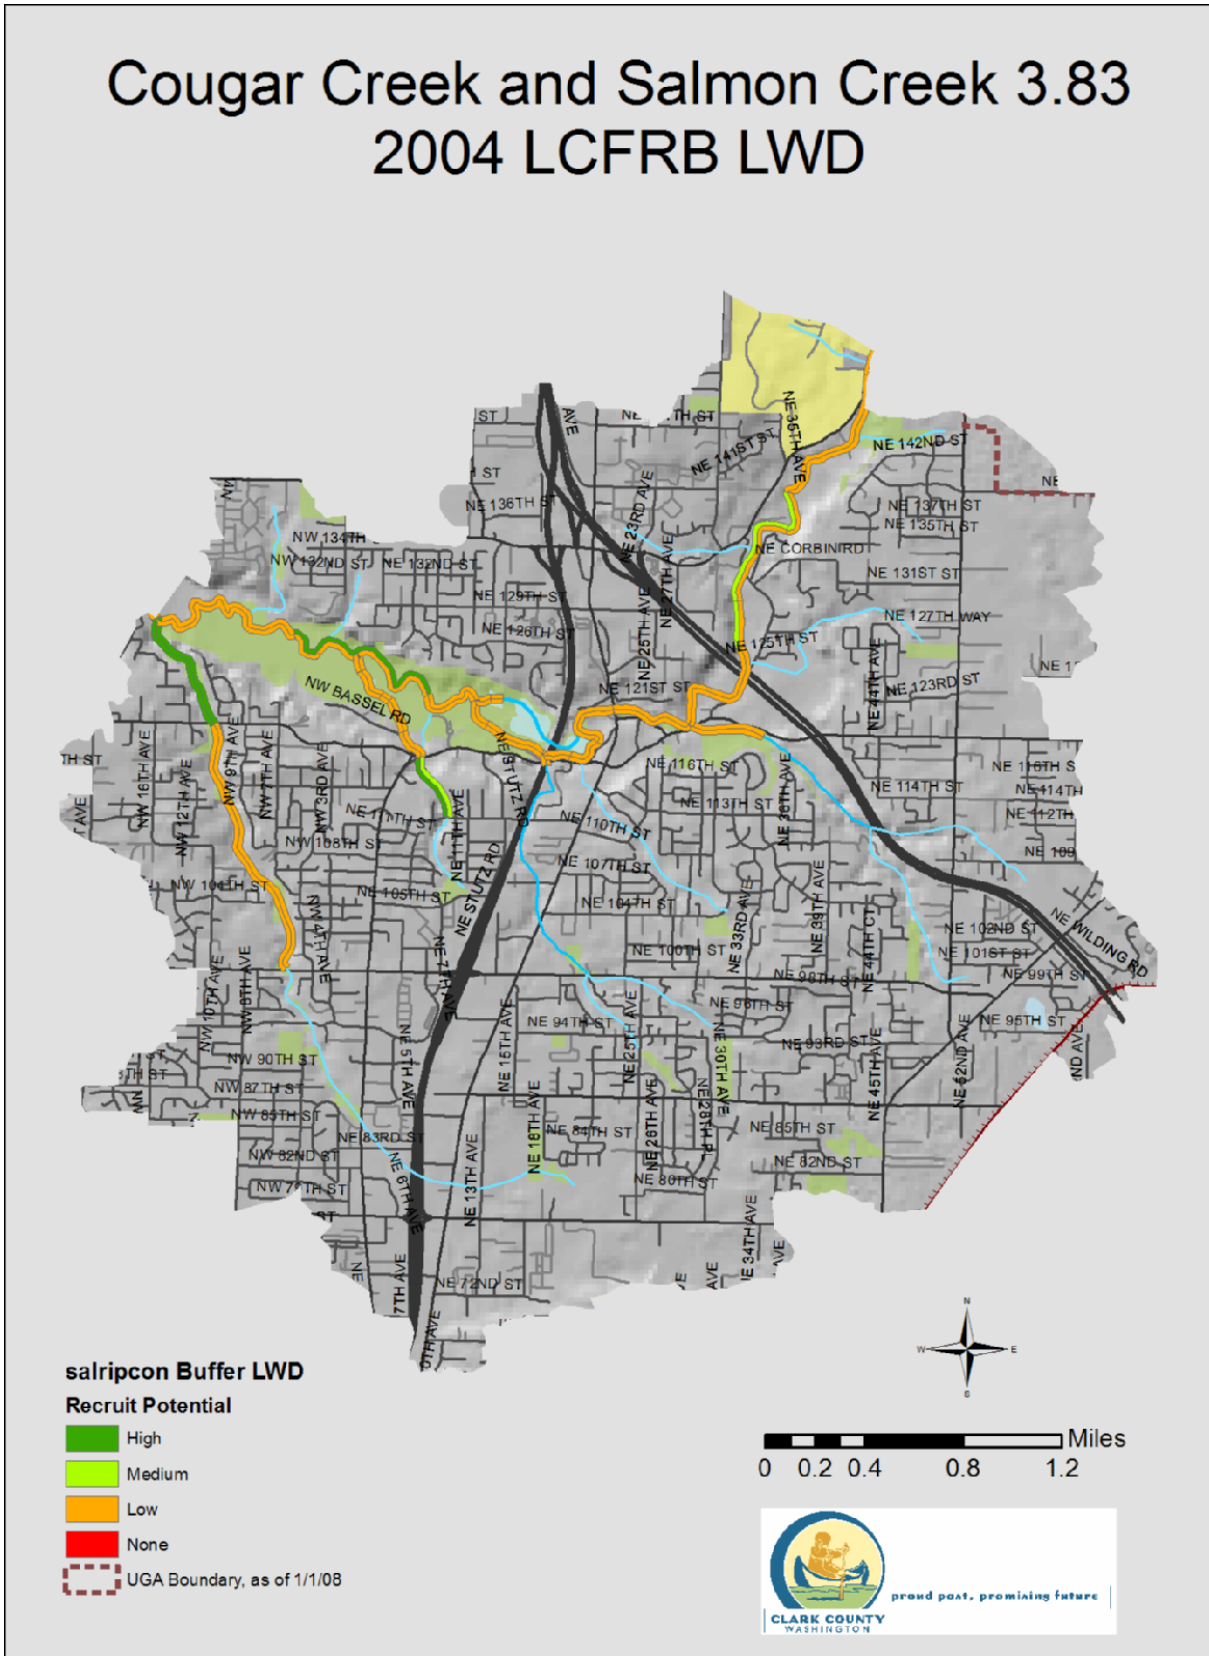
Figure 17: Salmon Creek (RM 03.83) and Cougar Creek LWD Recruitment Potential (adapted from R2 Resource Consultants, Inc., 2004)

Figure 17 shows the Salmon Creek (RM 03.83) and Cougar Creek subwatersheds LWD delivery potential. Within the Salmon Creek (RM 3.83) subwatershed, the survey includes the mainstem of Salmon Creek and portions of Suds and LaLonde Creeks. The mainstem of Salmon Creek is shown as having primarily low LWD recruitment along the approximate three mile distance surveyed. Review of the surveyed area and non-surveyed areas of Suds Creek, Tenny Creek and LaLonde Creek indicated primarily low LWD recruitment levels, with some small areas of medium recruitment.

The Cougar Creek subwatershed survey addresses only the lower reaches of Cougar Creek, which transitions from high levels of recruitment near the mouth of the creek, to lower levels further upstream. Review of orthophotography in the upper reaches estimated LWD recruitment potential ranging from low to none, with the lowest levels of recruitment located near the headwaters of Cougar Creek.

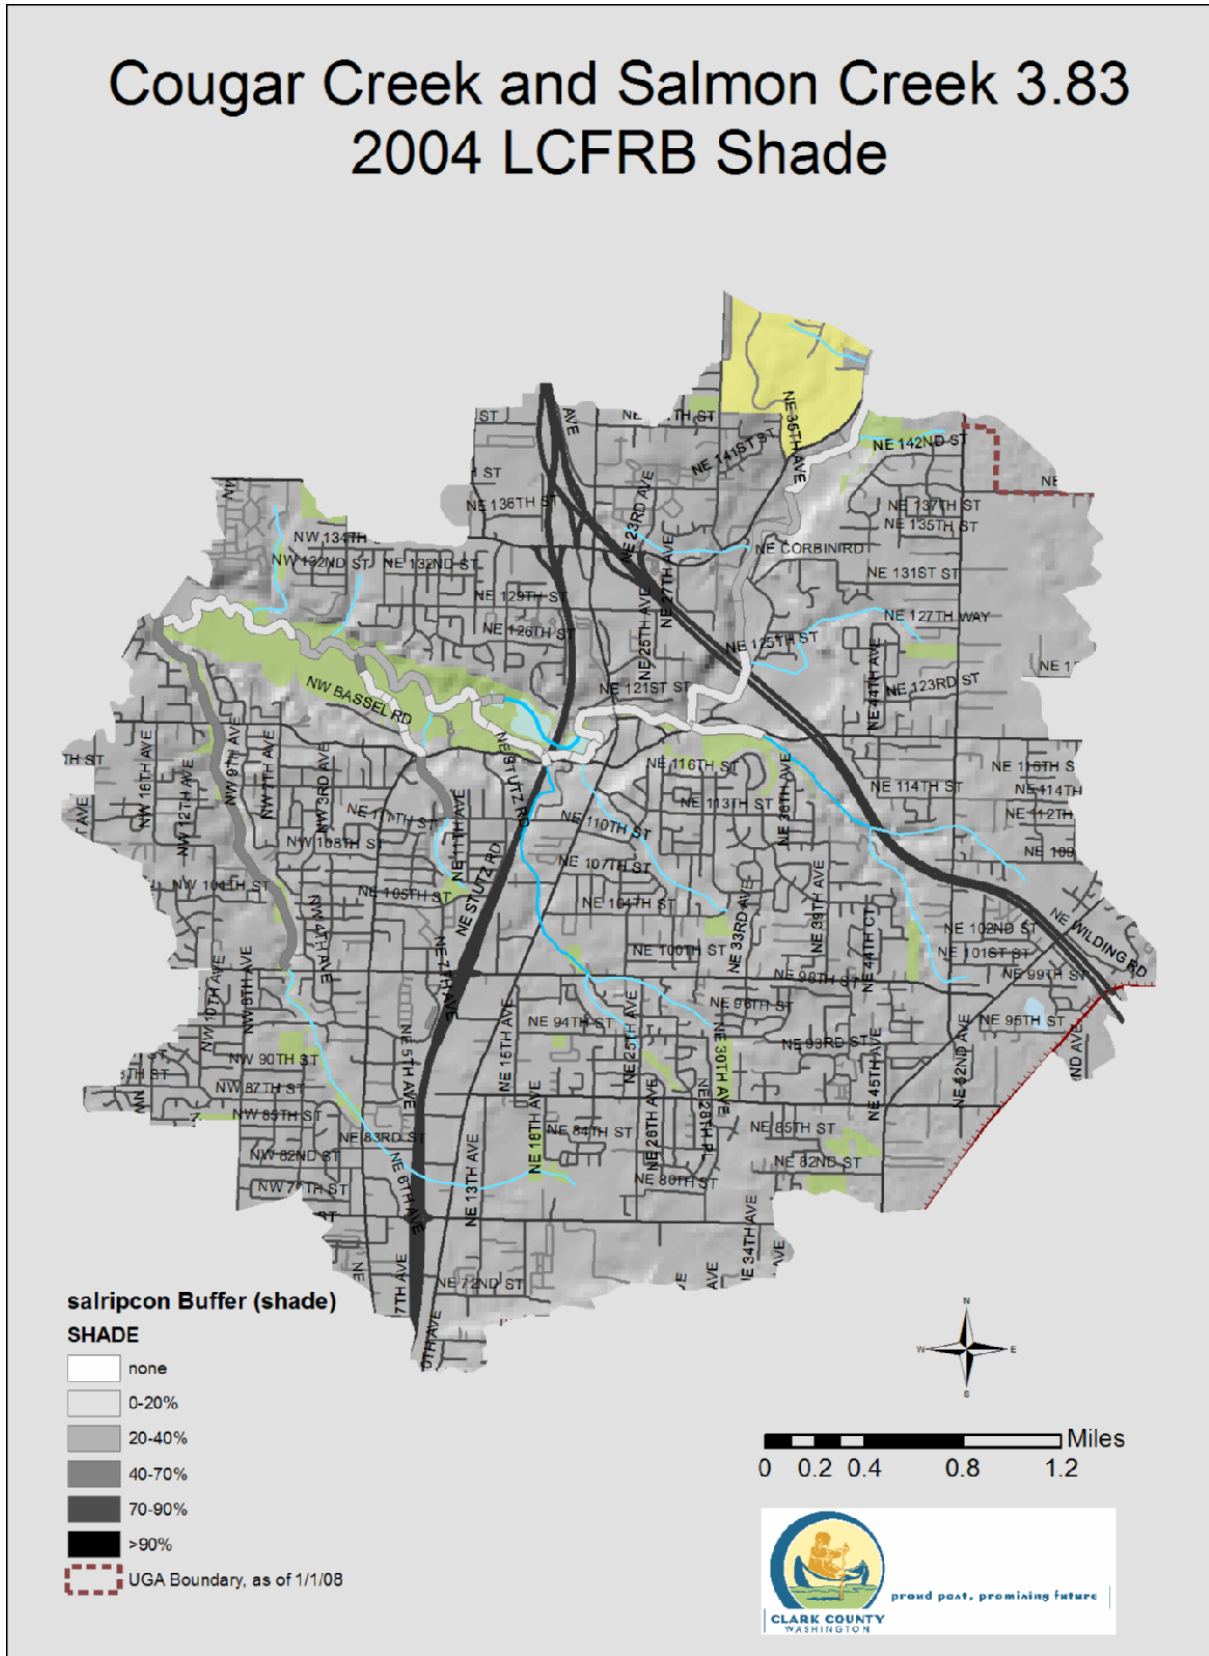
Figure 18: Salmon Creek (RM 03.83) and Cougar Creek Shade Values (adapted from R2 Resource Consultants, Inc., 2004)

The Salmon Creek (RM 03.83) and Cougar Creek subwatersheds shade ratings from the 2004 LCFRB Habitat Assessment are illustrated on Figure 18. Within the Salmon Creek (RM 03.83) subwatershed, the survey covered the mainstem of Salmon Creek and portions of Suds and LaLonde Creeks. The mainstem of Salmon Creek within the Salmon Creek (RM 03.83) subwatershed has shade levels ranging from 0 percent to 40 percent. Review of the surveyed area and non-surveyed areas of Suds Creek and LaLonde Creek indicated shade levels of varying from 0 percent to 70 percent. Tenny Creek is estimated to have shade levels ranging from 0 percent to 40 percent, based on orthophotography review.

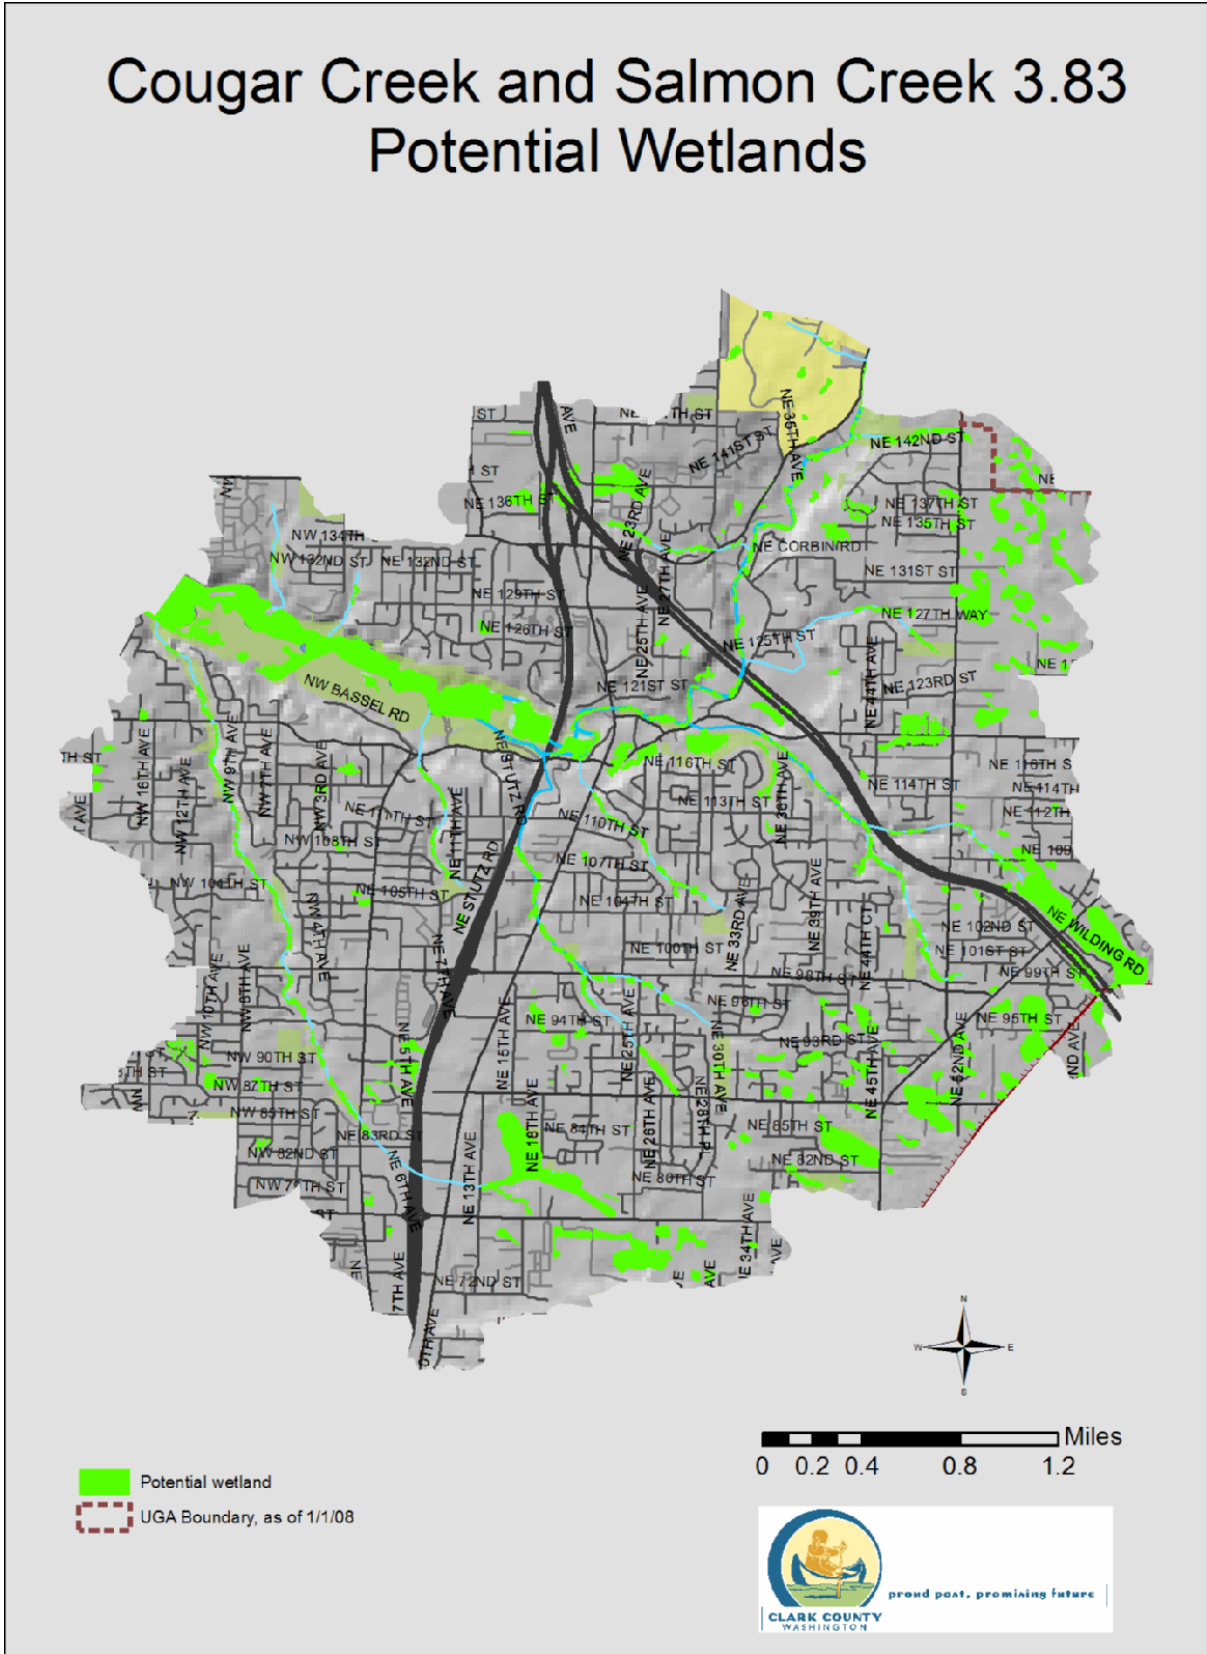
Figure 19: Salmon Creek (RM 03.83) and Cougar Creek Potential Wetlands

Figure 19 shows potential wetland areas within the Salmon Creek (RM 03.83) and Cougar Creek subwatersheds based on data from the county wetlands atlas, including the Clark County wetland model, National Wetlands Inventory, and high-quality wetlands layer.

Review of the wetland inventories and studies identified several project opportunities within publicly held or tax-exempt land. Within the Salmon Creek (RM 03.83) watershed, there are potential wetlands in the vicinity of the headwaters of Tenny Creek. Additionally, potential wetland areas owned by Clark County are located at the headwaters of Cougar Creek.

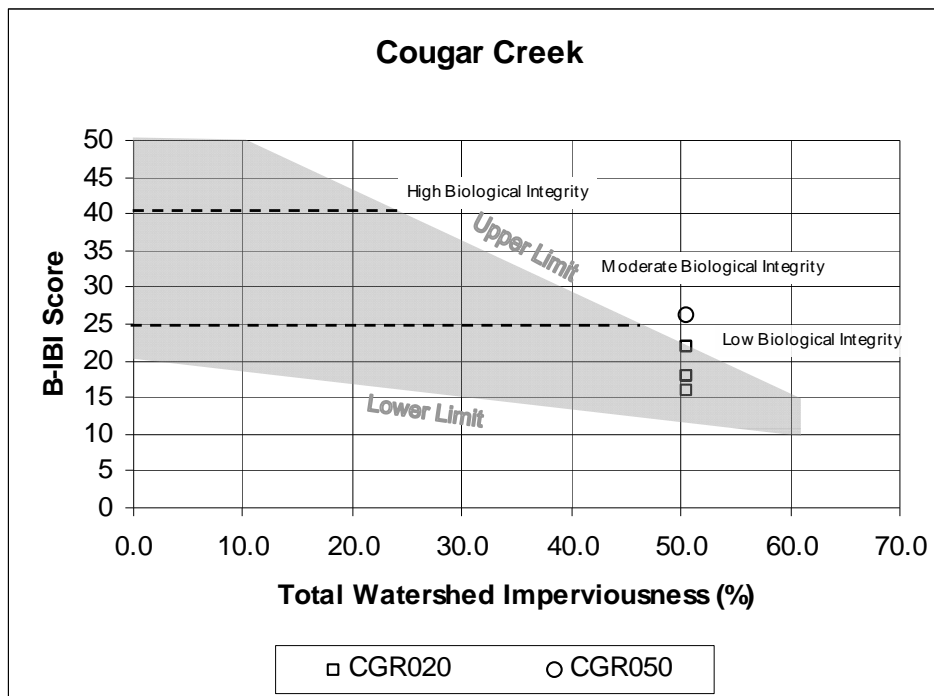
Figure 21 shows that three of the five annual Station CGR020 B-IBI scores are in the middle and two are at the upper limit of the range of expected scores, whereas Station CGR050's single B-IBI score is above the upper limit (estimated 2000 Total Impervious Area from Wierenga, 2005).

Given most of Cougar Creek's B-IBI scores fall within or slightly above those typically found for subwatersheds with 50 percent impervious areas, there may be limited opportunity to improve scores into the moderate range through habitat rehabilitation.

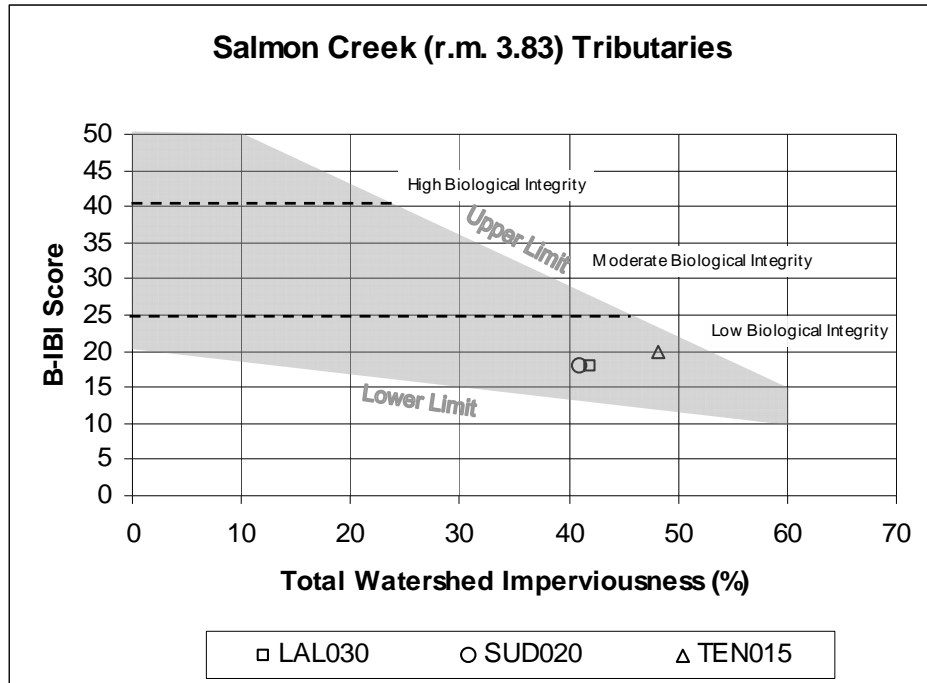
These three Salmon Creek tributaries B-IBI scores fall mostly in the middle of the expected ranges for their relatively high estimated 41 percent to 48 percent impervious areas. This implies an opportunity to increase the level of their biological integrity by improving habitat and stream conditions. Management strategies that limit further degradation and promote stewardship are important to possible improve biological integrity.

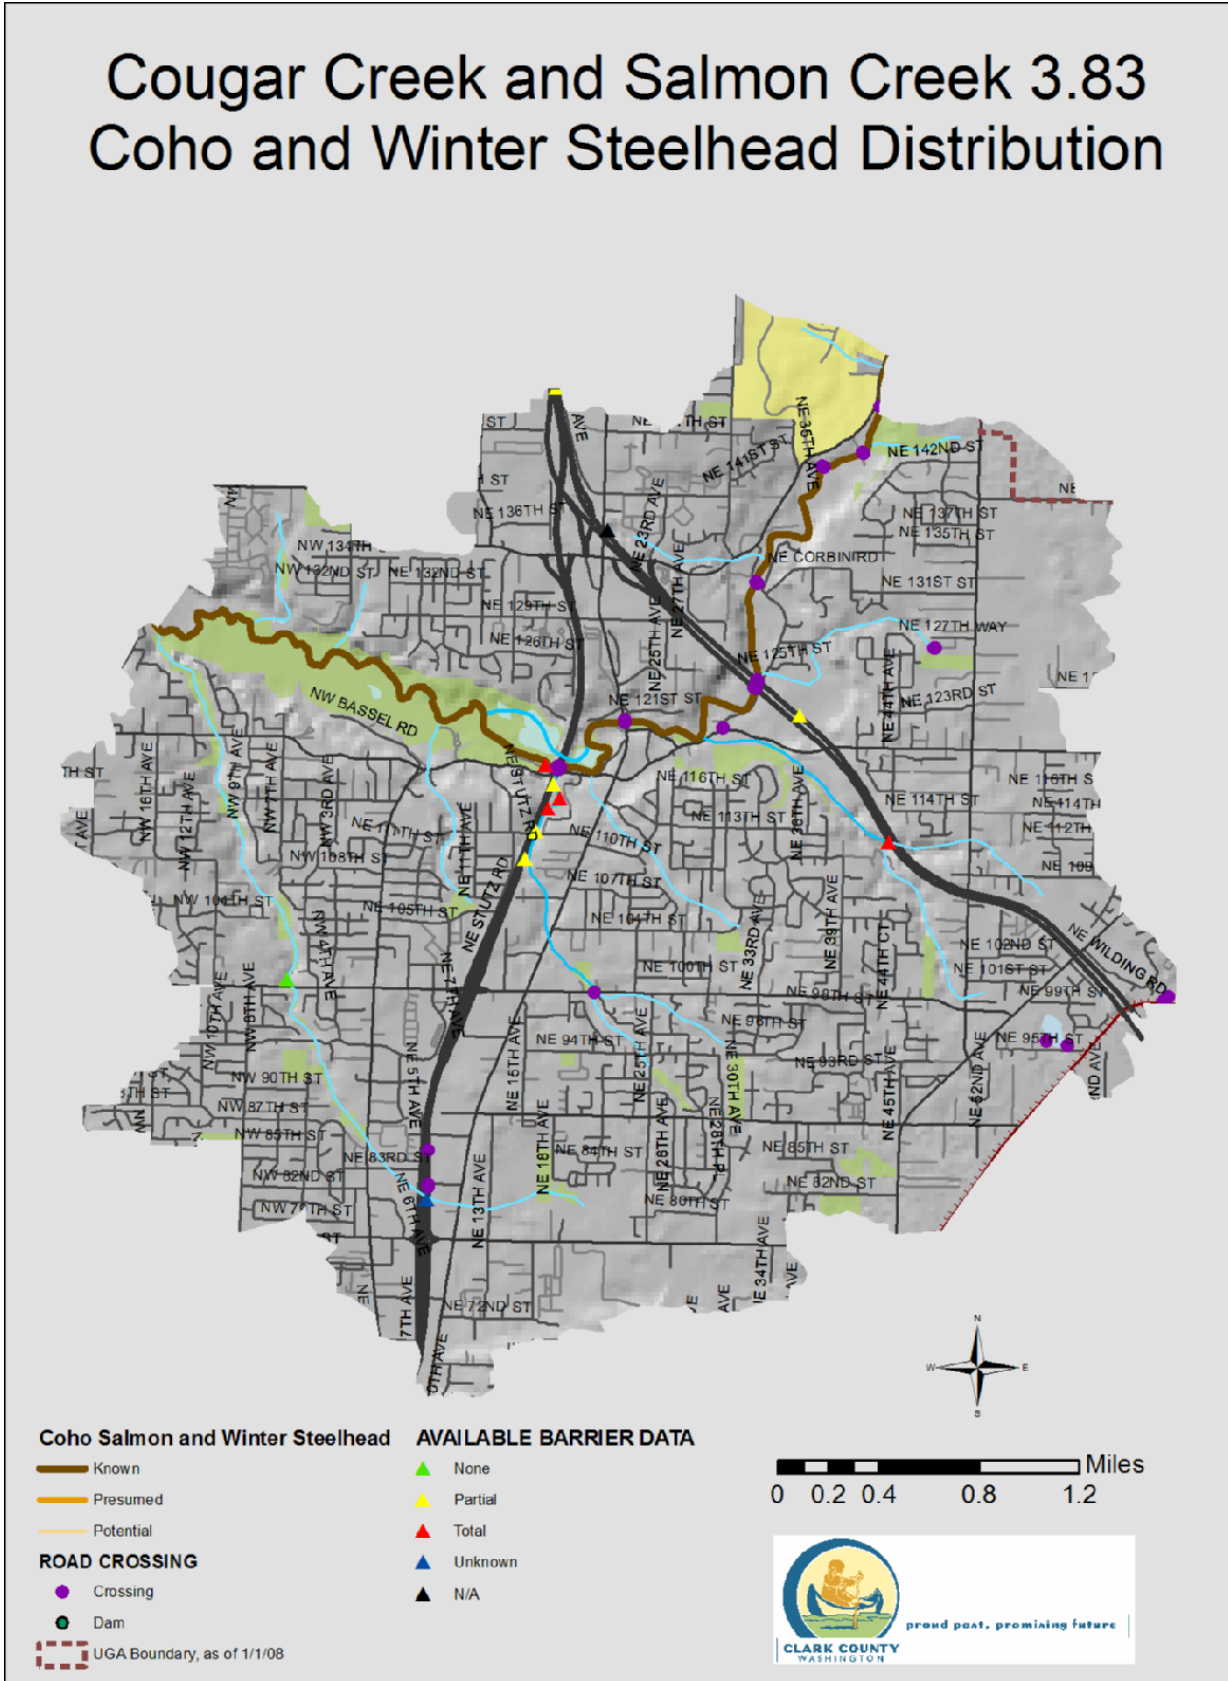
Figure 23: Salmon Creek (RM 03.83) and Cougar Creek Fish Distribution and Barriers

The fish distribution mapping figure suggests that anadromous fish use within the Salmon Creek (RM 03.83) subwatershed includes Coho salmon and winter steelhead (Figure 23). The SalmonScape fish distribution data also identified the known presence of fall Chinook within the mainstem of Salmon Creek.

The Cougar Creek subwatershed was not listed as having any known anadromous fish use. The SalmonScape fish distribution data identified the presumed presence of Coho salmon and winter steelhead within the mainstem of Cougar Creek. A series of waterfalls and cascades near its mouth probably block fish passage.
