Appendix D: Landscape Unit Conditions

Appendix D includes detailed results from the assessment of the Upper Cowlitz Cispus watershed. Landscape units (LUs) are first summarized here describing Hillslope and Valley Bottom characteristics in the Upper Cowlitz and Cispus Basin. Following that, individual LUs are described in detail.

Upper Cowlitz-Cispus
Community-based Habitat
Strategy Development

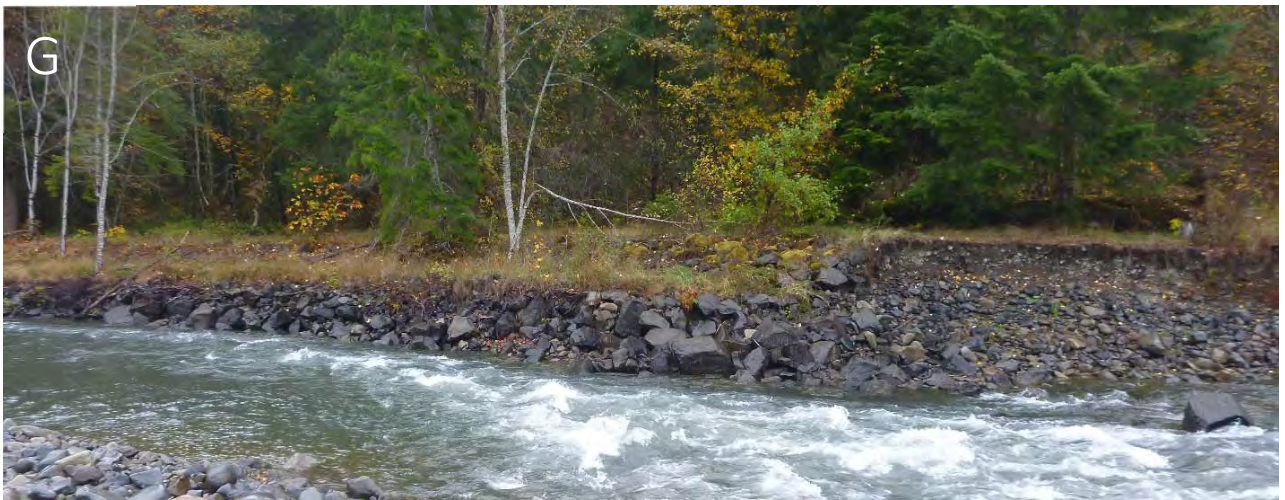
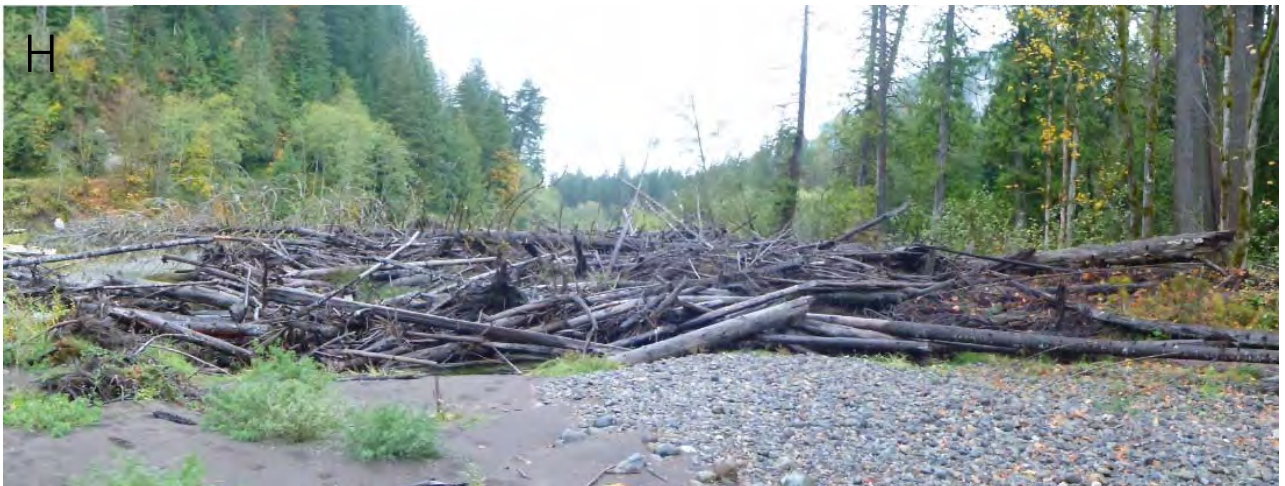
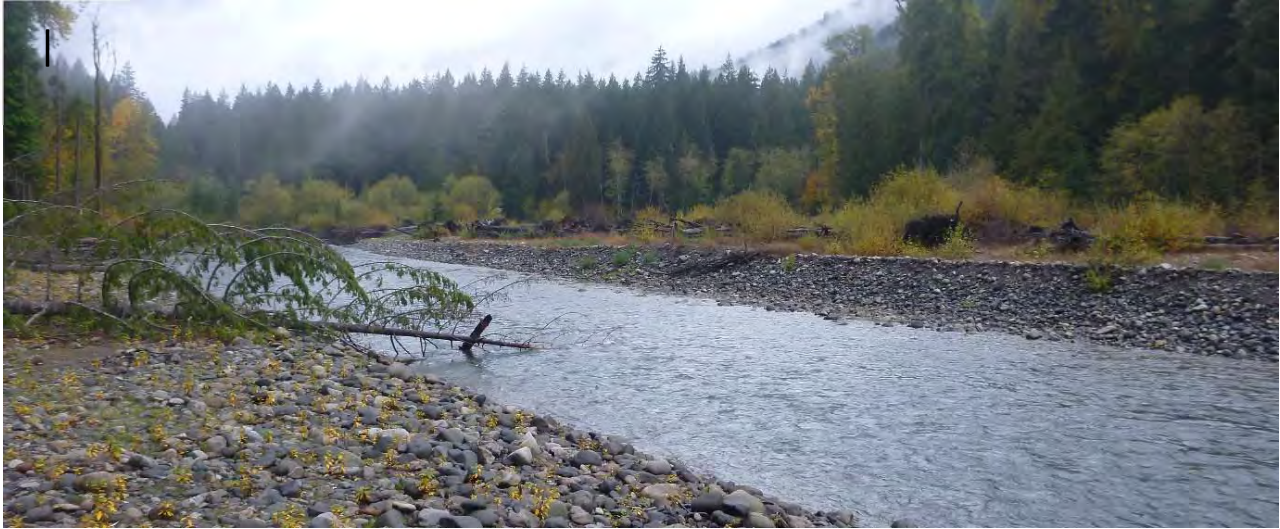
Figure 12. Representative images from the Cispus-Mid-Valley LU. A = USFS Road 23 repair near RM 21. B = large ELJ at upstream end of USFS Road 23 repair. C = push-up levee created across from USFS Road 23 repair. D = large wood complexity typical of this reach. E = high terrace being eroded into near RM 20. F = riprap bank along spur road along oxbow near RM 19.5. G = failing riprap bank near RM 19.5. H = large wood complexity typical of this LU. I = Channel incision through aggraded bed material upstream of Cispus Road Bridge.
