Geomorphology and Hydrology Assessment
for
Allen Canyon Creek

Department of Public Works
Clean Water Program
1300 Franklin Street
Vancouver, WA 98666

November 17, 2008

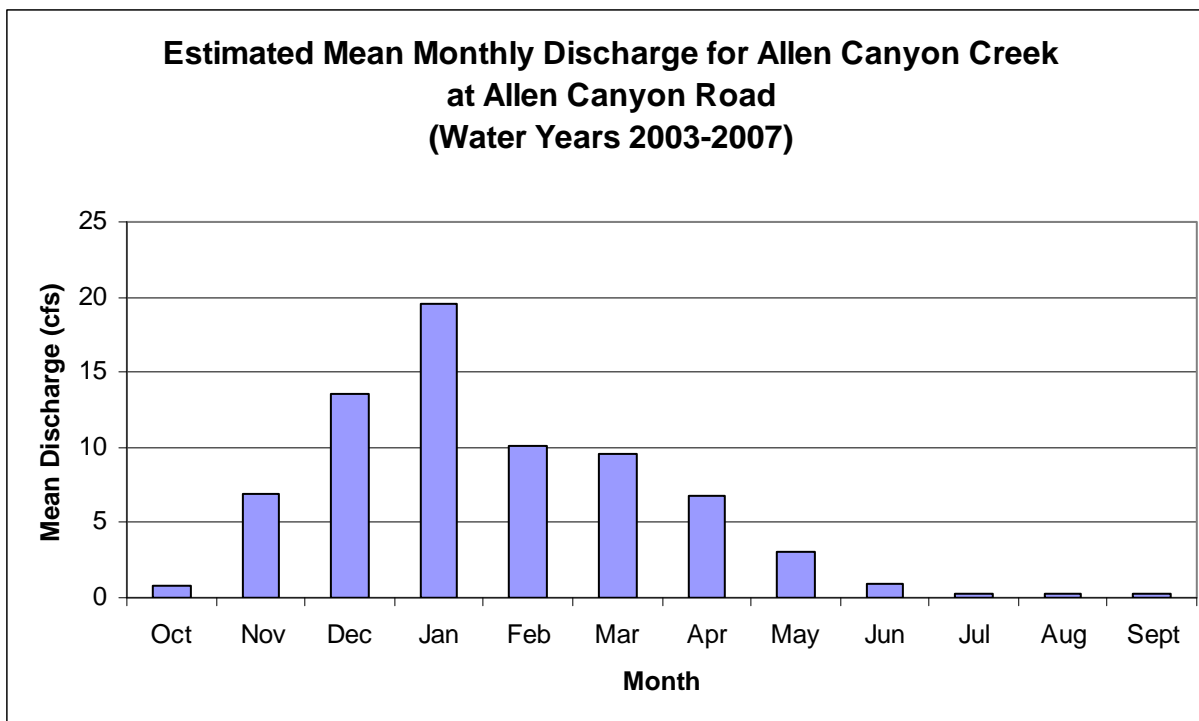
Figure 8. Estimated Mean Monthly Discharge for Allen Canyon Creek at Allen Canyon Road.

Mean monthly discharges for Allen Canyon Creek were estimated by transferring mean monthly flows for Gee Creek for water years 2003 through 2007 using the drainage area ratio and are shown in Figure 8. As seen in the figure, the highest flows occur during the winter and spring months with lows flows occurring during the summer and early fall months.

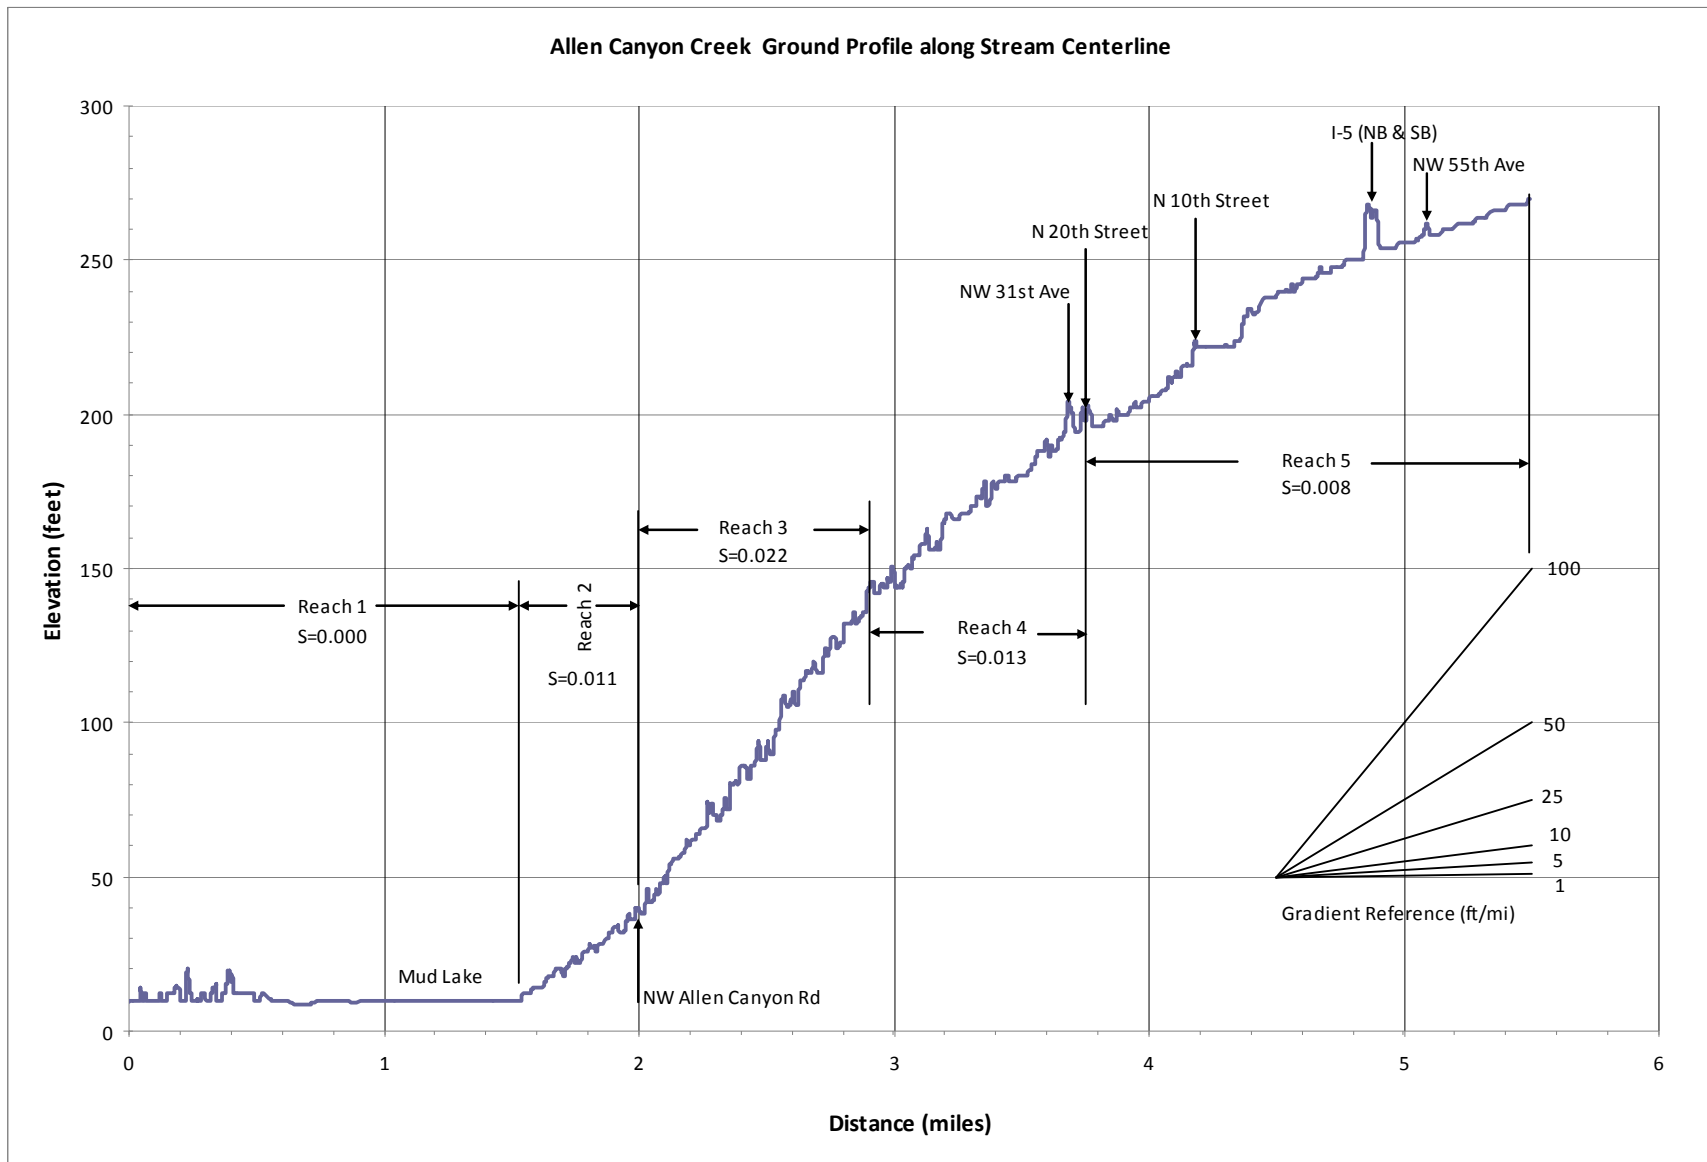
Figure 10. Ground profile along stream channel centerline for Allen Canyon Creek.

Available topographic data were used to develop a DTM of the basin and extract ground profiles along the stream centerlines. The channel slope, sinuosity, and bed material size were used to divide the channel into 5 separate reaches of similar geomorphic characteristics which are summarized in Table 4. Reach locations are shown in Figure 9. A stream centerline ground profile for Allen Canyon Creek is shown in Figure 10.

Allen Canyon Creek upstream of N 20th Street (Reach 5 in Figure 10), the majority of Tributary 1 and Tributary 2 upstream of N 10th Street are generally confined within a “V” shaped valley form. The confined valley form in the upper watershed is further evidence that these stream reaches are supply limited “source” reaches in that, over the long-term, sediment transport capacity generally exceeds sediment supply. These reaches will tend to incise over time and are considered to be the most susceptible to increases in peak flows and/or increases in the duration of flows that exceed the critical shear stress of the bed material. Gradual incision is expected to continue to occur with time unless there is sufficient grade control from vegetation, woody debris, or the underlying geology. Culvert crossings will continue to provide a form of grade control, although this is not typically their primary function. Further, significant discontinuities in grade at culvert outlets can have undesirable impacts on fish passage.

The reach of Allen Canyon Creek between N 20th Street (NW 289th Street and Allen Canyon Road (Reaches 3 and 4 in Figure 10) and Tributary 2 downstream of N 10th Street progressively become less confined as the valley bottoms flatten and widen becoming more trapezoidal in shape. These reaches are considered “transport” reaches in that, over the long-term, sediment transport capacity generally equals sediment supply. Temporary storage of sediment occurs within these reaches resulting in increased sinuosity compared to the upstream supply reaches.

The reaches of Allen Canyon Creek downstream of Allen Canyon Road (Reaches 1 and 2 in Figure 10) is a transport limited “response” reach in that, over the long-term, sediment supply generally exceeds sediment transport capacity. The channel slope is controlled at the downstream end by Mud Lake. This reduces the sediment transport capacity of the channel below the sediment supplied from upstream reaches resulting in long-term sediment deposition.

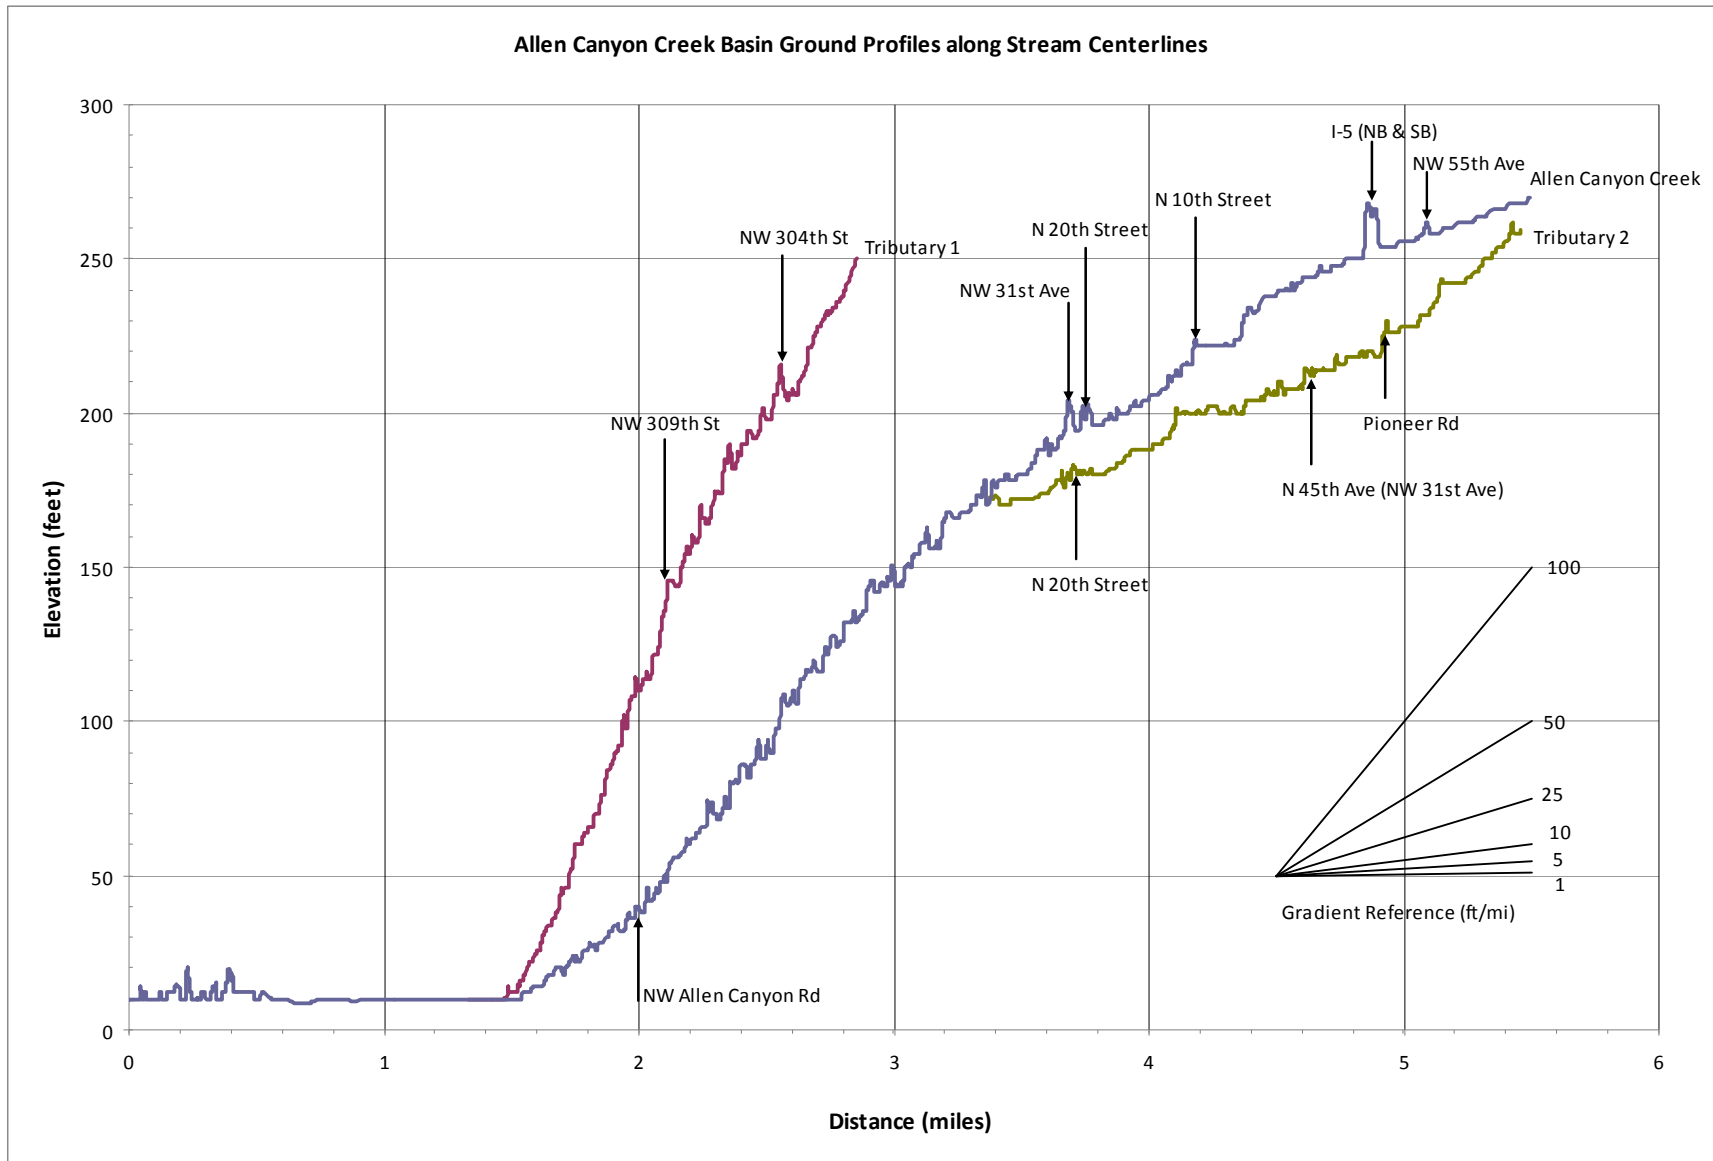
Figure 11. Ground profiles along stream channel centerlines for Allen Canyon Creek, Tributary 1 and Tributary 2.

The extracted ground profiles for Tributary and 1 and Tributary 2 are shown in Figure 11. The ground profile along Allen Canyon Creek was added to the figure for reference. As seen in figure, Tributary 1 has an average channel slope of approximately 180 feet/mile (0.034) while Tributary 2 has an average slope of approximately 40 feet/mile (0.008). Tributary 1 has a significantly steeper slope compared to both Allen Canyon Creek and Tributary 2. This is likely the result of both the structure and composition of the underlying geologic formations. Tributary 1 is oriented in approximately a north-south direction and is cutting across the surface of a southeast-northwest oriented anticline at approximately a 40-degree skew. The orientation of the anticline results in a northeast dip in the bedrock underlying Tributary 1. The streams orientation with respect to the dipping bedrock results in a relatively steep channel gradient. As the channel incises into the surrounding bedrock, it encountered greater resistance to erosion from the coarse grained Plio-Pleistocene conglomerate and cemented Sandy River Mudstone. Therefore, the channel is maintained at a much steeper slope than the remainder of the basin streams which are oriented approximately parallel to axis of the anticline.

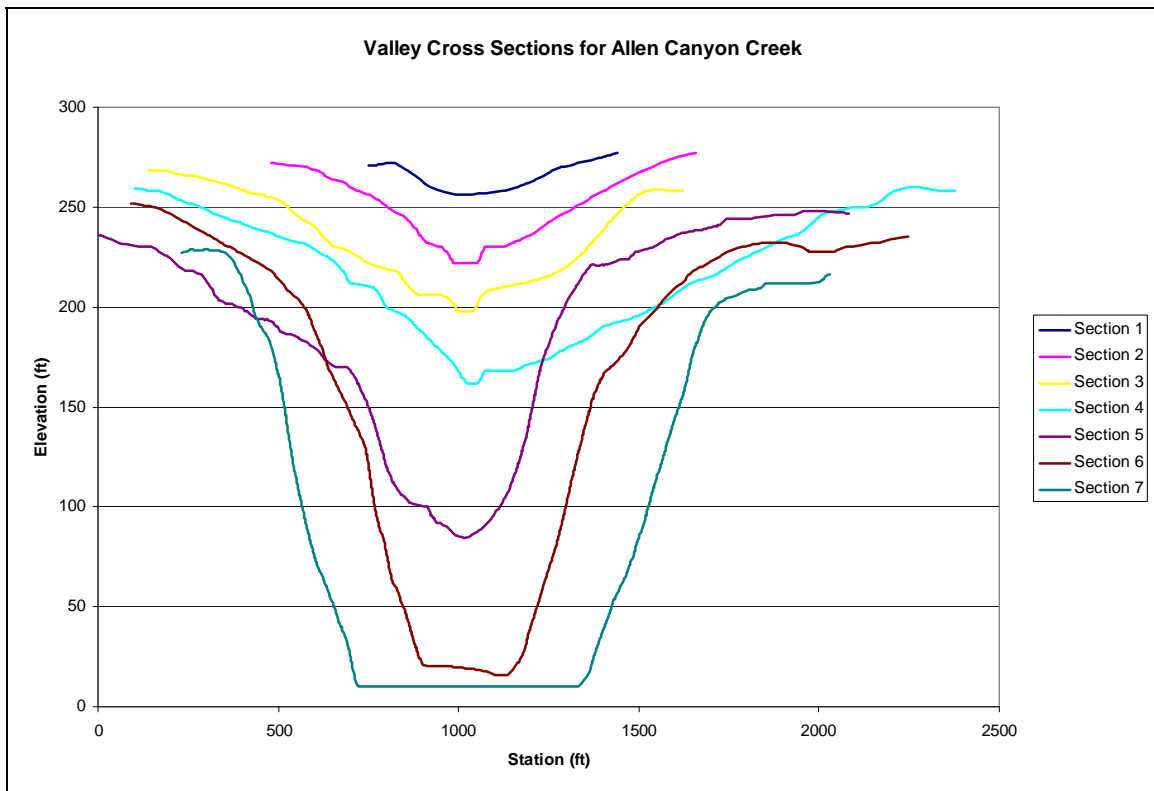
Figure 13. Valley cross sections for Allen Canyon Creek.

Selected cross sections located along the valleys of Allen Canyon Creek and its major tributaries were extracted from the DTM of the basin to help understand the valley geometry and how its form transitions from upstream to downstream. The locations of the extracted cross sections are shown in Figure 12. Valley cross section geometries for Allen Canyon Creek and its major tributaries are shown in Figure 13 through Figure 15.

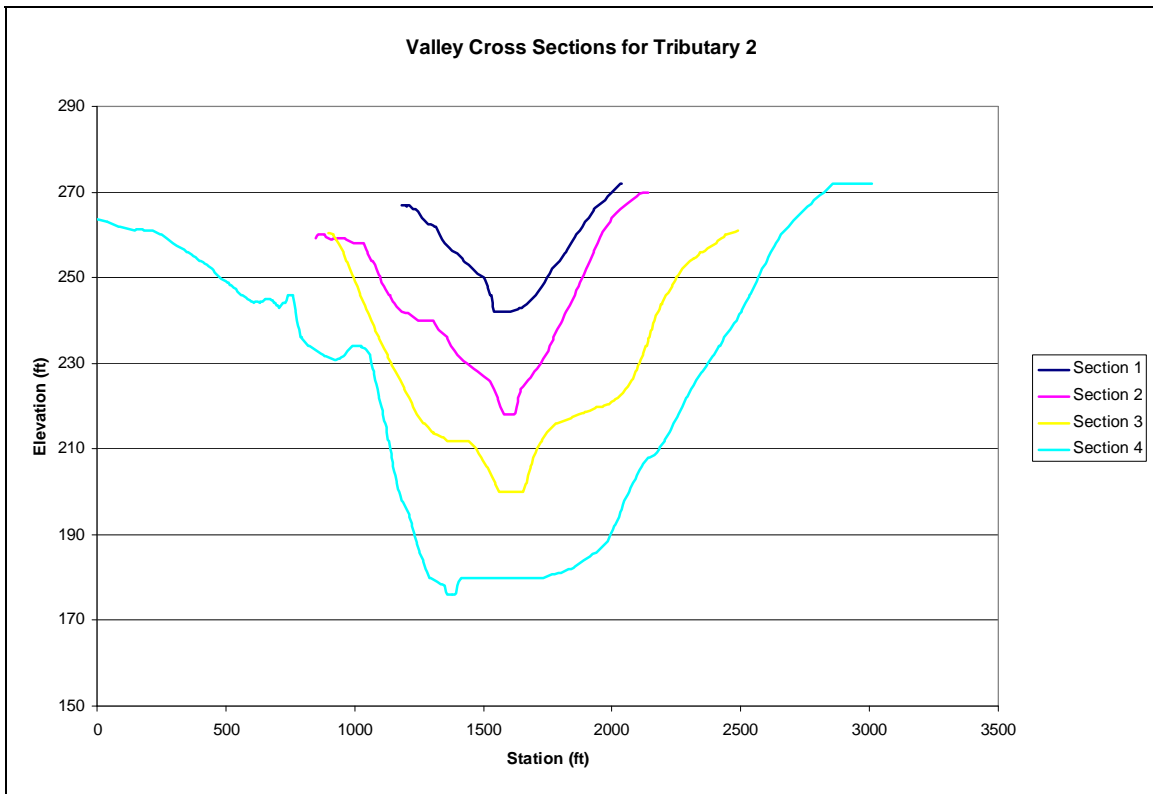
Figure 15. Valley cross sections for Tributary 2.

One anomaly in valley form is cross section 4 on Tributary 2 which appears to be much wider relative to the size of the channel than would be expected. Topographic data suggests that this portion of the valley as well as the rest of the Allen Canyon Valley downstream to Mud Lake is likely a remnant side channel of the prehistoric Columbia River.
