Big Tree Creek/East Fork Lewis River (RM 26.30)/King Creek Subwatershed Needs Assessment Report

Clark County Public Works Clean Water Program

March 2009

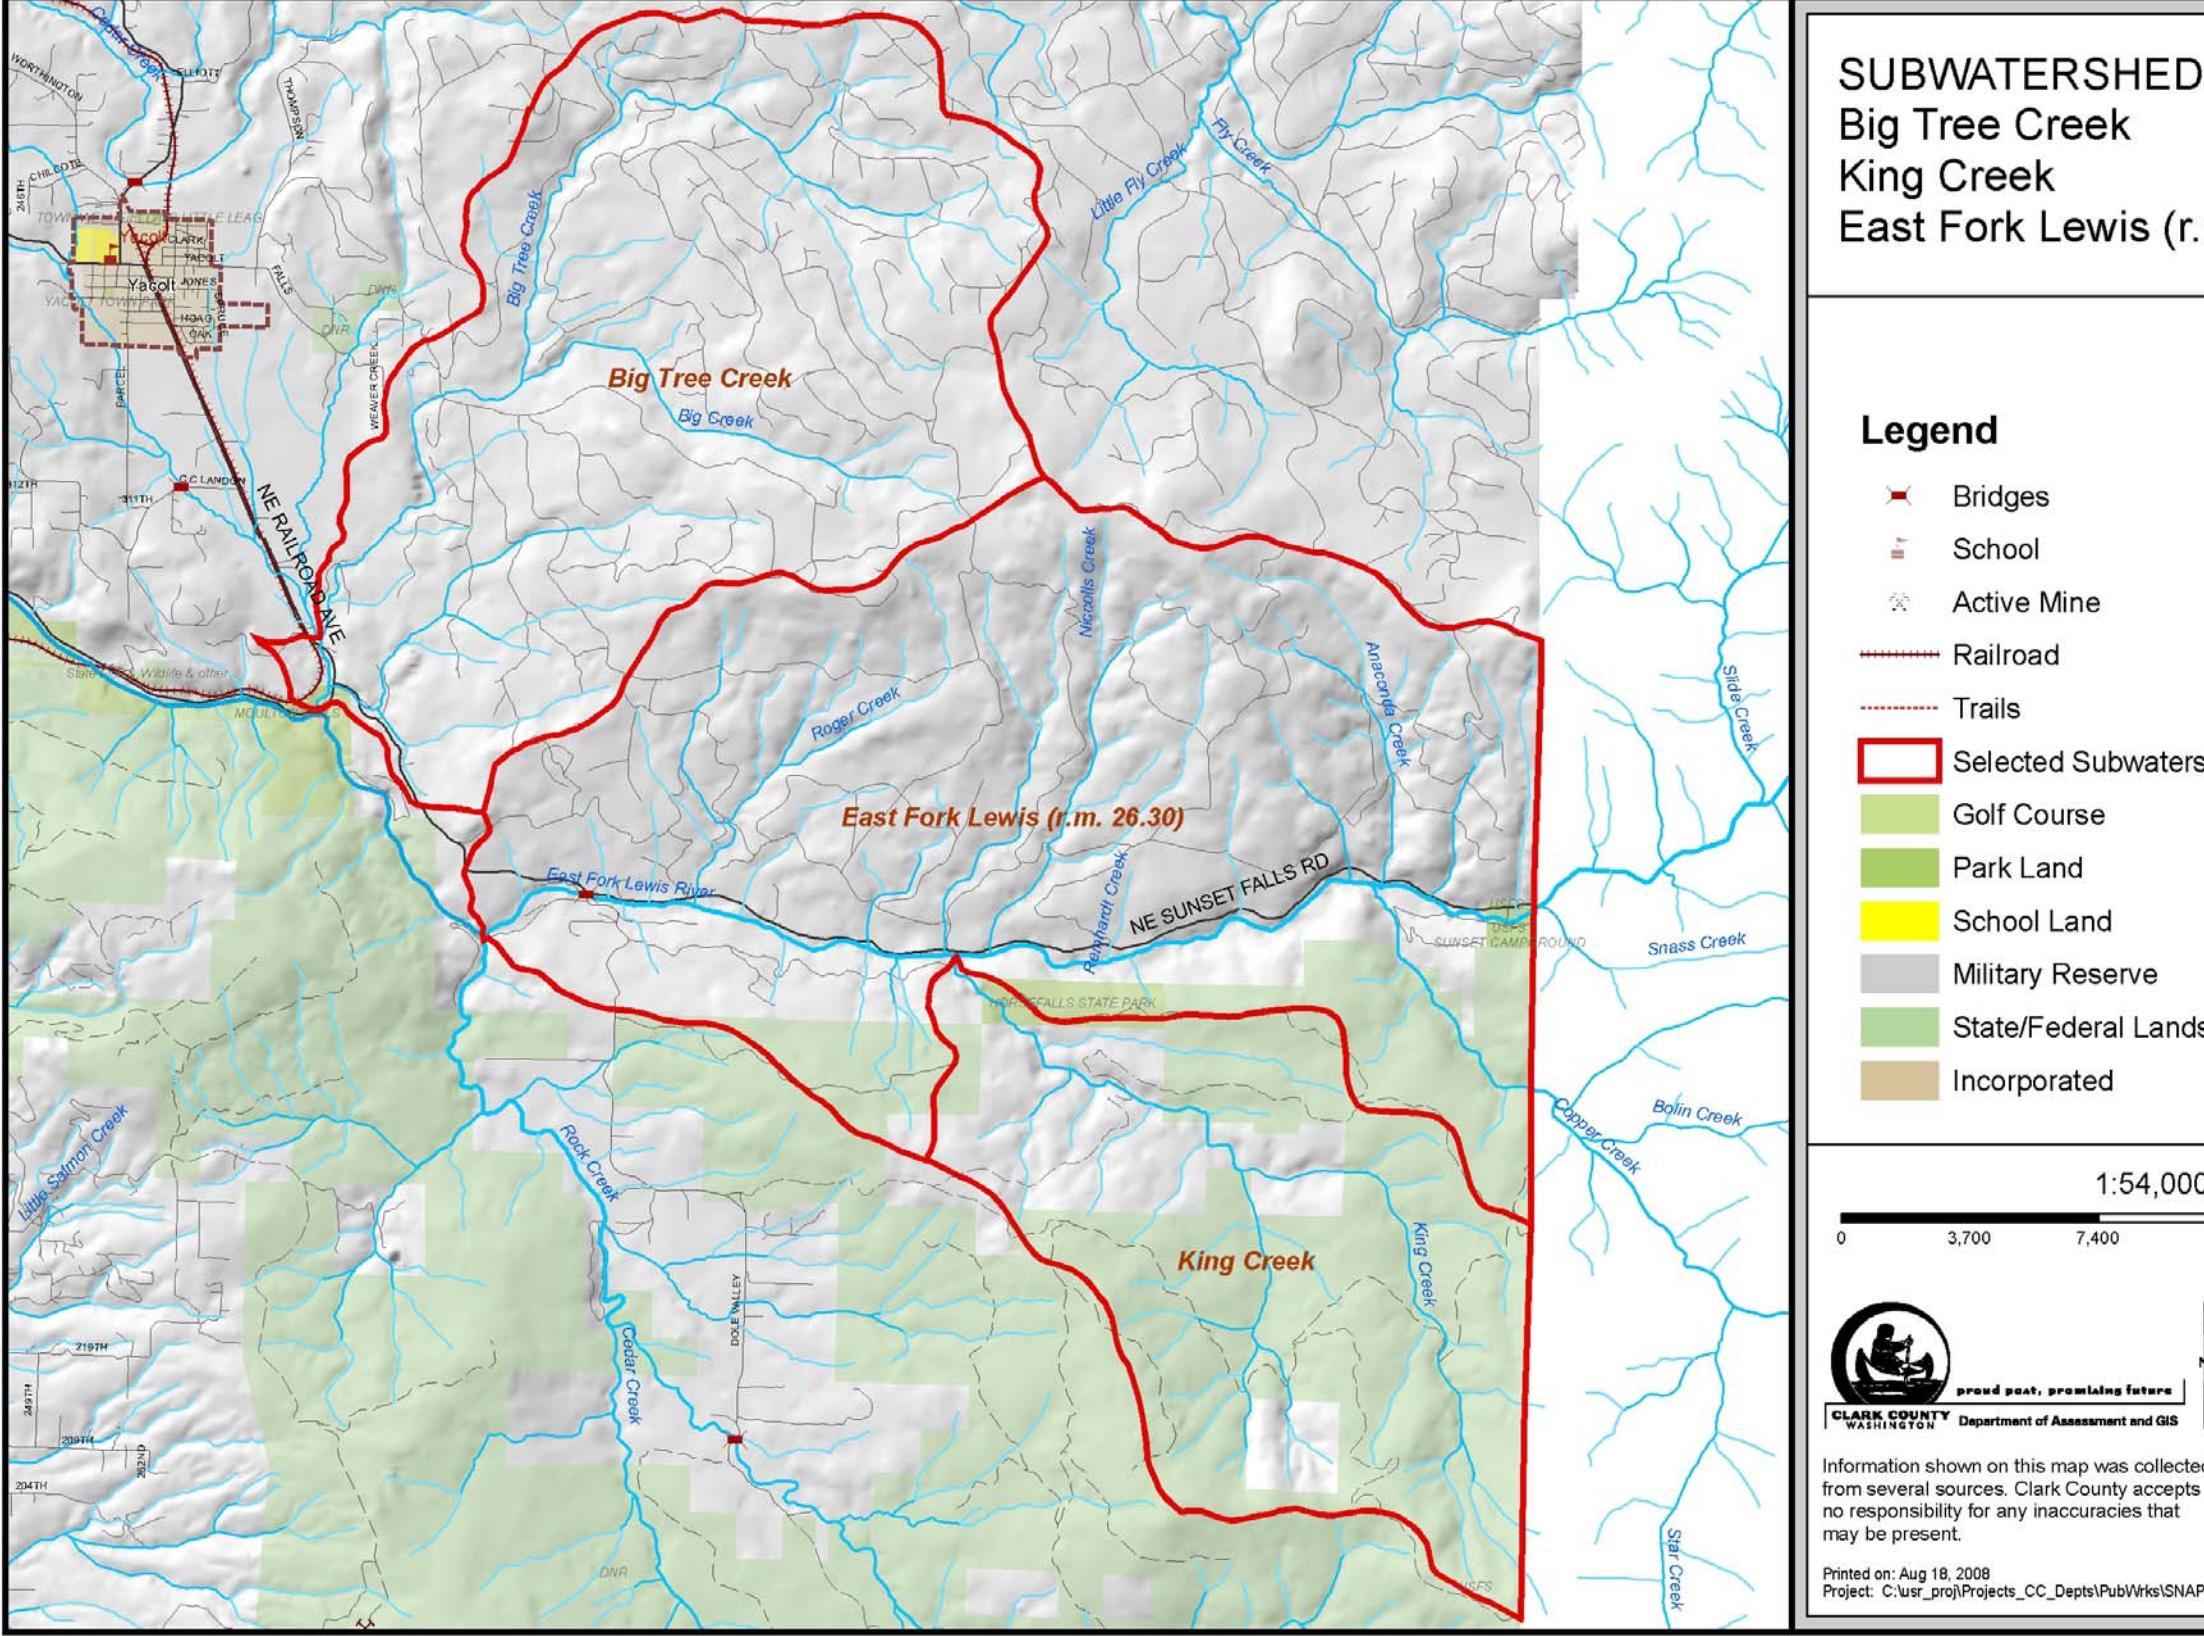
Figure 1: Big Tree Creek, East Fork Lewis River (RM 26.30), and King Creek Subwatershed Area Map

The study area is in mountainous terrain near the eastern boundary of Clark County (Figure 1). Big Tree Creek and King Creek subwatersheds are tributaries to the East Fork Lewis River (RM 26.30) subwatershed. Part of the basin is outside Clark County, in Gifford Pinchot National Forest in Skamania County, and not part of this study. The area is almost entirely commercial forest in state forest lands, with a few smaller private forest lots and residences in lower elevation areas.

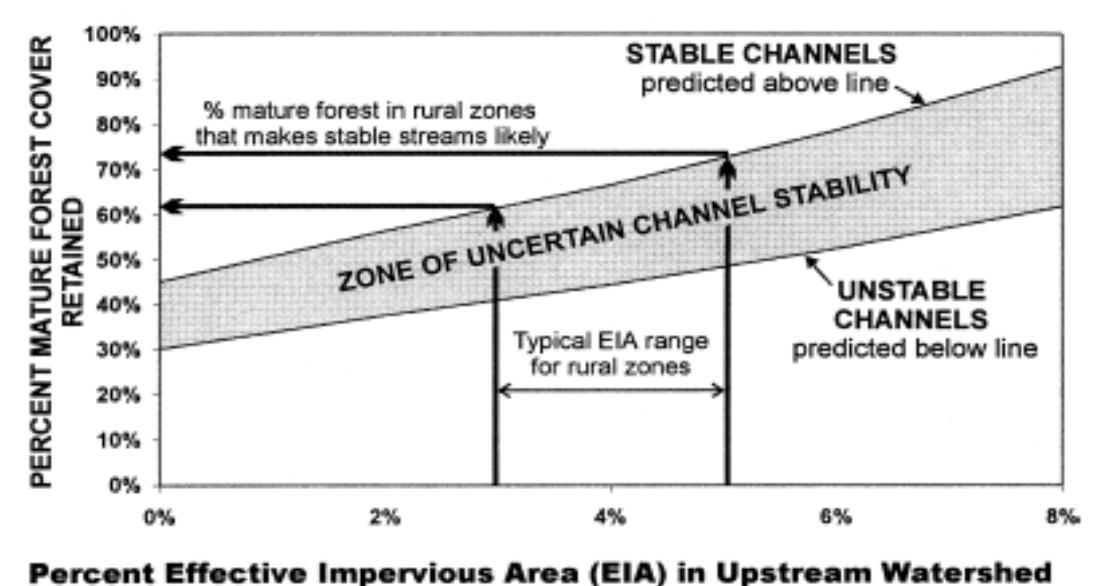
Figure 2: Channel Stability in Rural Areas (Booth, Hartley, and Jackson, June 2002)

In a recent publication by Booth, Hartley, and Jackson (June 2002), a relationship between forest and percent EIA was presented as a graphic (Figure 2). According to this figure, streams in King Creek and East Fork Lewis River (RM 26.30) should have predominately stable channels. Big Tree Creek subwatershed could be categorized as marginally unstable to potentially unstable, based on the amount of clear cuts characterized as impervious area and the limited amount of mature forest.

CHANNEL STABILITY AND FOREST RETENTION IN RURAL-ZONED BASINS

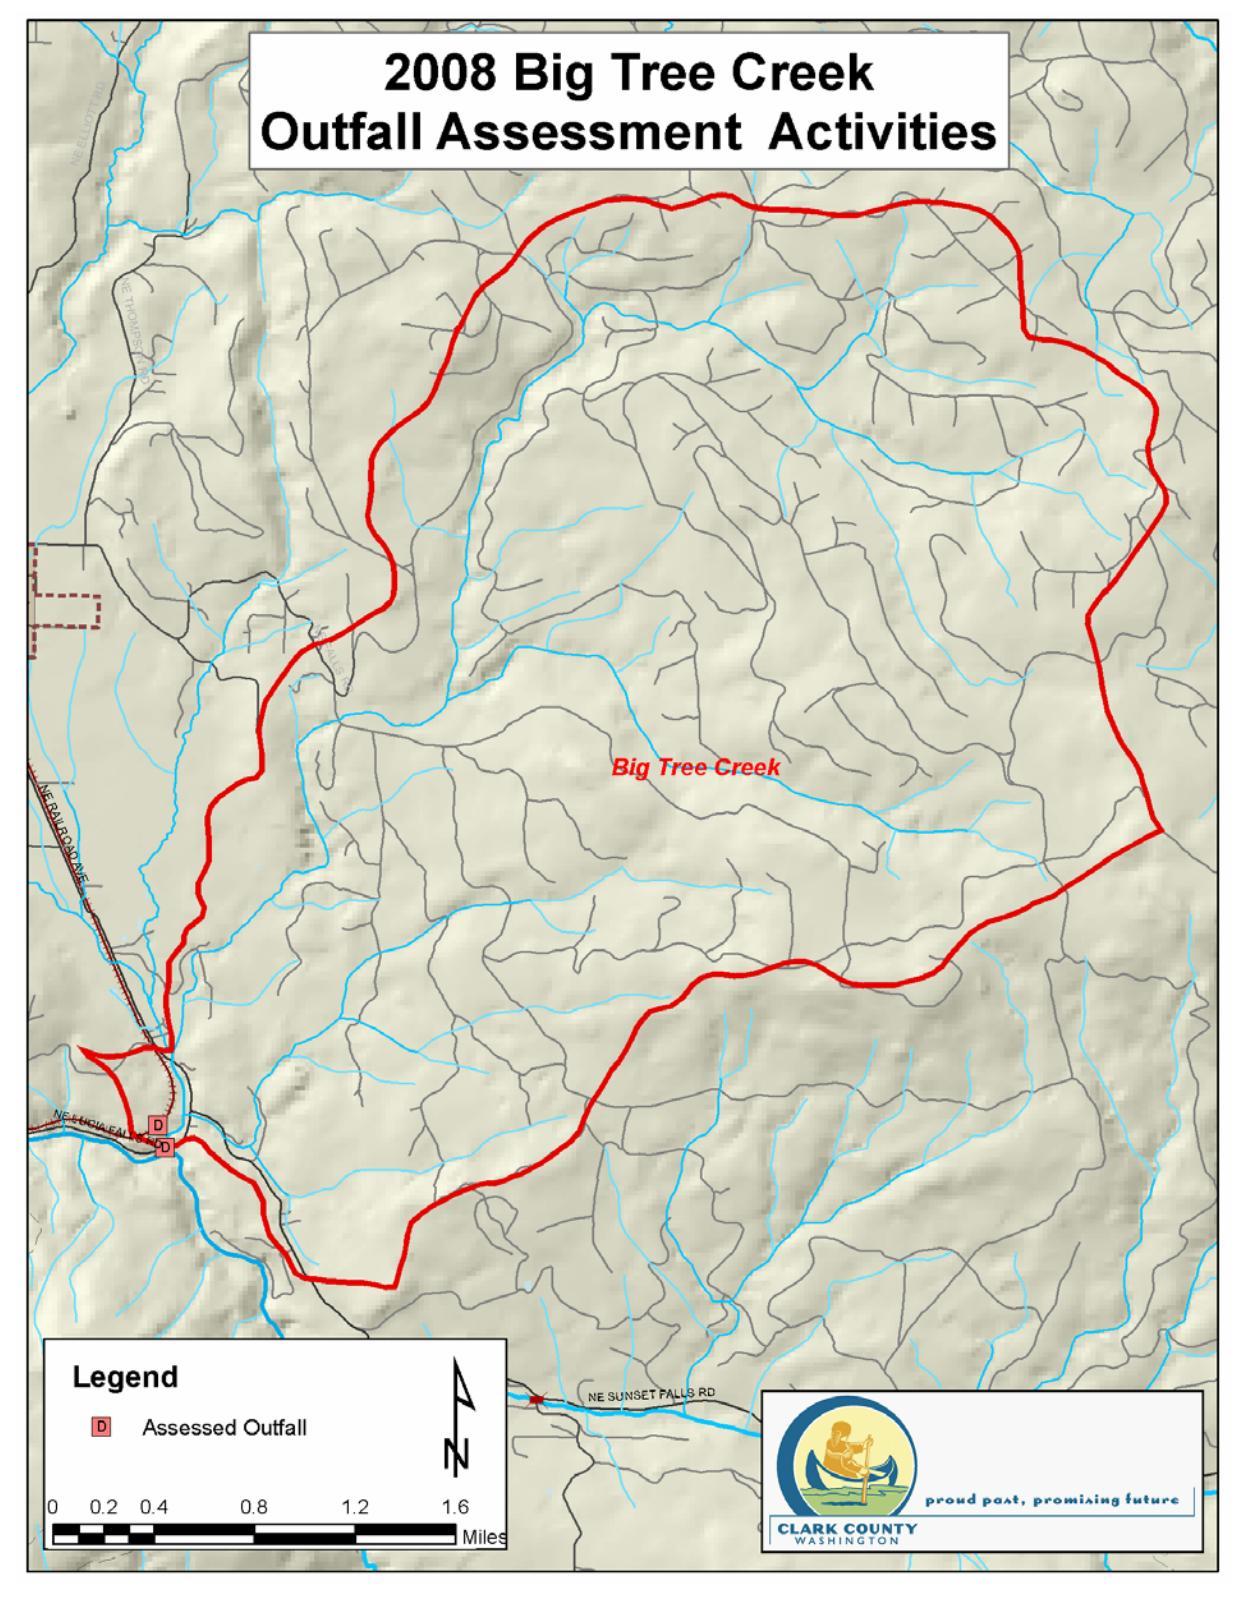
Figure 3: Summary of 2008 Outfall Assessment Activities in Big Tree Creek Subwatershed

As summarized in Table 7, 17 outfalls that discharged into critical areas were assessed in the Big Creek and East Fork Lewis River (RM 26.30) subwatersheds. Both of the outfalls in the Big Creek subwatershed were found to be in compliance. In the East Fork Lewis River (RM 26.30) subwatershed, 14 mapped outfalls that discharged into critical areas were assessed. All mapped outfalls were found to be in compliance. One unmapped outfall discovered during field activities was not in compliance due to a serious erosion and instability problem.

The outfall assessment project initiated one referral to a Clean Water Program Engineer. It was discovered that a serious erosion problem was occurring at an unmapped outfall. The repair of this outfall is included in the Analysis of Potential Projects section.

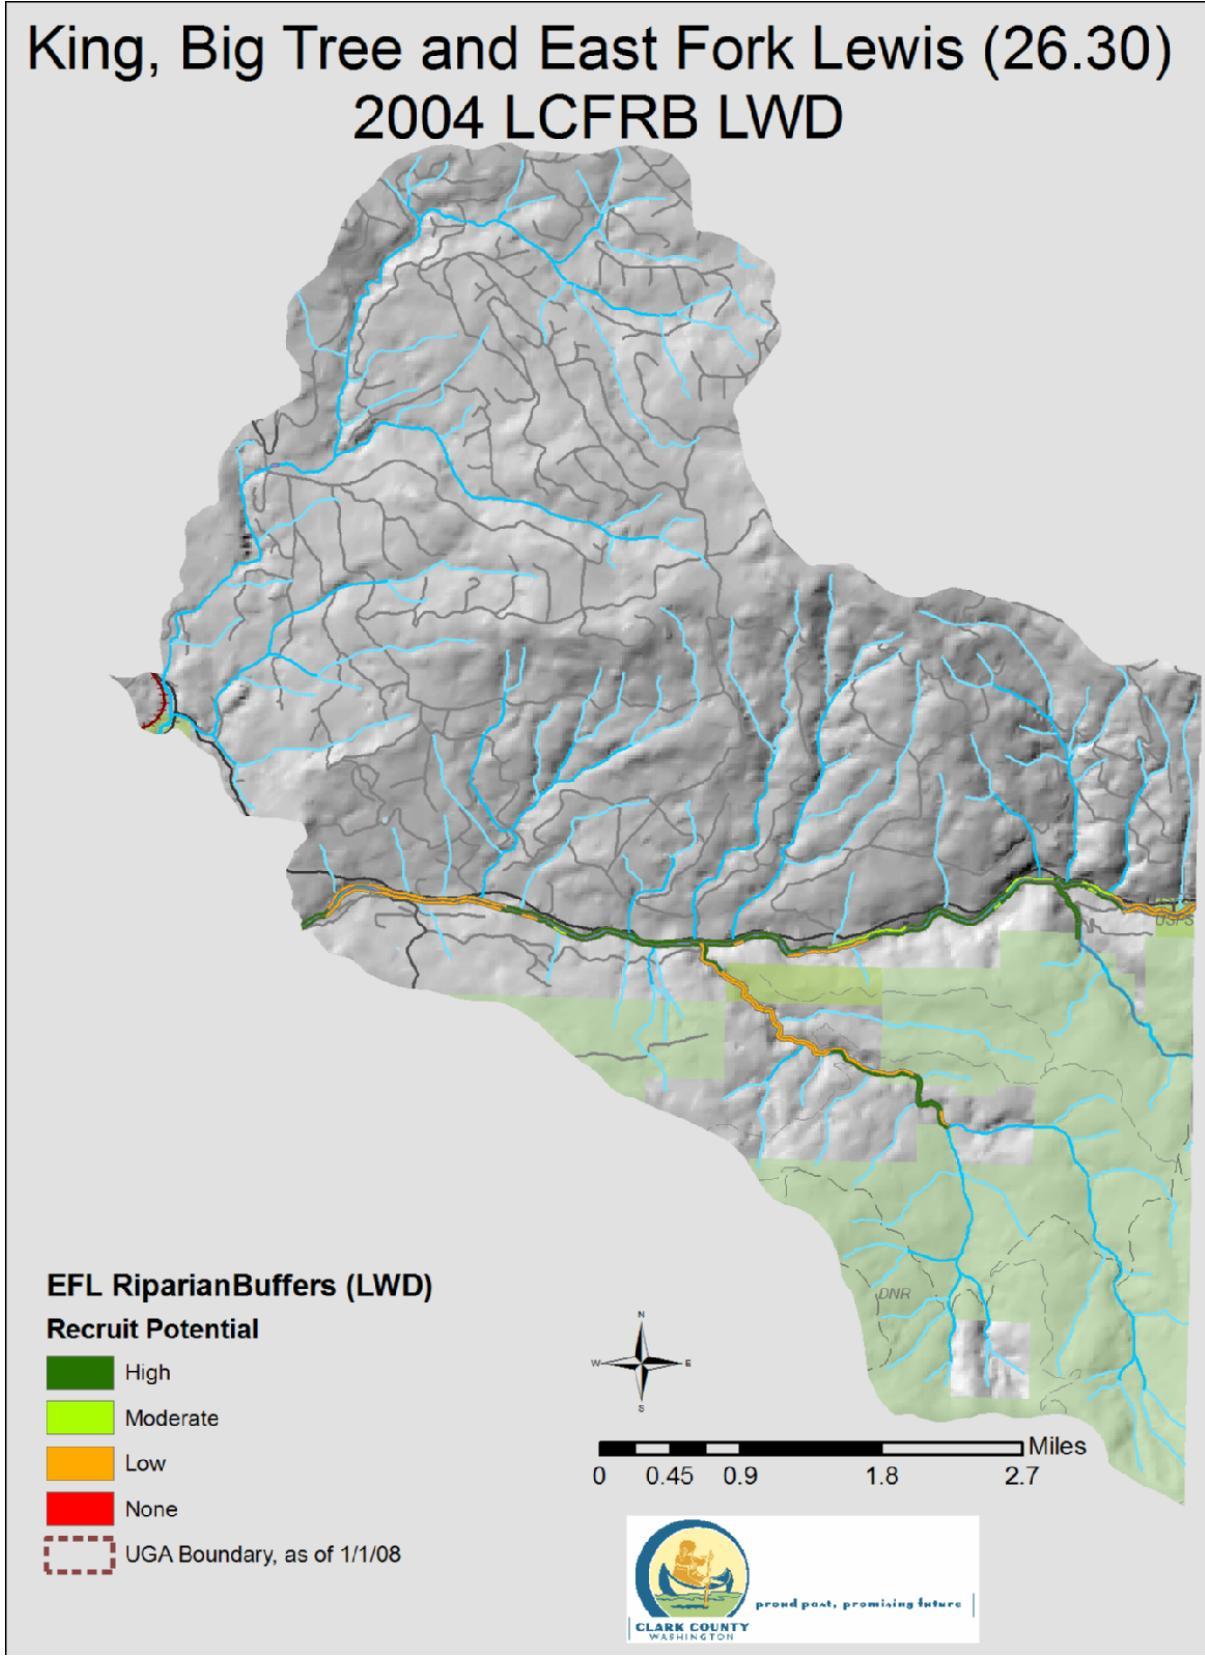
Figure 5: Big Tree Creek, East Fork Lewis River (RM 26.30), and King Creek LWD Recruitment Potential (adapted from S.P. Cramer and Associates, 2005)

The Big Tree Creek subwatershed was not surveyed as part of the 2005 Habitat Assessment, consequently LWD recruitment levels are based solely on orthophotography review. Big Tree Creek appears to have low LWD recruitment levels along the majority of its length, with the exception of a reach near its mouth. Big Creek, the left bank tributary to Big Tree Creek also appears to have low LWD recruitment levels, based on orthophotography review.

The majority of the mainstem of the East Fork Lewis River has high LWD recruitment potential along the approximate six-mile distance surveyed within the subwatershed. Copper Creek, a tributary to the East Fork above King Creek, has moderate to high levels of LWD recruitment along its surveyed and non-surveyed reaches based on orthophotography review.

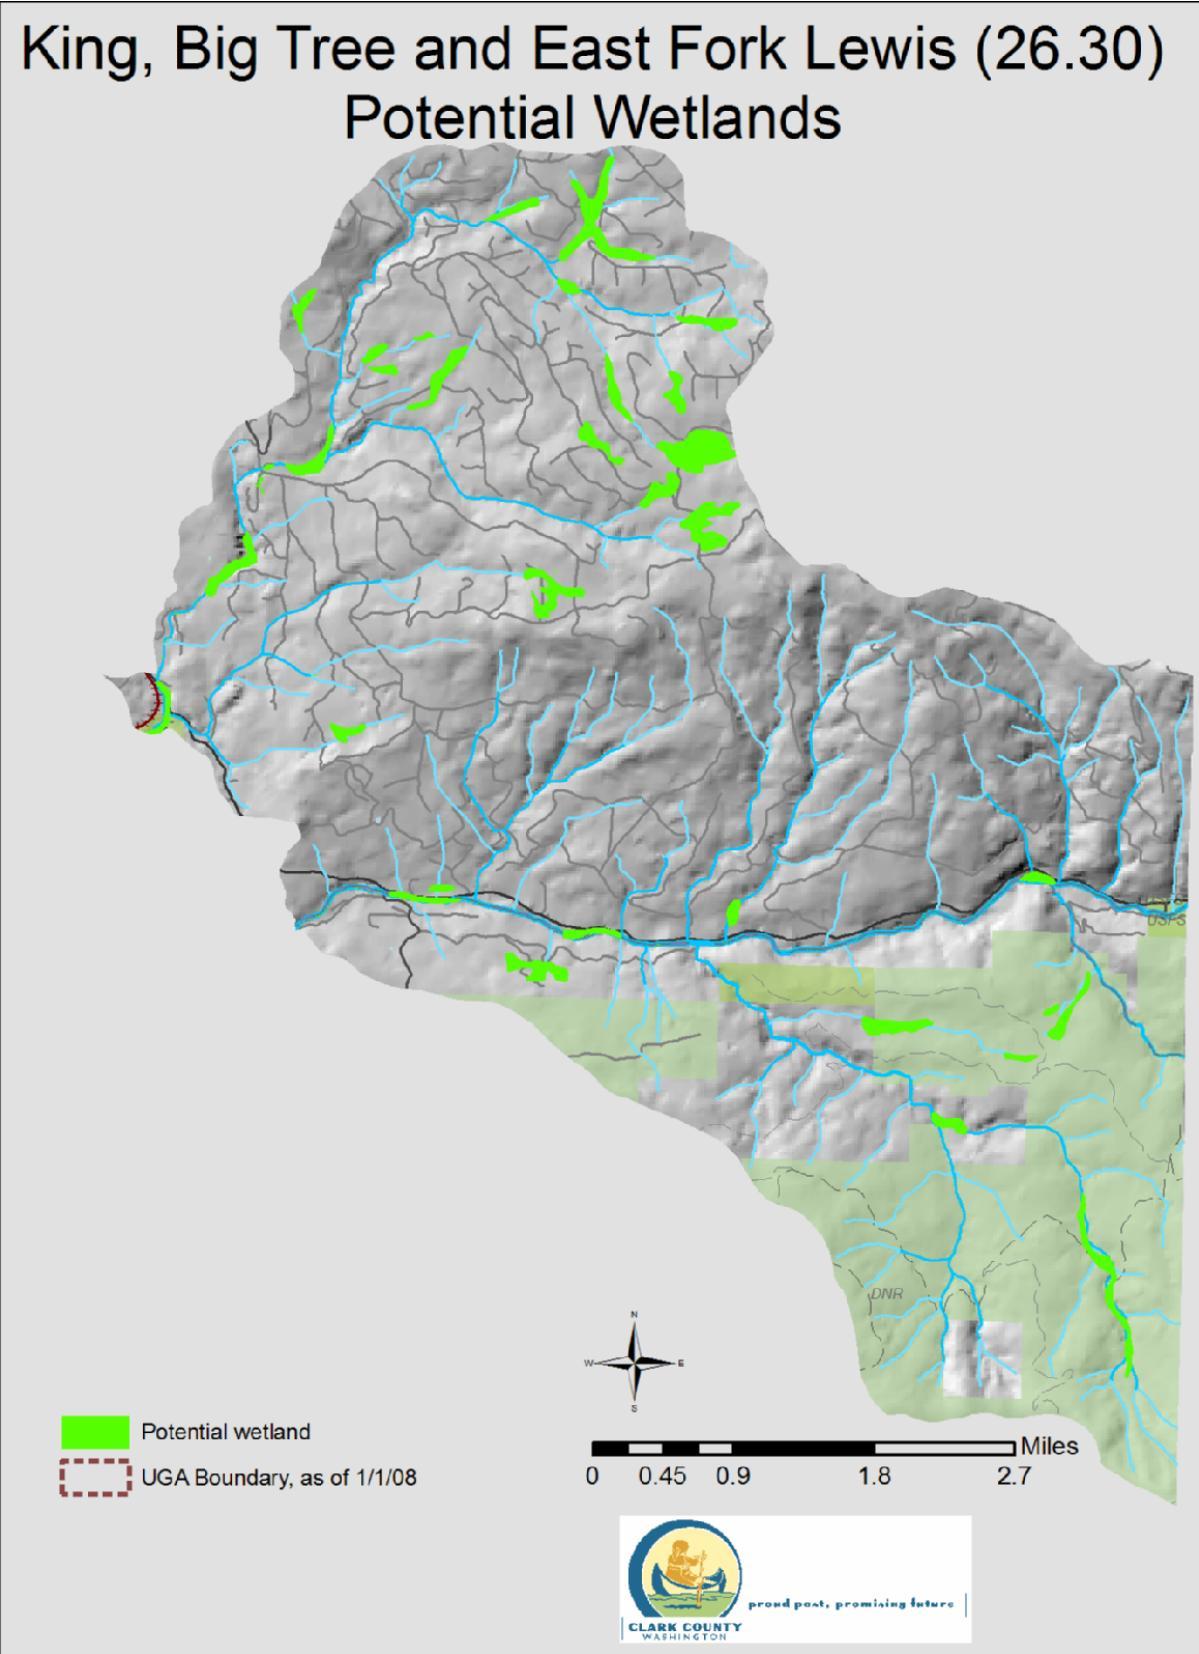
Figure 7: Big Tree Creek, East Fork Lewis River (RM 26.30), and King Creek Potential Wetlands

In the King Creek and East Fork Lewis River (RM 26.30) subwatersheds, potential wetlands are primarily associated with the stream channel floodplains of King Creek, the East Fork of the Lewis River, and its tributary, Copper Creek.

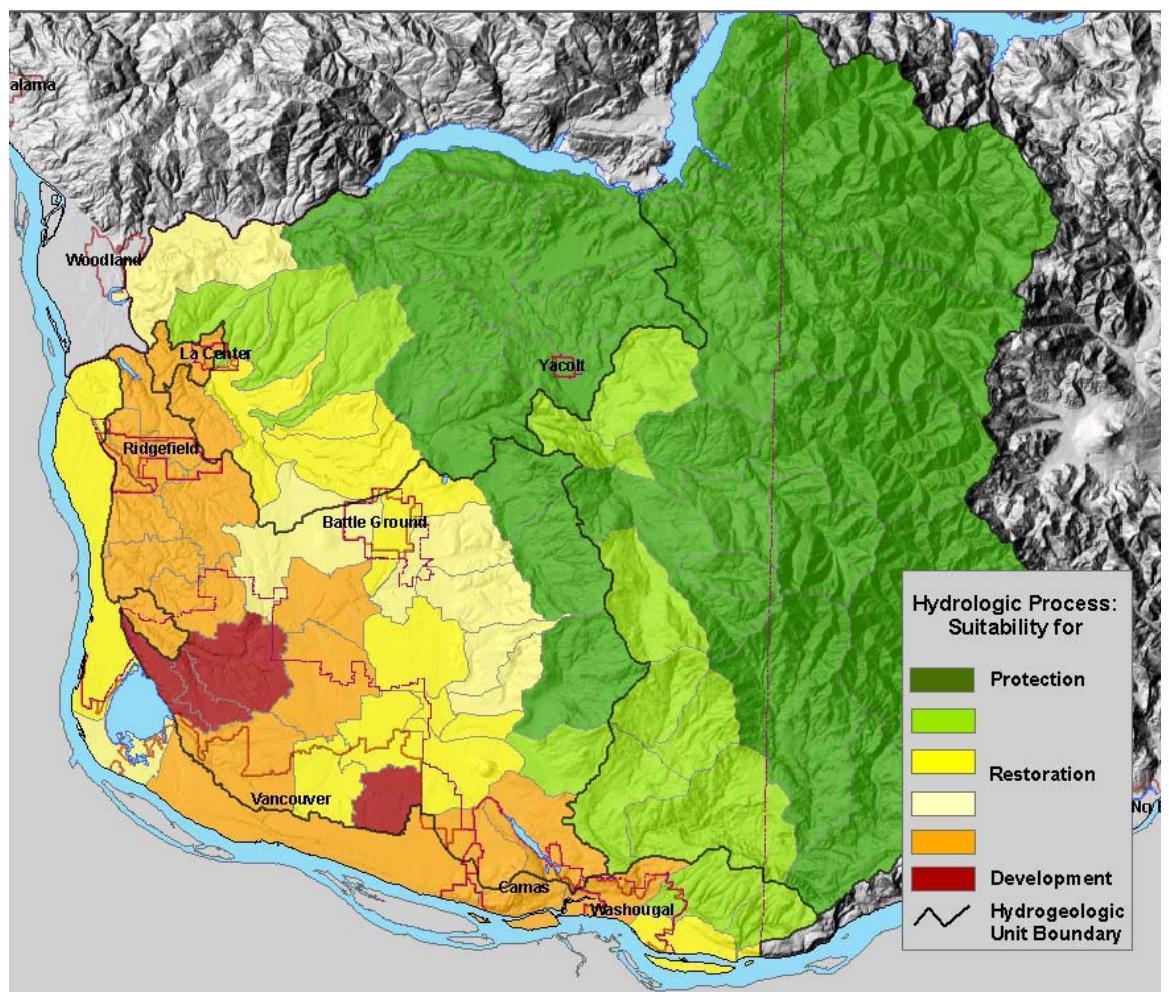
Figure 8: Priorities for suitability of areas for protection and restoration for the hydrologic process (from Draft Watershed Characterization of Clark County (Ecology, 2007)).

Figure 8 depicts priority areas for protection and restoration of hydrologic processes county-wide based on an analysis of the relative importance and level of alteration in each subwatershed.

In general, green areas have higher levels of importance for watershed hydrologic processes and limited alteration and should be considered for protection. Yellow areas have a higher level of importance for watershed hydrologic processes and a higher level of alteration and should be considered for restoration unless watershed processes are permanently altered by urban development. Orange to red areas have lower levels of importance for watershed processes and higher levels of alteration and should be considered as more suitable for development. Because orange areas represent a transition from restoration areas, planning measures employing both restoration and appropriately sited development should be considered (Ecology, 2007).

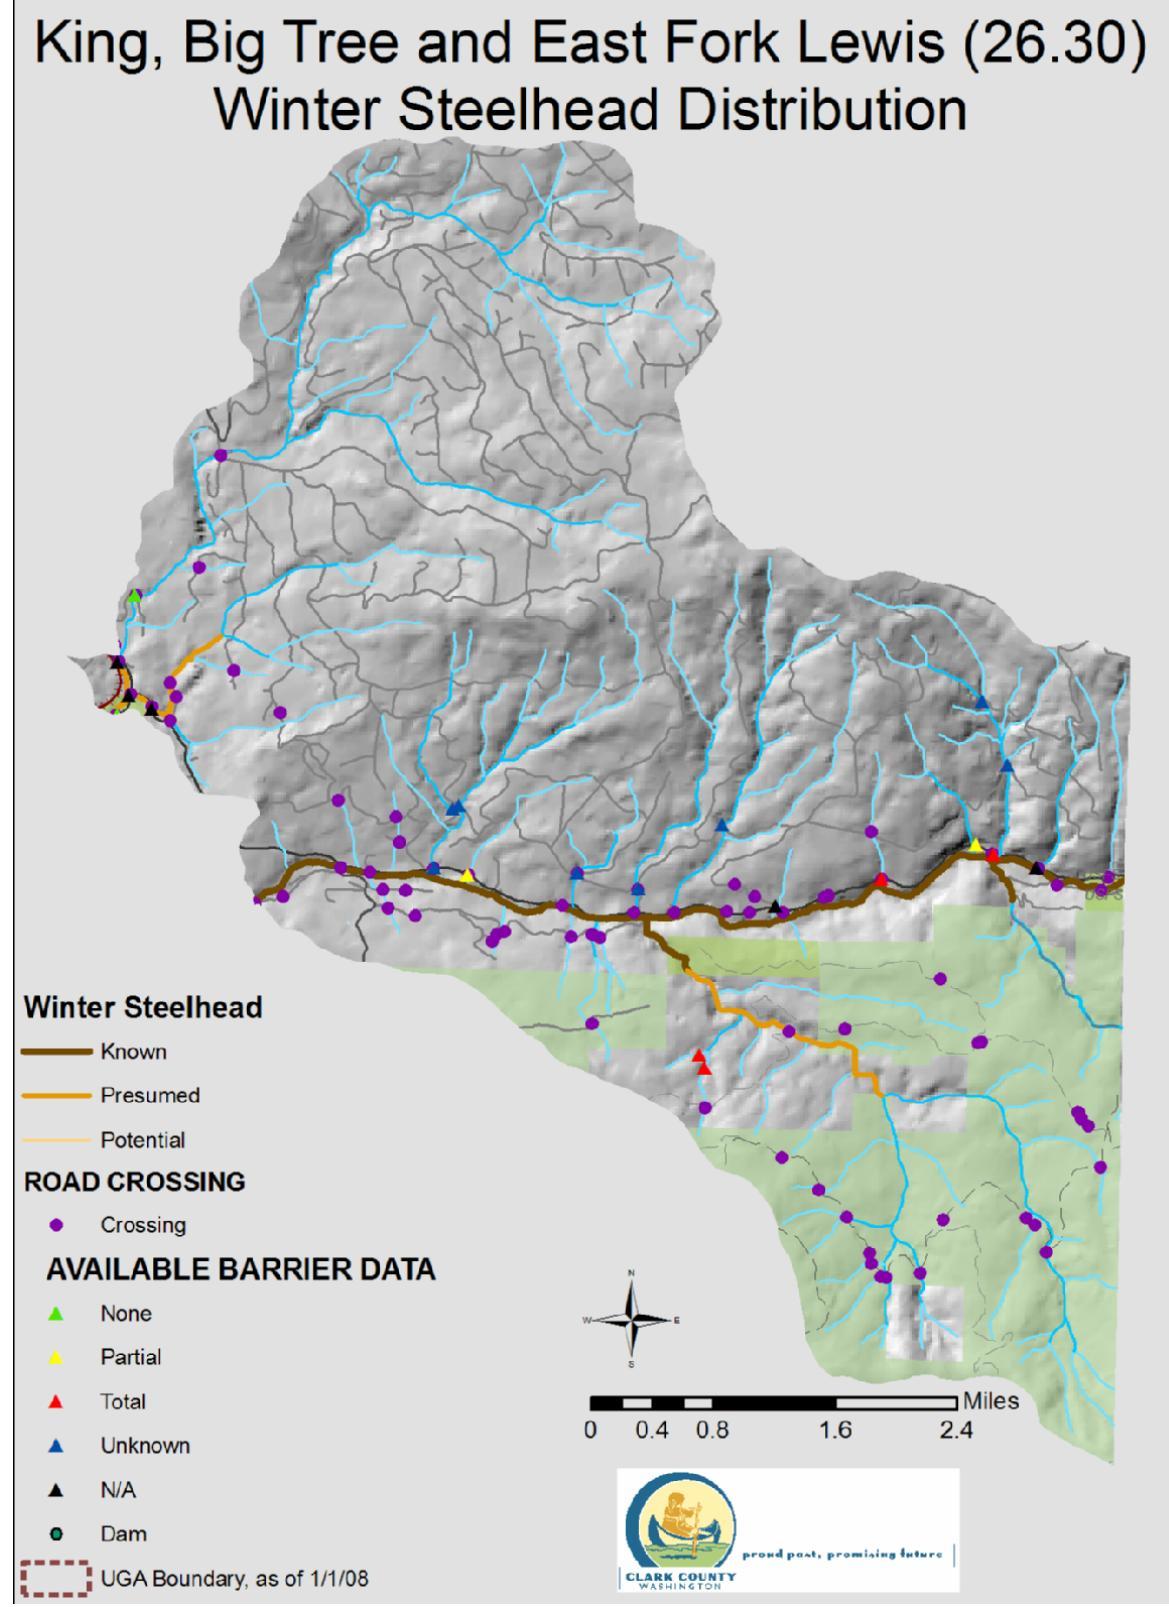
Figure 9: Big Tree Creek, East Fork Lewis River (RM 26.30), and King Creek Fish Distribution and Barriers

The LCFRB 2004 Lower Columbia Salmon Recovery and Fish & Wildlife Subbasin Plan identifies the East Fork Lewis River as Tier 1 reaches (highest priority), and its tributary, Copper Creek, as a Tier 4 tributary. King Creek is also a Tier 4 reach.

The Big Tree Creek subwatershed does not have any reaches with anadromous fish use; therefore, the reaches are not ranked by priority (reach tiers) for recovery.
