2008 Stormwater Needs Assessment Program

Vancouver Lake/Lake River Subwatershed Needs Assessment Report

Clark County Public Works Clean Water Program

March 2009

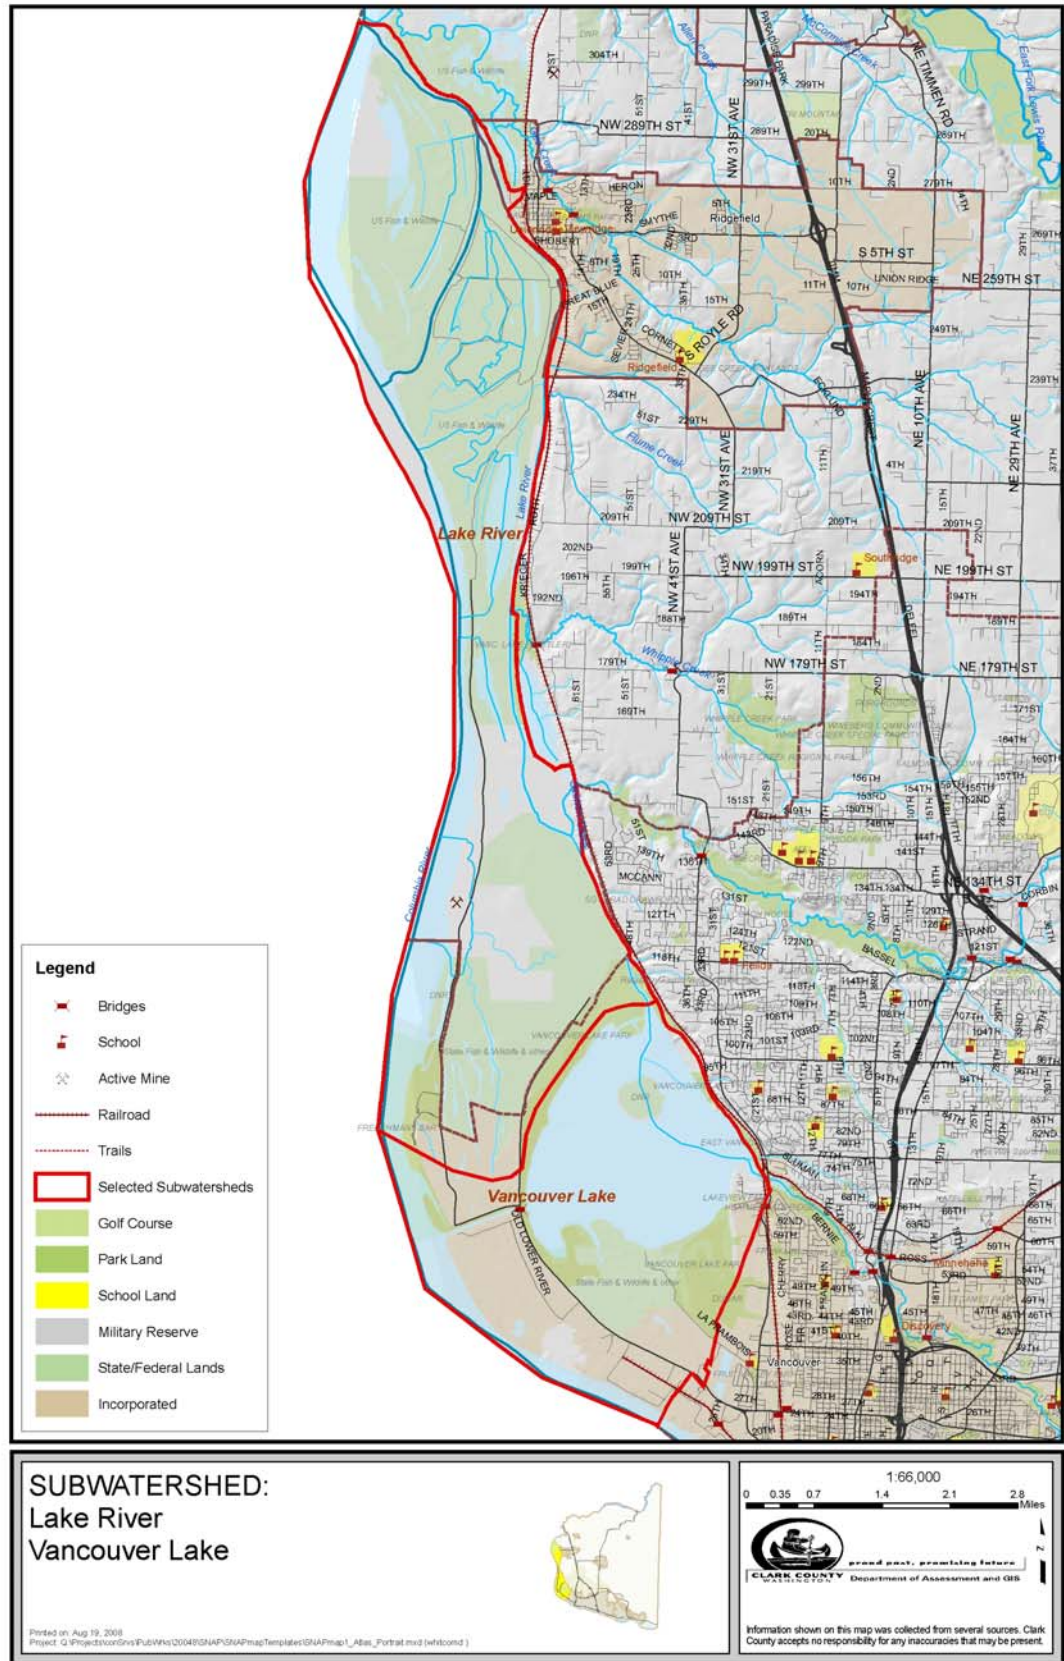
Figure 1: Subwatershed Map – Vancouver Lake and Lake River

Lake River originates in Vancouver Lake and flows northward along the east margin of the study area, eventually discharging into the Columbia River near Ridgefield. Numerous streams, including Salmon Creek, Whipple Creek, and Flume Creek drain from western Clark County into Lake River. Tidal effects cause Lake River to reverse flow back toward Vancouver Lake.

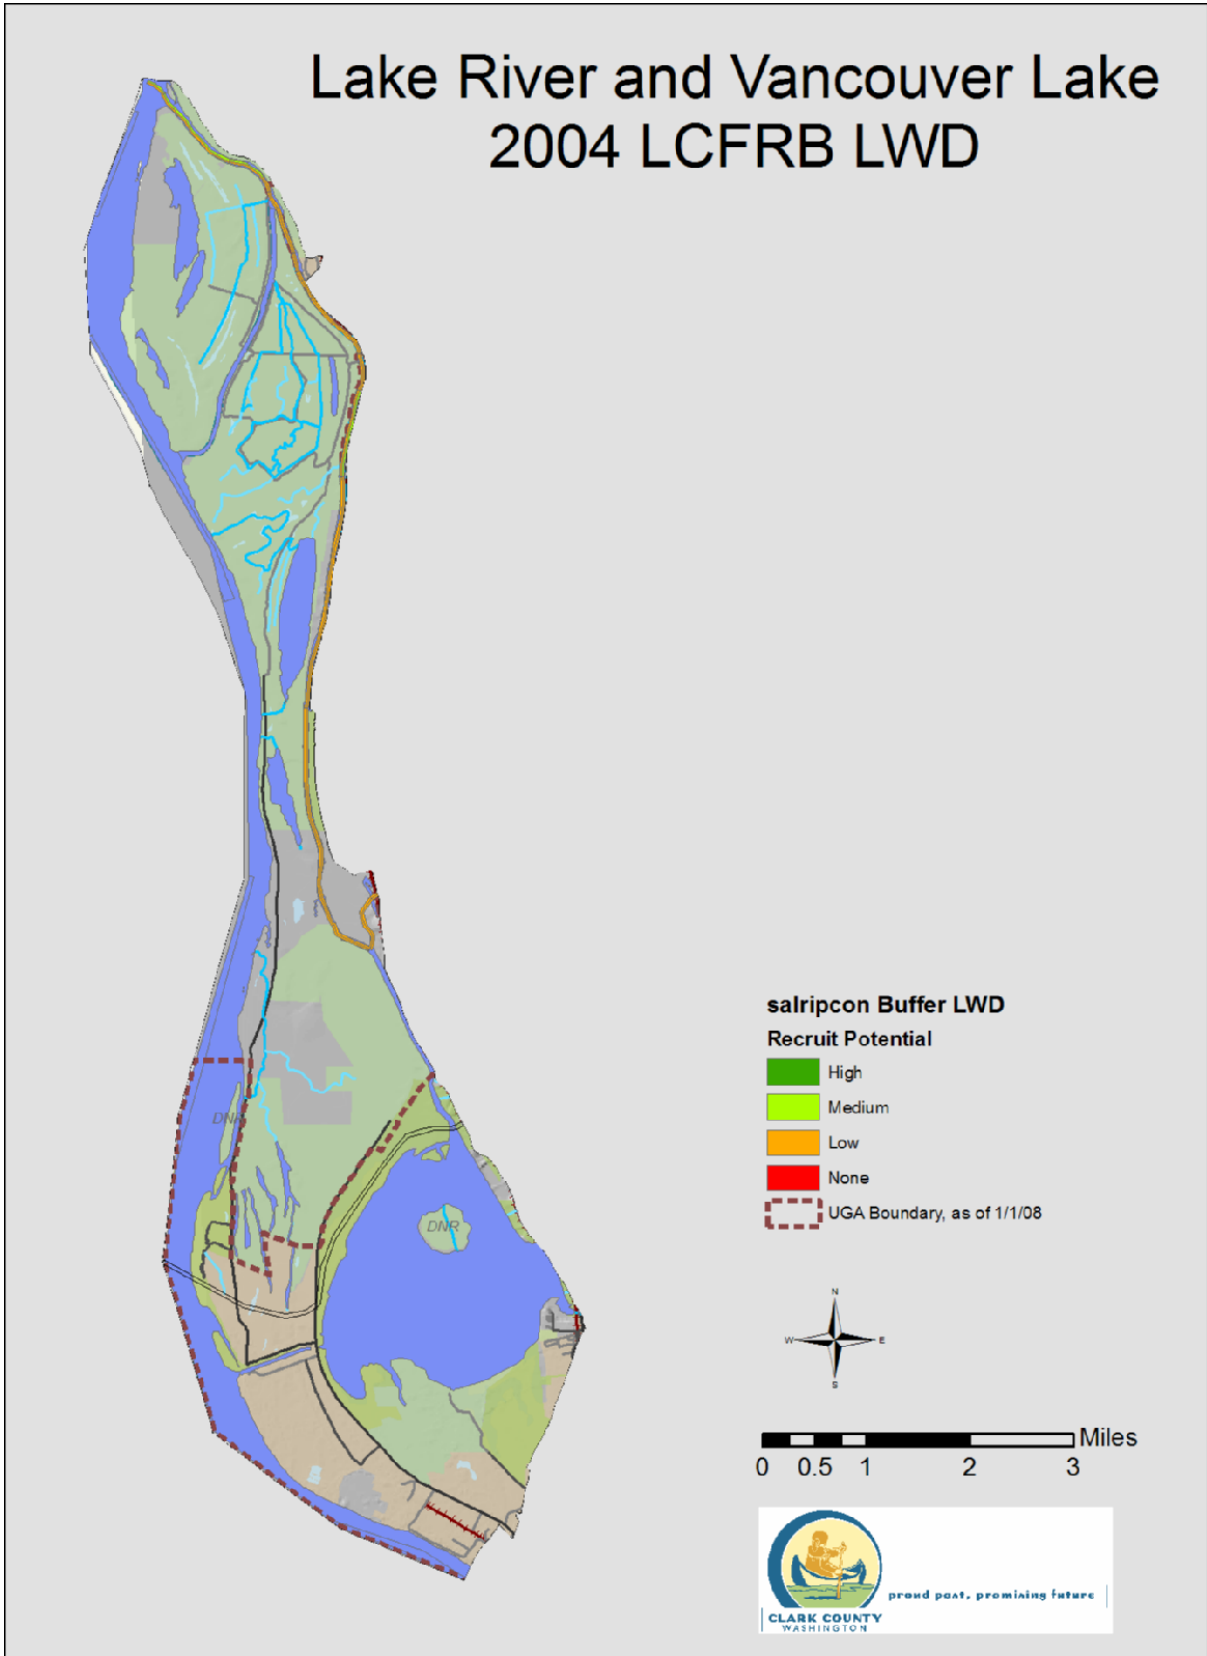
Figure 2: Vancouver Lake and Lake River LWD Recruitment Potential (adapted from R2 Resource Consultants, Inc., 2004)

Figure 2 shows the Lake River subwatershed's LWD delivery potential. The main stem of Lake River is shown as having primarily low LWD recruitment along the approximate seven-mile distance surveyed. This is due in part to the riparian vegetation consisting entirely of deciduous species and also that the disconnection of overflow channels and sloughs has prevented potential LWD recruitment to stream channels. (R2 Resource Consulting, Inc., 2004 and LCFRB, 2004). The unsurveyed portion of Lake River is estimated to have LWD recruitment levels of none to low based on orthophotography review.

In the 2004 LCFRB Habitat Assessment, LWD delivery potential was estimated as low in much of the Lake River subwatershed, with impaired riparian conditions throughout. Shade levels were off-target with respect to state standards, ranging from zero to 20 percent.

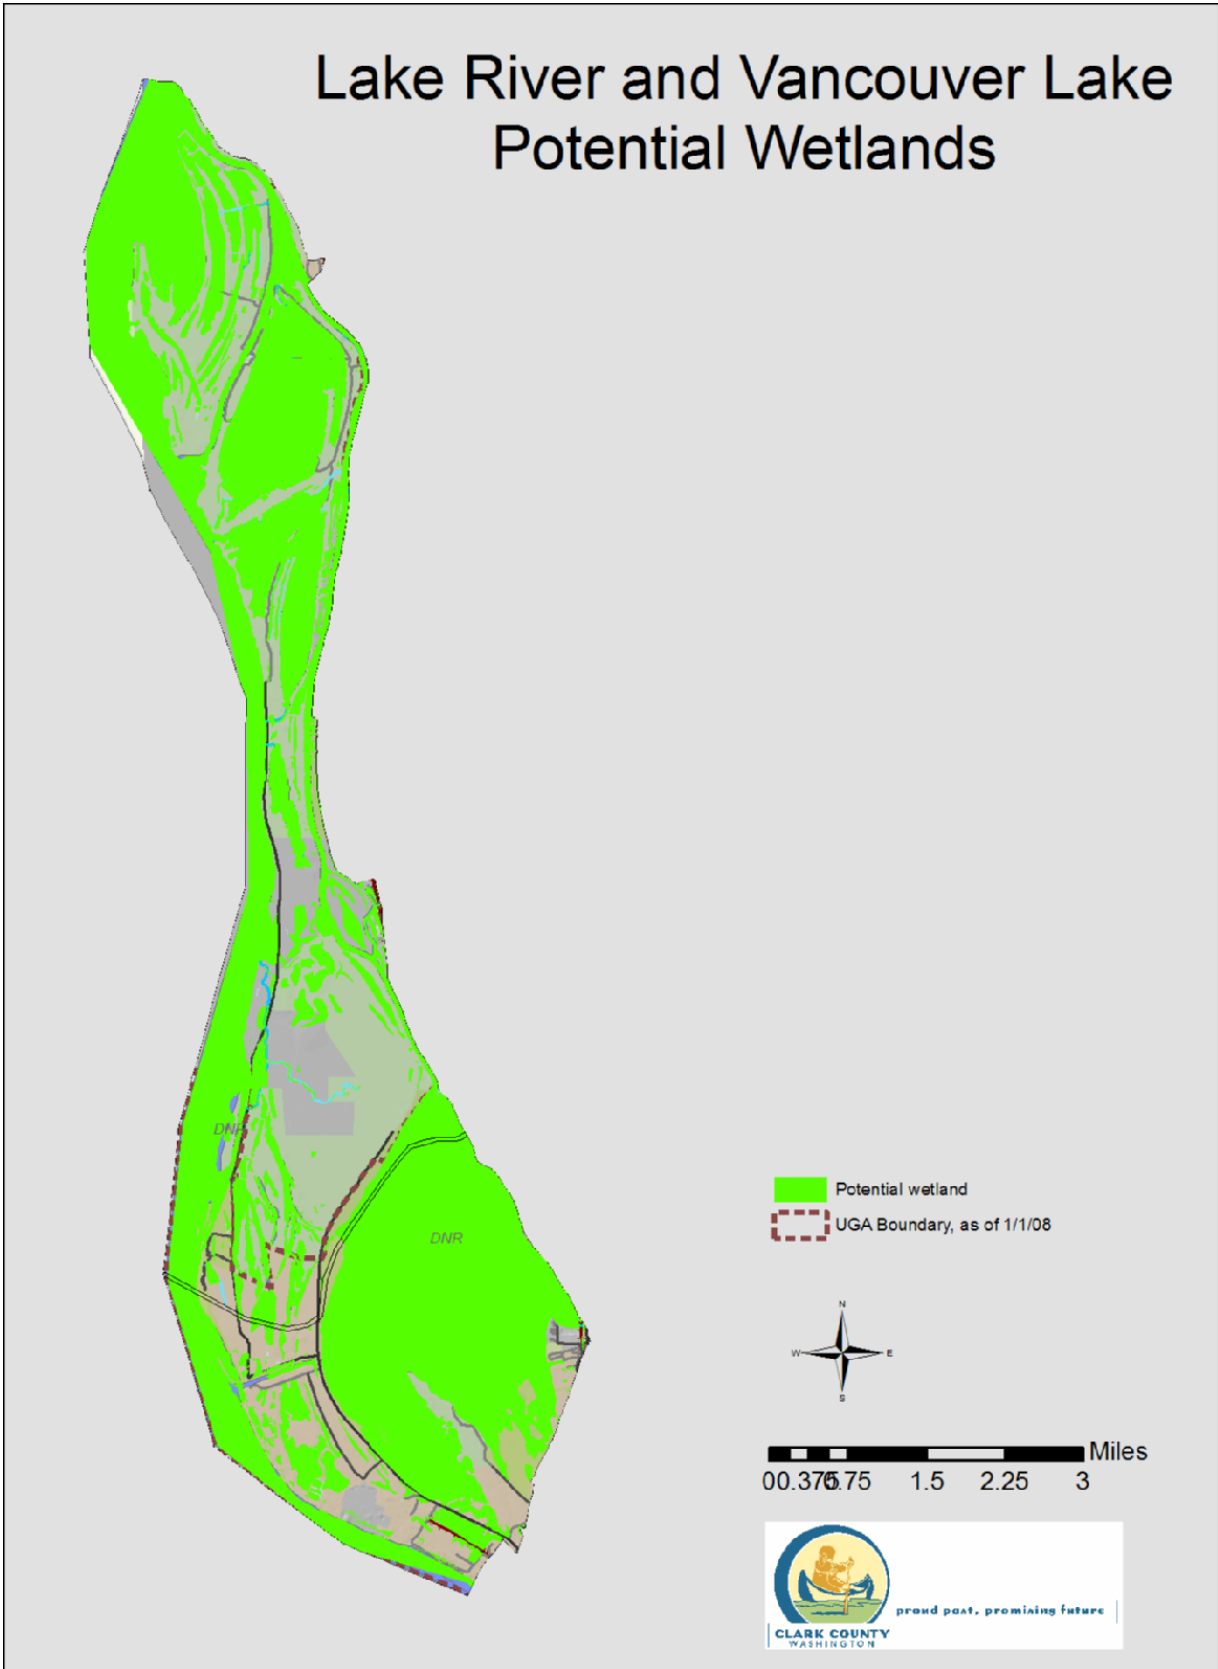
Figure 4: Vancouver Lake and Lake River Potential Wetlands

In the Vancouver Lake subwatershed, wetlands are primarily associated with Vancouver Lake and the Columbia River floodplain. Many of these wetlands are degraded by past agricultural activity.

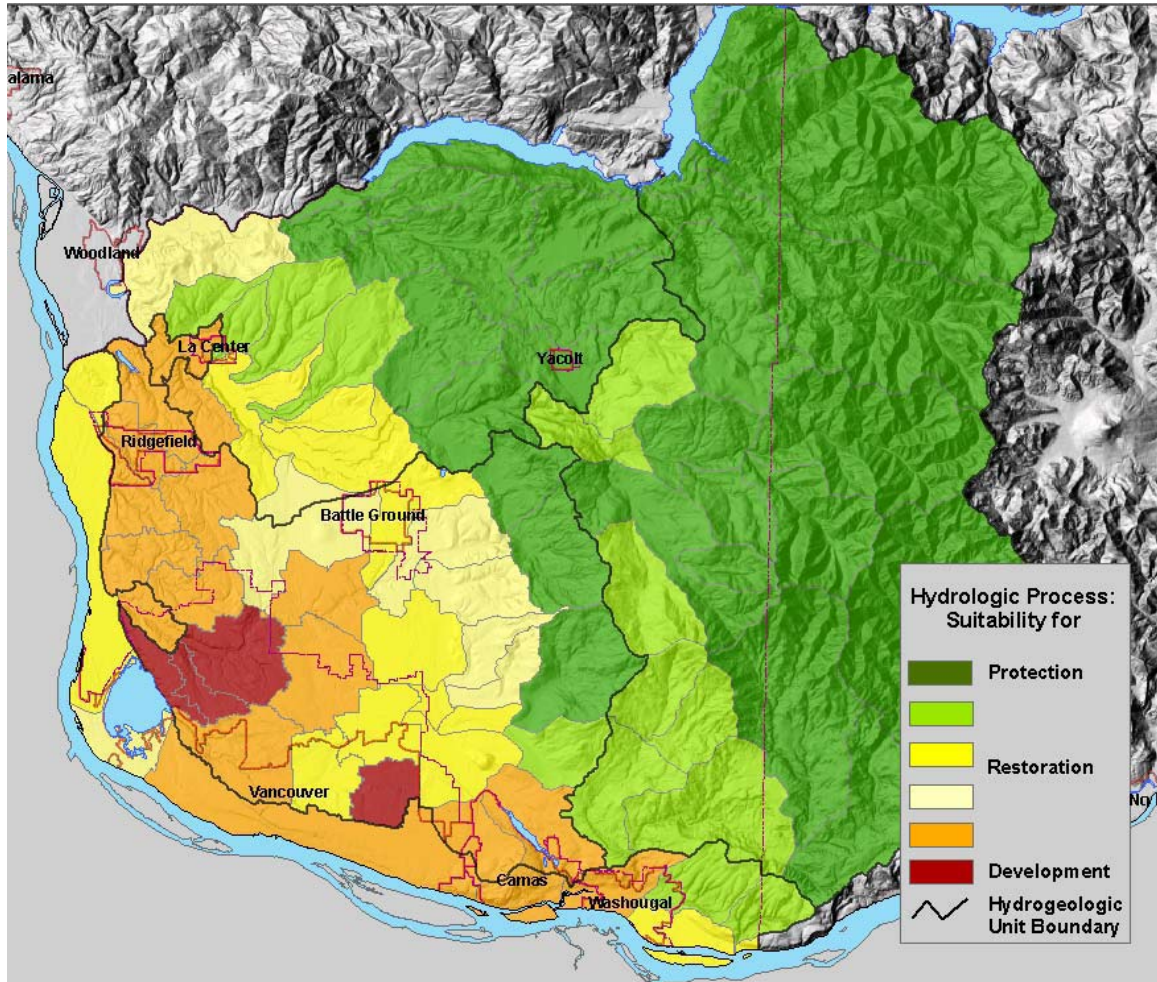
Figure 5: Priorities for suitability of areas for protection and restoration for the hydrologic process (from Draft Watershed Characterization of Clark County (Ecology, 2007)).

Figure 5 depicts priority areas for protection and restoration of hydrologic processes county-wide based on an analysis of the relative importance and level of alteration in each subwatershed.

In general, green areas have higher levels of importance for watershed hydrologic processes and limited alteration and should be considered for protection. Yellow areas have a higher level of importance for watershed processes and a higher level of alteration and should be considered for restoration unless watershed processes are permanently altered by urban development. Orange to red areas have lower levels of importance for watershed processes and higher levels of alteration and should be considered as more suitable for development (Ecology, 2007).

Ecology's draft wetland characterization of Clark County places the study area in a category suitable for restoration due to a higher relative level of importance for watershed processes and a higher level of current alteration from historical conditions.

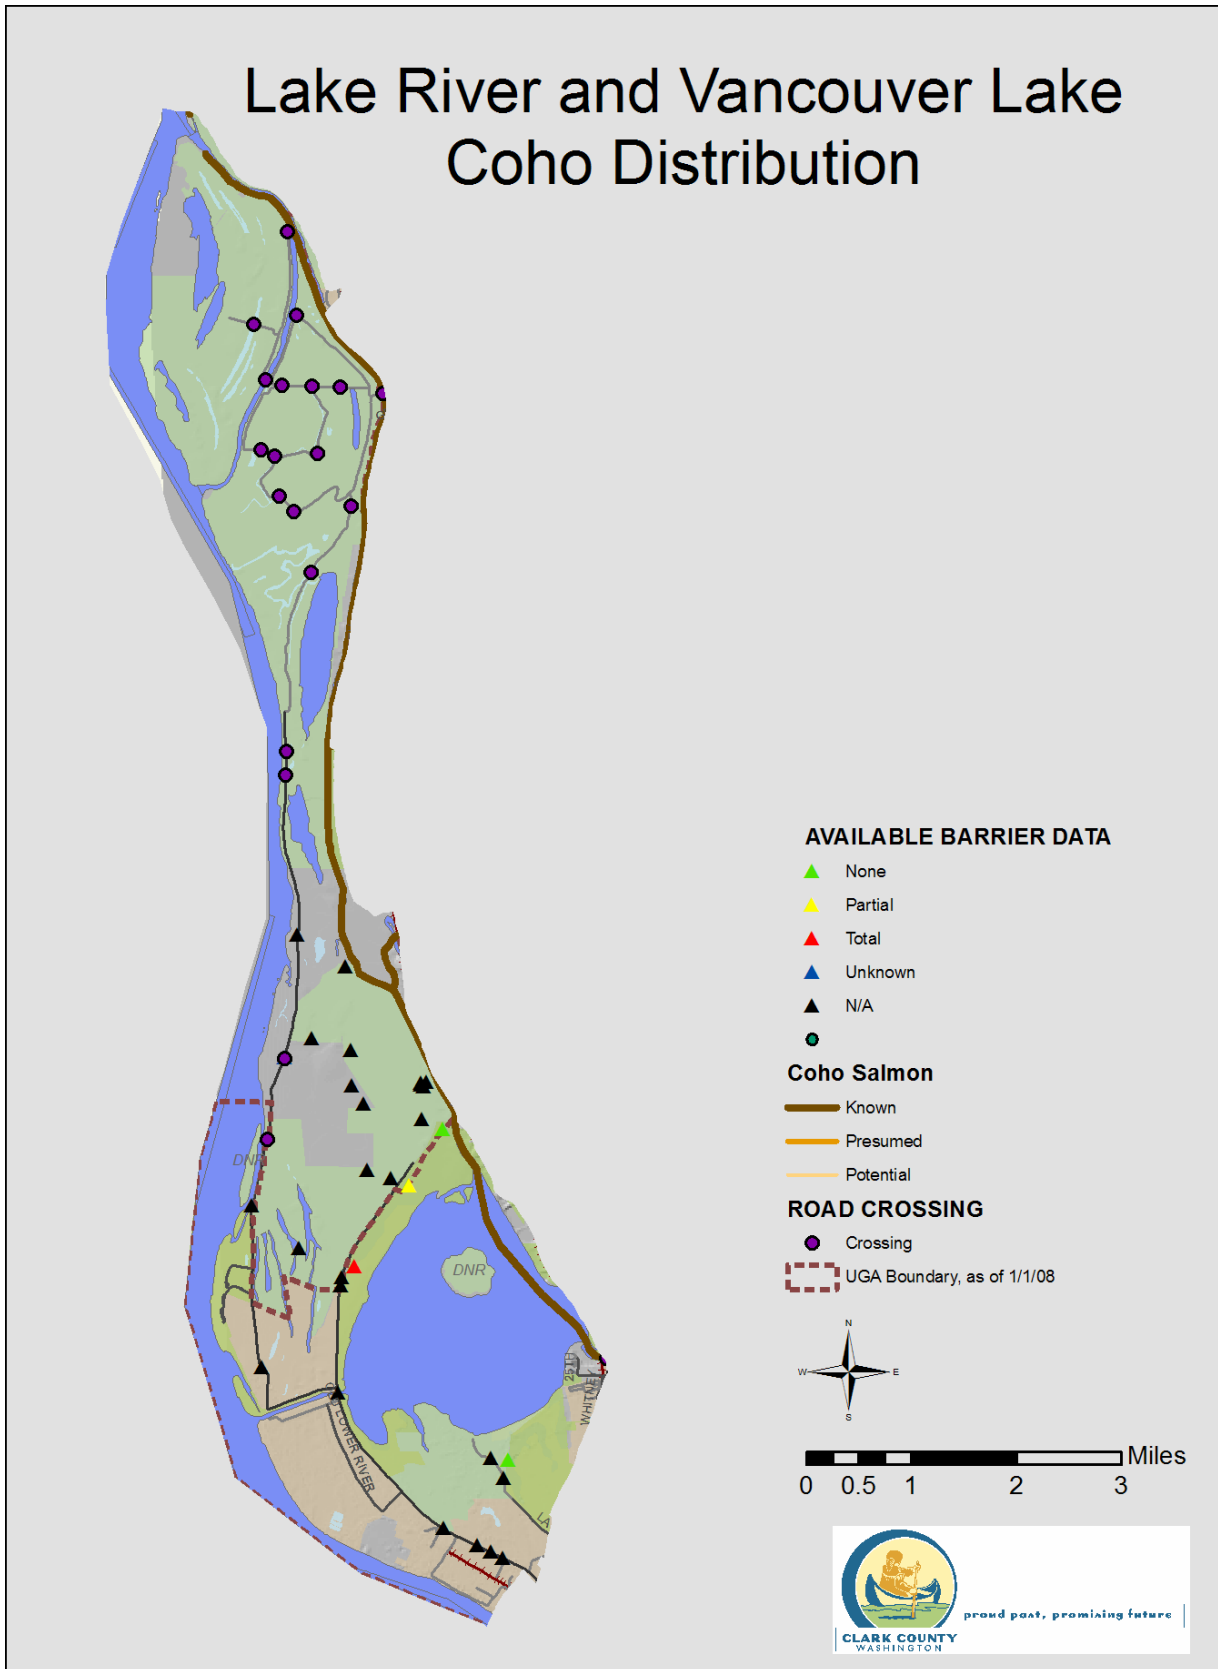
Figure 6: Vancouver Lake and Lake River Fish Distribution and Barriers

Vancouver Lake and the associated flushing channel to the Columbia River at the southwest end of the lake are not mapped as having any full or partial barriers. The flushing channel is a 4,400 foot long channel that allows water from the Columbia River to flow into Vancouver Lake. It has a system of culverts and tide gates at the lake end to prevent flow out of the lake. The flushing channel analysis completed by Fishman (2002) documented habitat conditions and juvenile salmonid use within the channel. Fishman concluded that: “current habitat conditions do not preclude the use of the flushing channel by ESA-listed salmonids. Suitability of habitat is likely seasonal, depending on water quality conditions and Columbia River levels”.
